CONDITION ASSESSMENT AND ANALYSIS
OF THE GODDARD MANSION
FORT WILLIAMS PARK,
CAPE ELIZABETH, MAINE

THE TOWN OF CAPE ELIZABETH
CAPE ELIZABETH, MAINE

SEPTEMBER, 2004

360.28.01

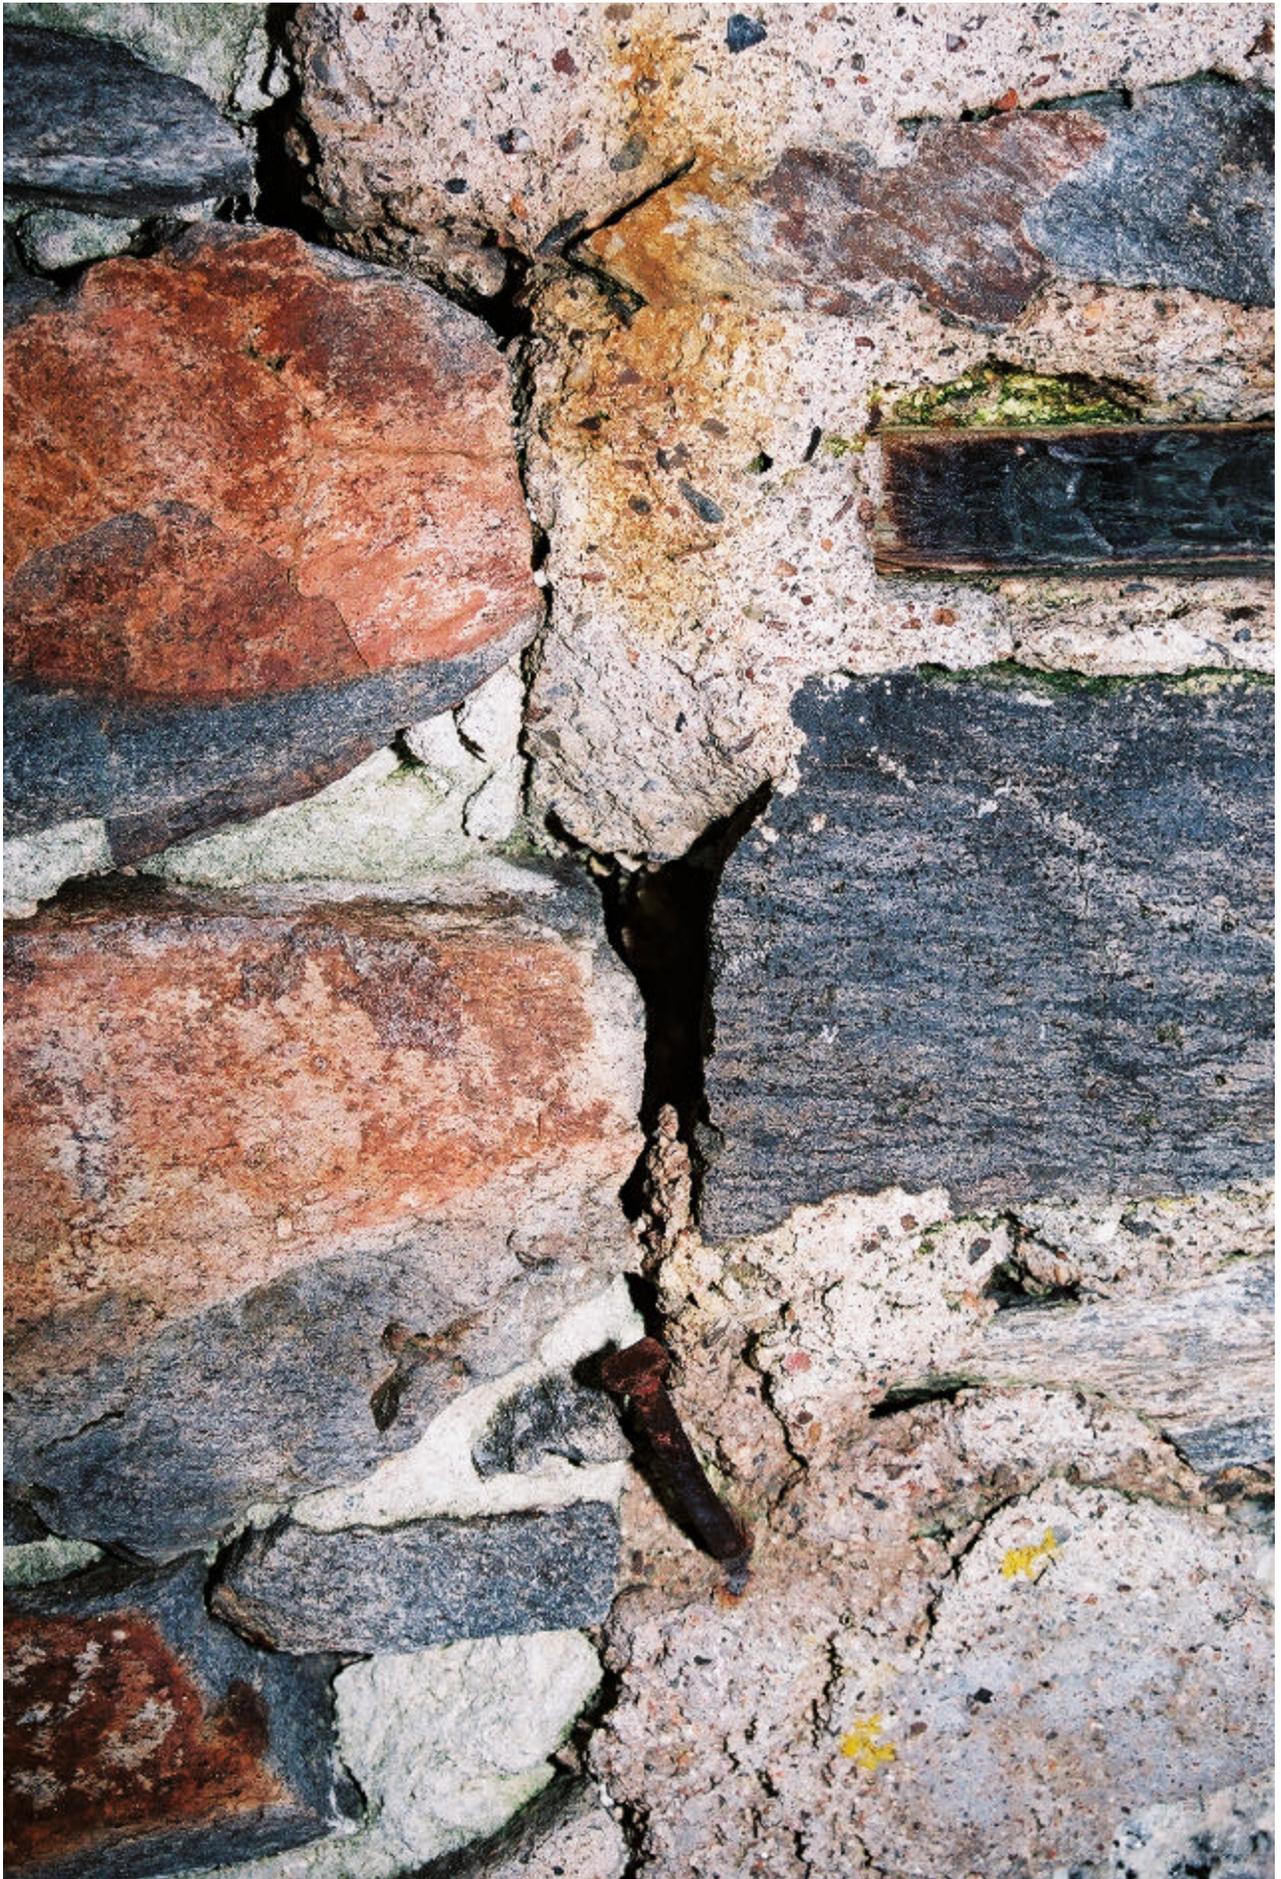
- i. Mortar Rating I: Areas of the walls which have been designated with a “I” are in poor condition. Many of these areas have become severely eroded allowing stones and mortar to fall from the wall, causing a hazardous condition. These areas should be the highest priority in the construction phasing process. See attached photograph #1: Type I Mortar Joint.

Photograph #1: Type I
Mortar Joint (Poor Condition)

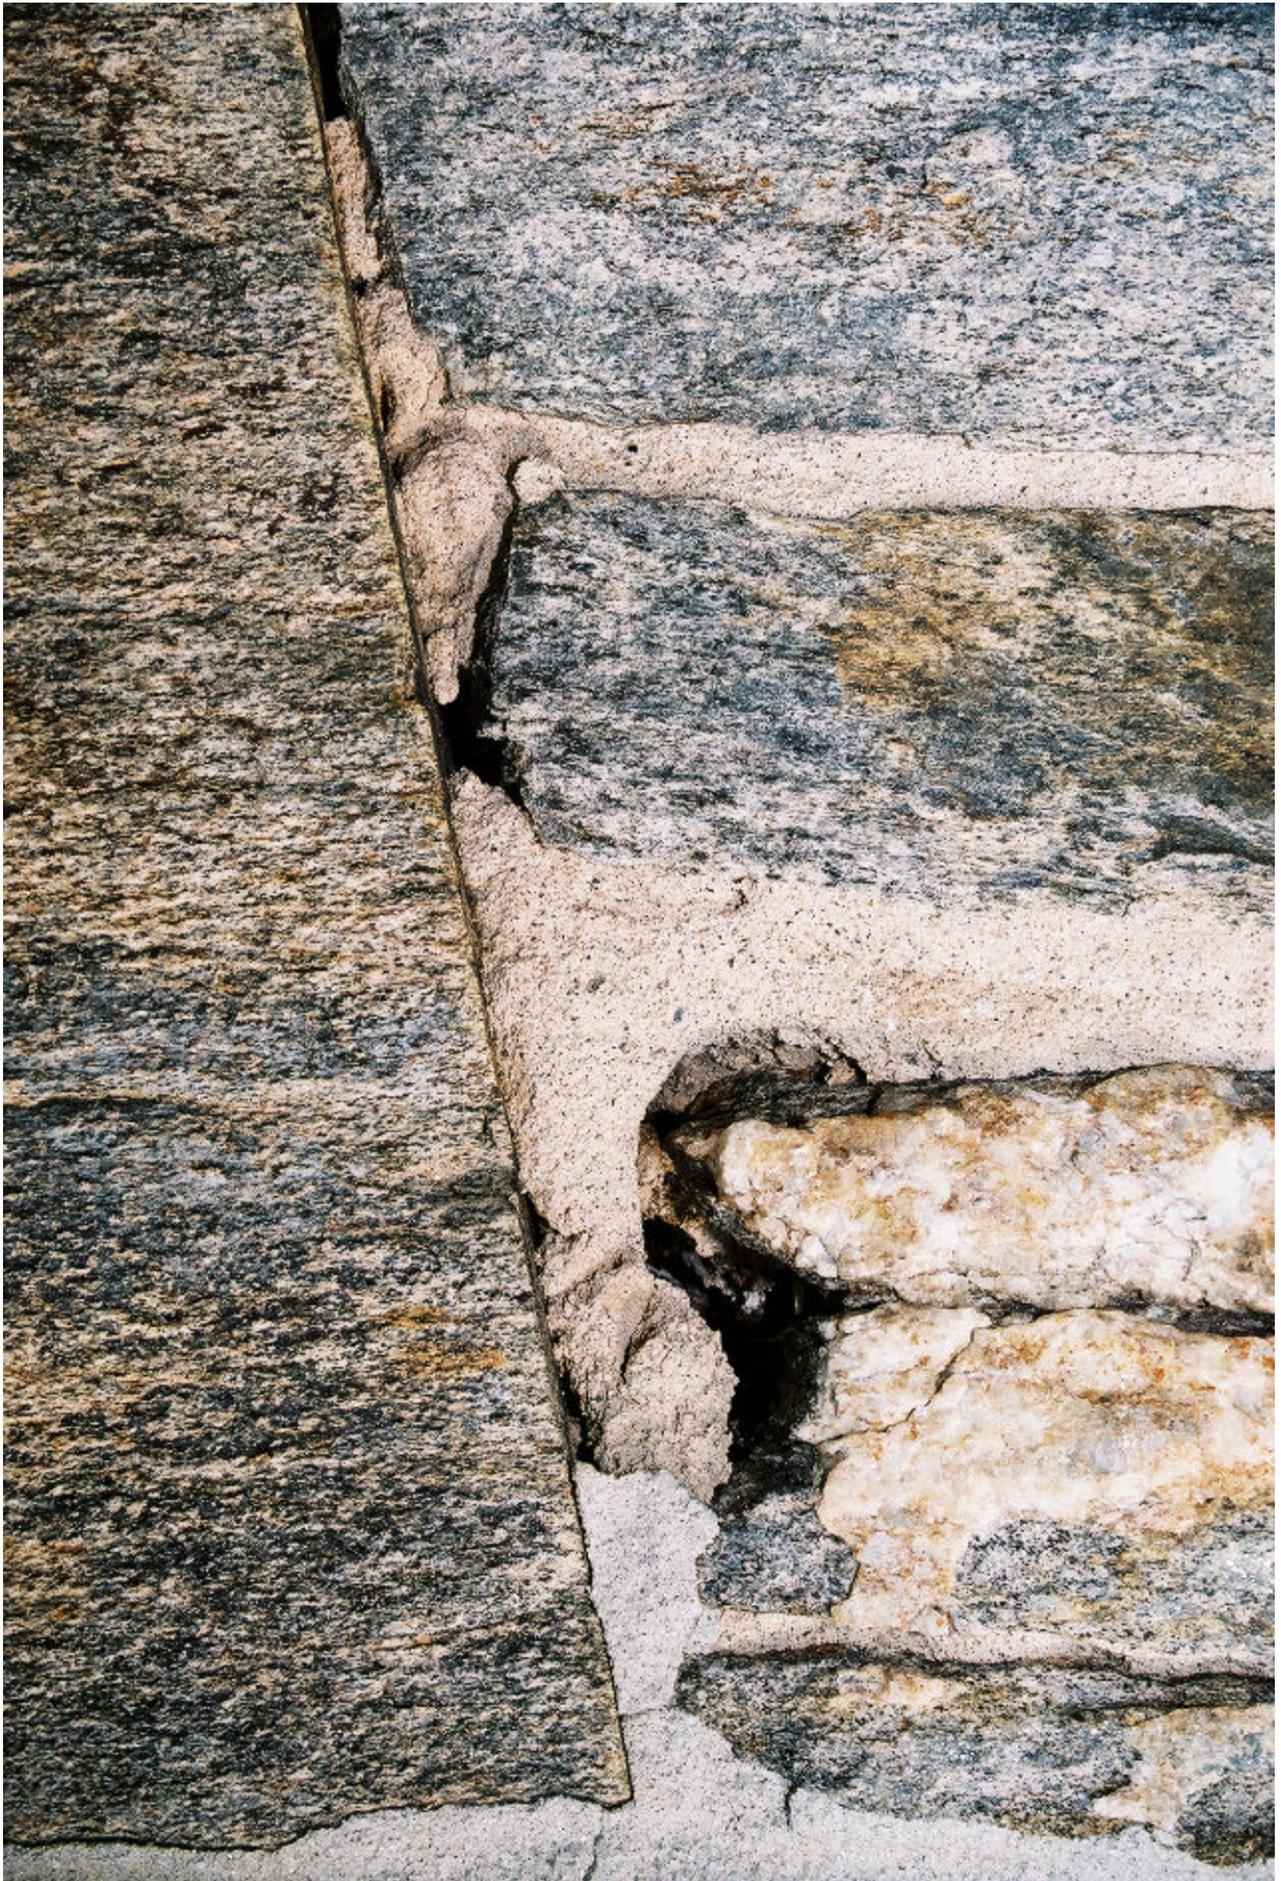
- ii. Mortar Rating II: Areas of the walls which have been designated with a “II” are in unsatisfactory condition. In most cases the mortar is still supporting the dead and live loads, but is in varying states of weathering. These joints are allowing water to access the joints; subsequent frost action will further degrade the mortar. See attached photograph #2: Type II Mortar Joint.

Photograph #2: Type II
Mortar Joint (Unsatisfactory Condition)

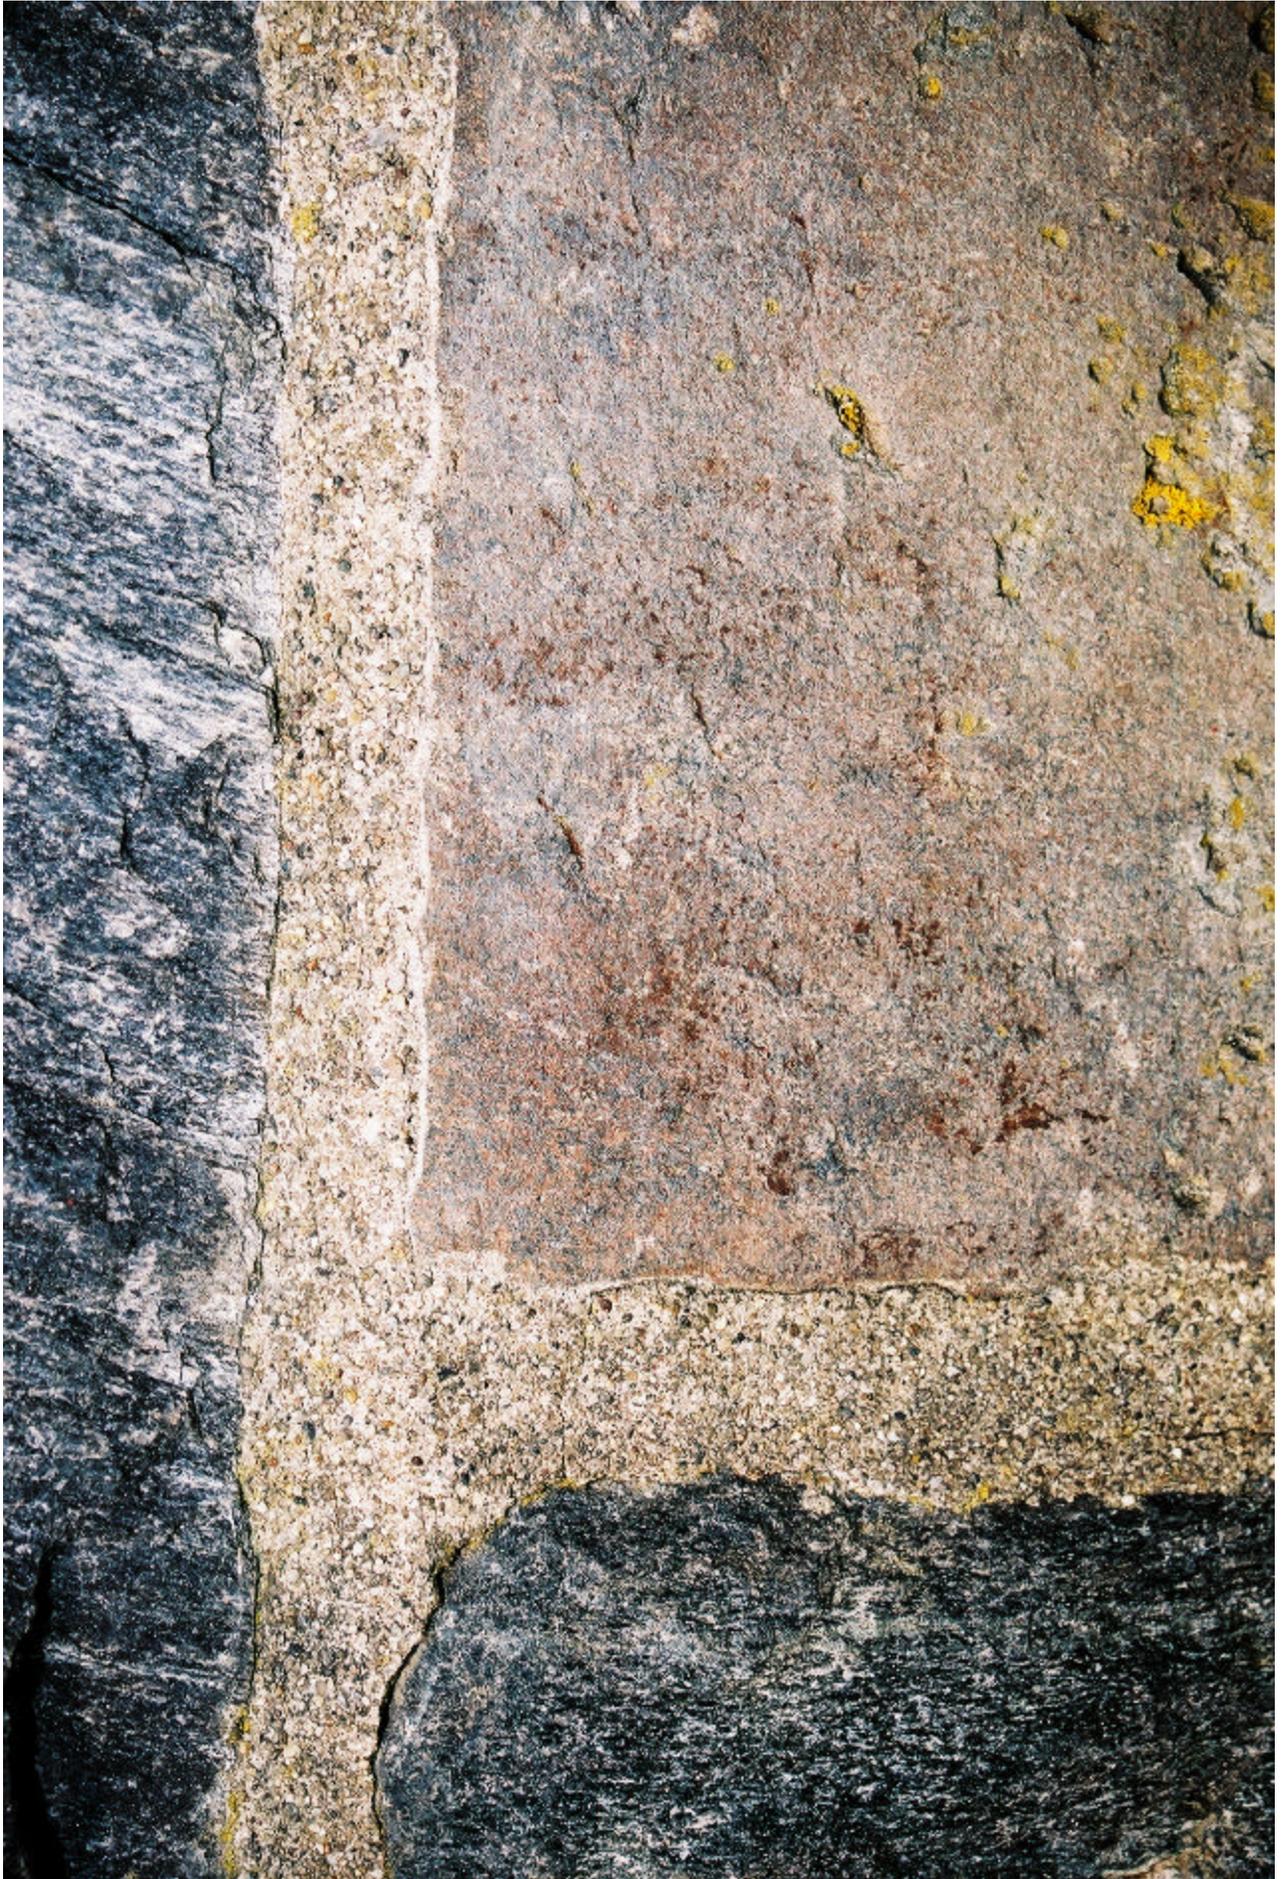
- iii. Mortar Rating III: Areas of the wall which have been designated with a “III” are in satisfactory condition. The mortar in the joints is tightly bonded to the stones or bricks making a watertight joint. See attached photograph #3: Type III Mortar Joint.

Photograph #3: Type III
Mortar Joint (Satisfactory Condition)

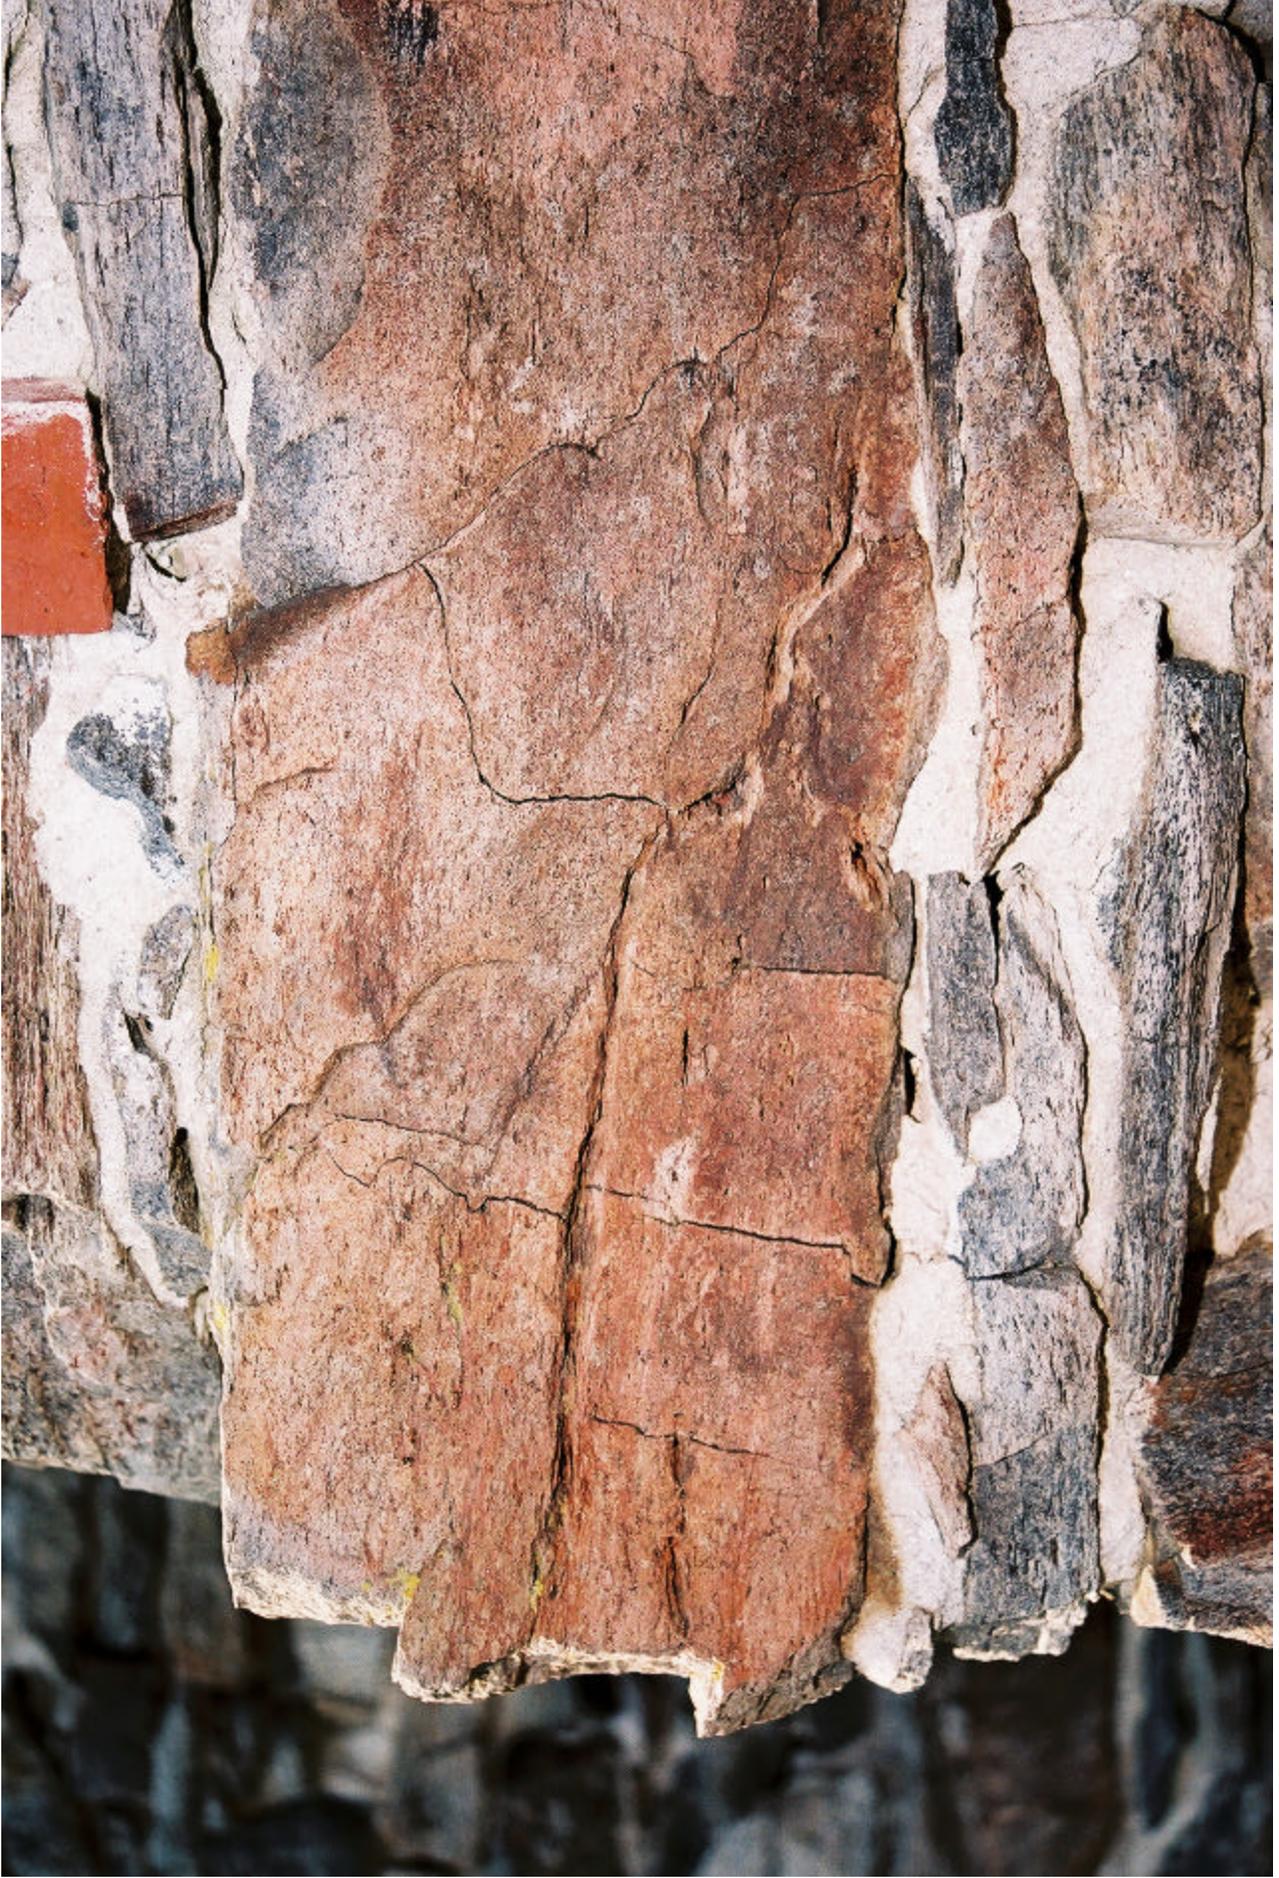
- a. Investigation of Masonry Stone: During the field investigation, the large areas of cracked masonry stone were noted. There are numerous individual stones which are cracked, but the integrity of the wall as a structural system did not appear to be compromised. The drawings and specifications will identify which types of cracked stones should be replaced. See attached photograph #4: Interior stone masonry.

Photograph #4: Interior Stone Masonry
Note cracks in stone and mortar.

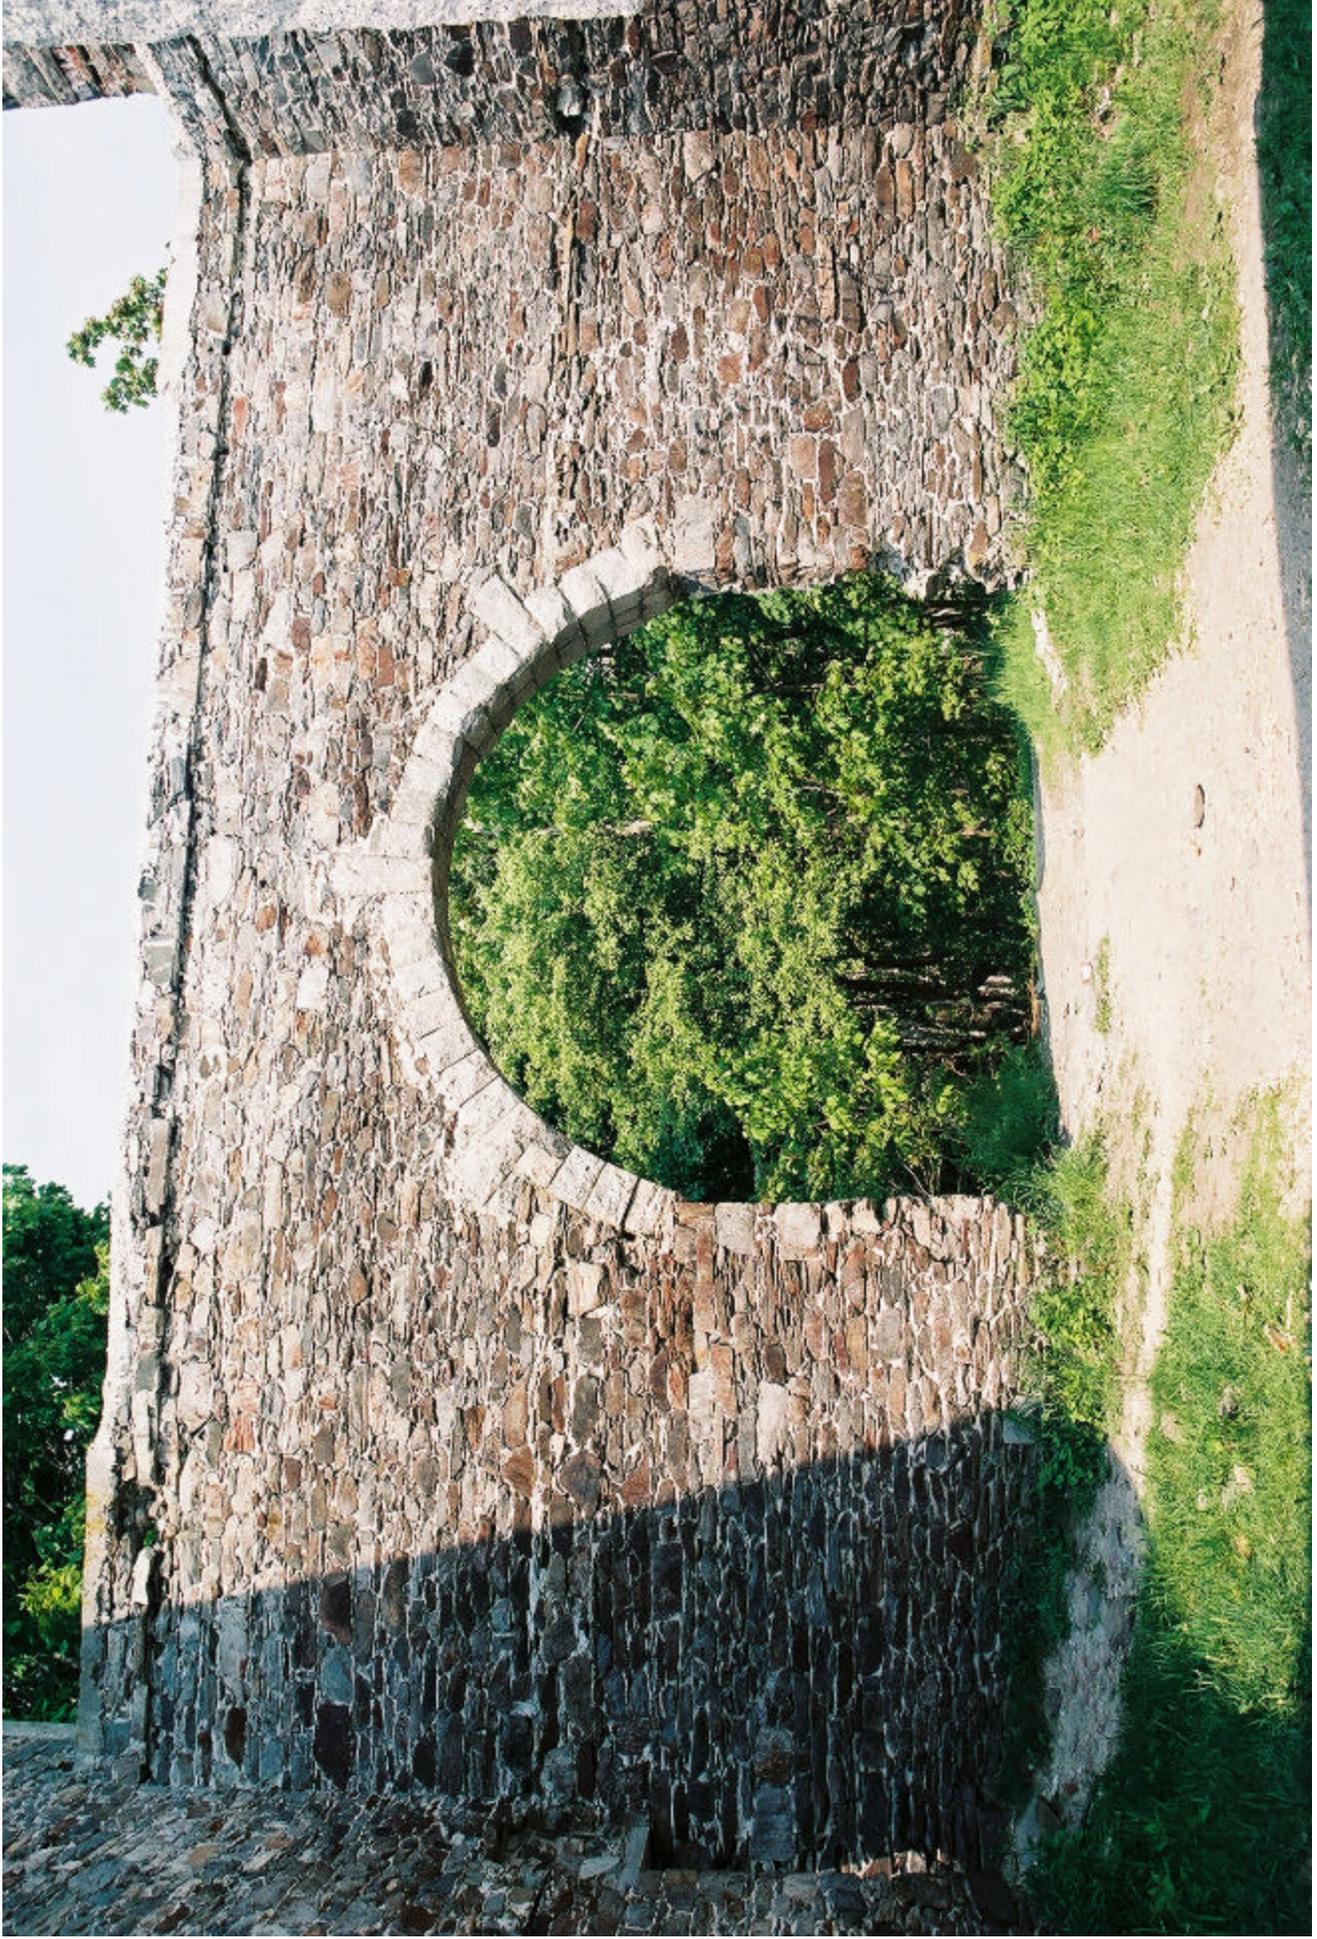
Photograph #5: Typical Interior Wall (Rubble Stone)

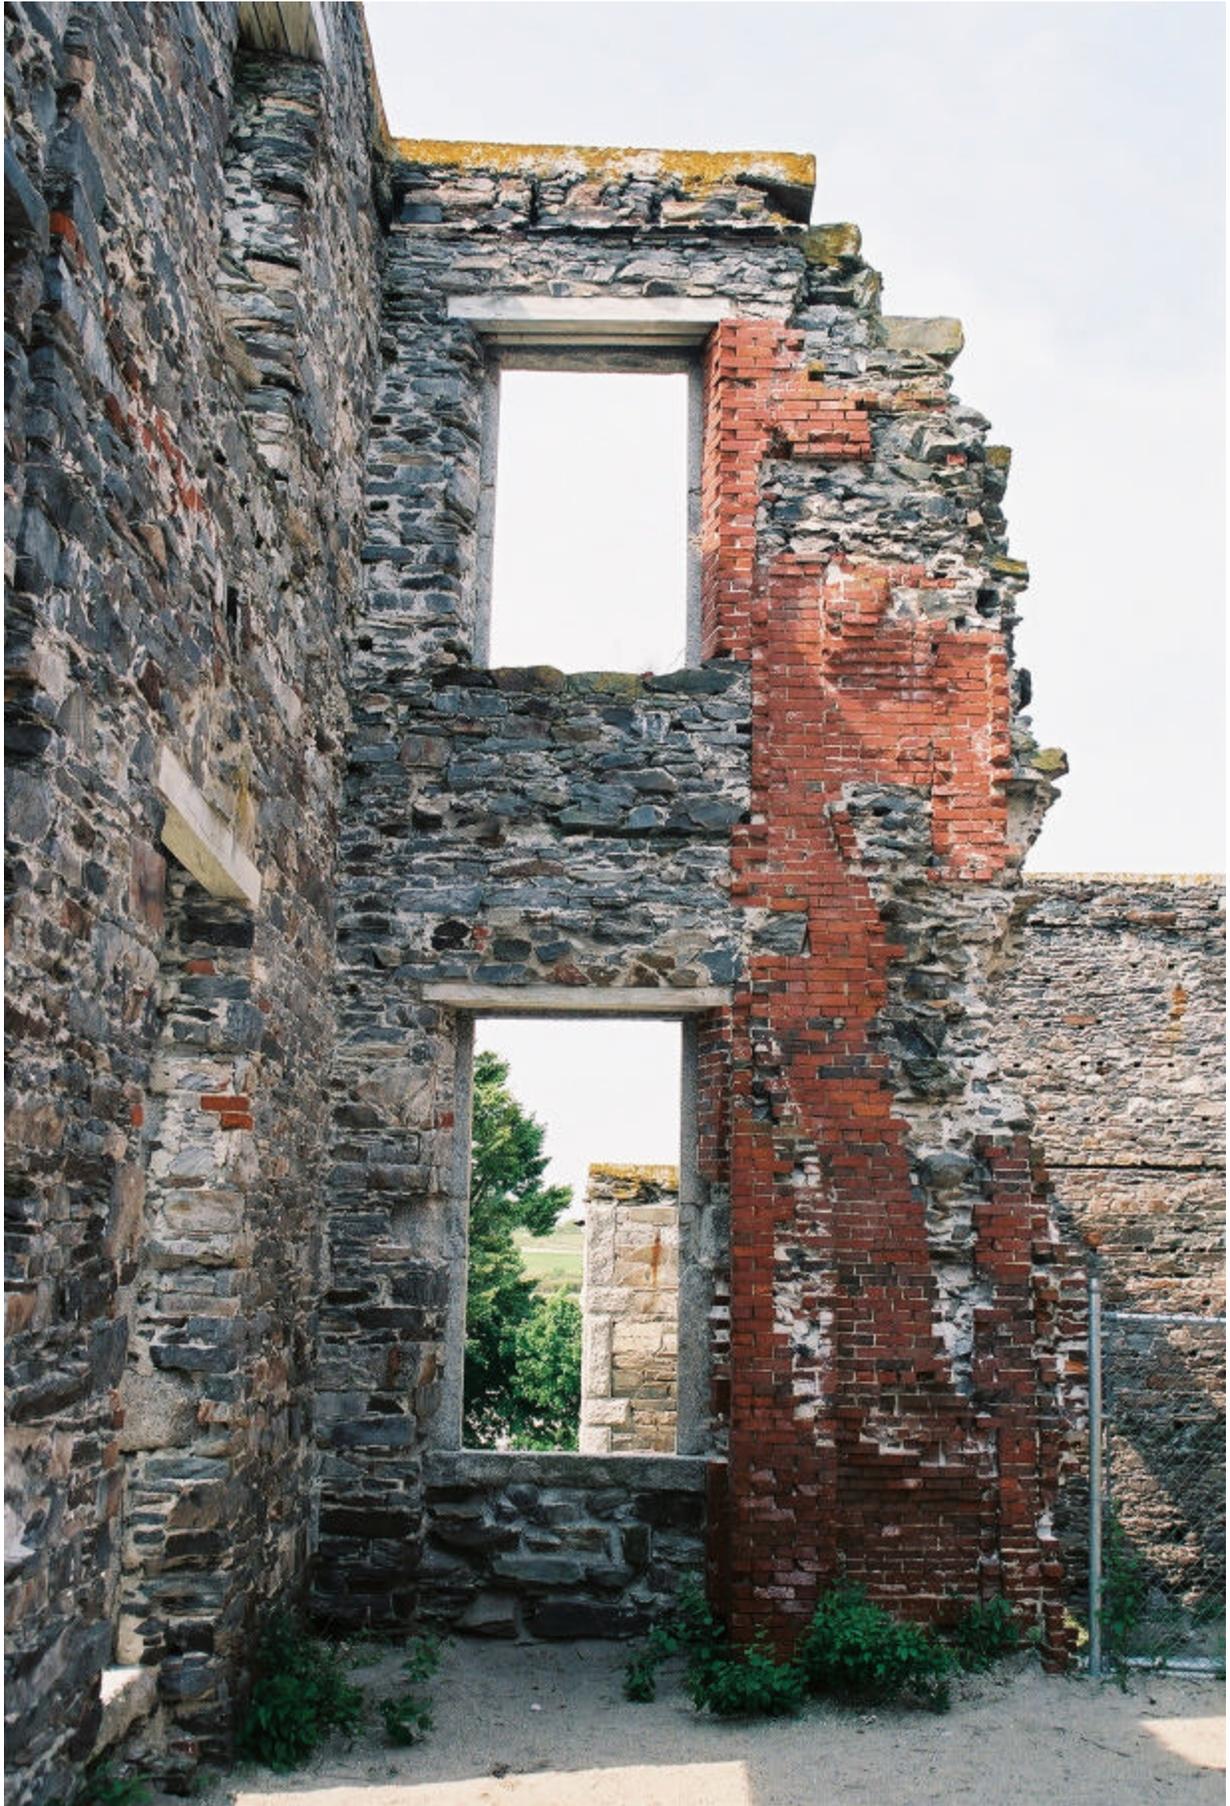
Photograph #6: Interior Wall
Note brick infill repair and typical interior rubble stone work.

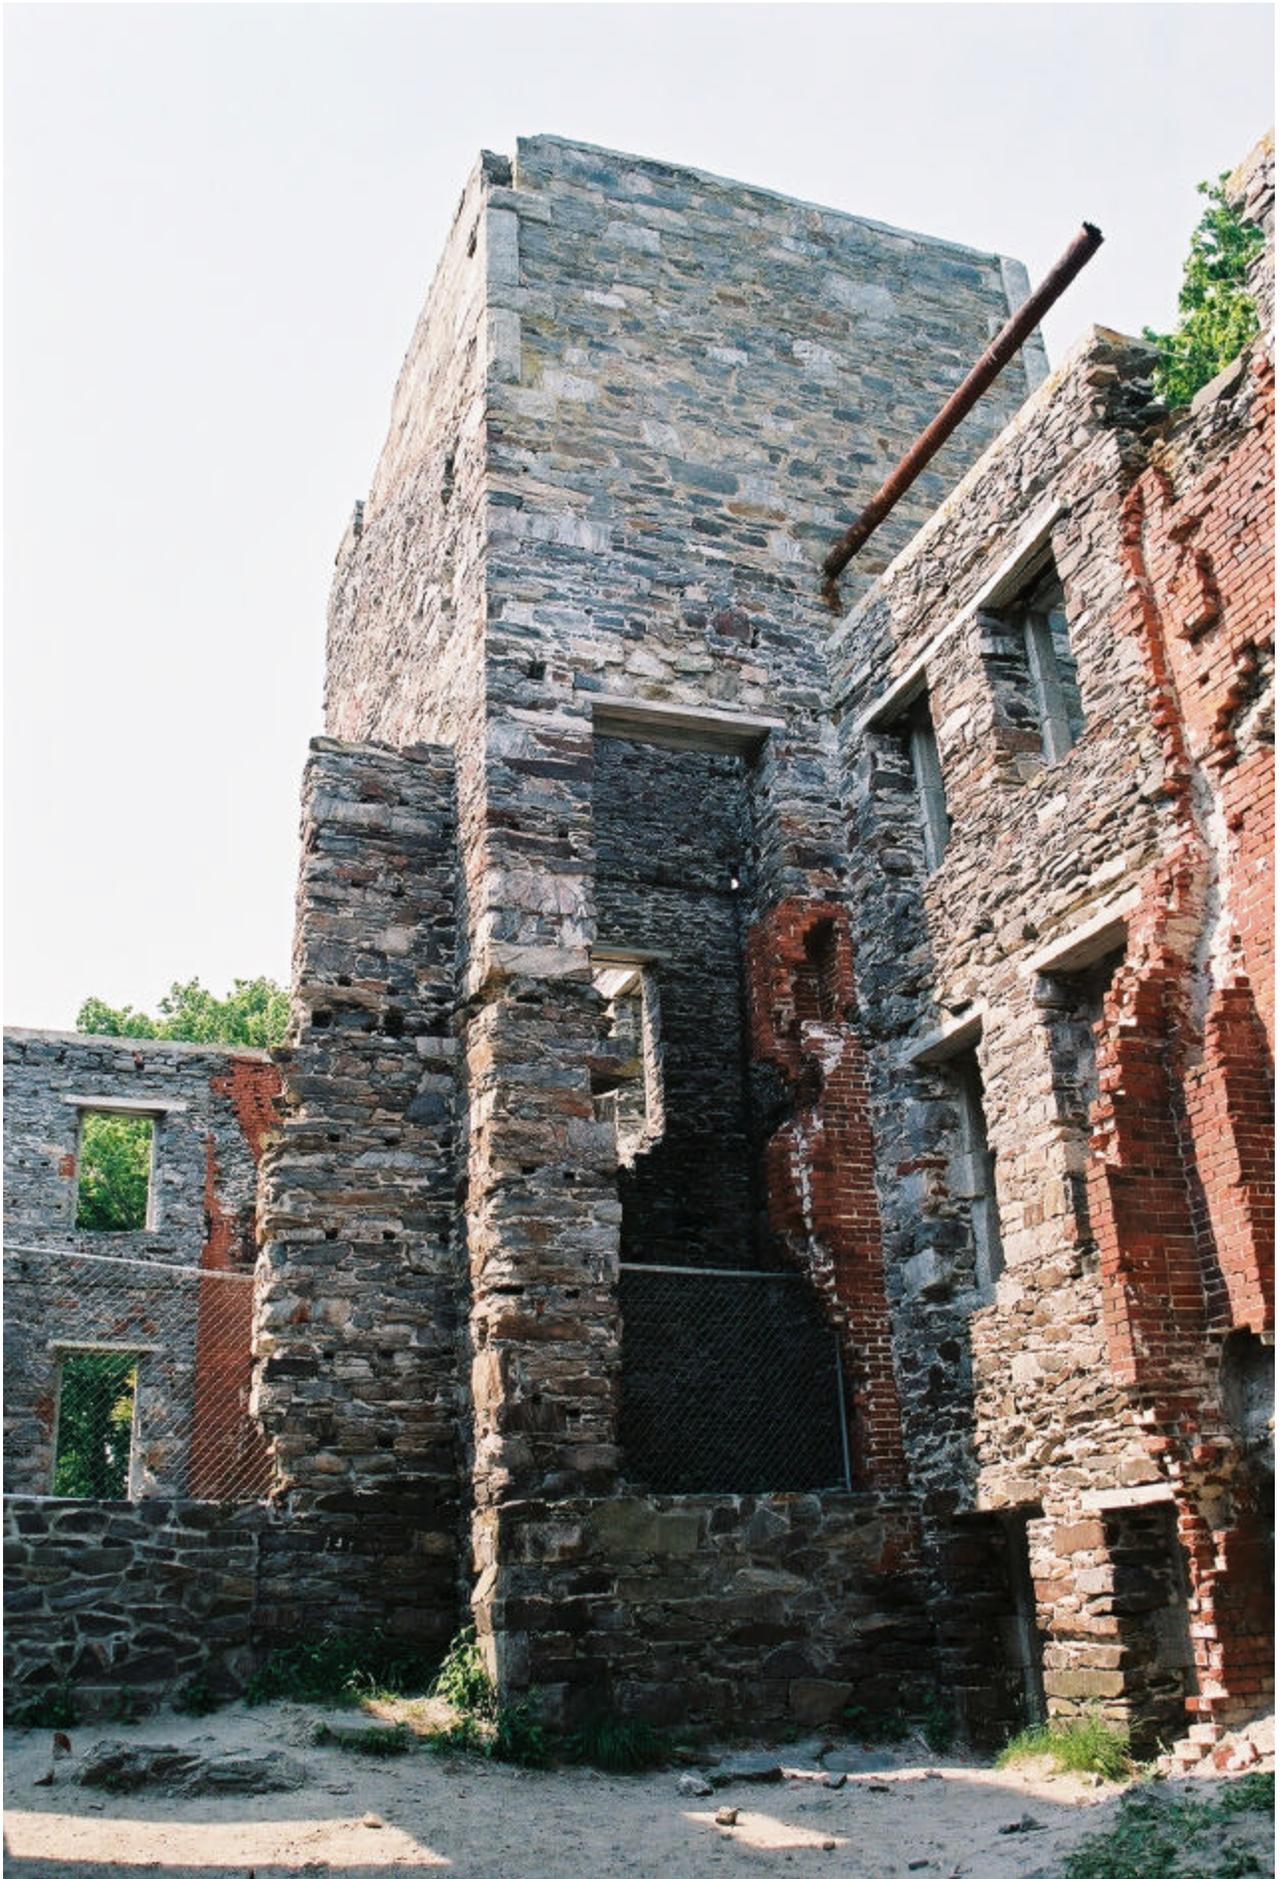
Photograph #7: Interior Walls
Note fireplace and chimney at right.

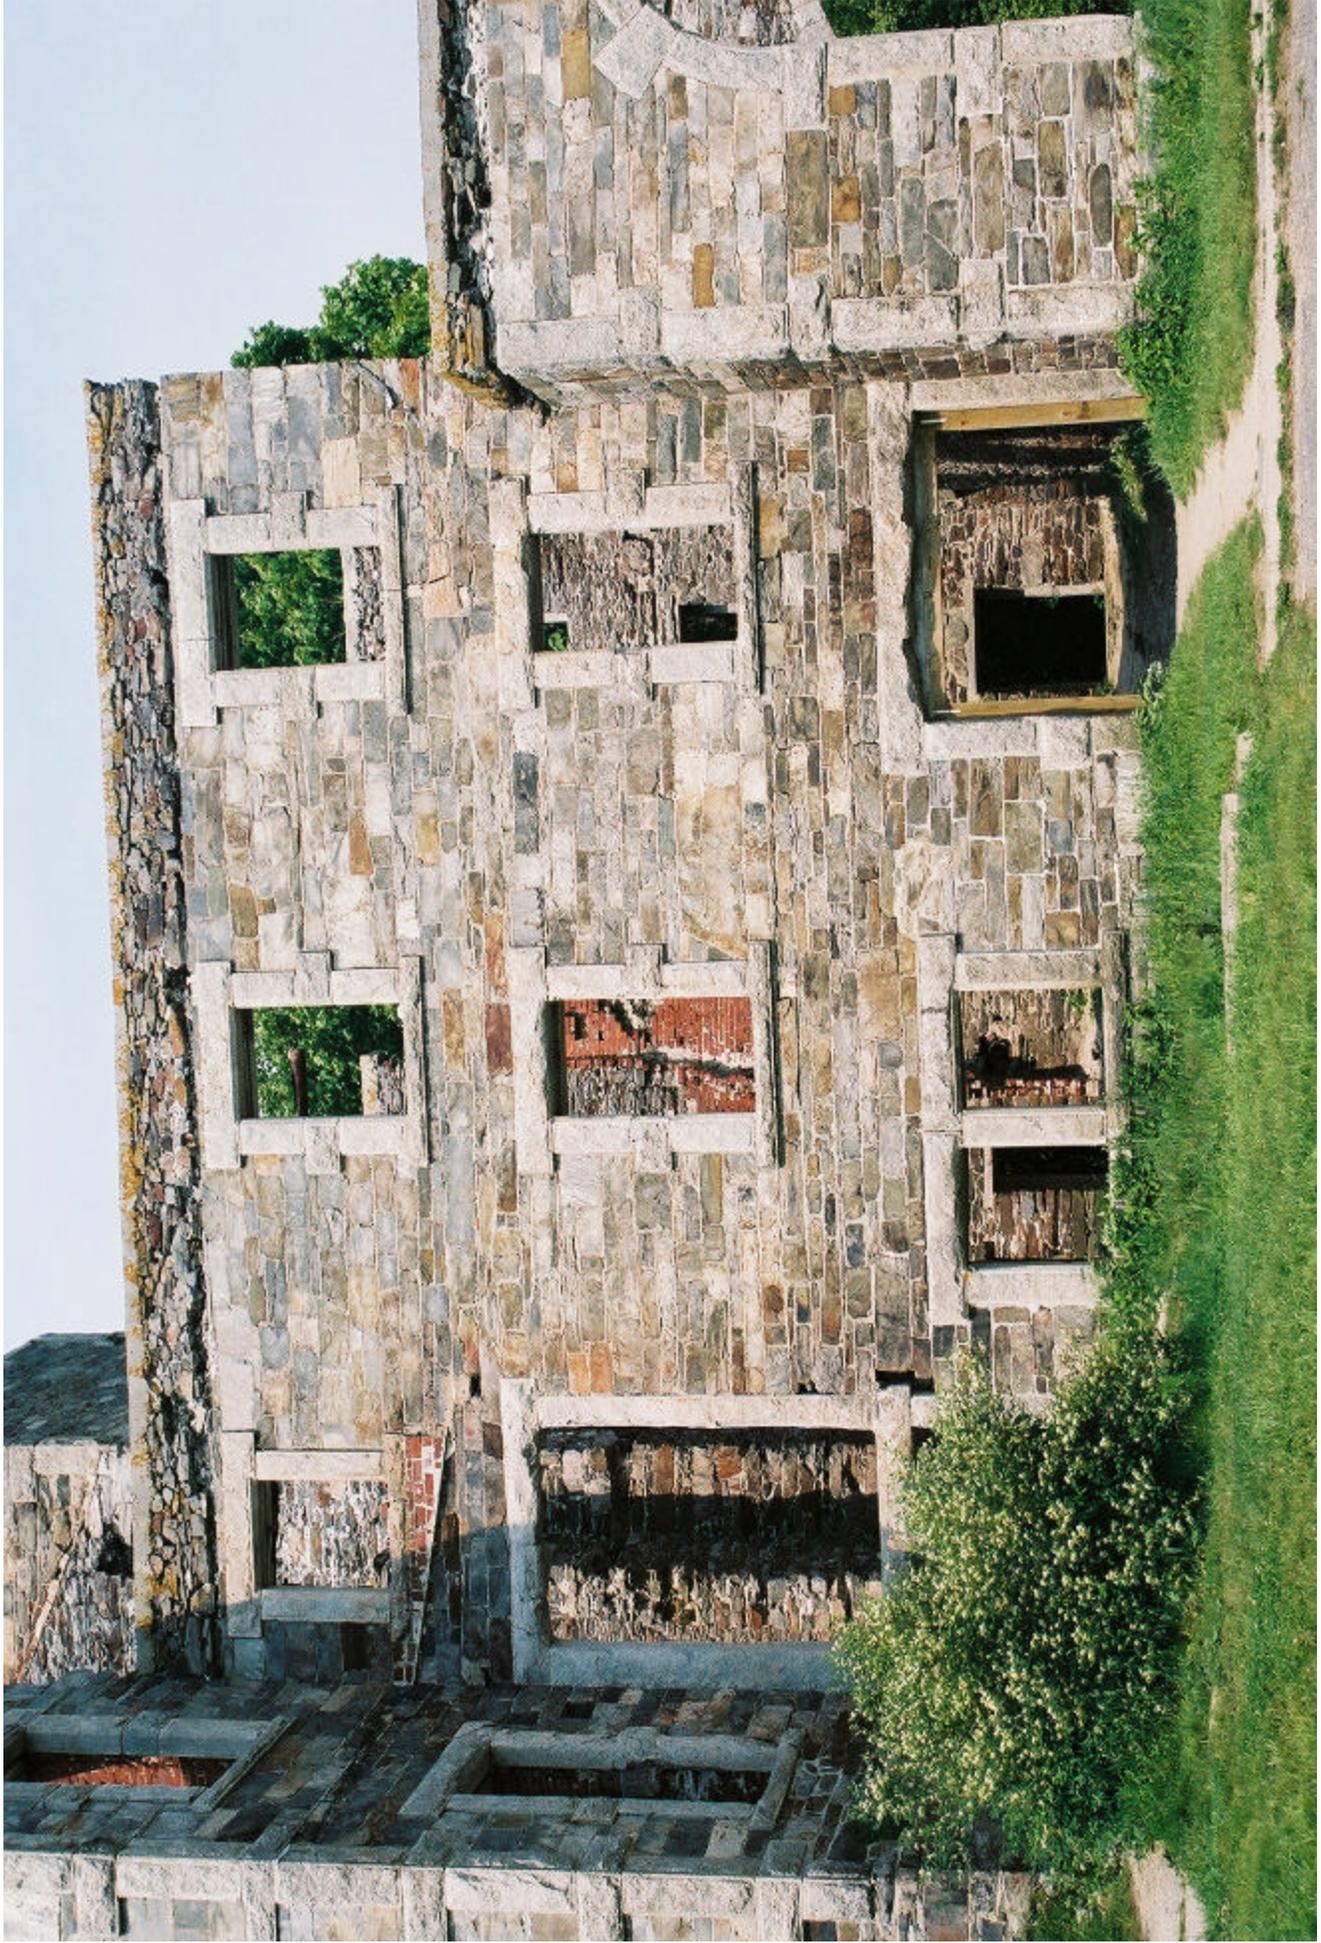
Photograph #8: Exterior Wall
Note rubble stone work at top of wall (formerly unexposed).

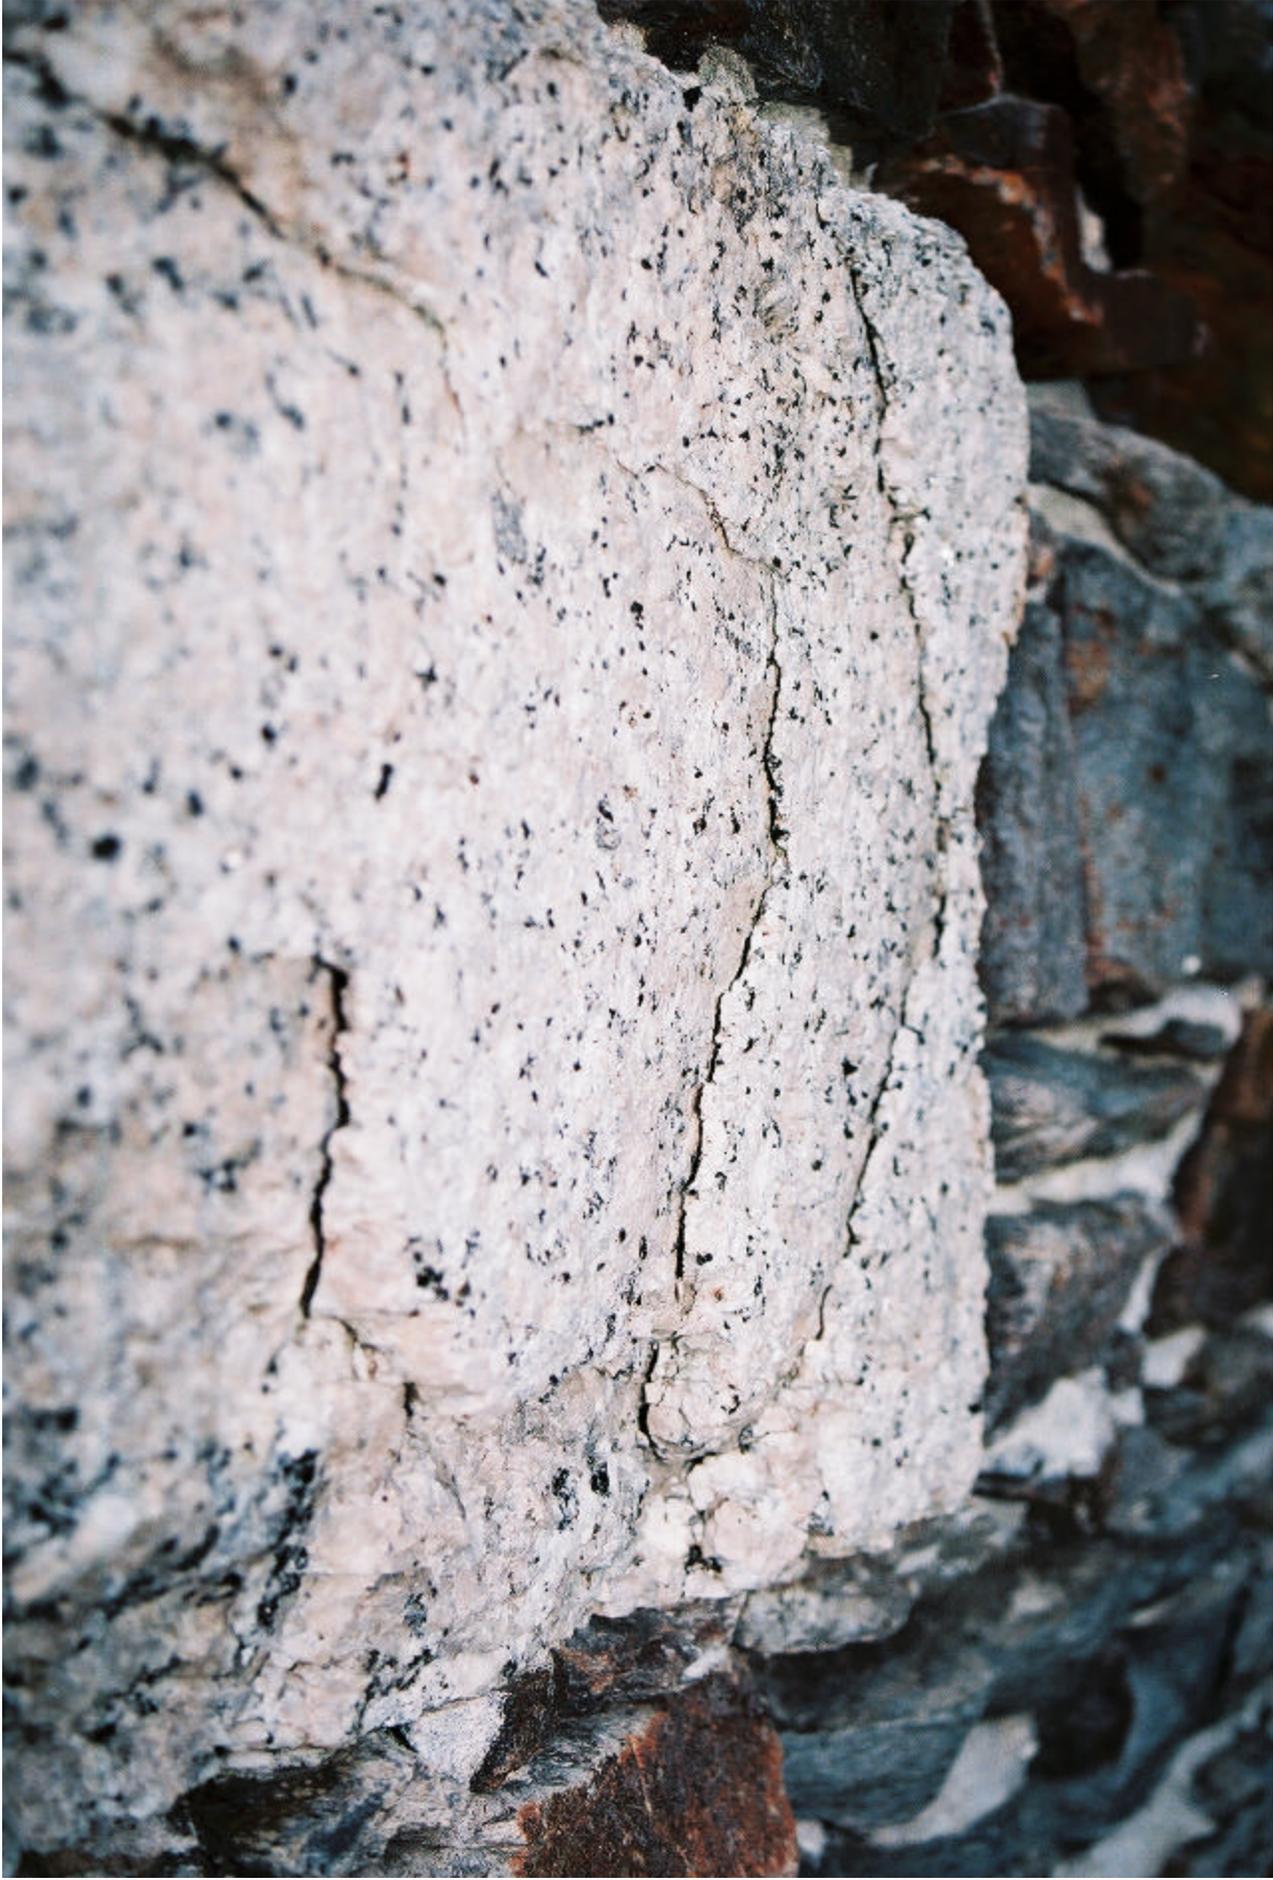
Photograph #9: Granite Header
Deterioration
