CONDITION ASSESSMENT AND ANALYSIS
OF THE GODDARD MANSION
FORT WILLIAMS PARK,
CAPE ELIZABETH, MAINE

THE TOWN OF CAPE ELIZABETH
CAPE ELIZABETH, MAINE

SEPTEMBER, 2004

360.28.01

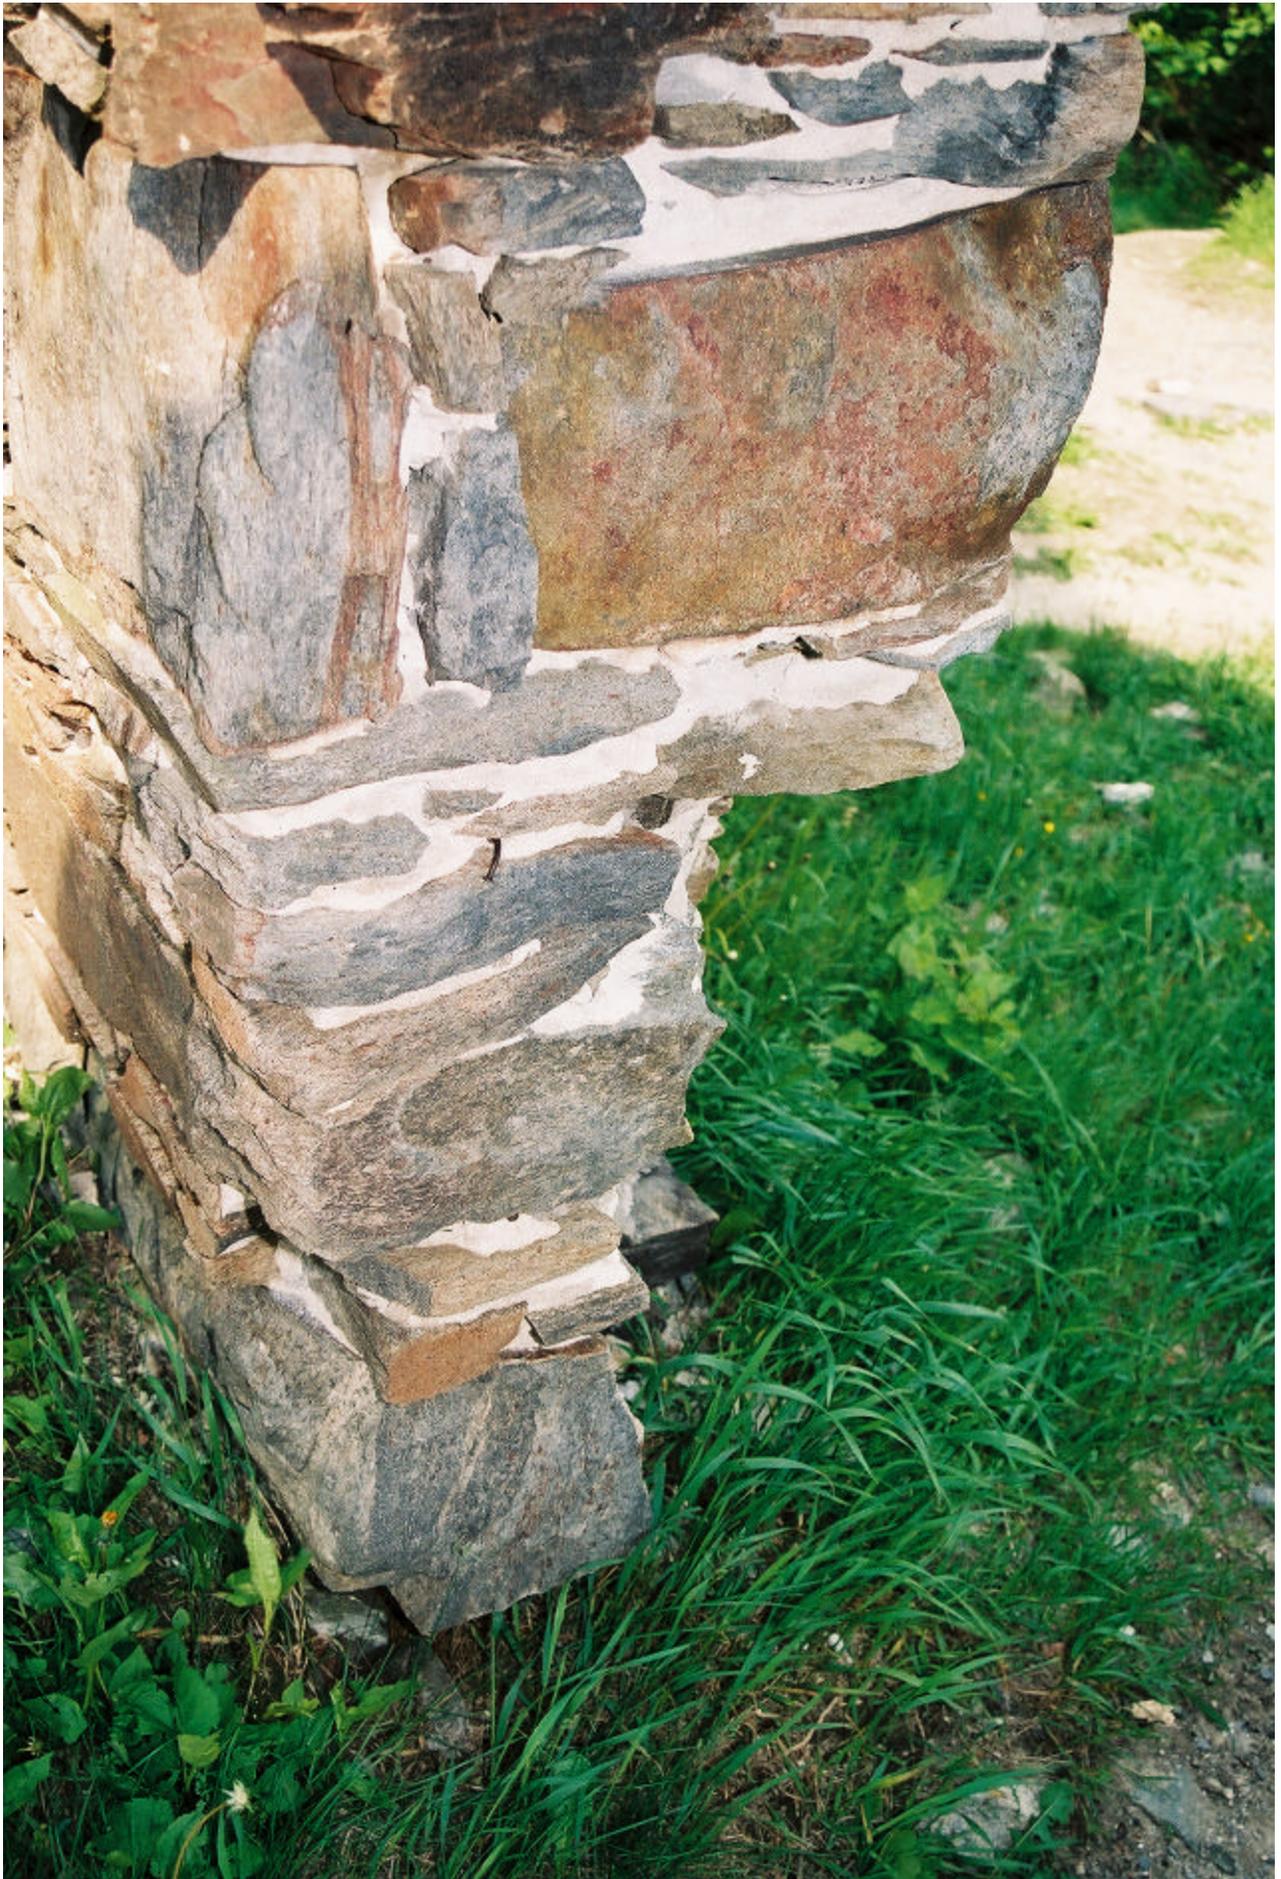
Photograph #10: Interior Wall 1
Note missing wall section.

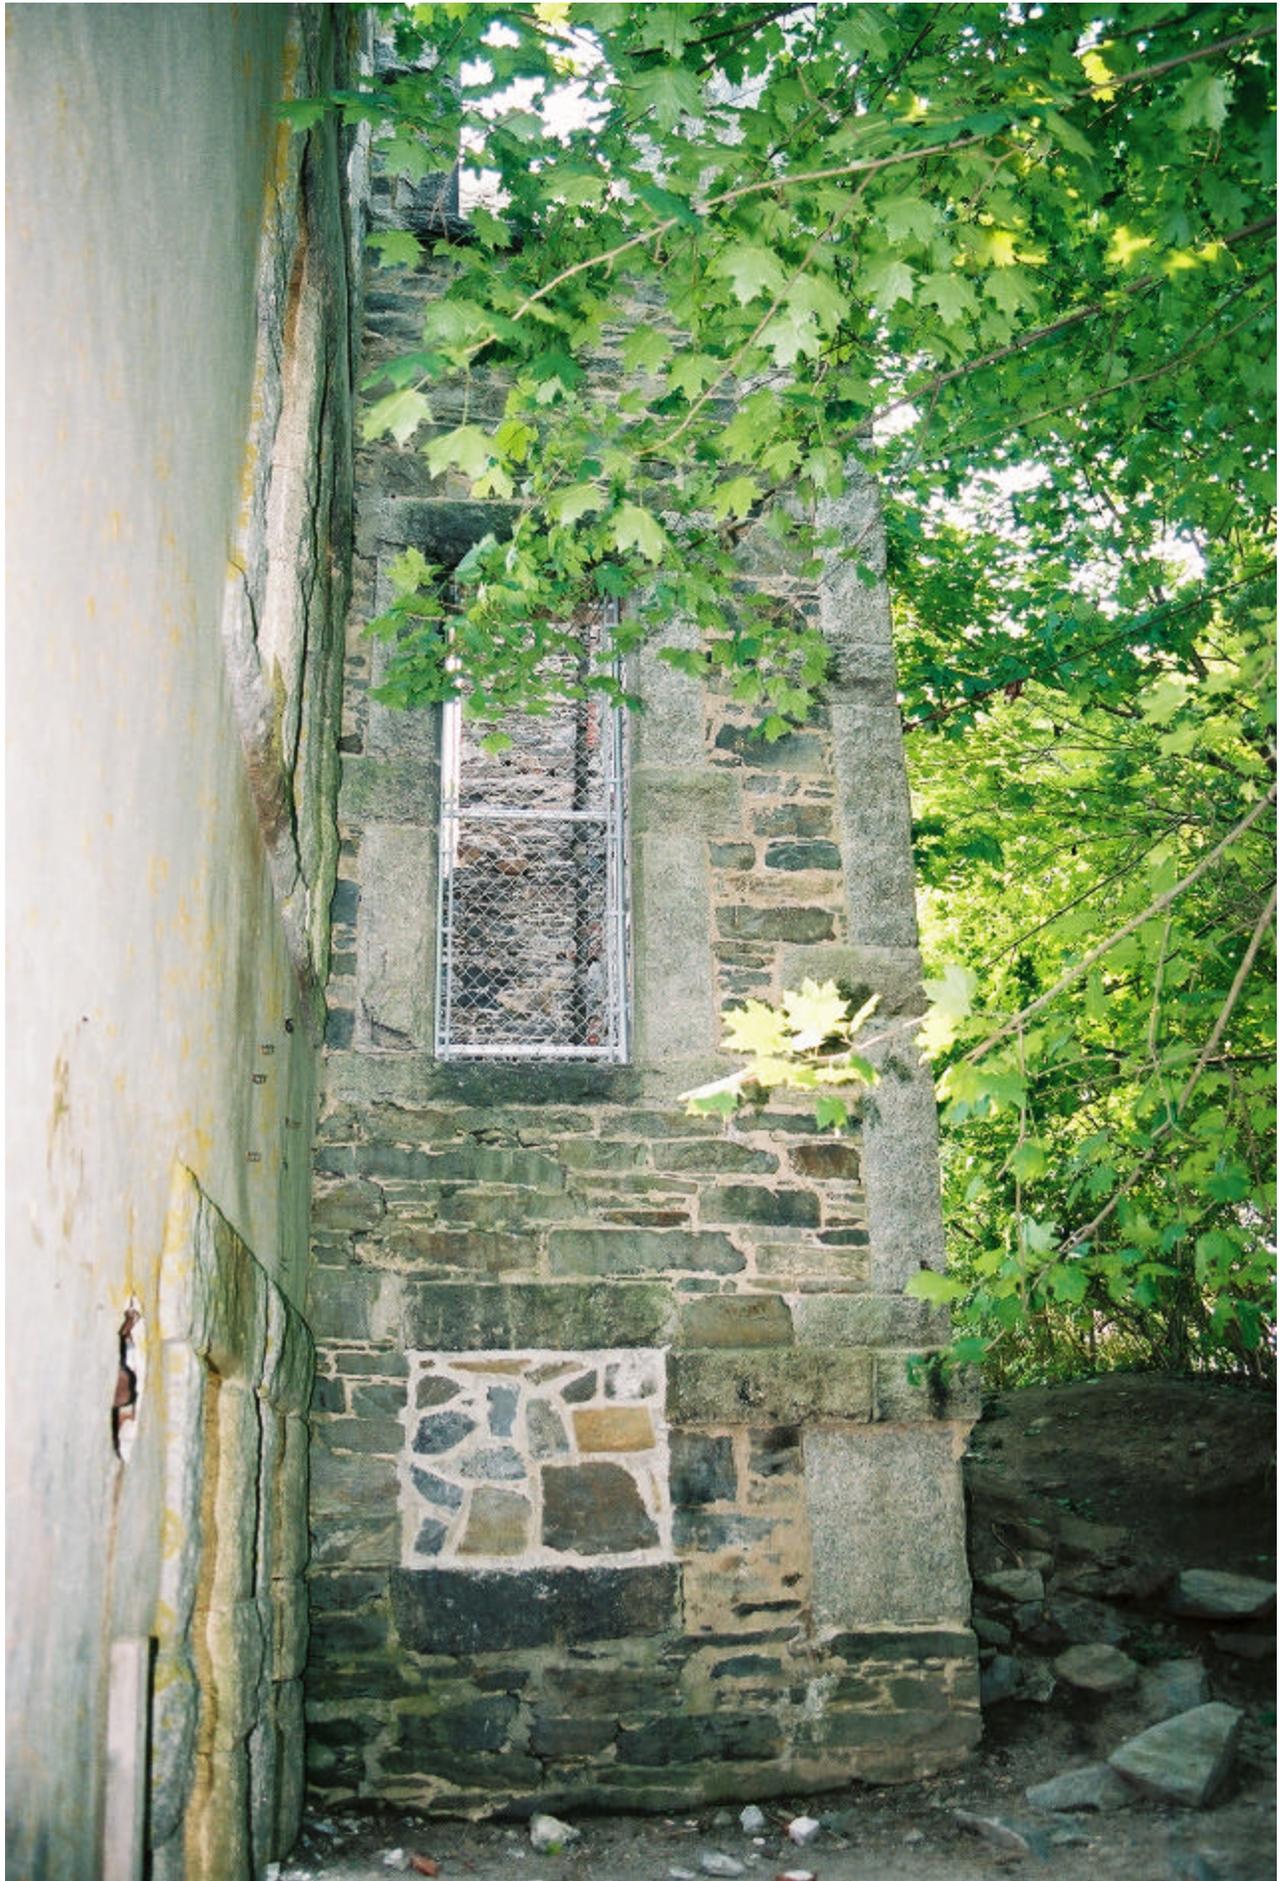
Photograph #11: East Face
Note grouted face at left.

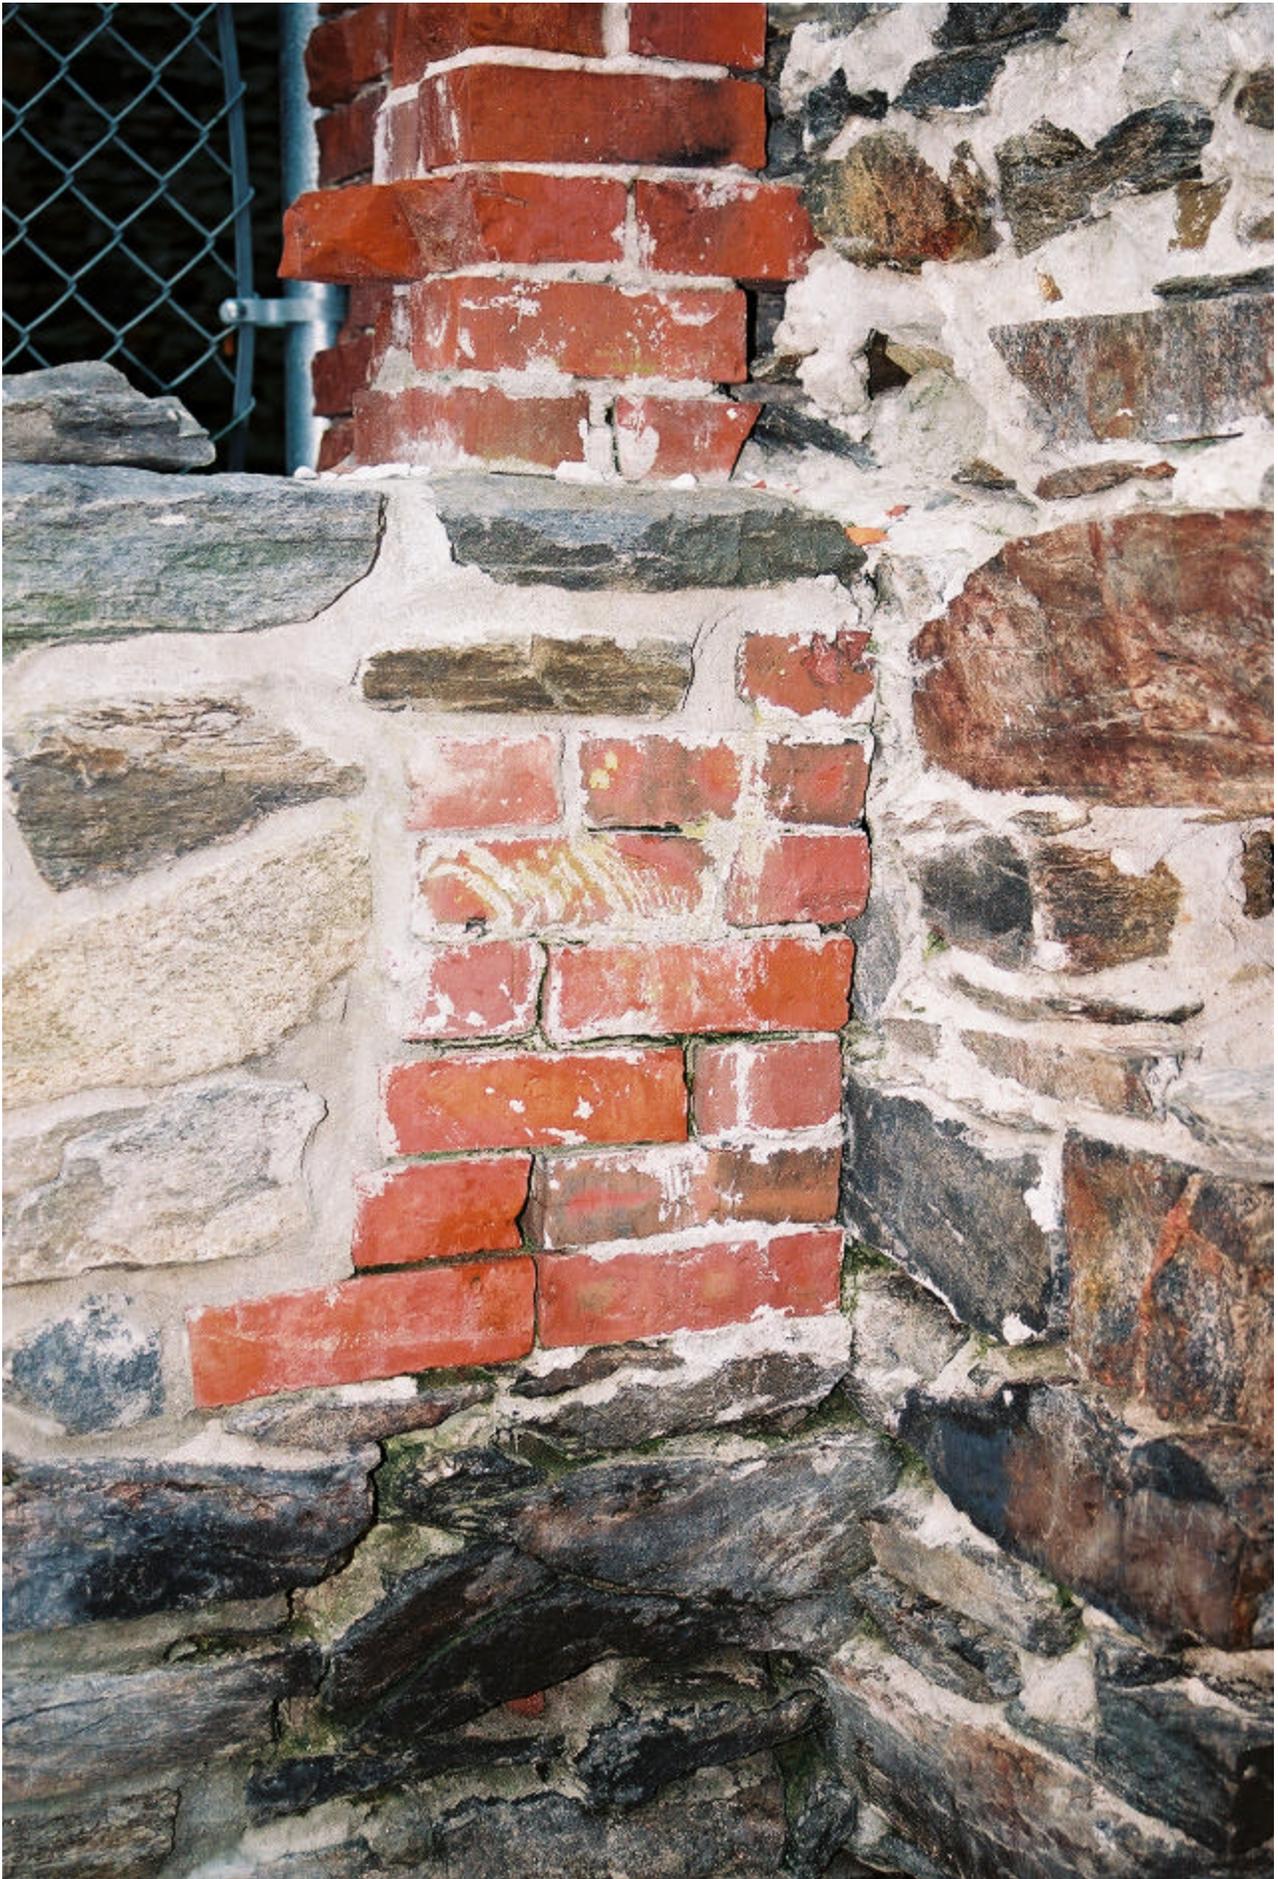
Photograph #12: Wall Repair using a brick infill.
Note cracks at mortar joints.
