Cape Elizabeth Culvert and Habitat Assessment Study

March 22, 2019

This report was prepared for the Town of Cape Elizabeth by Sebago Technics, Inc., the Wells National Estuarine Research Reserve, the Casco Bay Estuary Partnership and the Town of Cape Elizabeth under award CZM NA17NOS4190116 to the Maine Coastal Program from the National Oceanic and Atmospheric Administration, U.S. Department of Commerce. The statements, findings, conclusions, and recommendations are those of the authors and do not necessarily reflect the views of the National Oceanic and Atmospheric Administration or the Department of Commerce.

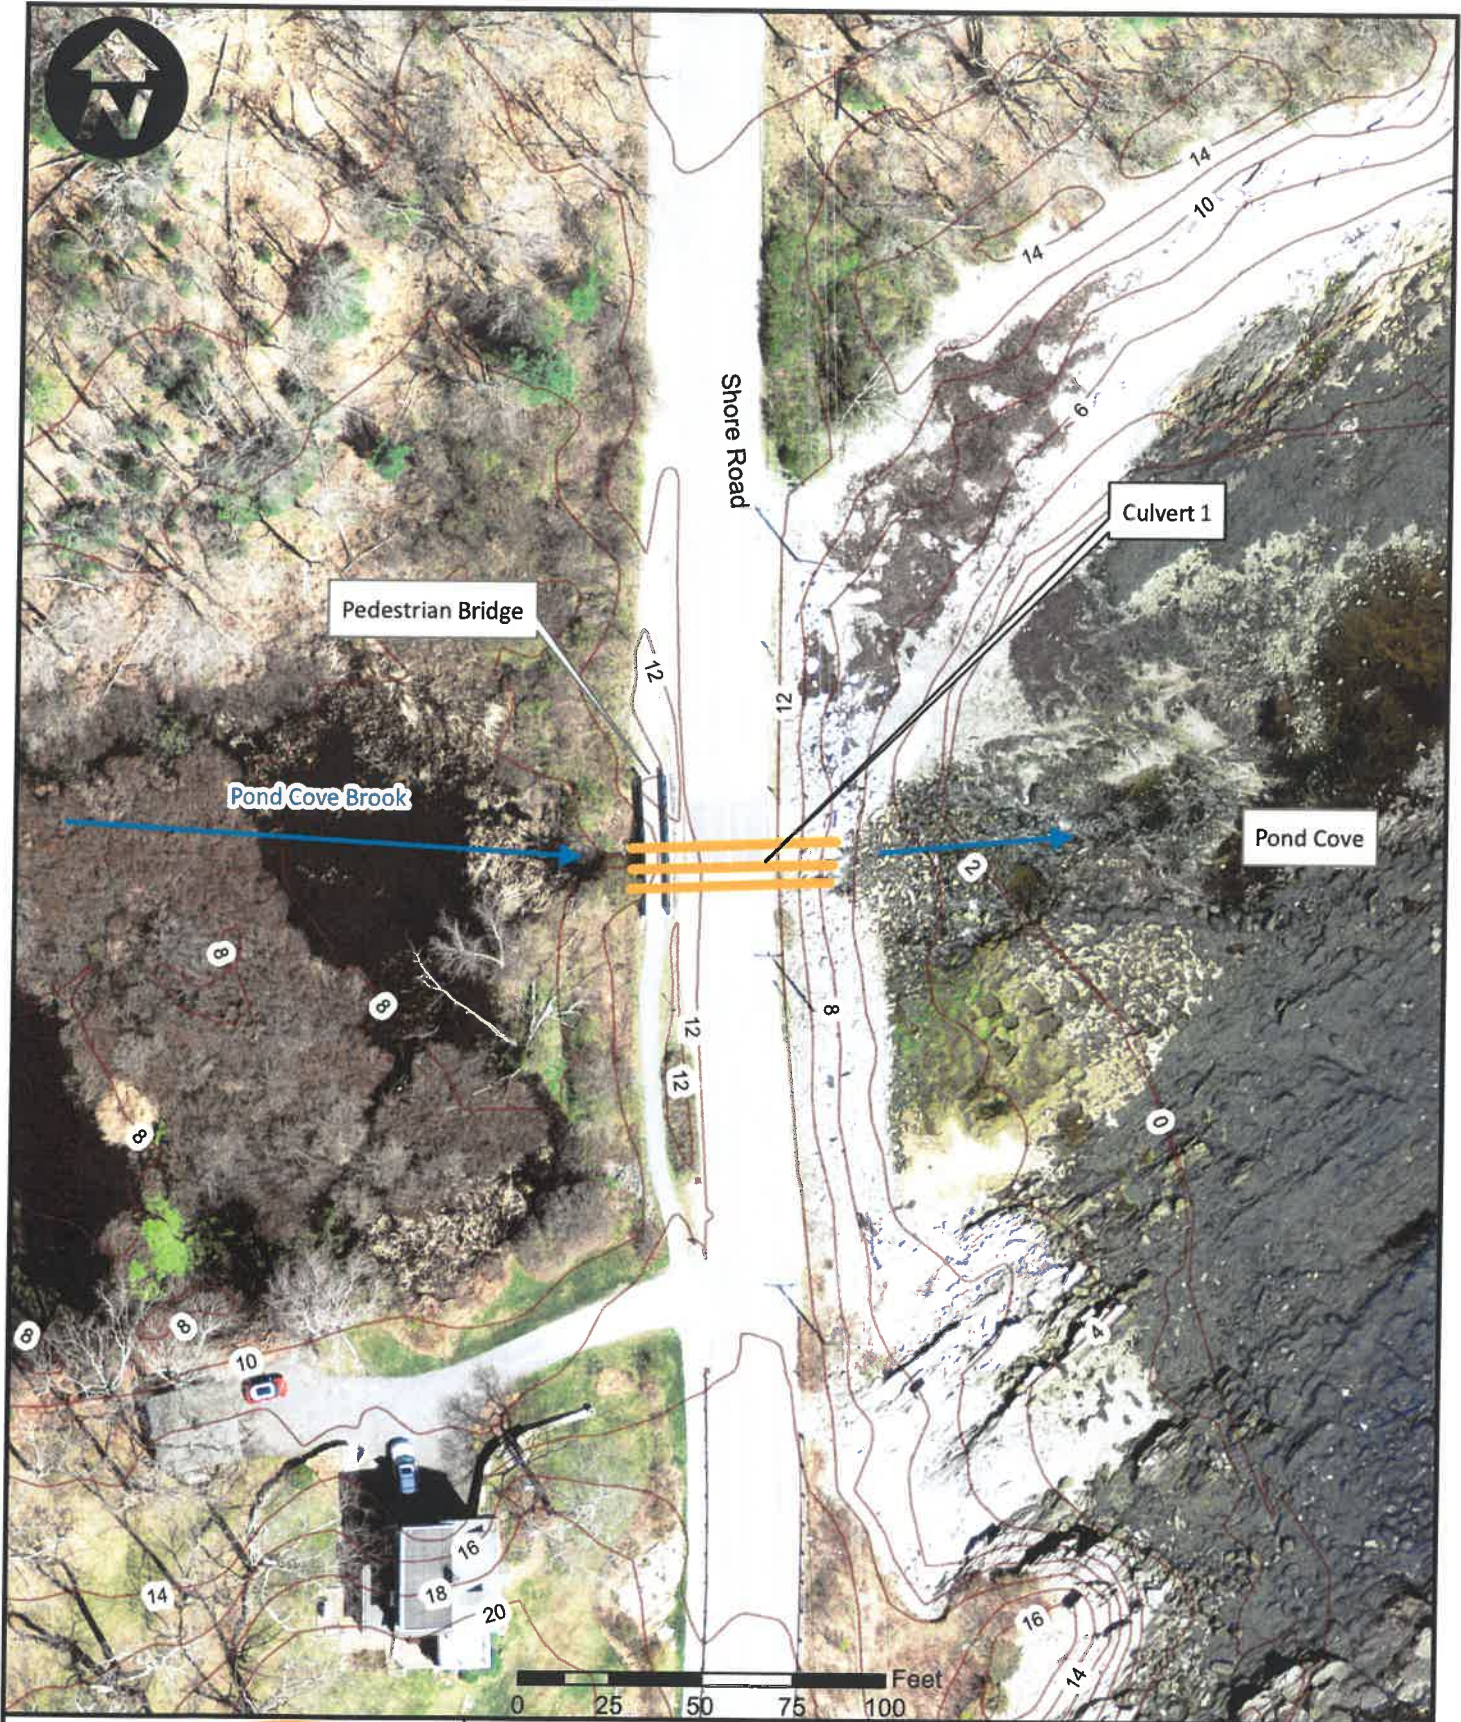
Photo 7 (06-06-18): Looking west at large rock and other ocean debris inside of northerly culvert. Being exposed directly to Casco Bay, ocean surges often push debris inside of these pipes creating an ongoing maintenance issue for the Town.

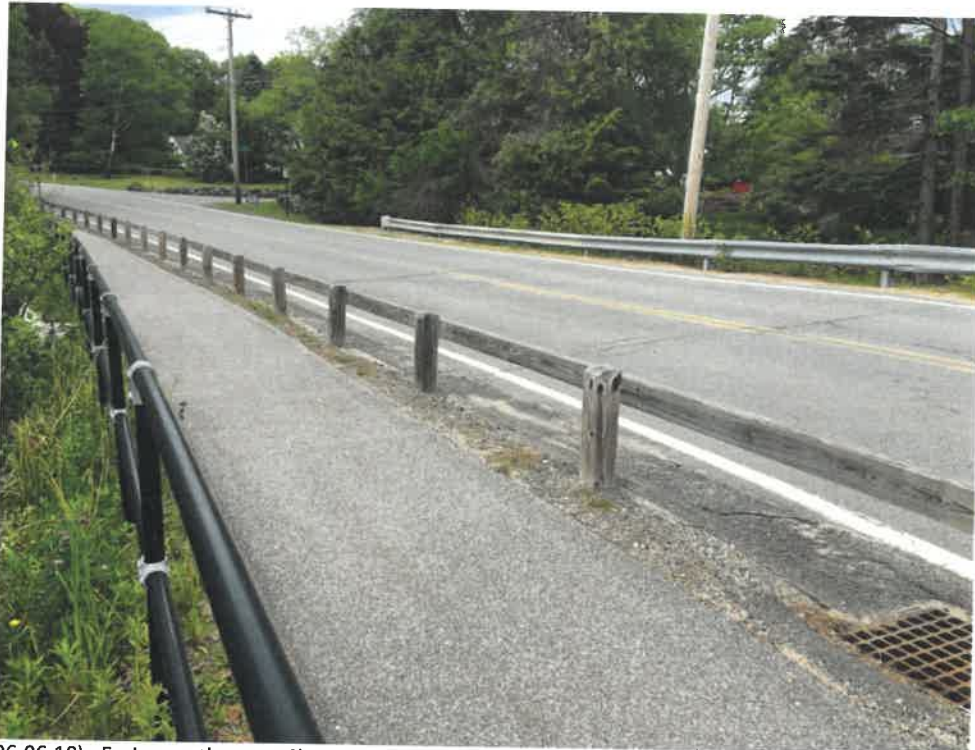
Photo 1 (06-06-18): Facing northeast at Shore Road crossing of the Dyer Pond outflow. Culvert crossing coincides with the pavement crack across the surface of Shore Road.

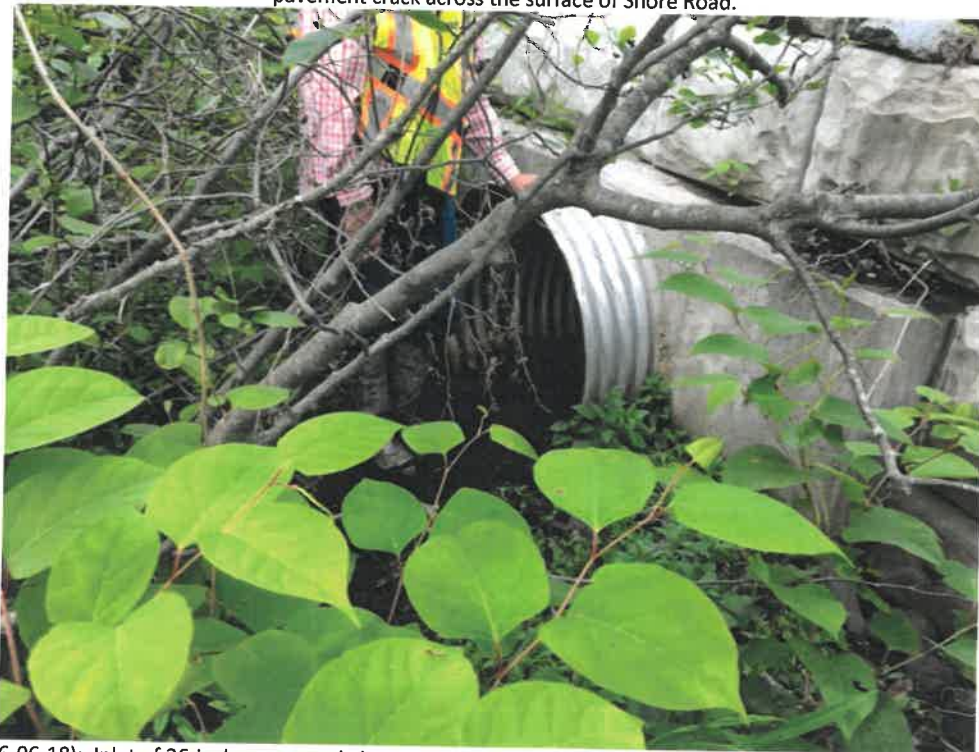
Photo 2 (06-06-18): Inlet of 36-inch corrugated aluminum cross pipe with a cast-in-place concrete collar and base set within a large concrete block "Stonestrong" retaining wall. Inlet is on the west side of Shore Road.

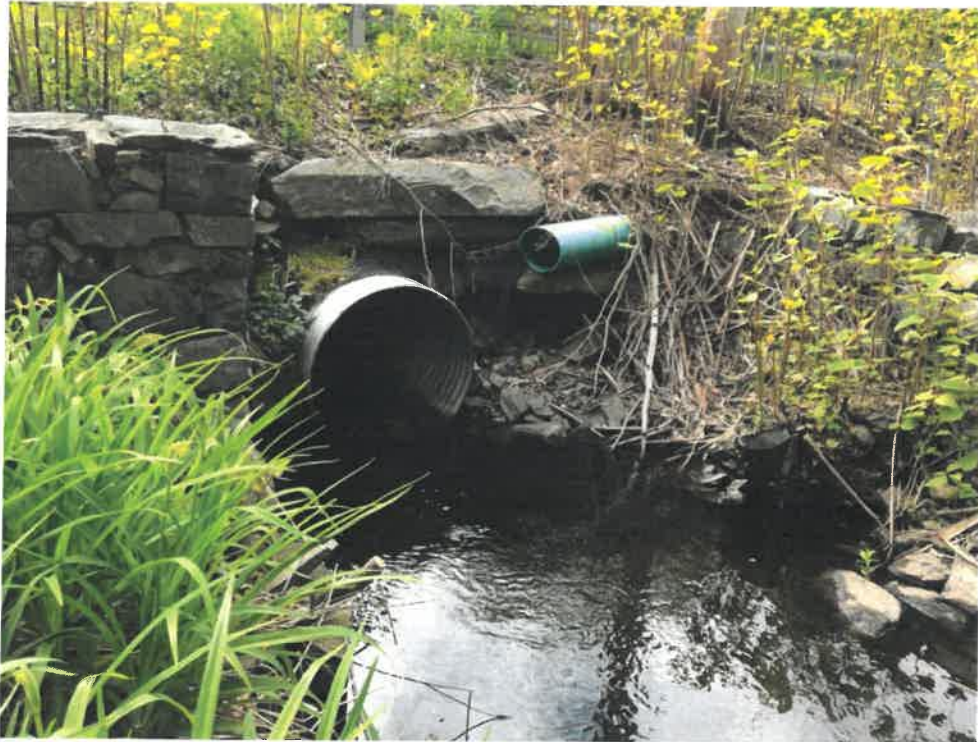
Photo 7 (06-06-18): Submerged outlet of culvert on the east side of Shore Road. Loose stones on headwall of outlet with smaller diameter green polyvinylchloride (pvc) pipe discharging well above the outlet invert elevation of the cross culvert.

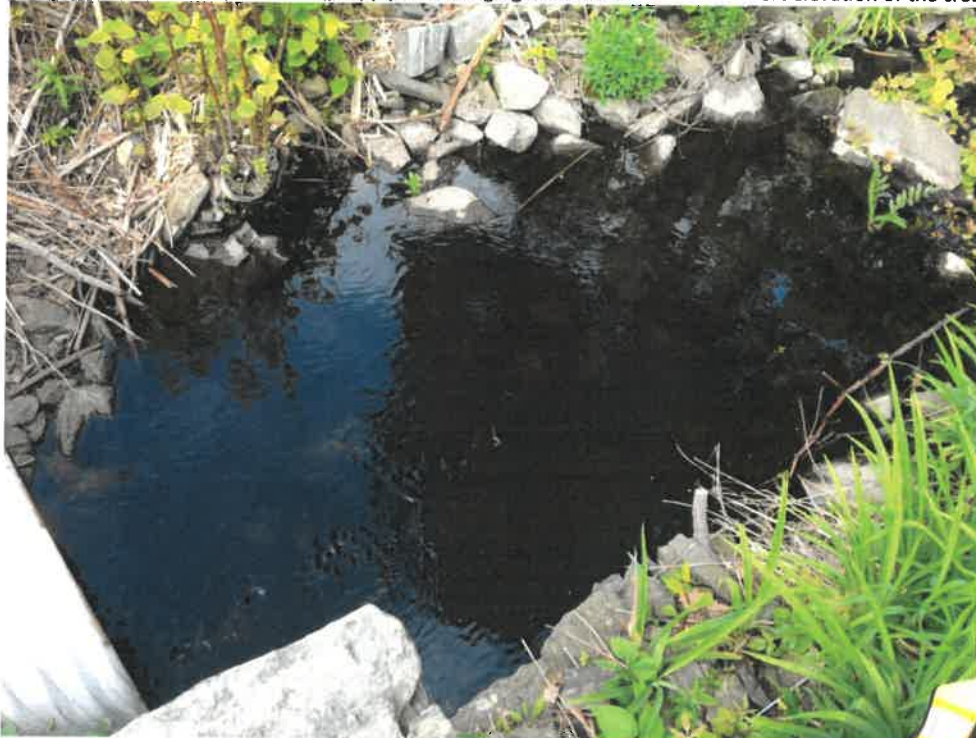
Photo 8 (06-06-18): Overhead view of culvert outlet with rip rap plunge pool apron area. Stone lined plunge pool dissipates energy of the outfall and reduces the velocity of the outflow to the receiving channel.

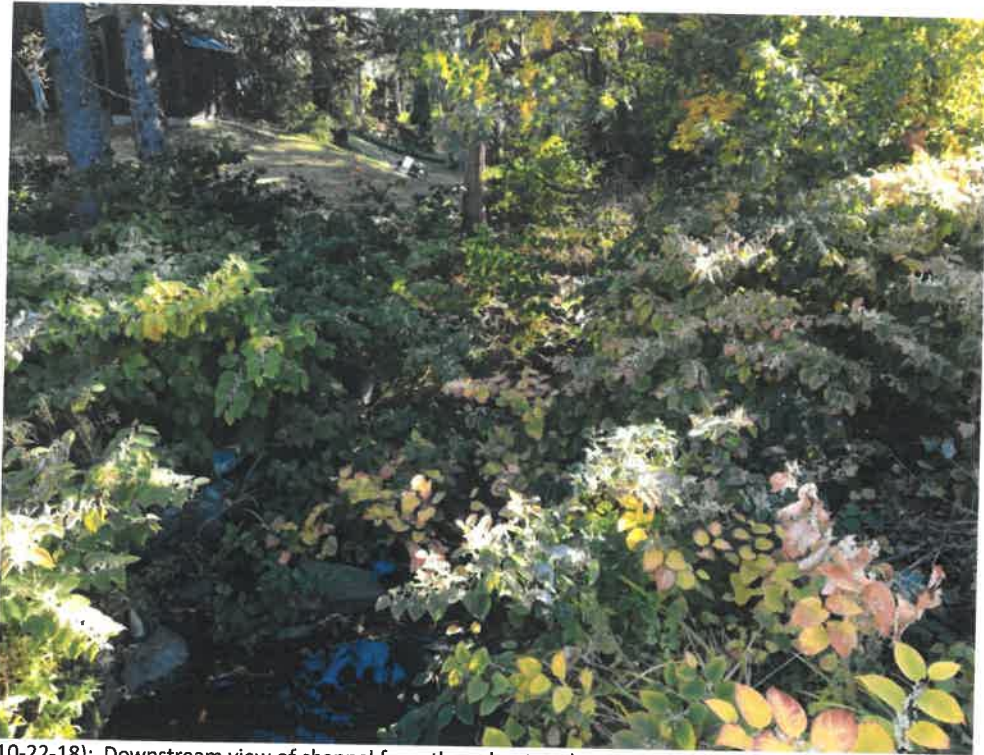
Photo 9 (10-22-18): Downstream view of channel from the culvert outlet rip rap plunge pool apron area on the east side of Shore Road. This flow travels to Casco Bay through the Delano Park neighborhood which is susceptible to high flow conditions.

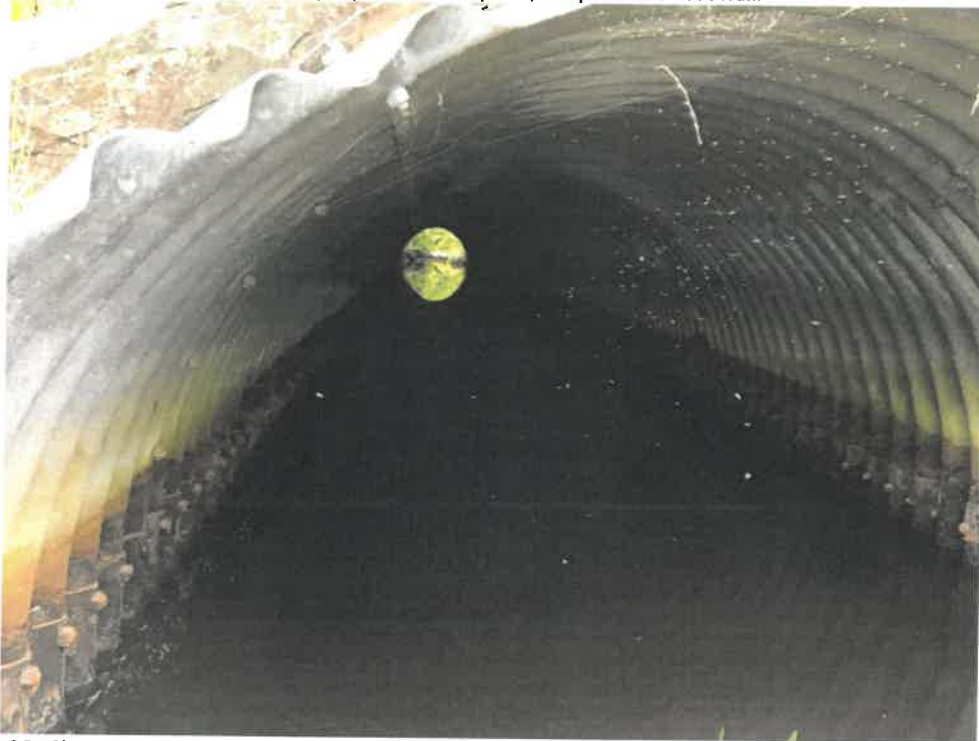
Photo 7 (06-06-18): Interior view of culvert from the outlet end on the west side of Route 77 toward the east side of Route 77 inlet. Corrosion evident along sidelines and invert of the pipe, however, the pipe alignment and integrity appear to visually be in good condition.

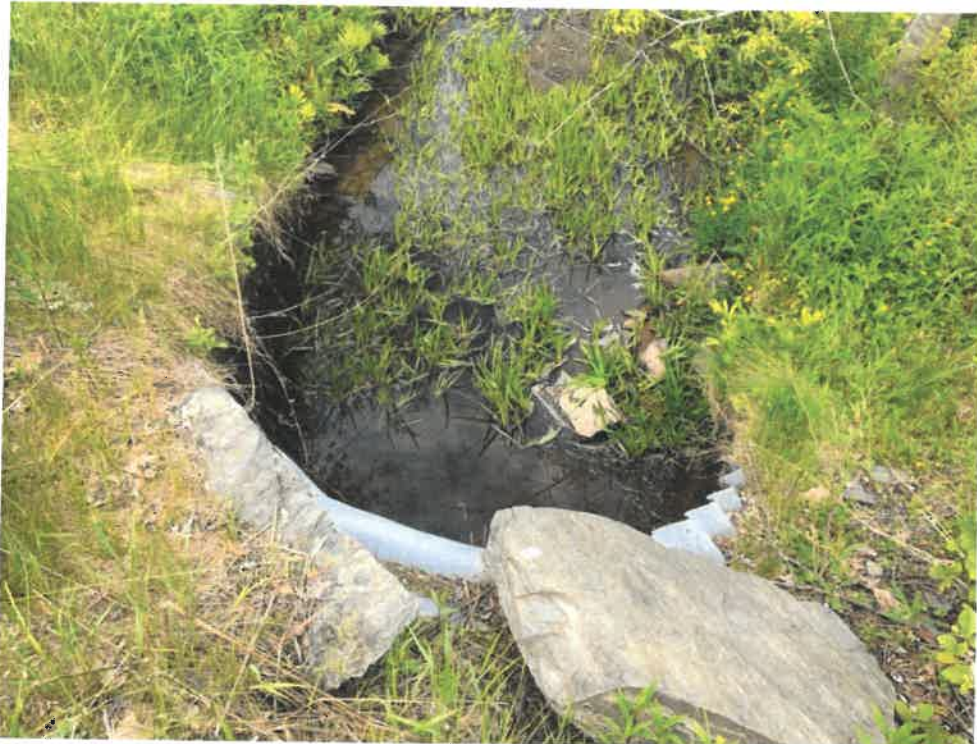
Photo 8 (06-06-18): Overhead view of culvert outlet with stones and vegetation in the outlet channel.

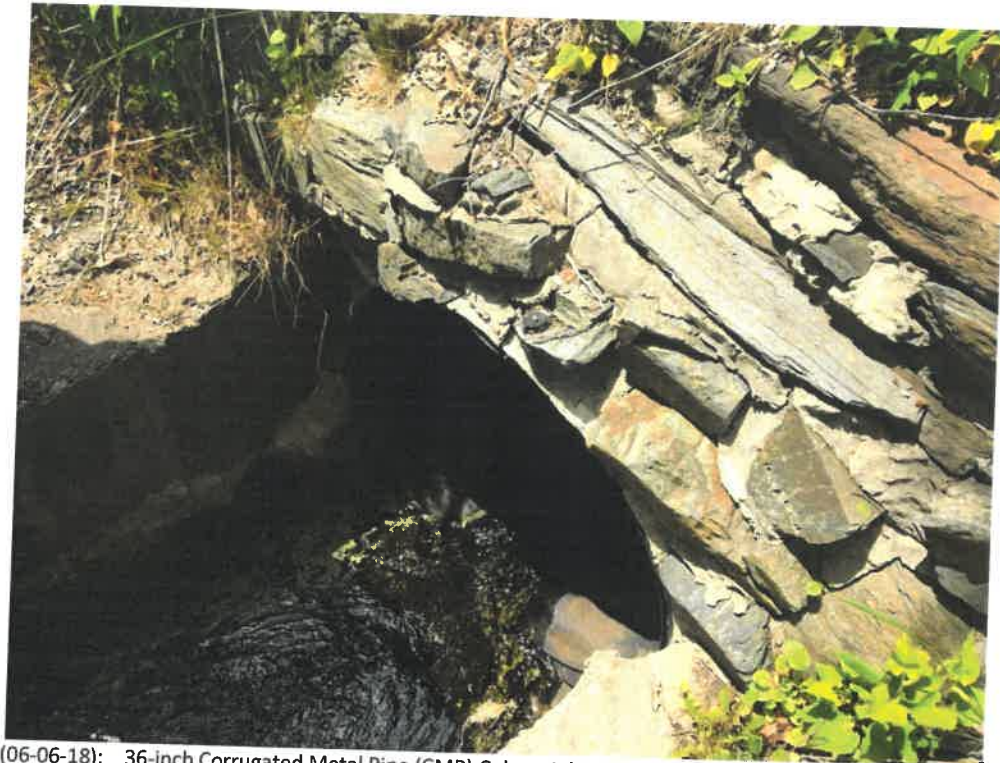
Photos 5 (06-06-18): 36-inch Corrugated Metal Pipe (CMP) Culvert inlet on south side of Spurwink Avenue. Pipe transitions into a 36-inch High Density Polypropylene (HDPE) under roadway. Grouted stone provides a headwall for the culvert inlet.

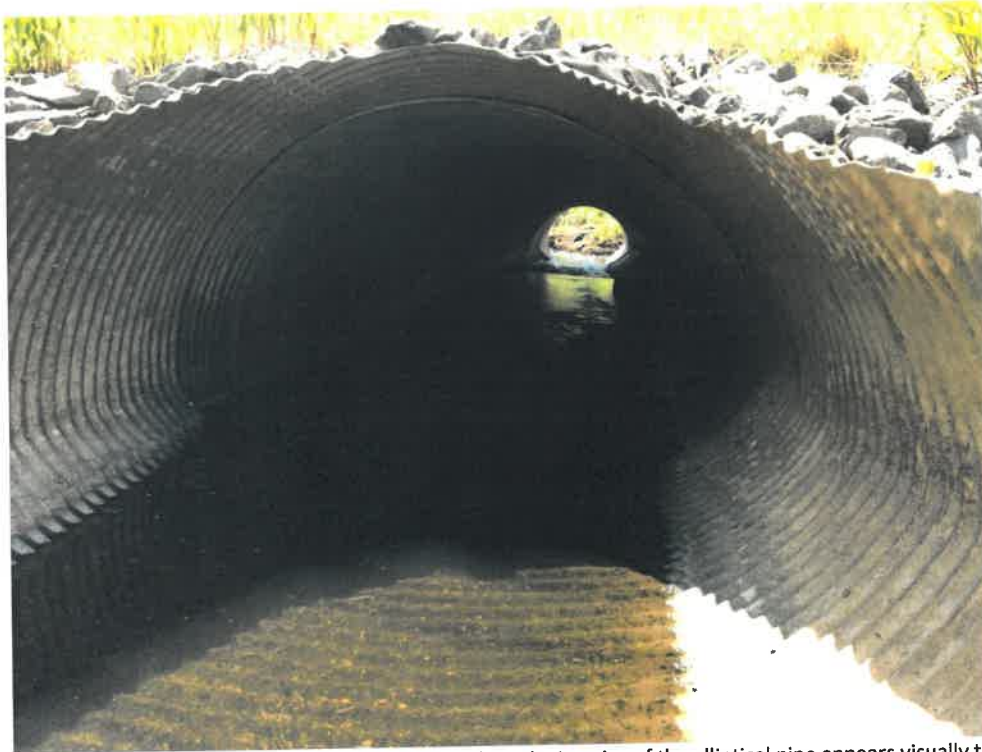
Photos 3 (06-06-18): Looking through the culvert from the inlet side, interior of the elliptical pipe appears visually to be in good condition, however, the flared end section appears to be pulling away from the last section of pipe.

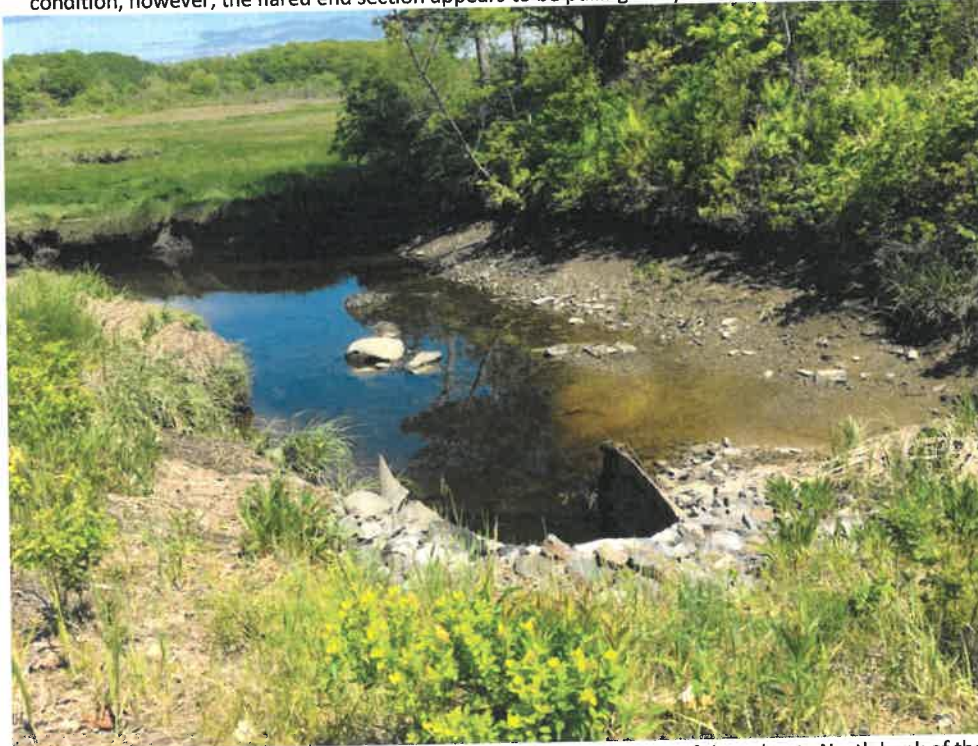
Photo 4 (06-06-18): Inlet to culvert with channel of the Spurwink River upstream of the culvert. North bank of the channel is eroded due to the sharp bend in channel just upstream of the culvert location and may need to be bolstered with rip rap armor at some point in the future.

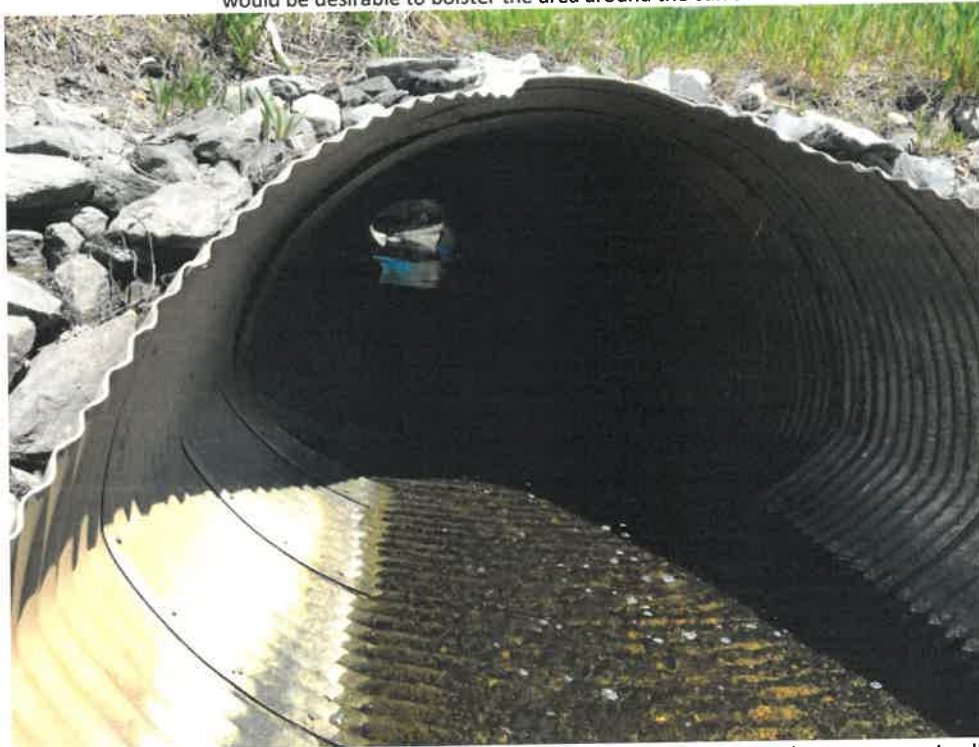
Photo 6 (06-06-18): Looking through the culvert from the outlet side, interior of the elliptical pipe appears visually to be in good condition, however, the flared end section appears to be pulling away from the last section of pipe.

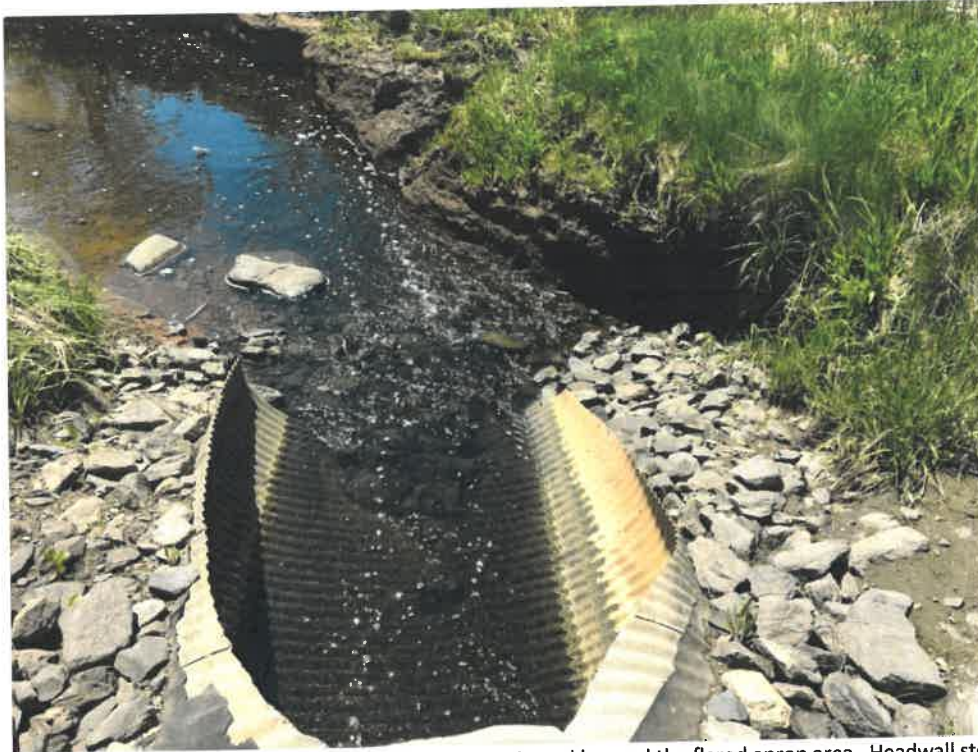
Photo 7 (06-06-18): Overhead view of culvert outlet with stones in and beyond the flared apron area. Headwall stones around the culvert appear to be depleted of rip rap layers and should be replenished.

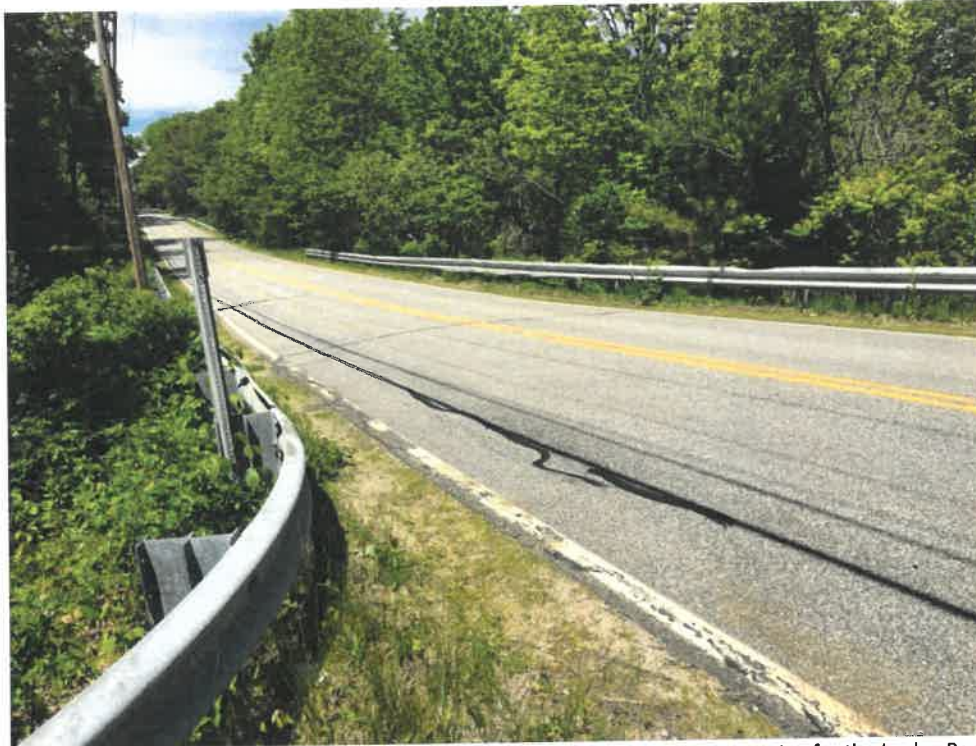
Photo 1 (06-06-18): Facing north at pavement surface of the Spurwink Avenue culvert crossing for the Jordan Pond outflow. Culvert crossing coincides with the pavement crack across the surface of Spurwink Avenue in the center of photo.

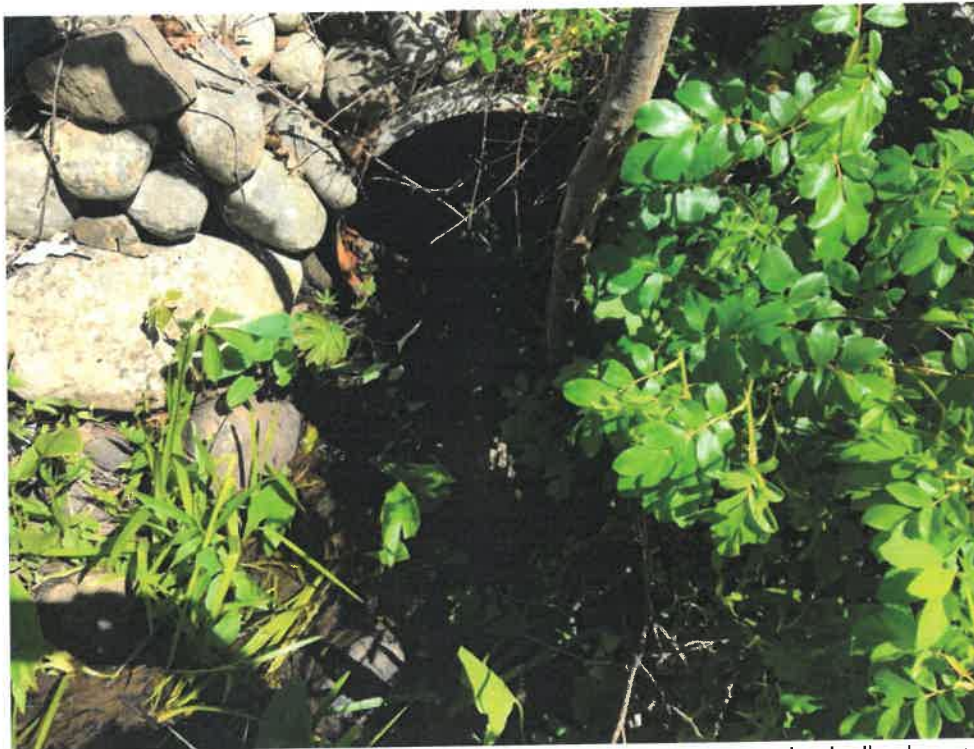
Photo 2 (06-06-18): Inlet of 24-inch corrugated aluminum cross pipe with a rip rap creating a headwall and apron. Inlet is on the west side of Spurwink Avenue and very thick vegetation made locating the culvert difficult.

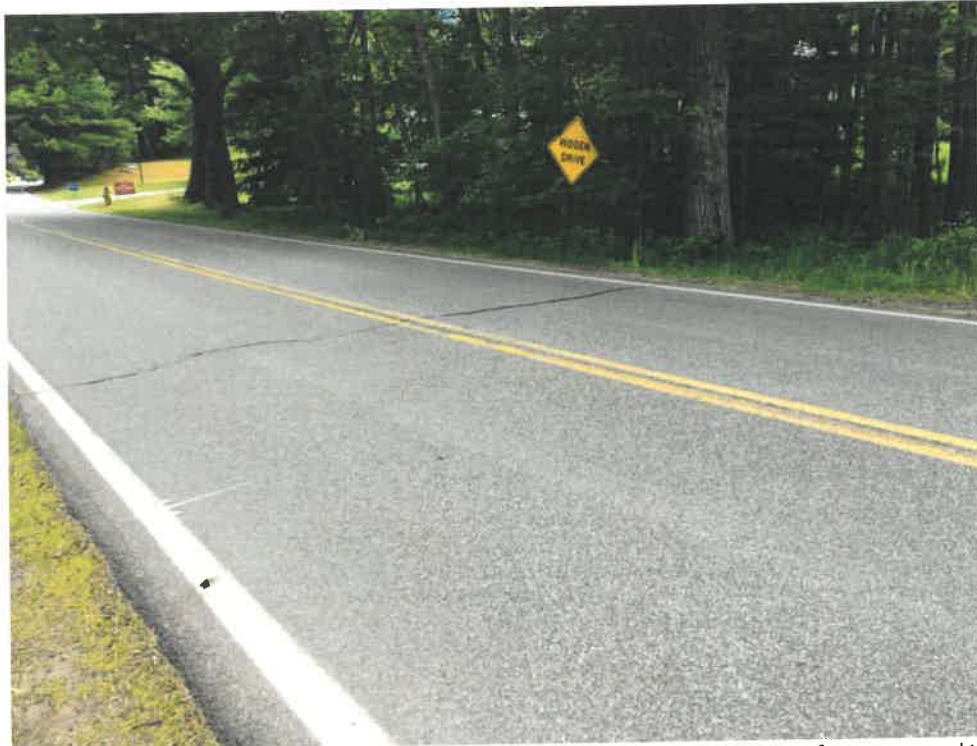
Photo 1 (06-06-18): Facing south at pavement surface of the Spurwink Avenue culvert crossing for an unnamed tributary to Trout Brook. Culvert crossing coincides with the pavement crack across the surface of Spurwink Avenue in the center of photo.

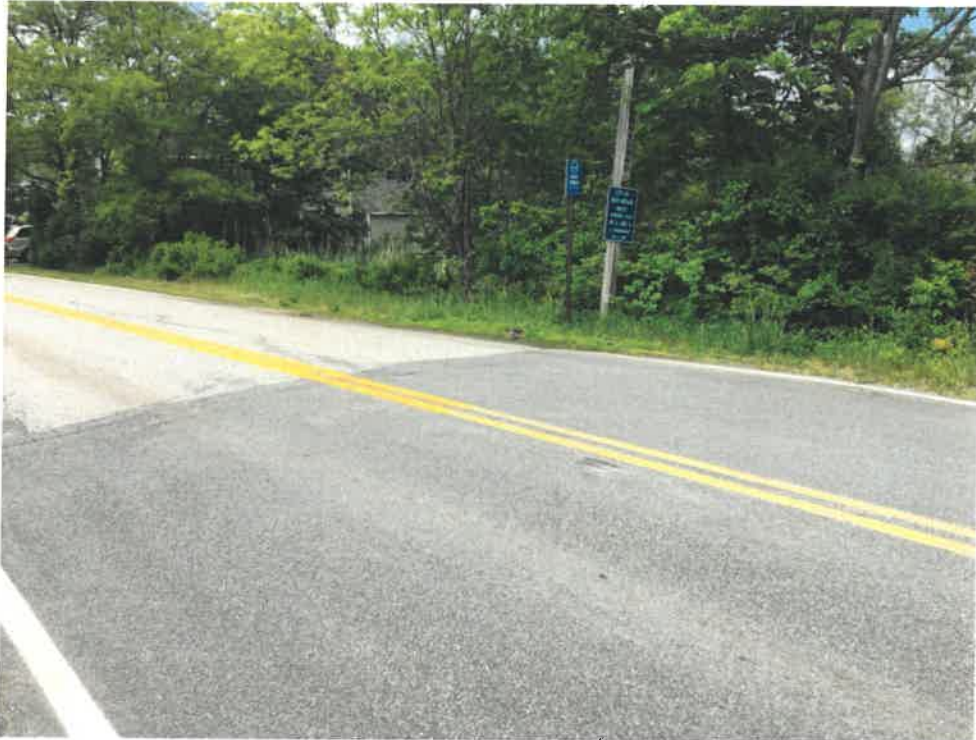
Photo 1 (06-06-18): Facing northeasterly at Spurwink Avenue crossing with Trout Brook which is an Urban Impaired Stream. Culvert crossing coincides with the pavement crack and change in pavement seam (which is also the South Portland municipal boundary) across the surface of Spurwink Avenue. Smaller blue sign indicates that the culvert is in the Trout Brook Watershed.

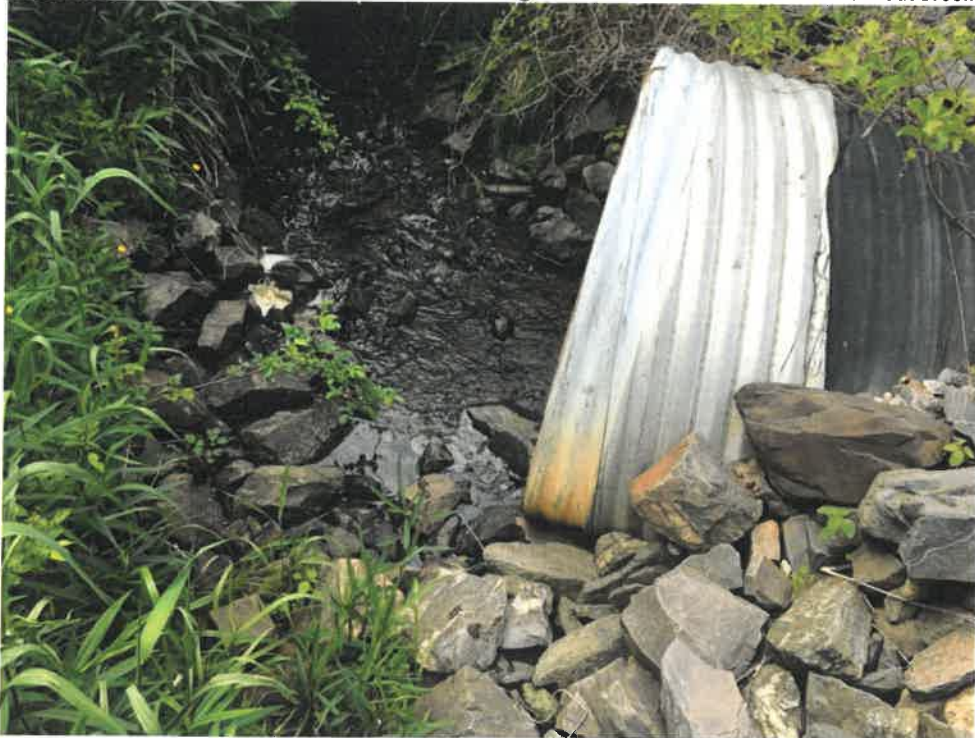
Photo 2 (06-06-18): Inlet of 60-inches wide by 44-inches tall corrugated aluminum elliptical cross pipe with rip rap apron and headwall. Flow curls into culvert abruptly after flowing southerly along and parallel to Spurwink Avenue.

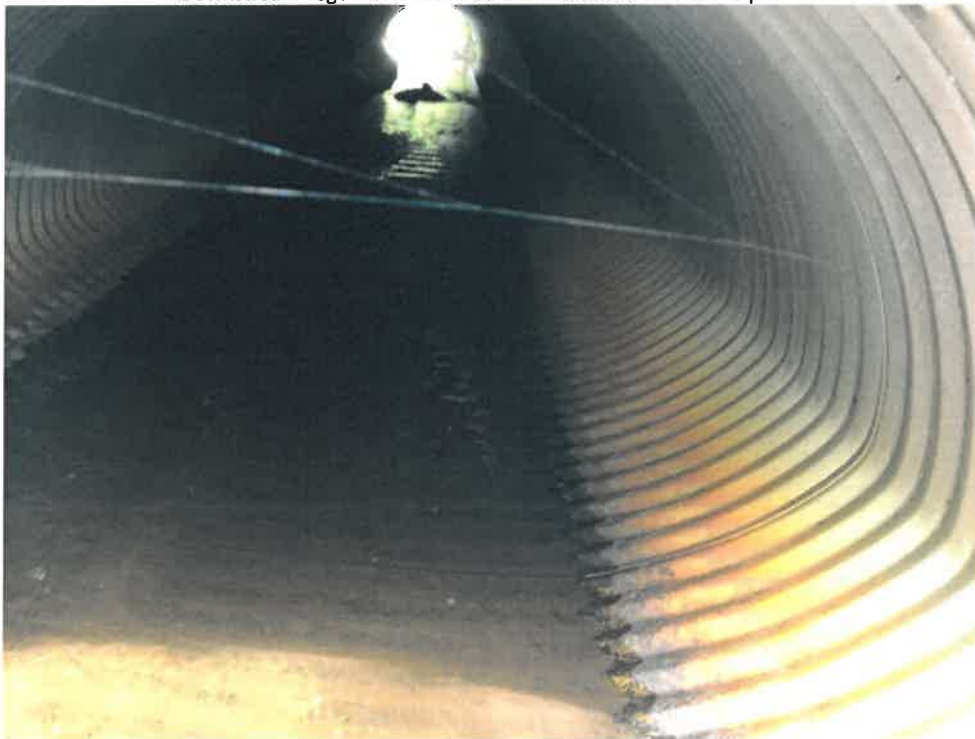
Photo 6 (06-06-18): Interior view of culvert taken from outlet to the inlet of culvert. Some corrosion visible along invert of pipe, however, the culvert appears visibly to be in good condition.

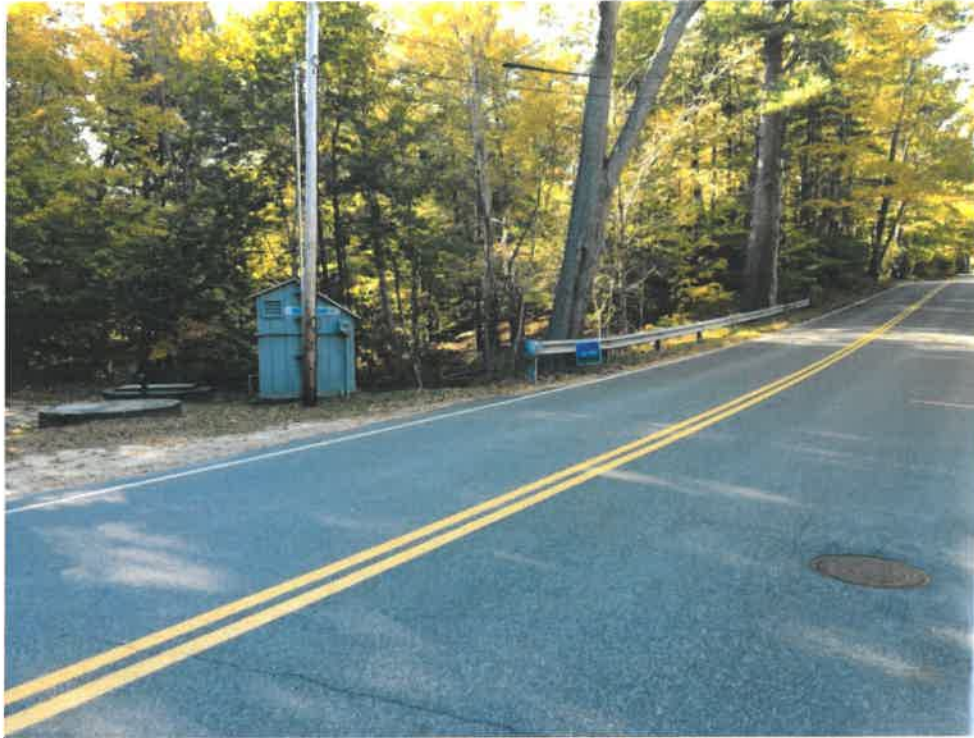
Photo 1 (10-22-18): Facing southeast at Mitchell Road crossing of Pond Cove Brook. Road is in good condition with a sanitary sewer pump station located near the brook (left hand side of photo).

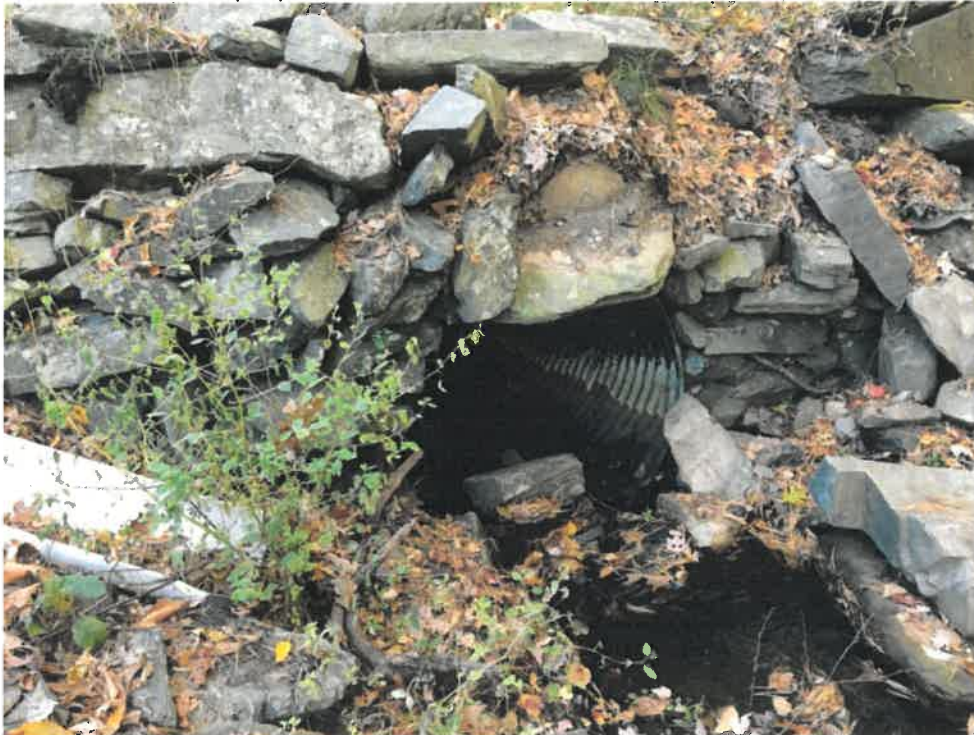
Photo 2 (10-22-18): Submerged inlet of 48-inch corrugated metal pipe with corroded invert and various stones blocking the inlet from reaching full flow capacity. The stone headwall needs to be reset.

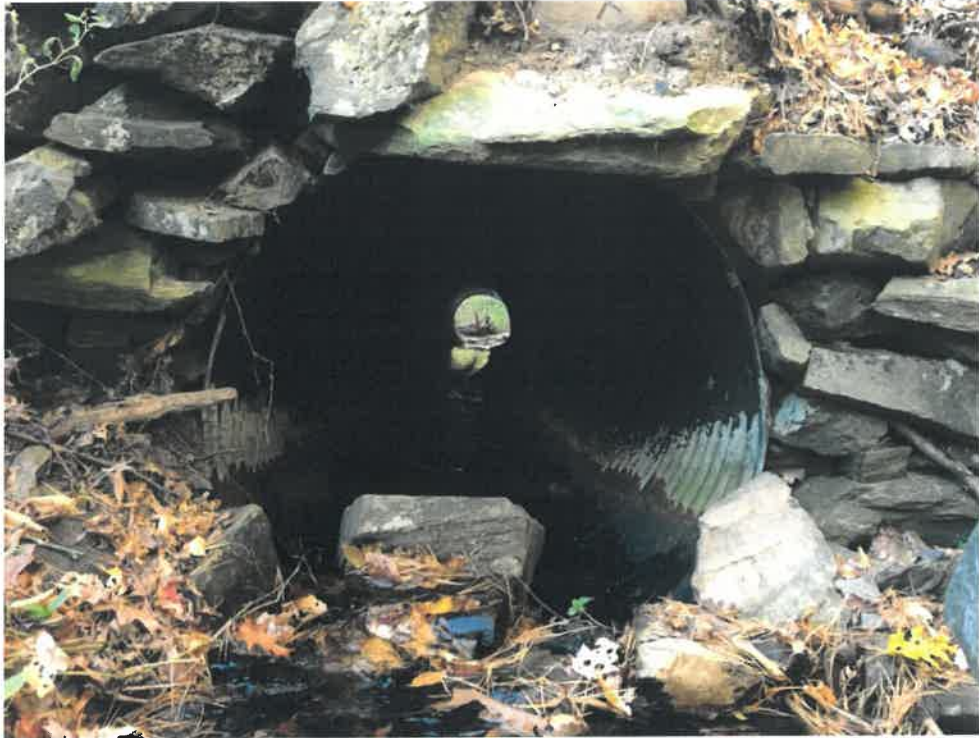
Photos 3 (10-22-18): Looking through the culvert from the inlet side, interior of the pipe appears visually to be in a degraded condition with the invert of the pipe clearly corroded.

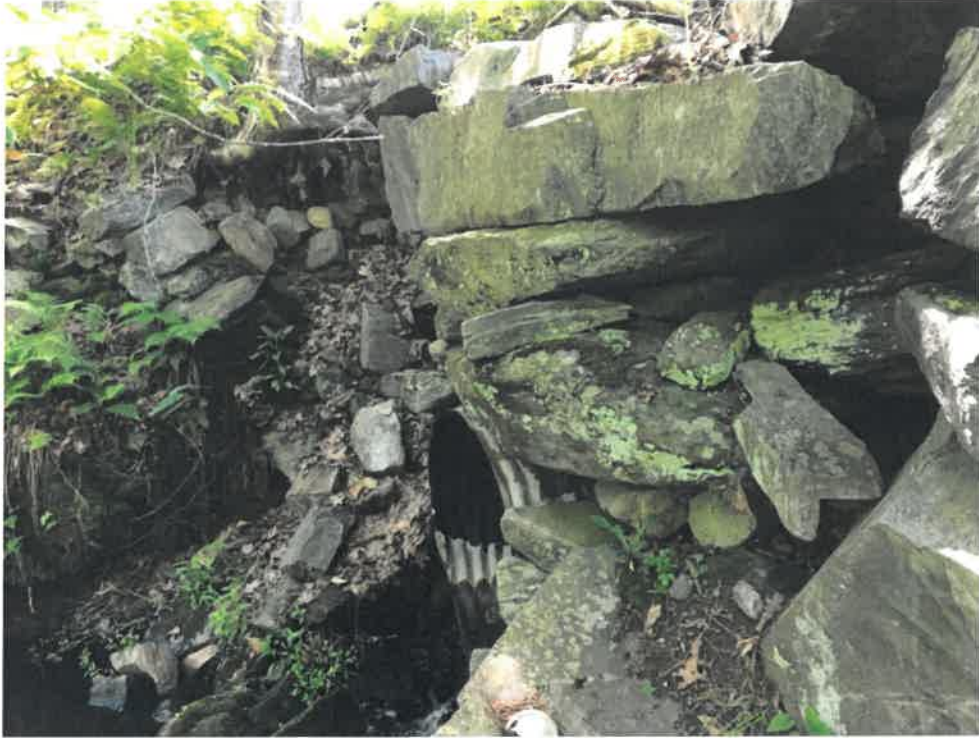
Photo 7 (06-06-18): Stone headwall at the outlet has deteriorated and has many loose and dislodged stones.

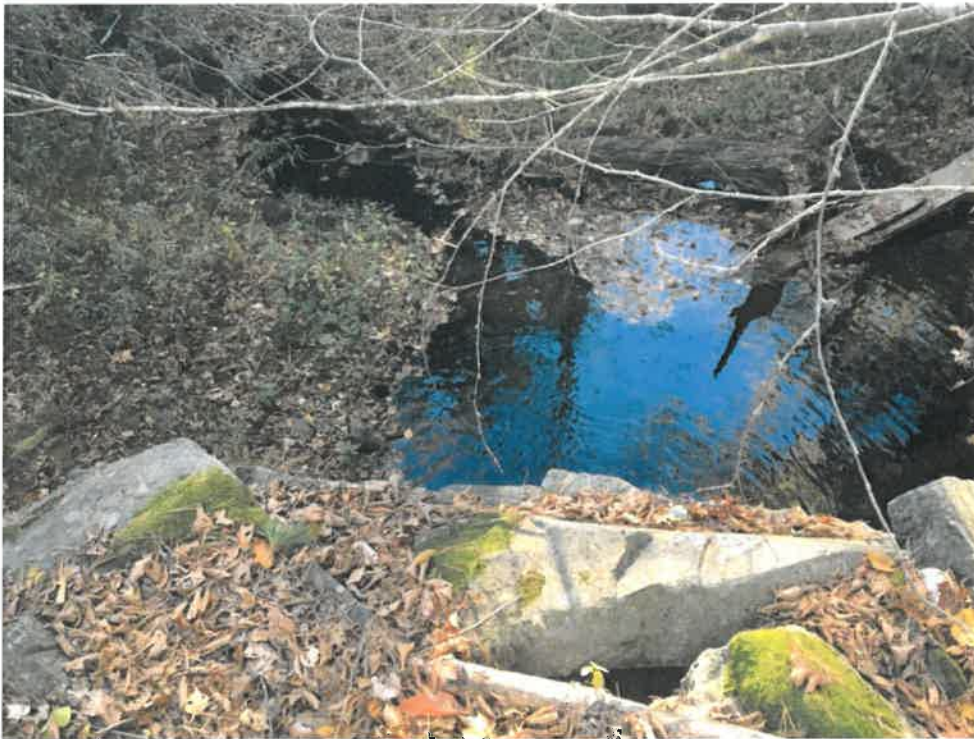
Photo 8 (10-22-18): Overhead view of culvert outlet with loose stones in the stone headwall.

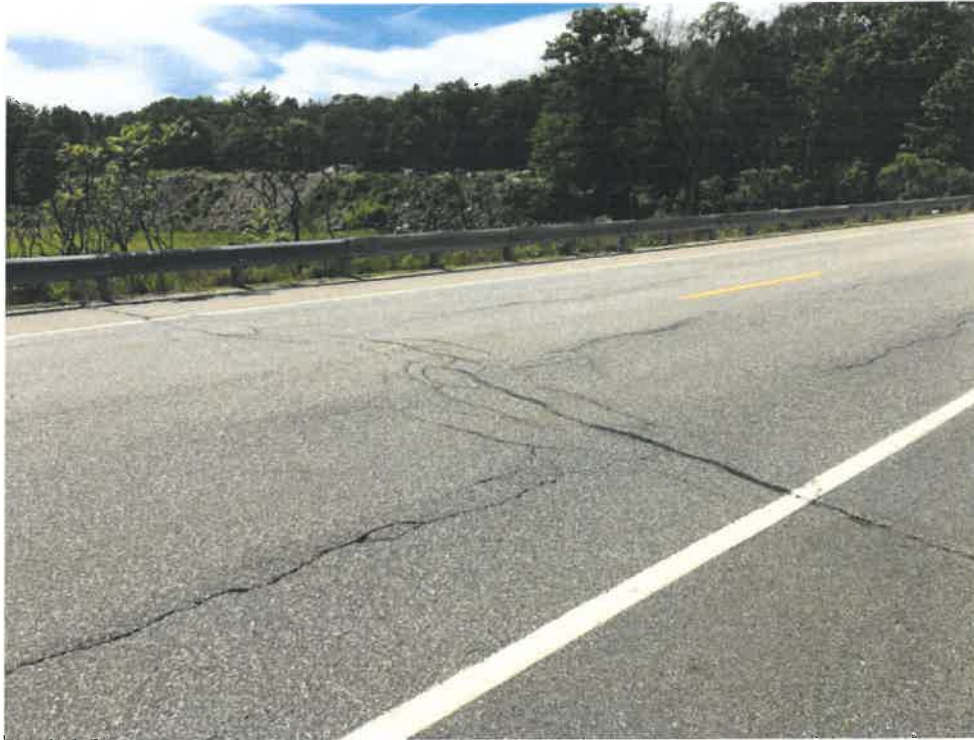
Photo 1 (06-20-18): Facing west at Ocean House Road (Route 77) crossing of Alewife Brook. Culvert location coincides with the crack across the pavement surface. Culvert is located relatively deep in relation to the road surface elevation with a steep roadway embankment.

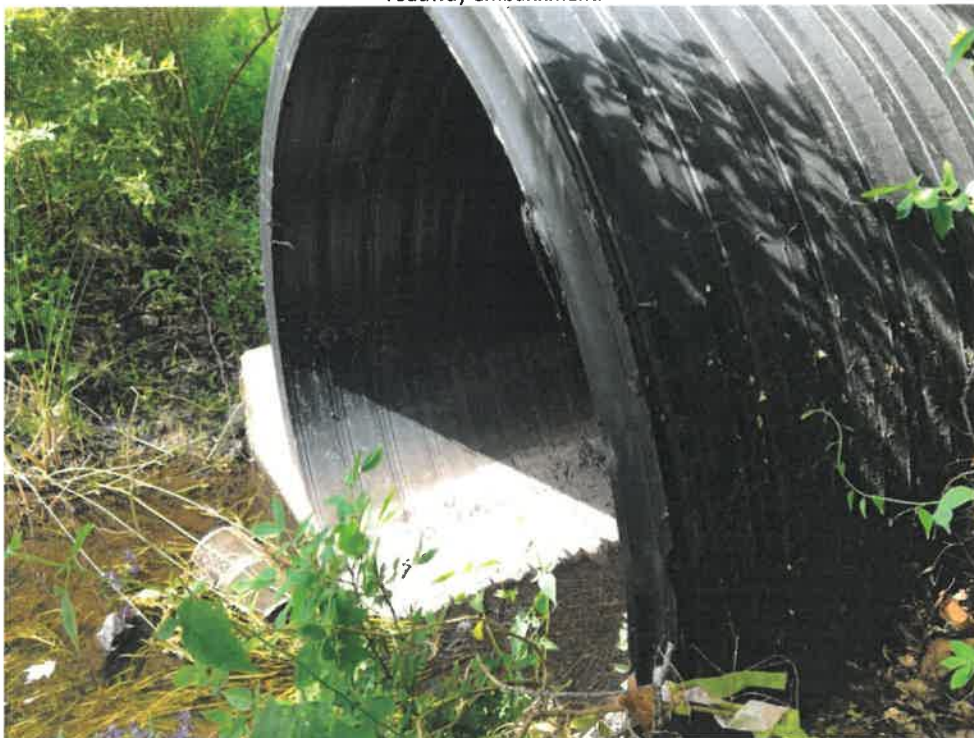
Photo 2 (06-20-18): Submerged inlet of the 70-inch high density polyethylene liner pipe within the original corrugated aluminum cross pipe. Pipe is supported on a concrete saddle.

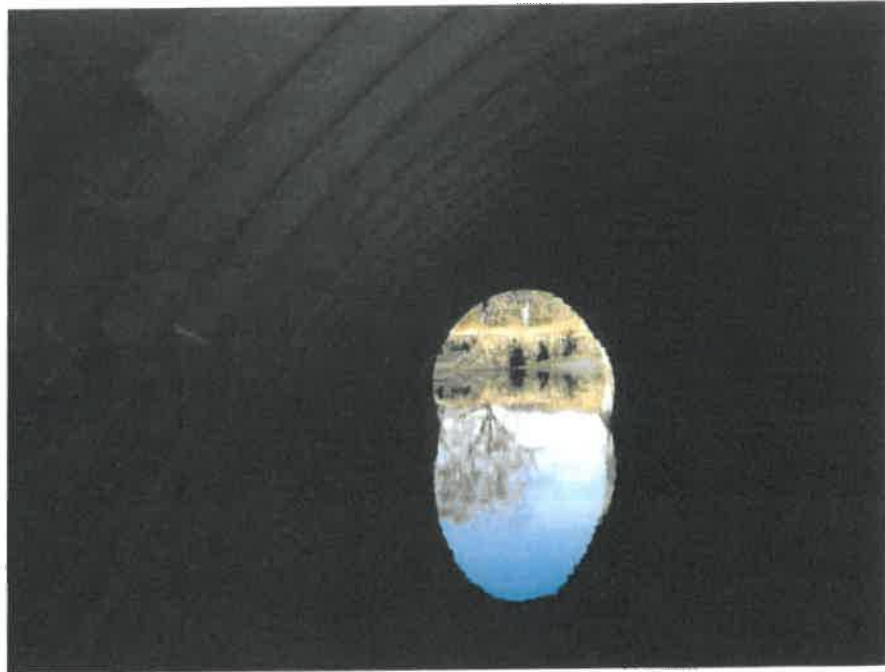
PHOTO 3

Description General view of barrel showing some corrosion along bolt line
