Cape Elizabeth Culvert and Habitat Assessment Study

March 22, 2019

This report was prepared for the Town of Cape Elizabeth by Sebago Technics, Inc., the Wells National Estuarine Research Reserve, the Casco Bay Estuary Partnership and the Town of Cape Elizabeth under award CZM NA17NOS4190116 to the Maine Coastal Program from the National Oceanic and Atmospheric Administration, U.S. Department of Commerce. The statements, findings, conclusions, and recommendations are those of the authors and do not necessarily reflect the views of the National Oceanic and Atmospheric Administration or the Department of Commerce.

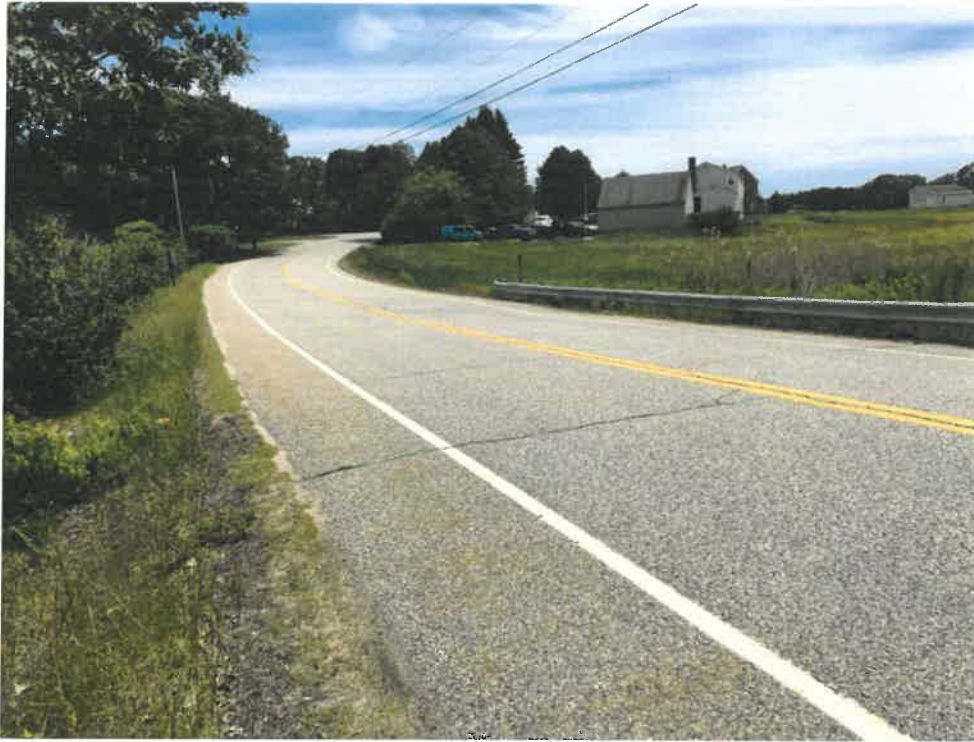
Photo 1 (06-20-18): Facing south Sawyer Road crossing of the culvert. Crack on surface of the road may be due to the presence of culvert.

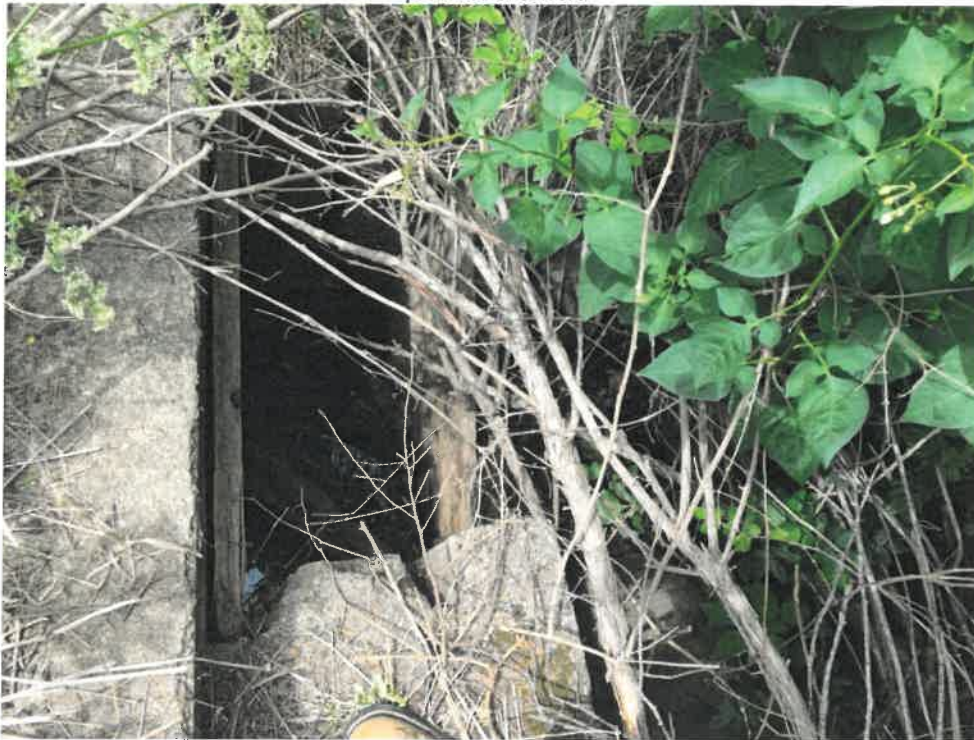
Photo 2 (06-20-18): Inlet of 36-inch High Density Polyethylene (HDPE) pipe headwall on northeast side of Sawyer Road. Concrete headwall conceals the HDPE pipe and pieces of concrete support wooden boards that creates an inlet weir to create an impoundment upstream of the pipe.

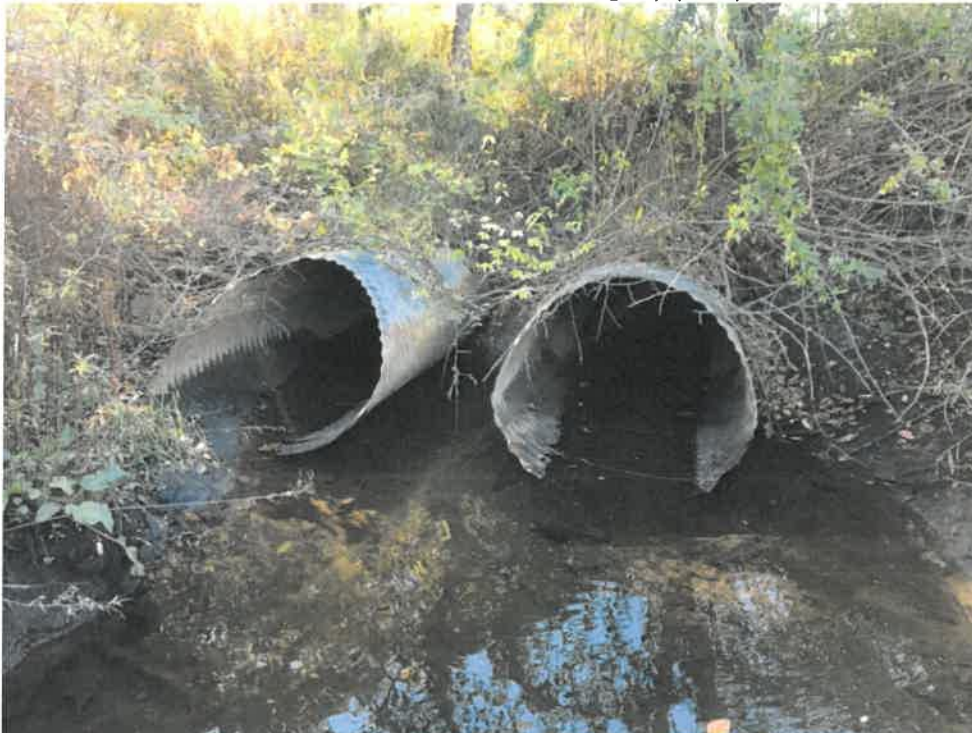
The group agreed that Culvert #15, Willow Brook, is a high priority for replacement. The culvert is in poor condition and also supporting two public sewer pipes. The culvert is located 200 feet (est.) upstream of the Spurwink Marsh, rated high value for wildlife by the Maine Department of Inland Fisheries and Wildlife. Failure of the culvert might also result in failure of the sewer lines, with a resulting catastrophic discharge of sewerage into the marsh.

Photo 2 (10-22-18): Inlets of the two, 48-inch wide by 36-inch tall corrugated aluminum pipes located northerly of the sanitary sewer crossing embankment. Inverts to both pipes are corroded and in decay.

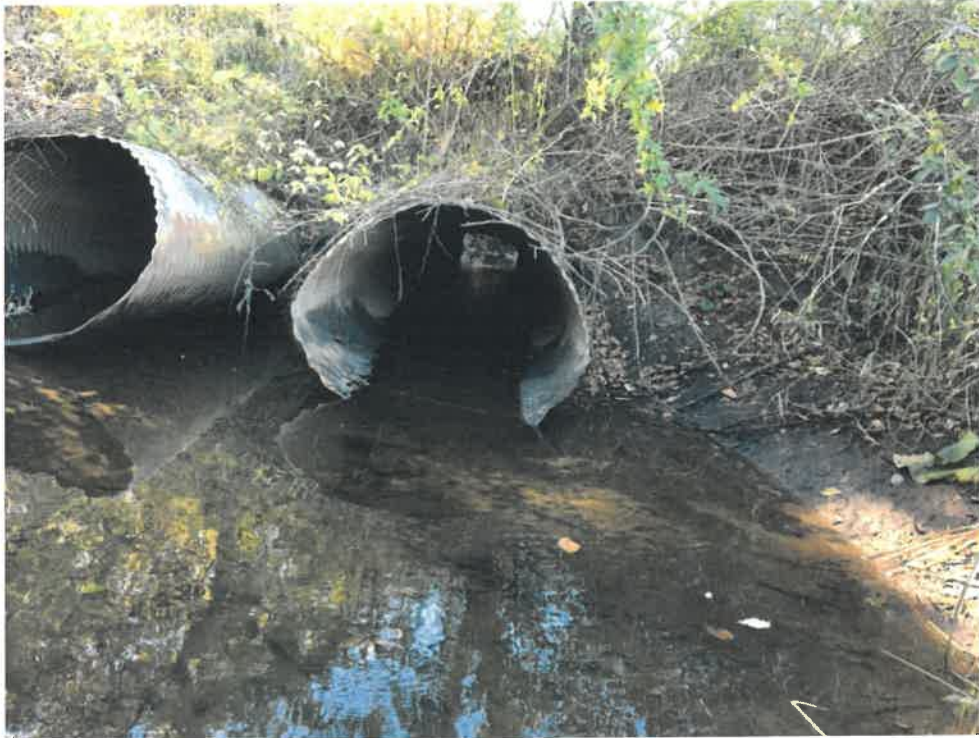
Photos 3 (10-22-18): Looking down the barrel of the westerly inlet of the two Inlet culverts. Culverts' inlet invert has rusted away and the pipes are in poor condition.
