Fort Williams Projects Final Report

**Main Entrance Gate
Interpretive Signs at Battery Knoll
Bleachers
Batteries
Goddard Mansion**

March 26, 2009

Re: Fort Williams Projects – Final Report

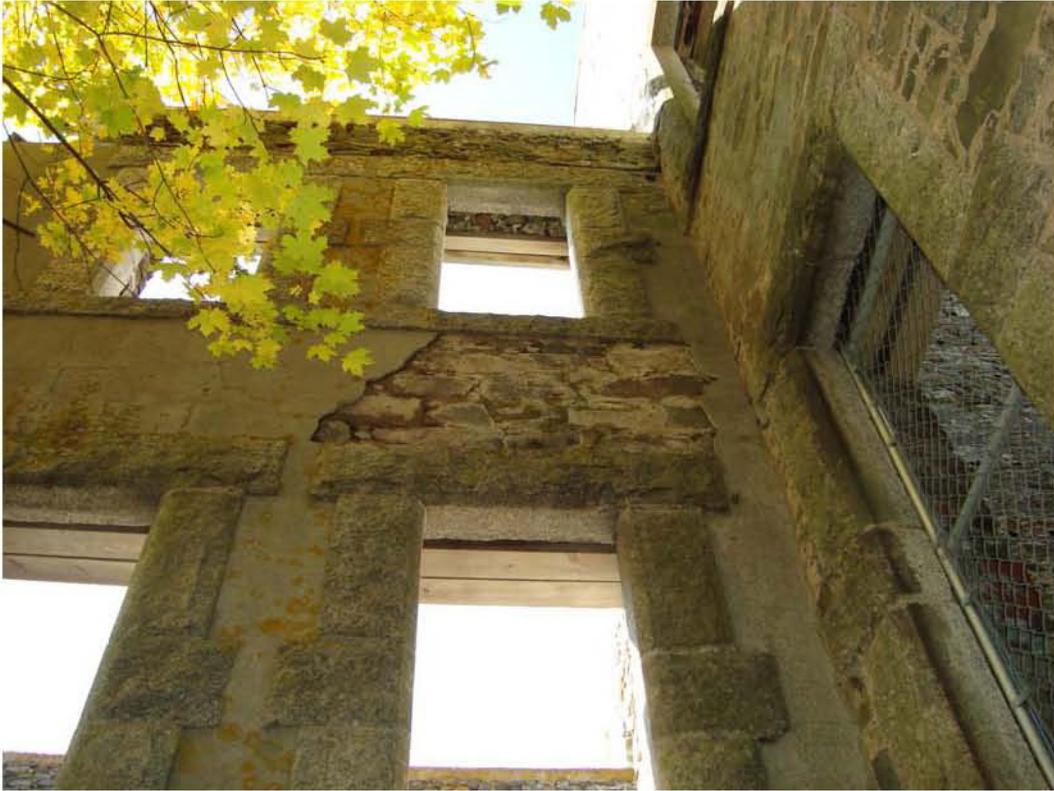
Parging on the east wall was found to be in poor condition with areas of spawling observed. These areas are identified on the attached drawings. This finding varies significantly from the previous report issued in 2004 which states the parging was in good condition. We believe the spawling is caused by moisture infiltration in the stone masonry behind the parged surface. Water moves down the wall face and enters the wall interior, migration to and being trapped by the parging. Through freeze/thaw action, the parging is pushed off the stone surface creating cracks and eventually resulting in spawling of the parge coat. Prior to failure and loss of the parging the trapped moisture deteriorates the mortar causing loss of strength and voids. The mortar joints, once weathered, are further deteriorated by subsequent freeze/thaw action. We believe safety concerns are present for observers outside of the ruin due to falling mortar at spawling locations. Tree growth was observed in very close proximity to the exterior of the ruin in this area. This is a detriment to masonry not only due to poor air flow and ventilation of the masonry, but roots may also penetrate and undermine the structure resulting in significant structural damage.

Location of spawled parging on East Wall.

Where parged areas of the east wall are spawling, we believe the parging should be completely removed over the entire extent of the wall. This will not only alleviate safety concerns associated with falling parge coat but also discontinue the weathering of the stone masonry mortar joints caused by trapped moisture. The masonry will be allowed to breath and moisture will no longer be captured between the two surfaces. Once parging is removed, mortar joints shall be raked and repointed. In an effort to aid air circulation on the east wall, we recommend tree growth be removed within a 25 foot proximity of the wall.

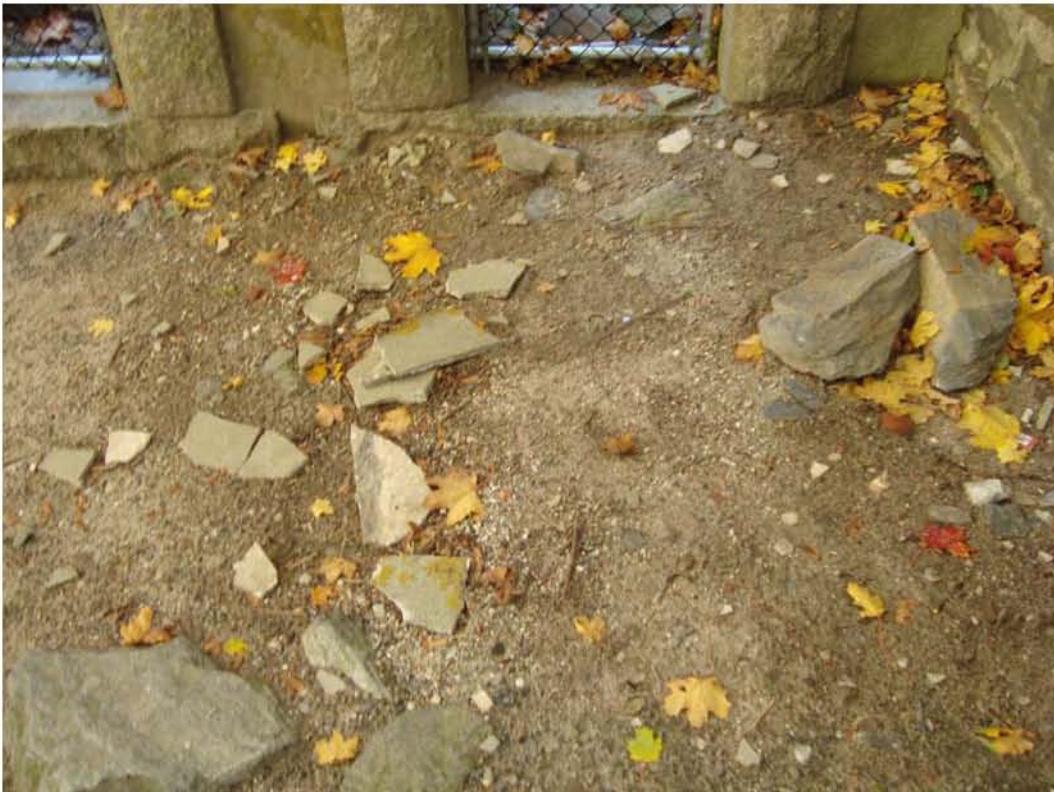
Debris from spawled parging on East Wall.

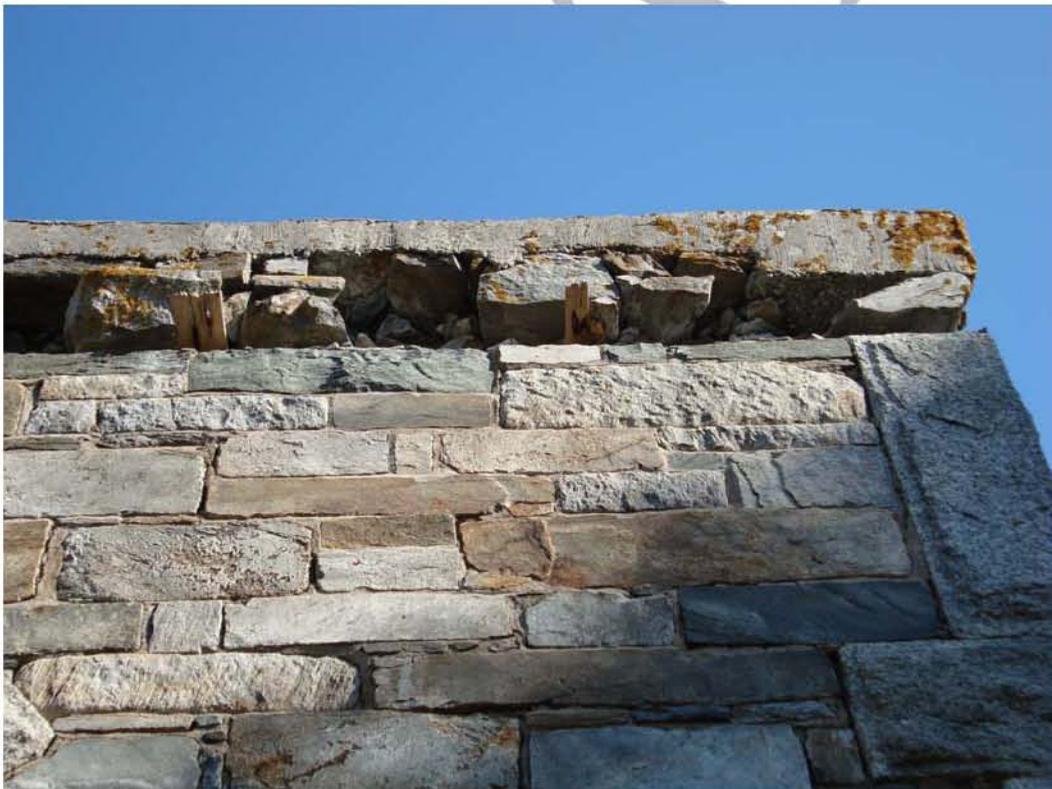
The masonry mortar joints range in condition from satisfactory to poor. These areas are identified on the attached drawings and are classified in the same manner as the previous assessment. The majority of the area in poor condition exists at the top of walls in which the stone appears to have not been intended for such exposure. In many of these

locations, directly below the concrete cap, masonry stones were observed to be completely loose and free of restraint creating a safety concern in our opinion. While the fencing at the perimeter of the ruin does restrict access to the interior of the ruin, we believe significant safety concerns exist for observers outside of the ruin.

Stone rubble with concrete cap typical around majority of building perimeter

The attached drawings indicate the locations of the various mortar joint conditions. We are of the opinion that masonry mortar joints in poor condition should be immediately addressed with focus on the band of loose stone at the top of most of the walls which present potential of falling onto observers. We believe this safety concern should be addressed as follows.

- Immediately erect a temporary fence or barrier around the perimeter of the ruin such that observers are kept a safe distance from potential falling stones.
- Once fencing is erected, point the loose stone masonry at top of walls with mortar.

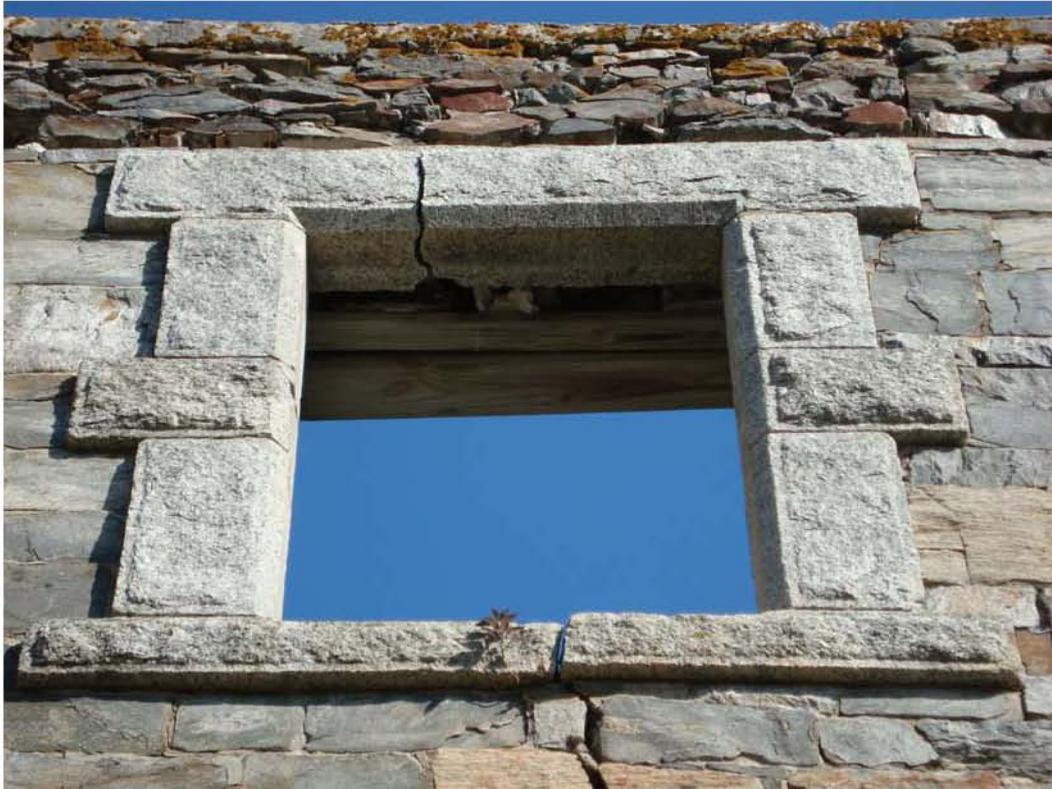
There are a number of locations where new cracks in the granite headers, sills and jambs are present. We believe these are due to weathering of the stone in the time since the last assessment. Radial spawling of the granite was observed in many locations however the spawling has seen little change since 2004. We agree that this spawling is the result of the controlled burn as the previous report mentions. The condition of the wood headers appears to be unchanged from the time of the last assessment.

Crack through granite header and sill

Where cracked granite lintels exist without any supplemental shoring, we recommend these lintels be shored utilizing pressure treated lumber headers and jambs at the inside of the existing opening similar to other existing shored locations. See attached drawings for locations.

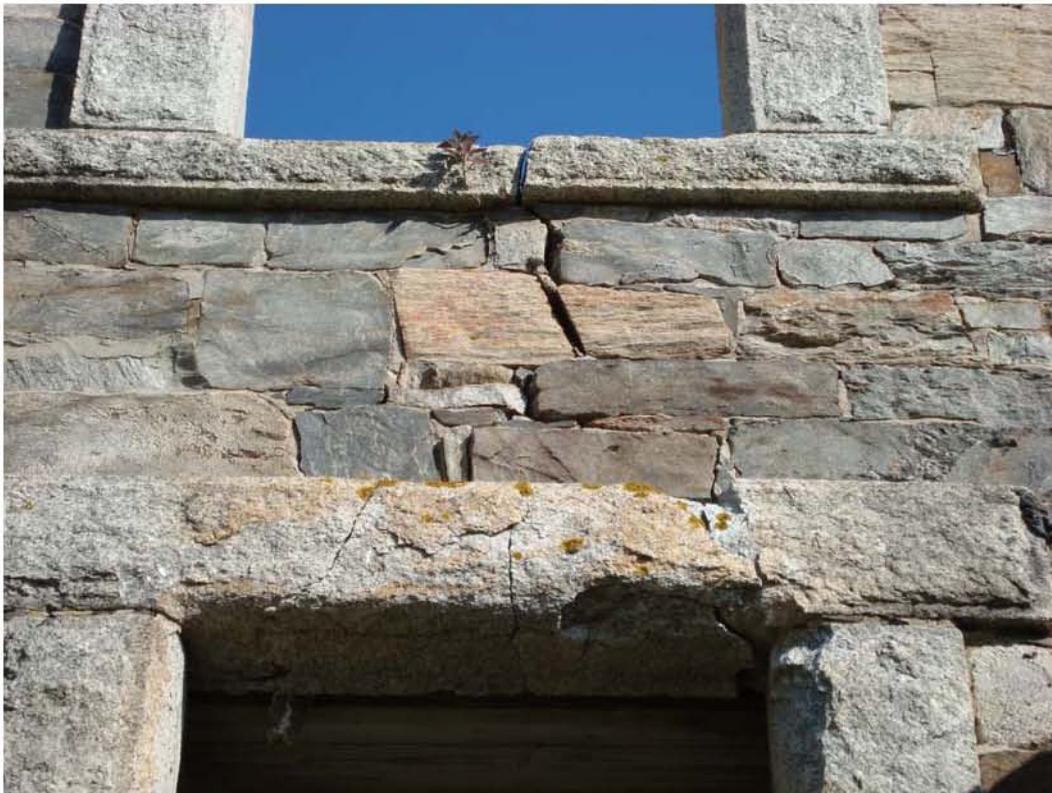
Crack through granite sill above, stone masonry and granite header below

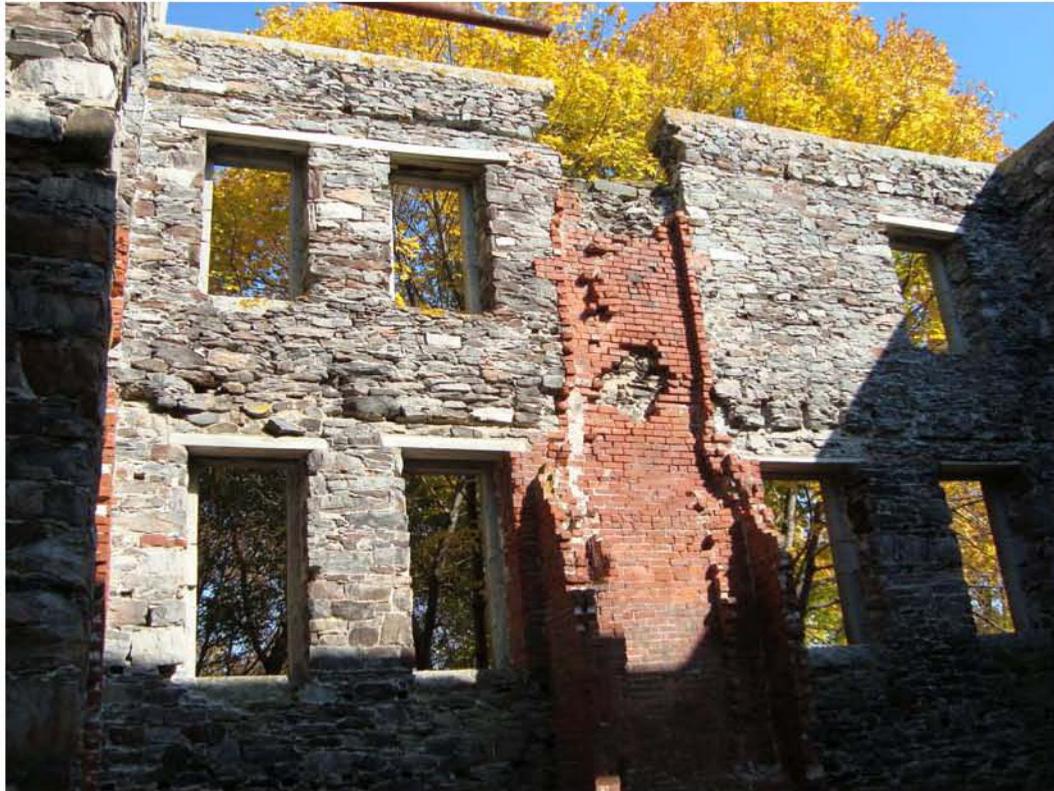
Loose brick at East Wall chimney

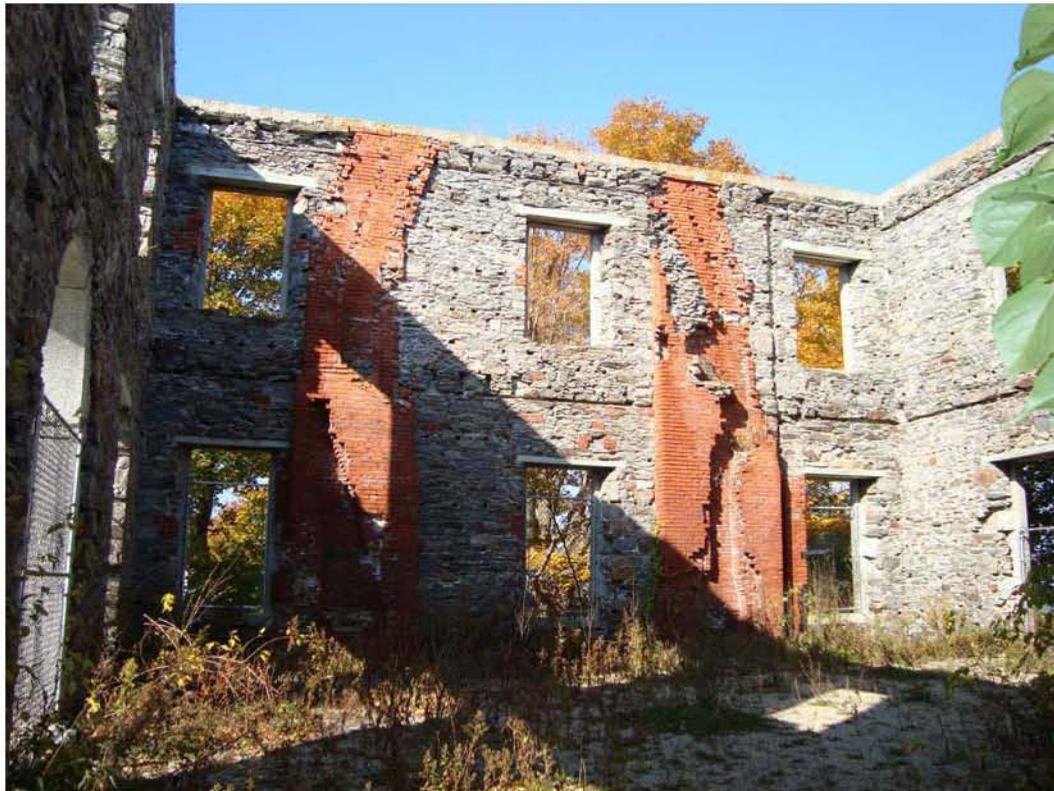
Loose brick at North Wall chimneys

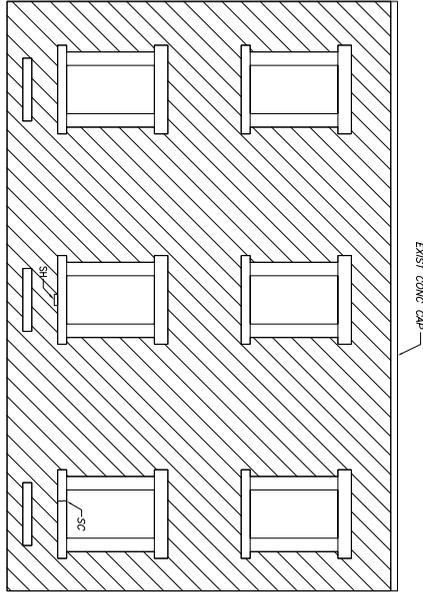
ⓓ EXTERIOR ELEVATION
SCALE: 1/4" = 1'-0"

TYPE I = 0 SQ FT
TYPE II = 952 SQ FT
TYPE III = 0 SQ FT

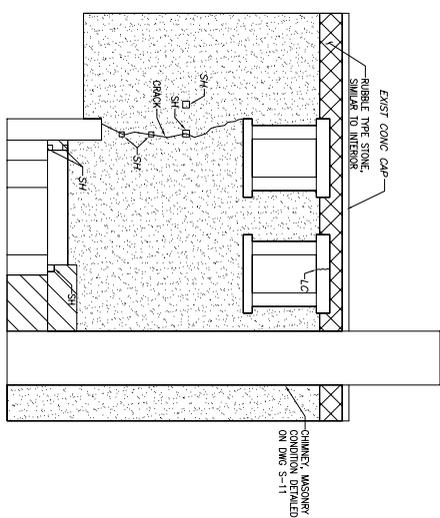
ⓔ EXTERIOR ELEVATION
SCALE: 1/4" = 1'-0"

TYPE I = 35 SQ FT
TYPE II = 20 SQ FT
TYPE III = 440 SQ FT

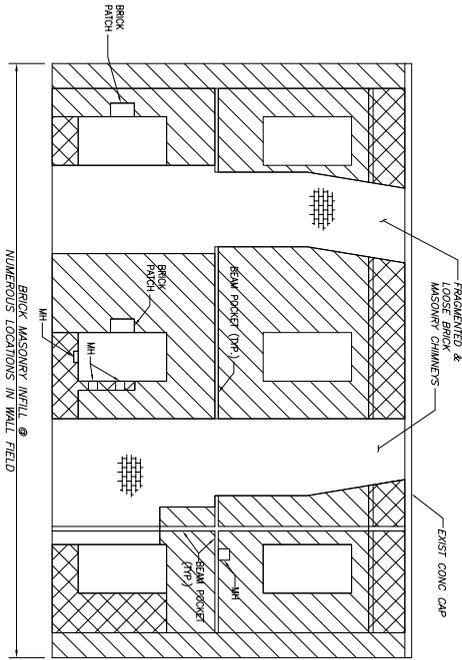
D INTERIOR ELEVATION
SCALE 1/4" = 1'-0"

TYPE I = 133 SQ FT
TYPE II = 430 SQ FT
TYPE III = 0 SQ FT

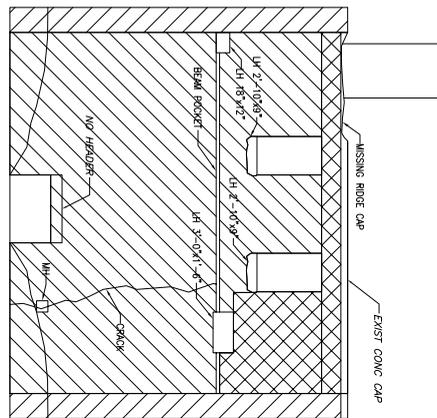
E INTERIOR ELEVATION
SCALE 1/4" = 1'-0"

TYPE I = 100 SQ FT
TYPE II = 512 SQ FT
TYPE III = 0 SQ FT

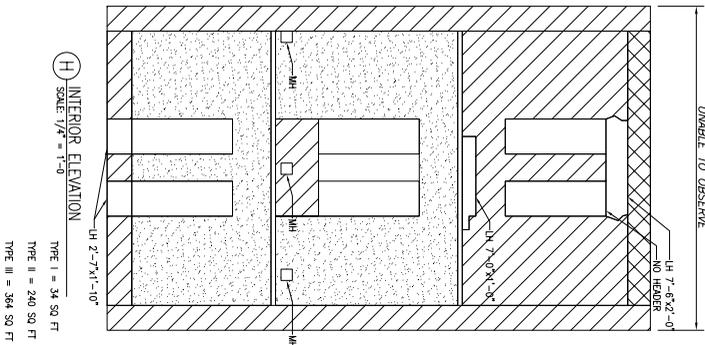
H INTERIOR ELEVATION
SCALE: 1/4" = 1'-0"

TYPE I = 34 SQ FT
TYPE II = 240 SQ FT
TYPE III = 364 SQ FT

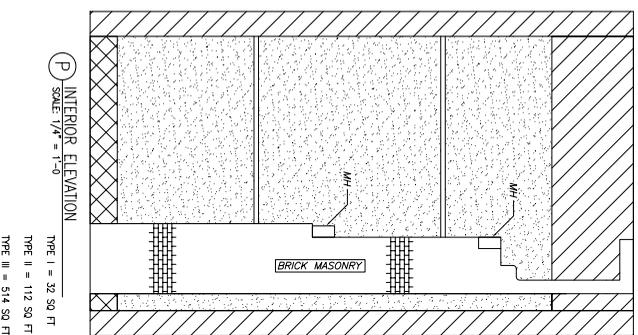
P INTERIOR ELEVATION
SCALE: 1/4" = 1'-0"

TYPE I = 32 SQ FT
TYPE II = 112 SQ FT
TYPE III = 514 SQ FT

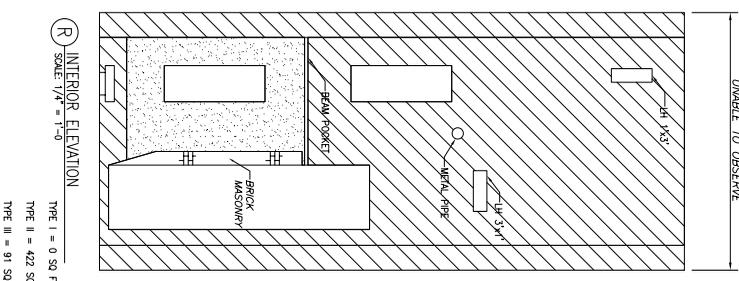
R INTERIOR ELEVATION
SCALE: 1/4" = 1'-0"

TYPE I = 0 SQ FT
TYPE II = 422 SQ FT
TYPE III = 91 SQ FT

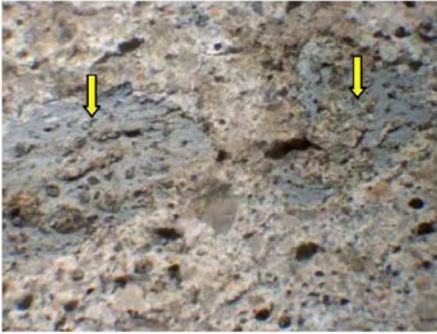
Figure 4. Remnants of a gray polymeric coating on the surface of the core are marked with arrows. The small depressions in the coating contain dormant plant life. The width of the field of view is 0.25 inch.

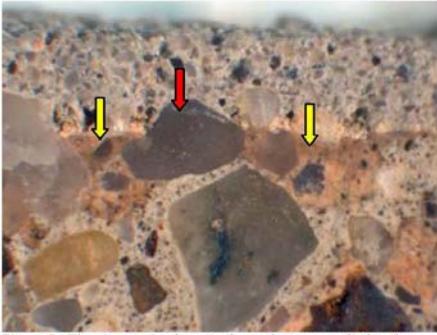
Figure 5. The air entrained mortar layer that was applied to the surface of the core is visible along the top of the photo. The red arrow marks a sand particle that was exposed on the eroded surface of the base concrete at the time the mortar layer was applied. The yellow arrows mark the tan-colored fully carbonated portion of the cementitious matrix of the base concrete. The width of the field of view is 0.5 inch.

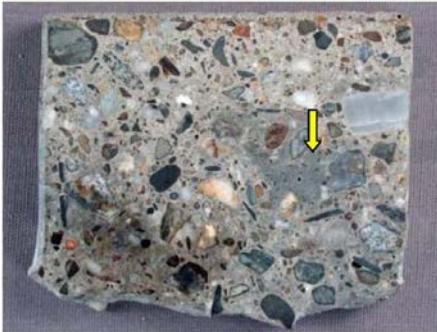
Figure 6. One of the lapped surfaces used for the studies is pictured. The yellow arrow marks a dark gray concentration of incompletely dispersed portland cement. Note the small size of the coarse aggregate particles (pea gravel 3/8 to 1/2 inch maximum nominal dimension). Many of the aggregate particles can be seen to exhibit darkened (clarified) rims which may be indicative of a reaction with the surrounding cementitious matrix. The width of the sample is 2.5 inches.

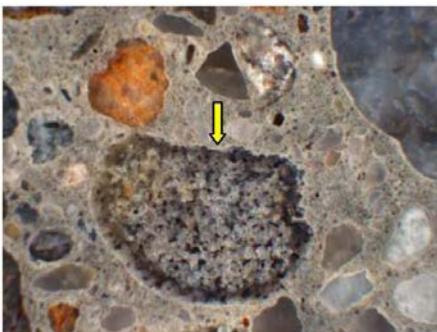
Figure 7. A coarse aggregate particle composed of granitic rock that has a clarified rim is marked with an arrow. No evidence of deleterious expansion is present. The width of the field of view is 0.5 inch.

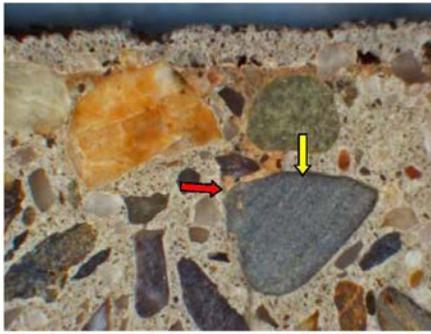
Figure 8. A fine grained siliceous rock particle that exhibits a partial darkened rim is marked with a yellow arrow. Note that the particle does not have a darkened rim along the left side of the particle where it is in contact with a crack and carbonated cementitious matrix (marked with a red arrow). The width of the field of view is 0.5 inch.

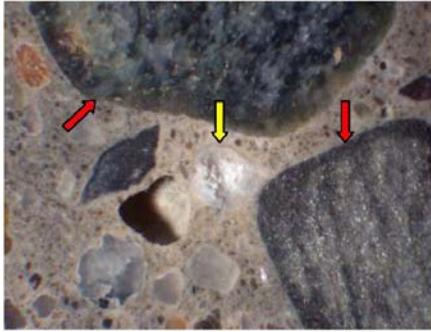
Figure 9. An air void located near the base of the core that is filled with a white secondary deposit is marked with an arrow. Note the darkened bands around the perimeters of the particles marked with red arrows. The width of the field of view is 0.25 inch.

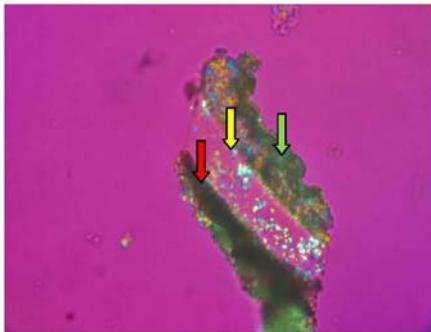
Figure 10. A fragment of the rim of the white secondary deposit contained in the void pictured in Figure 9 as viewed using polarized transmitted light is pictured. (The gypsum plate is in the light path.) The yellow arrow marks the optically isotropic region. The red arrow marks the fragment of cementitious matrix of the concrete that is adjacent to the perimeter of the void. The green arrow marks the highly birefringent dull white material that fills the bulk of the void. The width of the field of view is 0.015 inch.

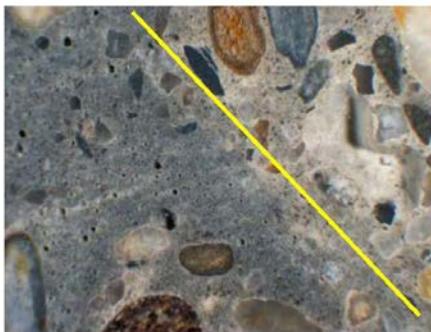
Figure 11. A close-up of the dark gray region of the matrix that is deficient in aggregate content is visible to the left of the yellow line. Note the small spherical voids contained in the dark gray zone. Similar voids were not detected in the body of the matrix.

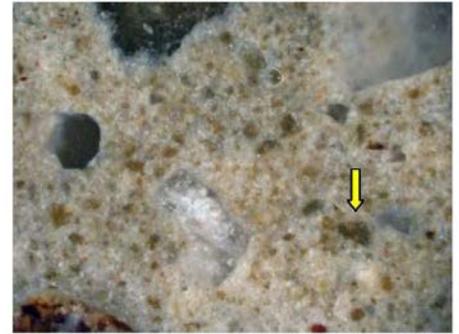
Figure 12. A close-up of the dark gray region reveals the presence of very closely spaced coarsely ground residual cement particles. The yellow arrow marks a portland cement particle that has a length of 0.007 inch (and would be retained on a 80 mesh screen). The width of the field of view is 0.11 inch.

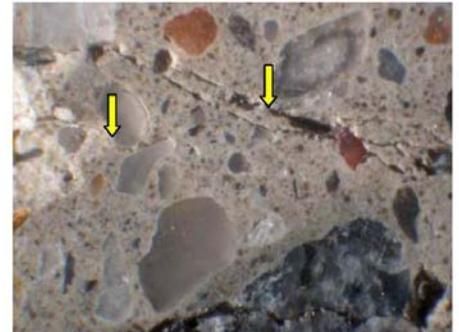
Figure 13. Two cracks that may be indicative of freeze-thaw distress and that are located near the base of the core are marked with arrows. The width of the field of view is 0.25 inch.
