**Town of Cape Elizabeth**  
Seven Building Facility Study  
*Cape Elizabeth, Maine*

HARRIMAN | Architects + Engineers

**Introduction****Town of Cape Elizabeth Facilities Study**

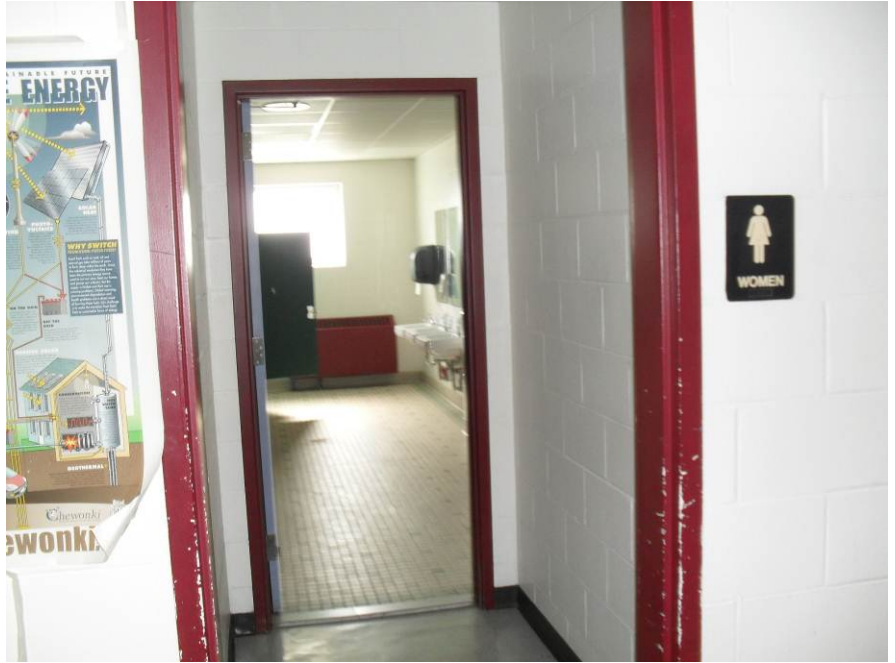
*Doors to Student Toilets*

The students toilet door entrances are not ADA compliant for clearances on pull side of door. Recommend minimum renovation to make entrances compliant.

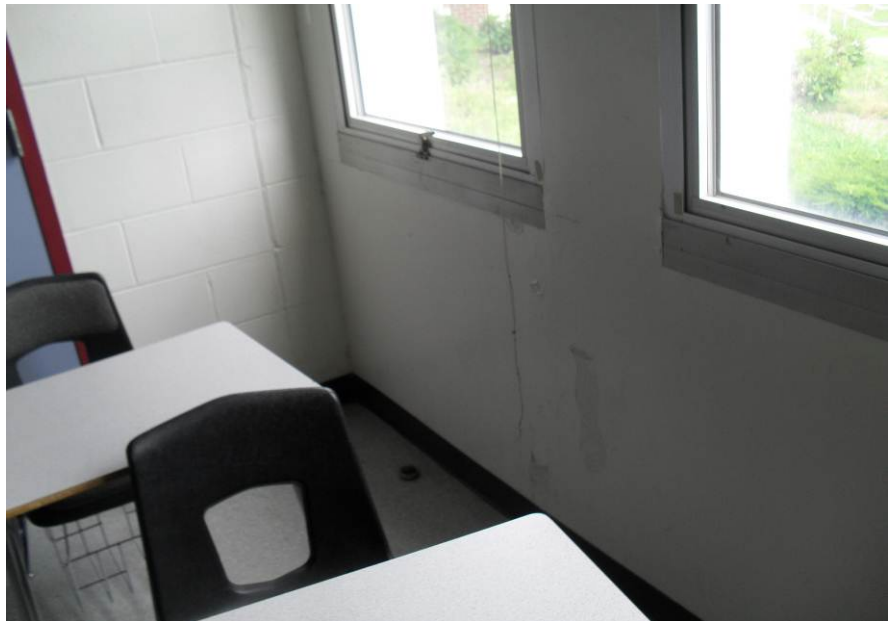
*Peeling Paint on Drywall  
at Windows*

Viewing the interior drywall panels around the windows it is apparent that water penetration around the windows and panels is the direct cause of the paint peeling and drywall failures and cracks you are witnessing. The window system is as originally constructed, a narrow-line non-thermally broken aluminum window frame and sash with a single glazed panel. Most of the window units have had the single pane glazing replaced with an insulated window glazing panel that appears to be around 3/4" thick.

Even though there are benefits to replacing the glazing, the unit is installed in a non-thermally broken aluminum frame system. The sill frame of the unit does not have a sill flashing under the frame. The jambs are directly anchored to the precast panel with the frame mechanically attached to this anchor.

The precast concrete window panel system is anchored to the structure through a series of connection angles and weld plates. On the back of the precast panels a layer of insulation and drywall was installed directly to the precast panel. No information could be found on the drawings indicating how the drywall was attached to the precast panel or to any direct framing behind it.

There are areas above the suspended ceiling where the back of the panel is un-insulated or a layer of insulation is applied without a drywall layer. The manner in which this whole assembly is constructed provides an environment for condensation to build over time. Even though every room with this assembly was not observed, the rooms viewed shows signs of cracking and peeling or recent repair due to previous damage.

We would recommend to the Cape Elizabeth School Department that this becomes a very high priority on your Capital Improvement Project list. The potential for mold build-up behind the drywall is very high and in the present school environment of constantly minimizing health and safety risks the potential liability exposure could be become very serious.

We would recommend a forensic analysis to verify and confirm our suspicions and an appropriate plan of action be put in place to repair this condition.

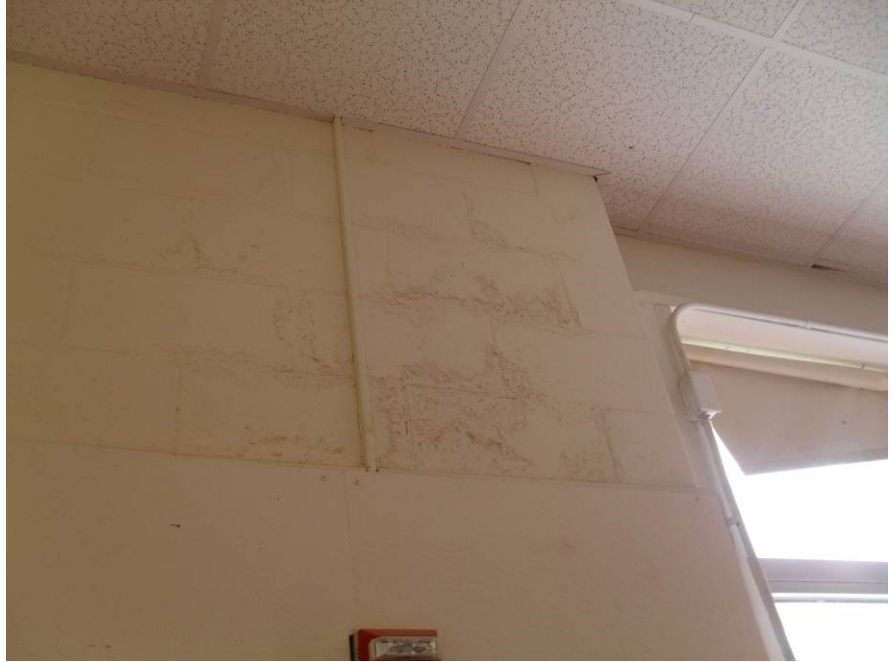
*Exterior Wall – Art  
Room Wall Damage*

The second photo shows a similar condition on the exterior wall of the art room. In this room the damage is relatively close to the precast concrete window panel system which suggests that the entry point may be related to a flashing or joint system failure.

If the source of water entry is unknown then we would recommend a forensic study to find and correct your water entry source before you repair the walls and repaint.

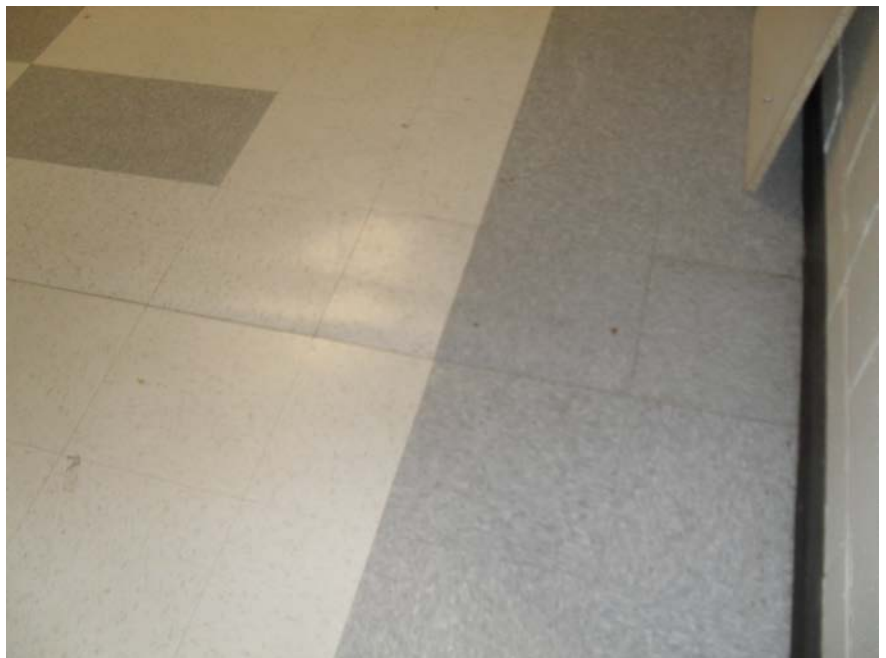
At the transition area of the second and third floor corridors there was a hump in the floor tile going wall to wall across the corridor. Research of the construction documents indicates that this hump is a location of a floor control joint system.

Recommended repair would be to cut out the existing control joint system and install a new metal floor expansion joint system with a VCT insert.

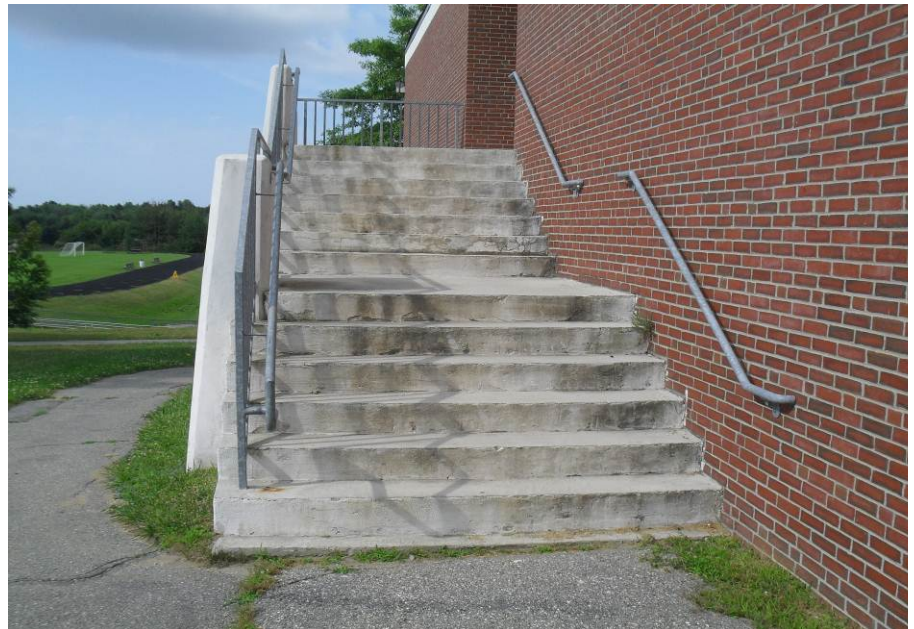
*Exterior Stairs*

Exterior concrete exit stairs are in bad shape and the cement based parging system used to patch the stairs has deteriorated and is falling off due to temperature and weather exposure. We would recommend replacement of these stairs with a new poured in place concrete stair and metal cast in nosing.

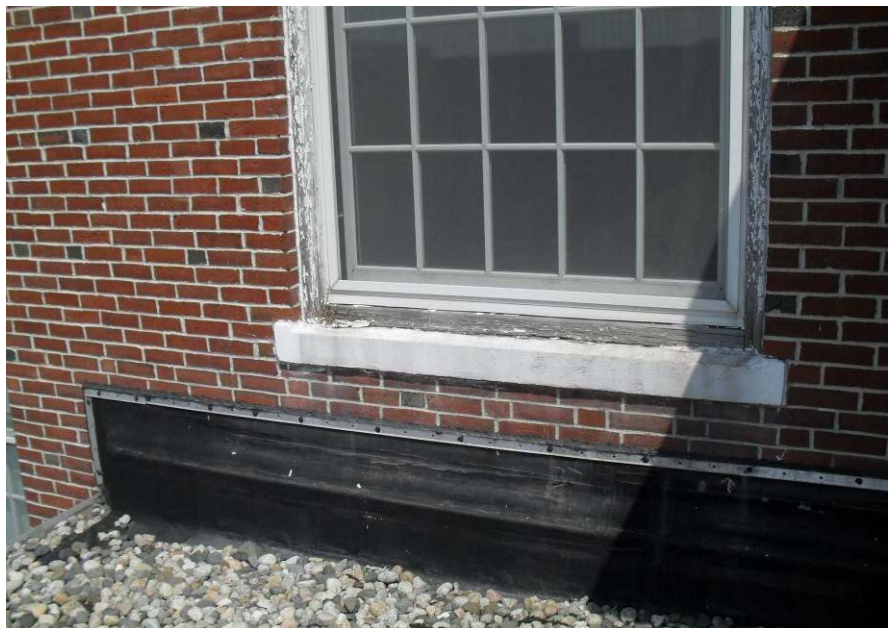
*Existing Wood Window Frame Badly Deteriorated*

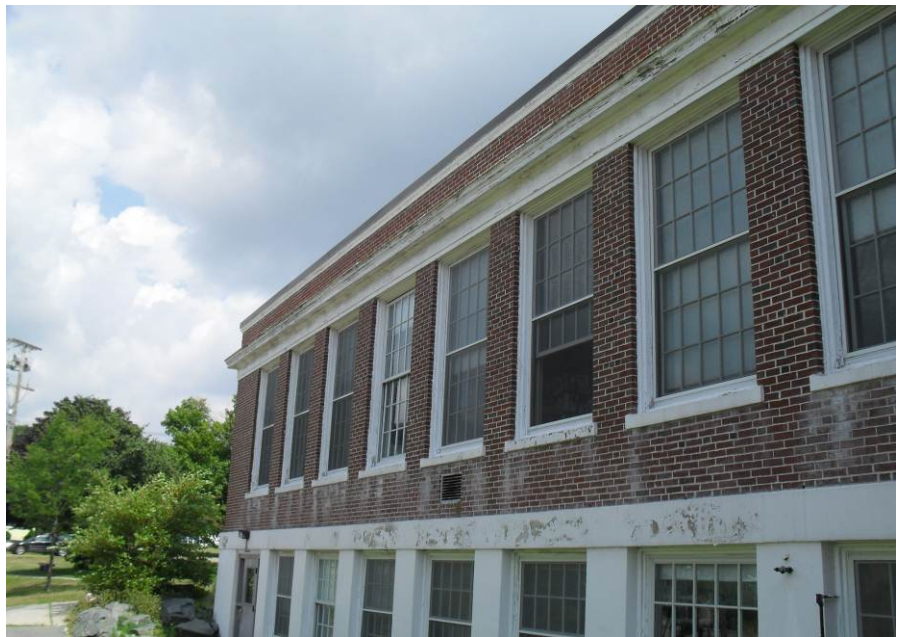
*Broken Window Sills –  
Concrete Requiring  
Repainting*

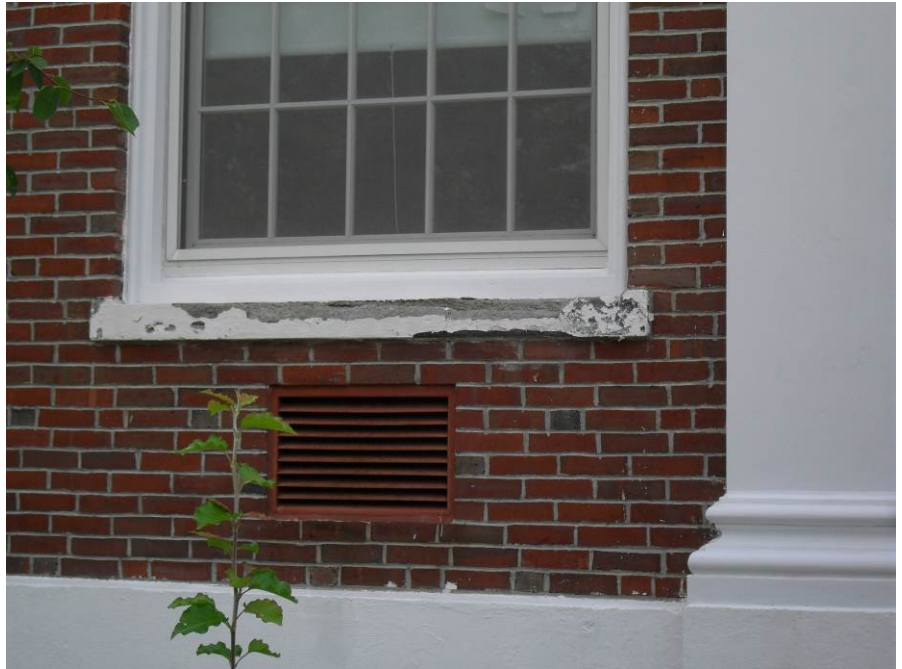
*Broken Cast Stone  
Window Sill*

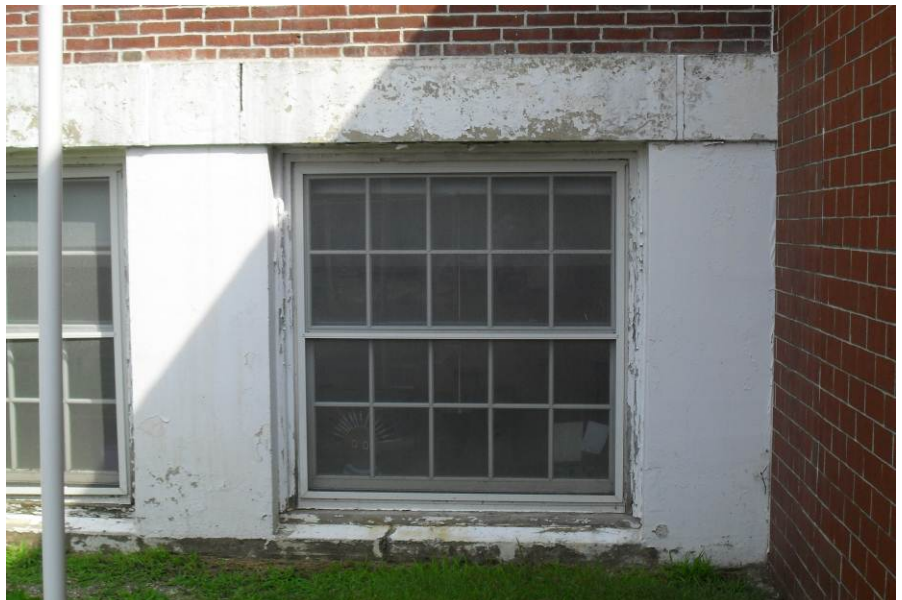
*Concrete and Windows  
Requiring Repair and  
Refinish*

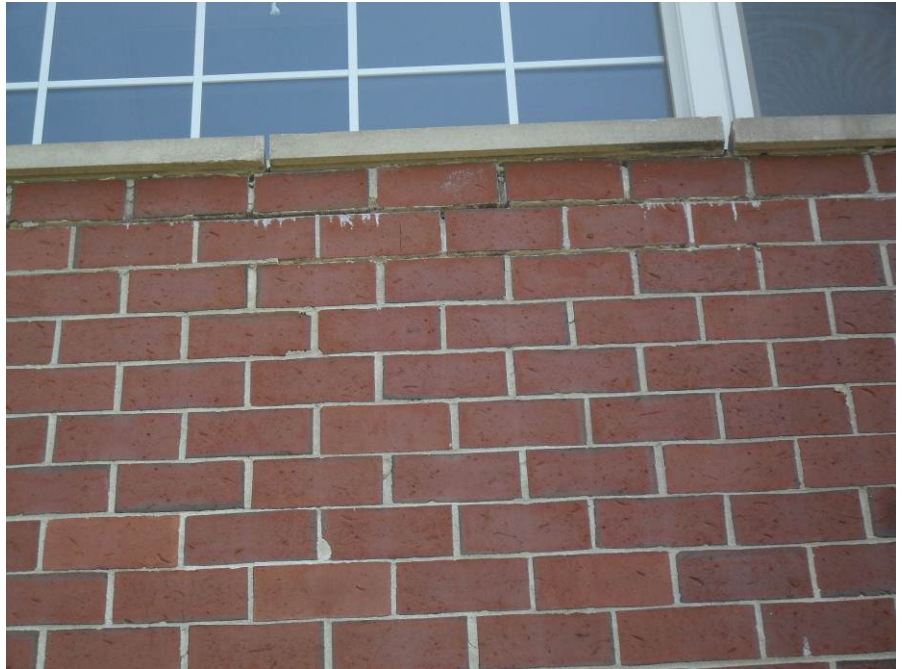
*Butt Joints and Mortar  
Joint Damage*

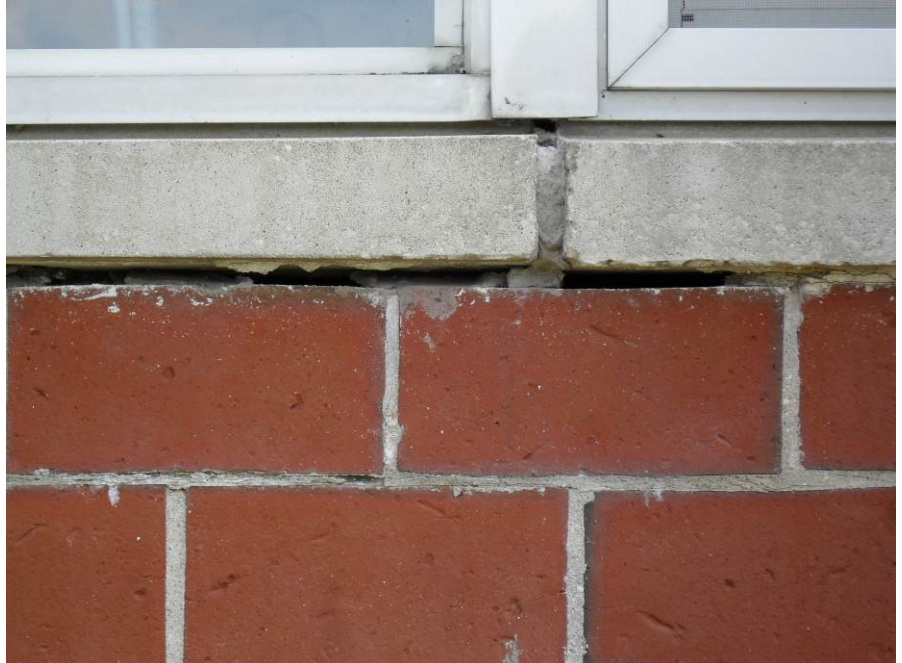
*Consistent Window Sill  
Damage*

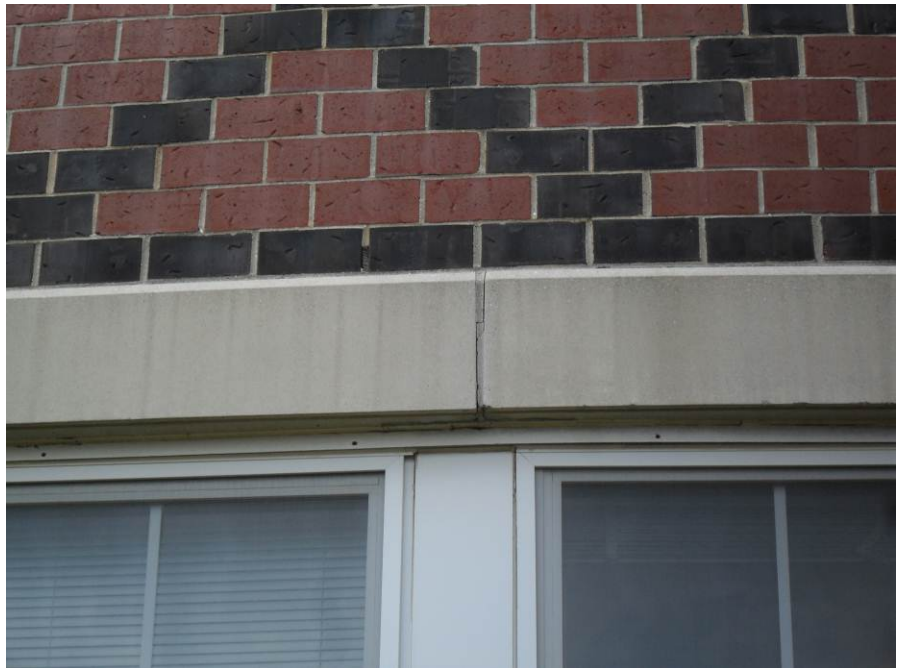
*Broken Joint Between  
Units*

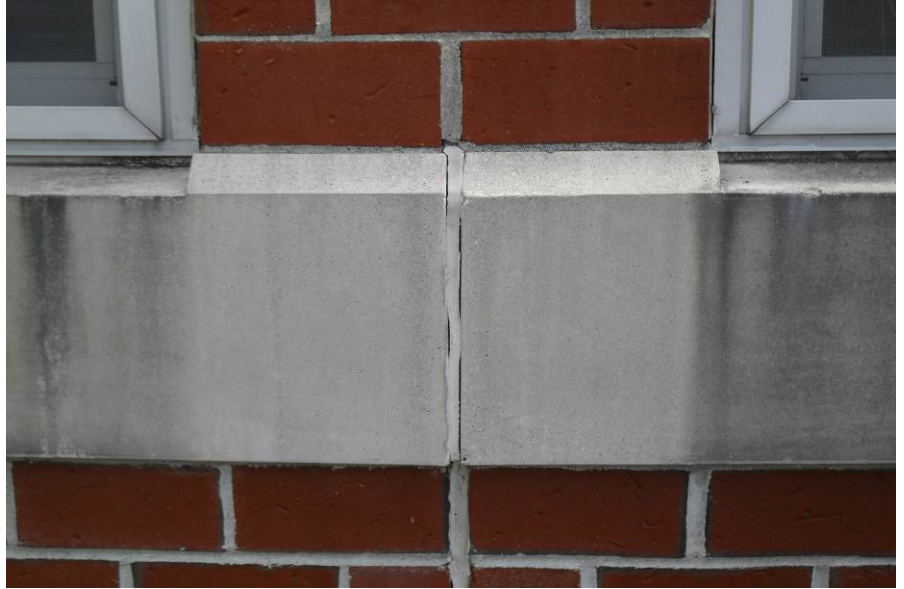
*Repair Failed*

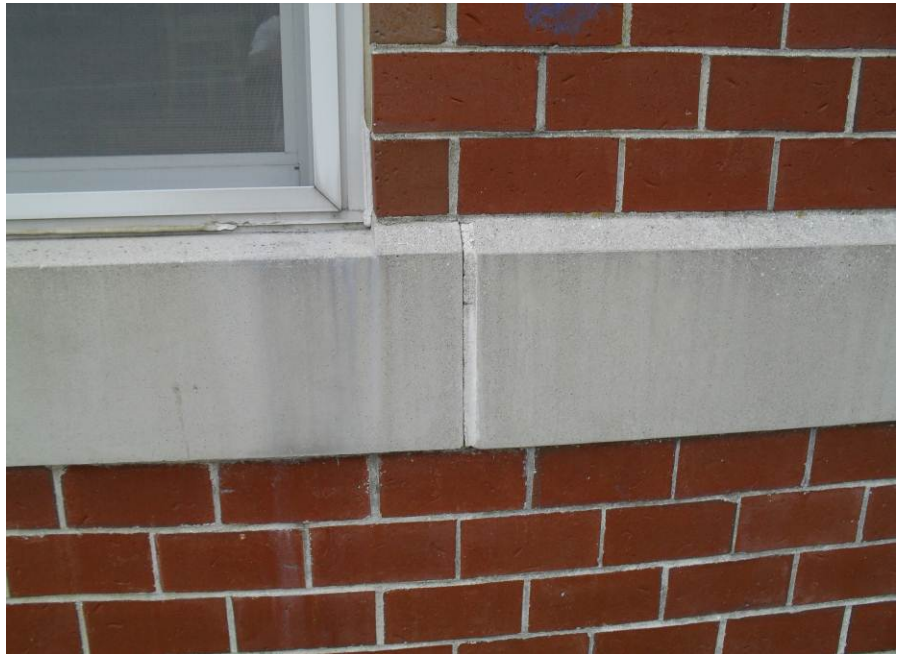
*Mortar Joint Failure*

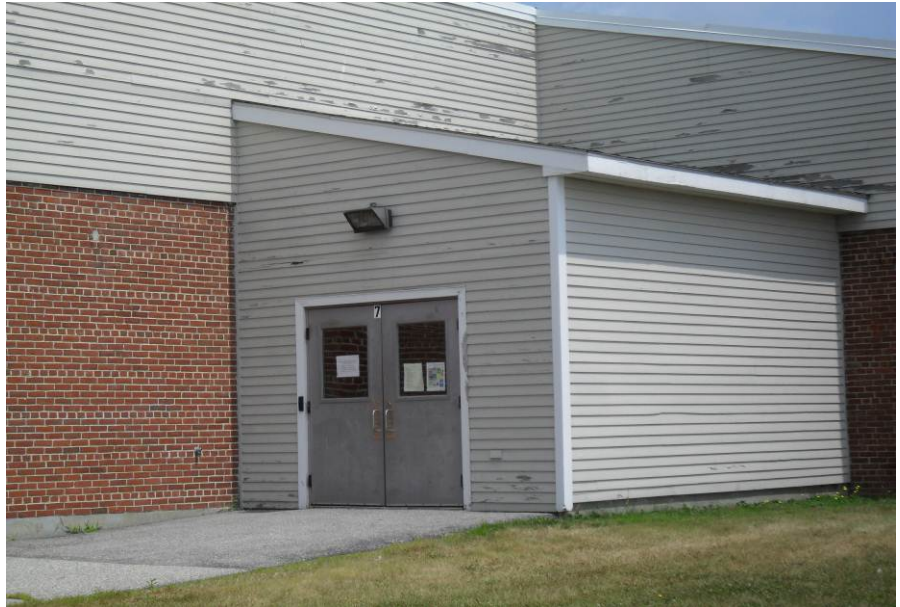
*Wood Clapboard Siding Needs Repainting*

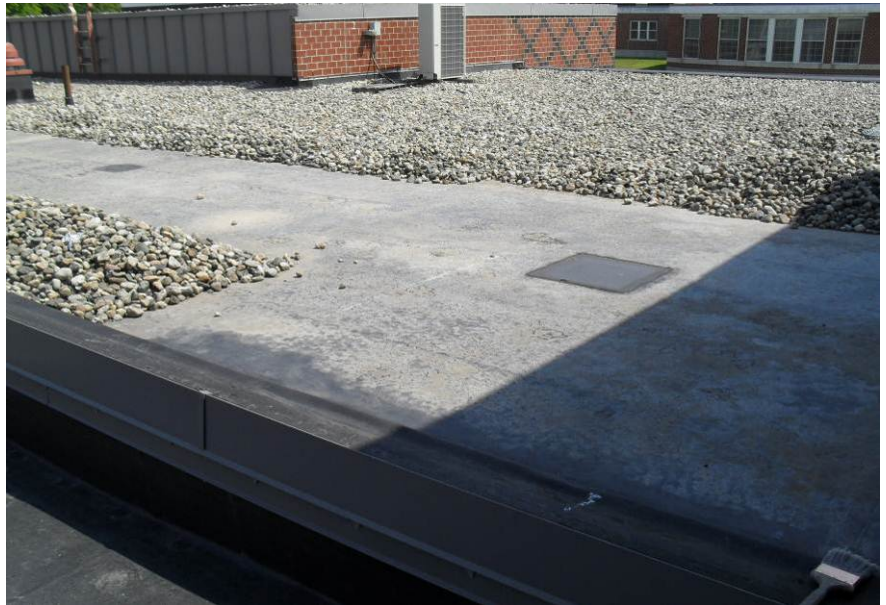
*Roof Membrane Badly  
Worn*

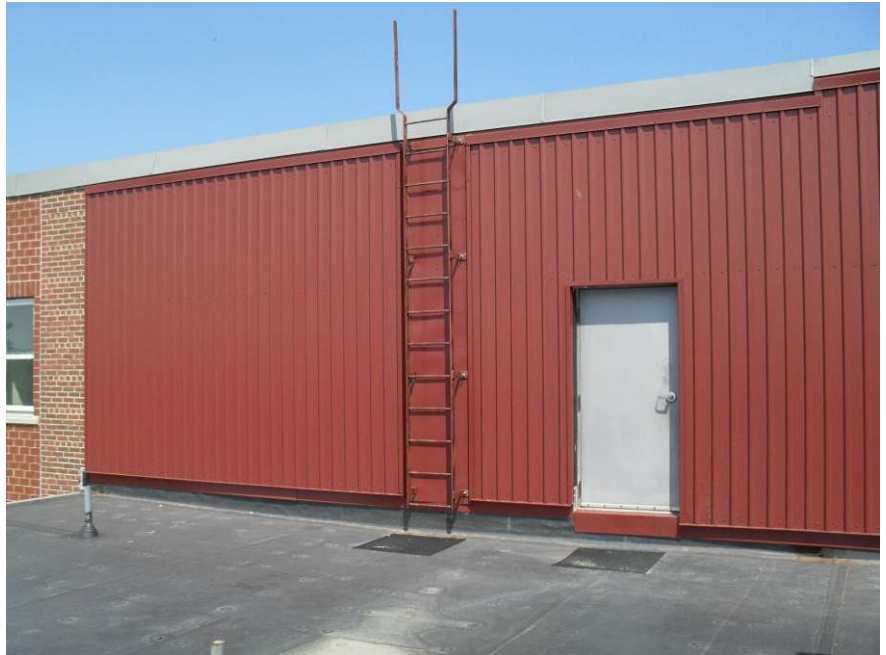
*Vertical Ladder –  
Noncompliant*

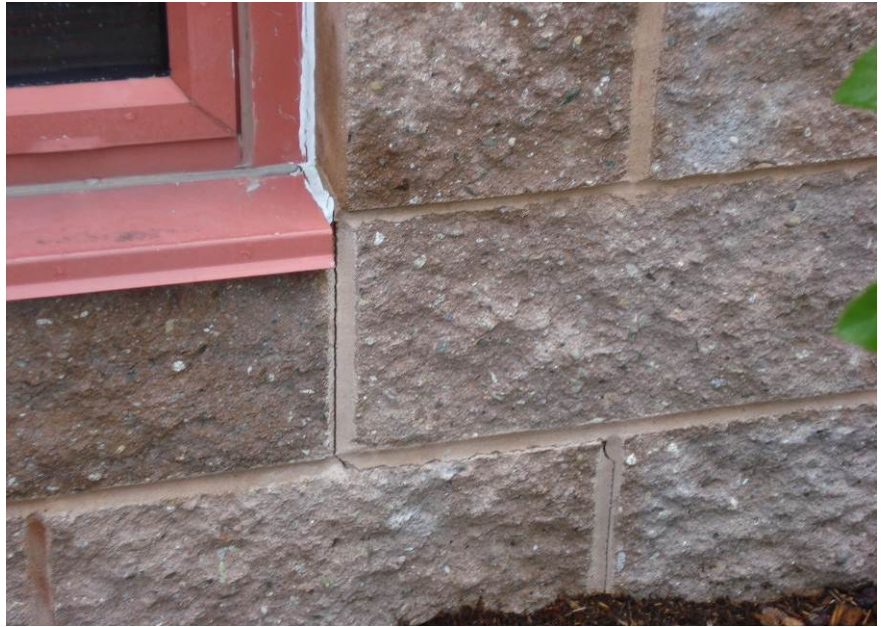
*Stepped Cracked Joint*

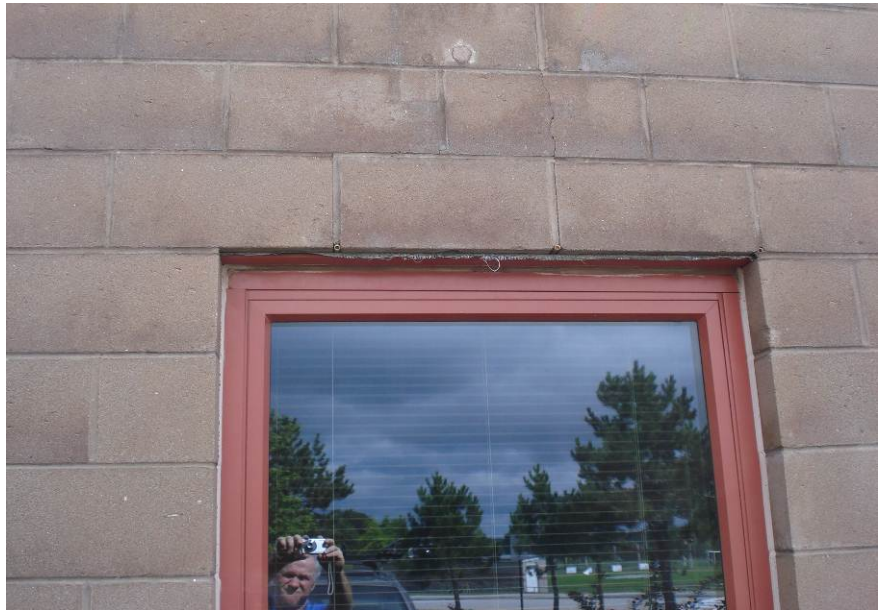
*Window Head – Crack  
Through Joints and  
Block*

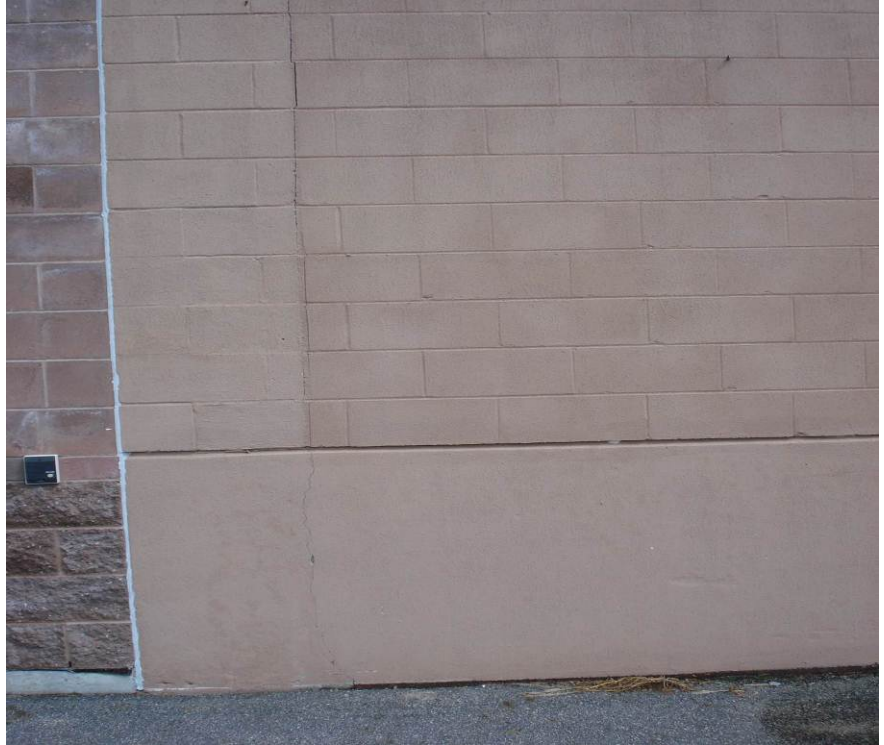
*Crack in Existing Block and Foundation*

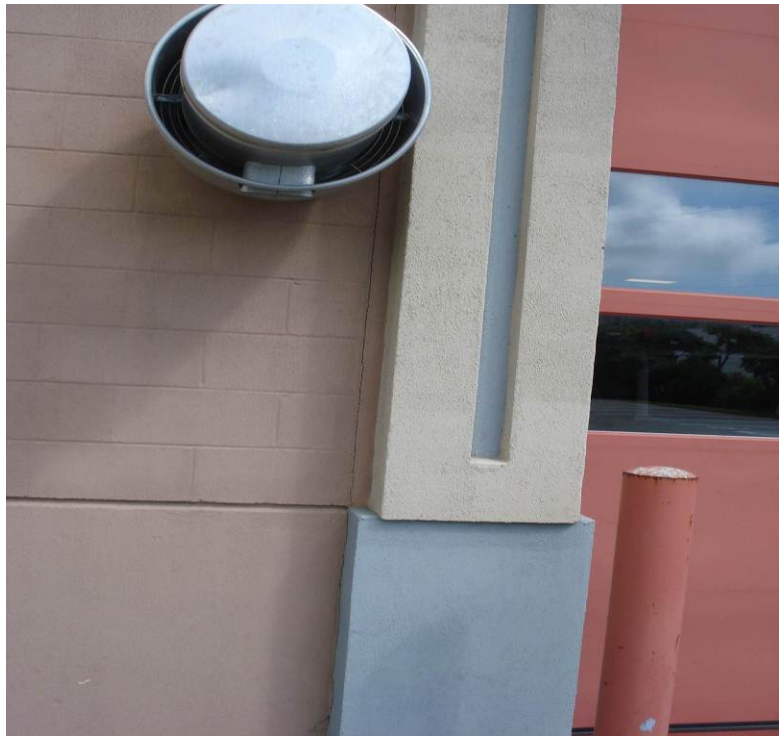
*Control Joint Failure*

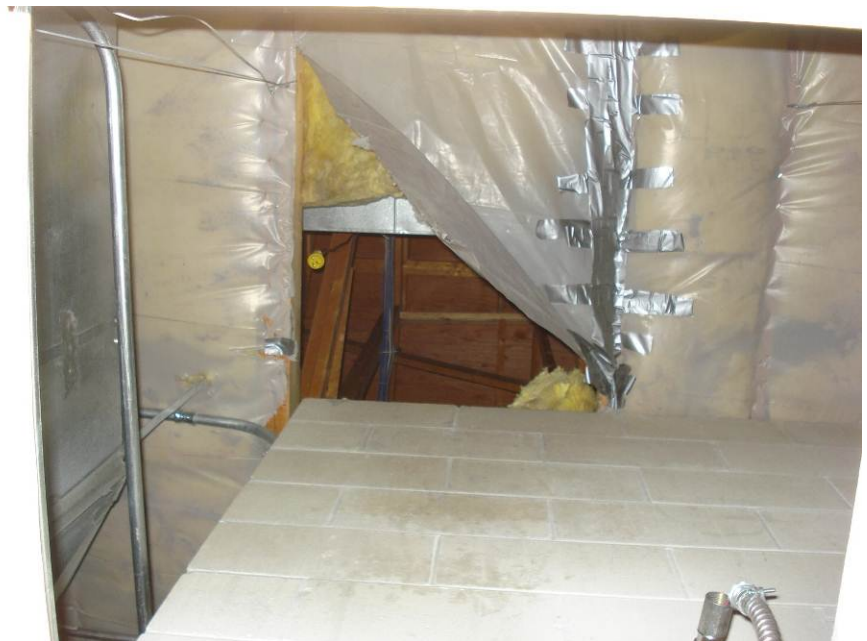
*Major Hole in Insulation  
Barrier*

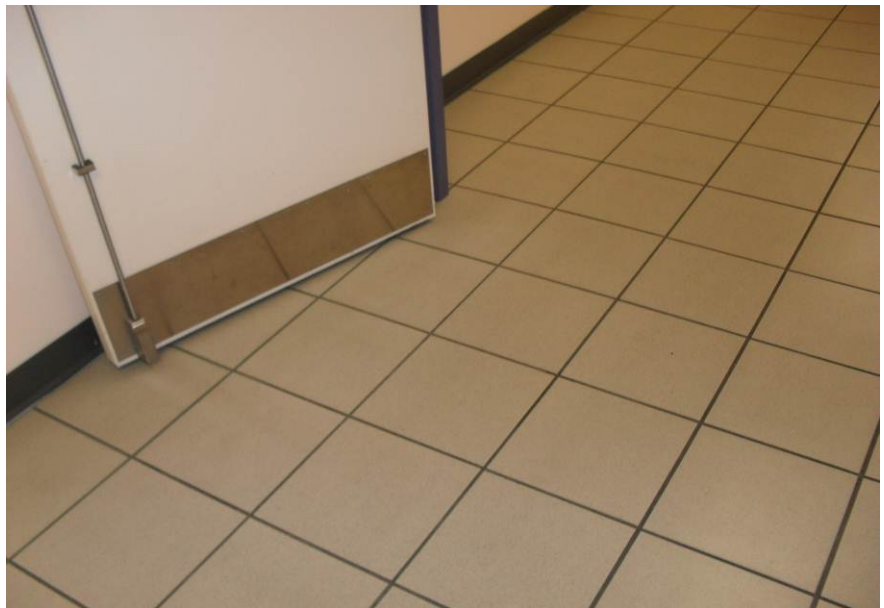
*Floor Strike Plate  
Missing*

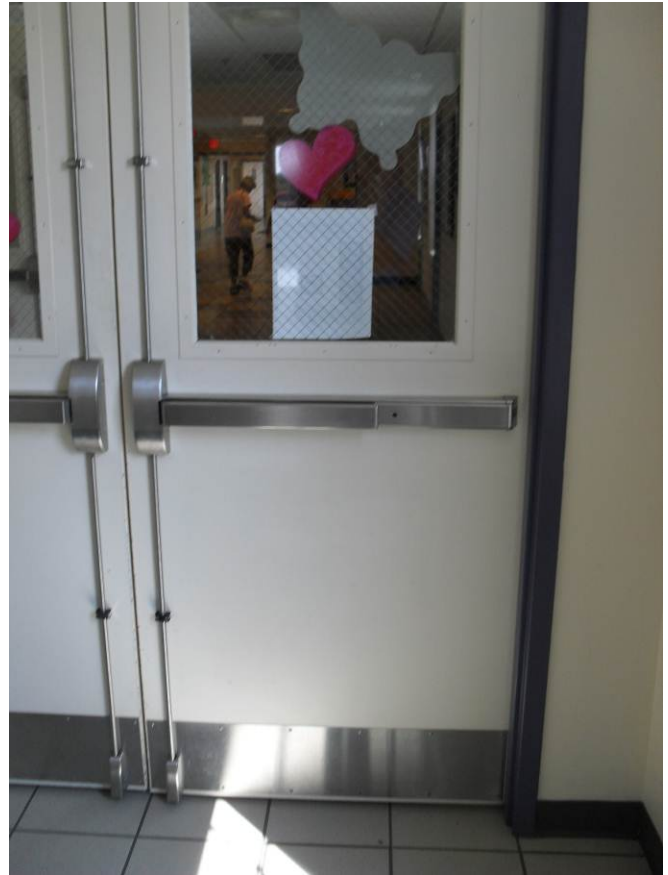
*Wire Glass in Rated  
Doors – Not Allowed  
Per Code*

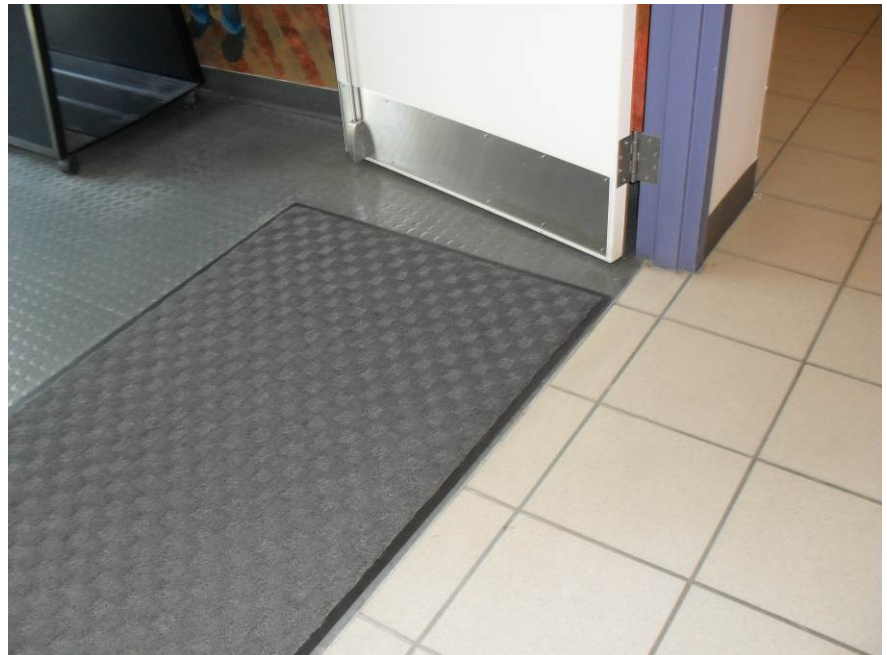
*Floor Strike Plate  
Missing – Doors to  
Main Entrance*

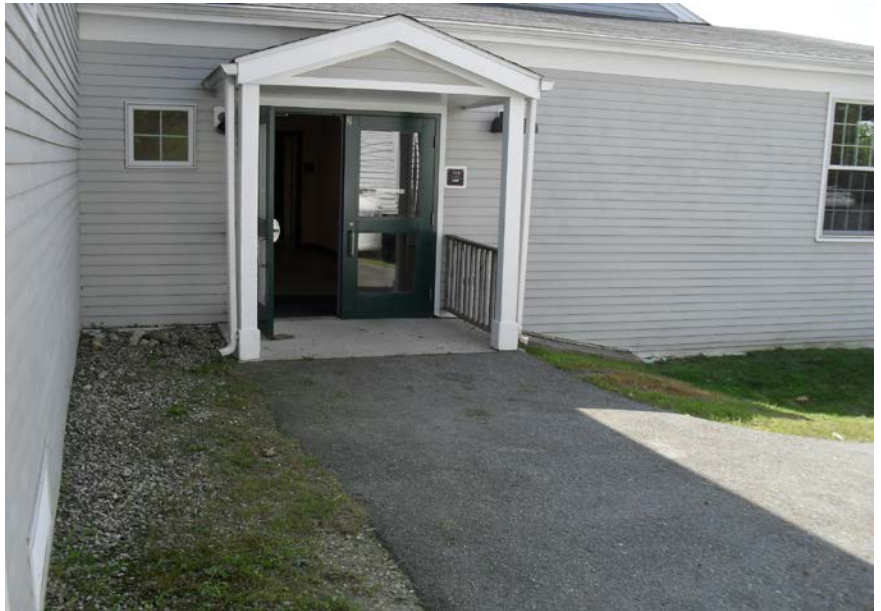
Exit doors at the side entrance cannot be fully open for exiting under freeze conditions. It has been reported that the leading edge of the door becomes stuck in a partially opened position after contacting the concrete entry slab. The entry slab is not a structural slab and is subject to ground freeze when moisture from the roof is introduced into the ground under and heaves the slab upward.

This is a Life Safety code issue that should be repaired immediately. The recommended repair is to remove the canopy and slab and replace with a structural slab and foundation and replace the canopy.

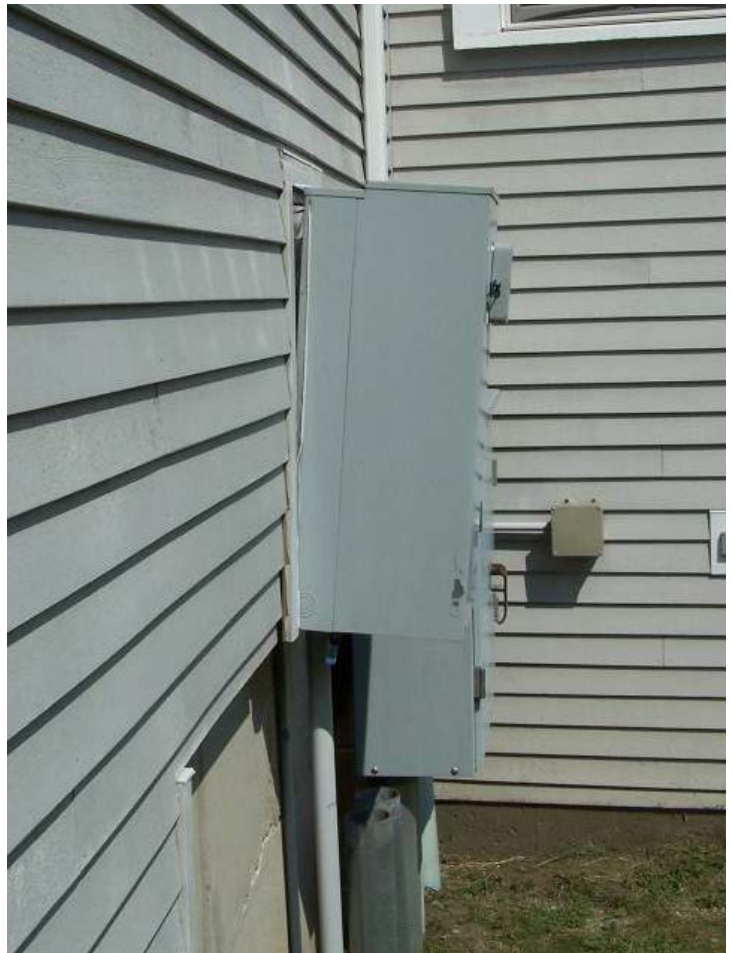
*Meter Enclosure Partially Detached*

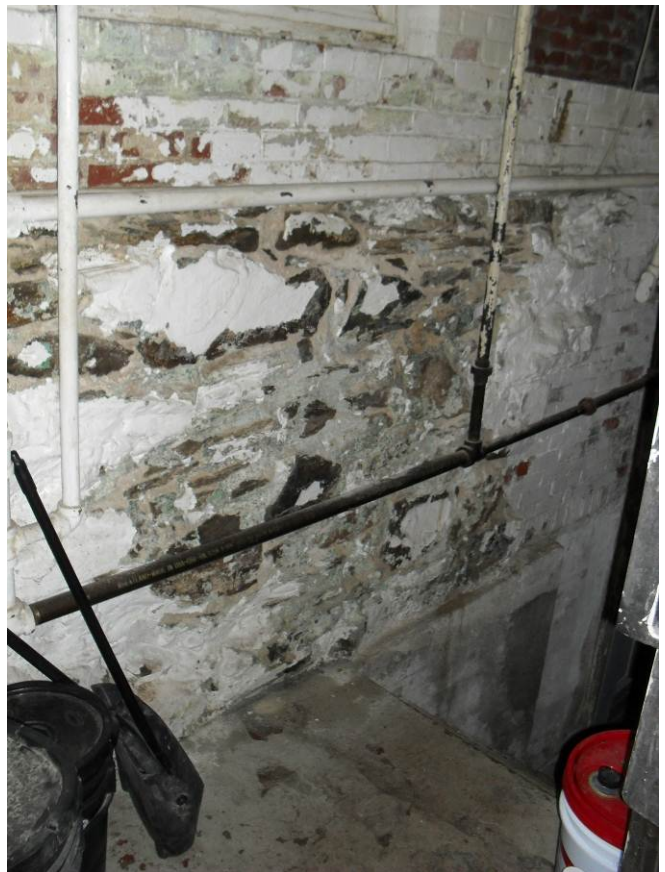
*Stone Wall Foundation  
with Evidence of Water  
Penetration*

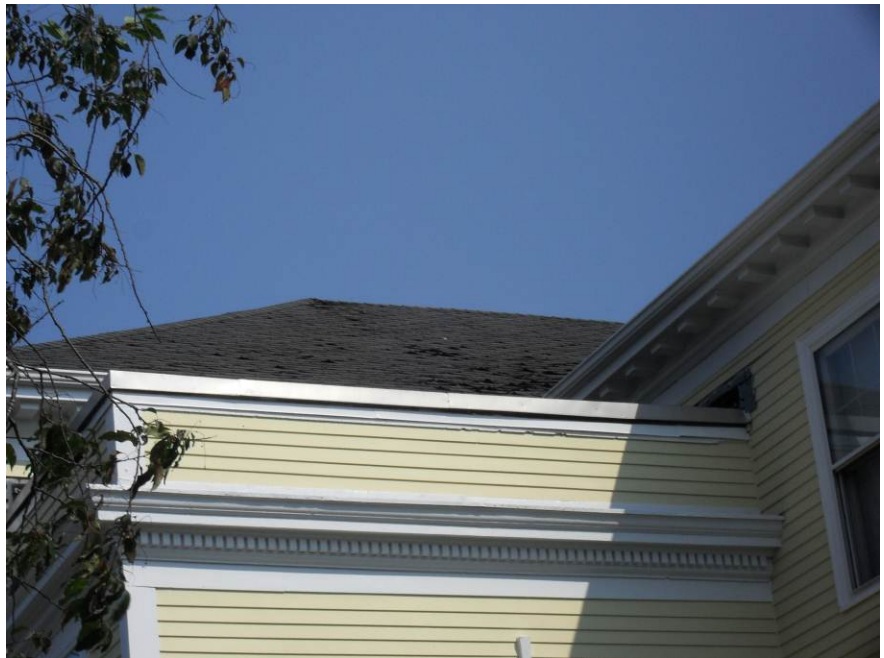
*Partial roof area that has some areas that have been replaced. There are also badly deteriorated shingles that need to be replaced.*
