Remediation Plan for Private I/I Sources Identified in the Ottawa Road CSO Service Area

Town of Cape Elizabeth, Maine

*Presented at Town Council Workshop Session
June 15, 2015*

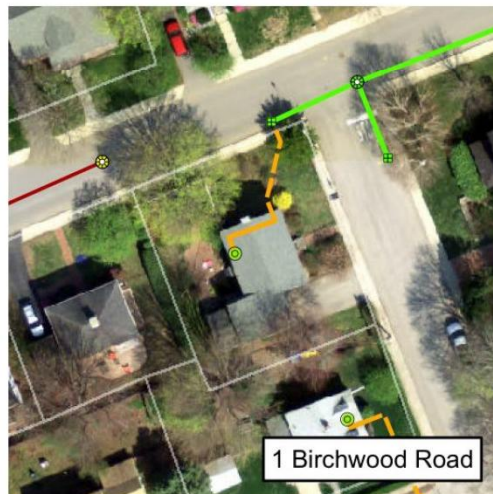
Interior Work Detail:	Details 1, 2, 3

Proposed Solution – 1 Birchwood Road

Illicit connection:	Sump Pump Floor Drain
Possible Solutions:	Sump Pump <ol style="list-style-type: none">1. Redirect sump pump to yard2. Redirect sump pump to existing catch basin3. Do nothing Floor Drain <ol style="list-style-type: none">1. Dye test and plug if necessary2. Dye test and replace floor drain structure with sump and install second sump pump if necessary3. Do nothing
Recommended Solution:	Sump Pump: Redirect sump pump to existing catch basin Floor Drain: Dye test and replace floor drain structure with sump and install second sump pump if connected
Reasoning:	Discharge location of the floor drain is not known so dye testing is required. There is a catch basin located in front of the property for discharge of the sump pump. The floor drain becomes active when the existing sump pump is overwhelmed. If the floor drain is connected, installing a second sump pump should prevent flooding.
