**APPENDIX A**  
**SUMMARY OF HISTORICAL DOCUMENTS**  
**TROUT BROOK WATERSHED-BASED MANAGEMENT PLAN**  
**SOUTH PORTLAND & CAPE ELIZABETH, ME**

**Trout Brook Watershed Management Plan**  
**Appendix B – Stream Channel Assessment Reports**

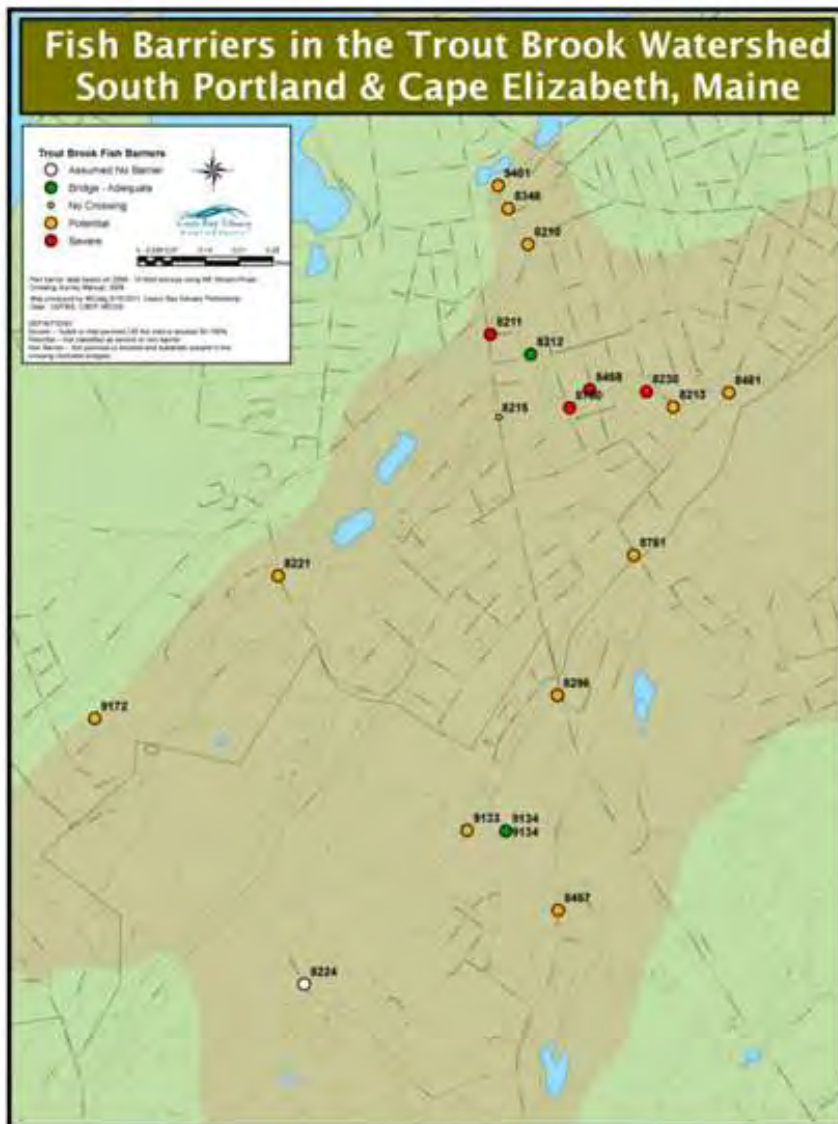
18 culverts, three were rated as passable, 11 were rated as potential barriers and 4 were rated as severe barriers (Figure 1). The Hinckley Park ponds on Kimball Brook were not evaluated through the study since they are not road culverts. However, the lower pond presents a severe fish barrier since there is a drop of several feet between the dam outlet and the stream channel below.

The watershed's fish barriers were also associated with flooding concerns and undersized culverts. The CBEP study found that all three severe barriers on Trout Brook were also considered flood hazards by Cumberland County Emergency

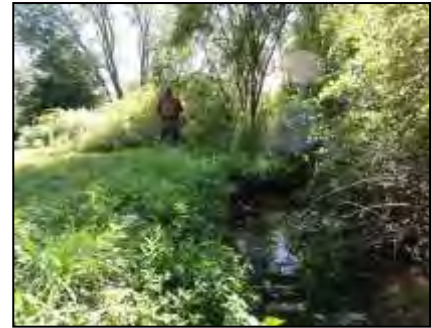
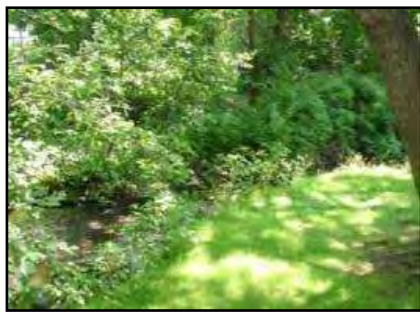
The SCA survey documented 28 areas where the stream buffer was absent or inadequate. The length of inadequate buffer was just over 2,000 feet on each side of the stream. In terms of relative severity, there were 4 high, 12 medium and 12 low severity sites. As mentioned above, many of these were associated with other types of problems. 21 of the inadequate buffer sites were also associated with erosion. In many cases, lawn or invasive Japanese knotweed left streambanks vulnerable to bank streambank erosion. Seven of

the sites were also locations with yard waste dumping, where the piles of debris had likely smothered the natural streamside vegetation.

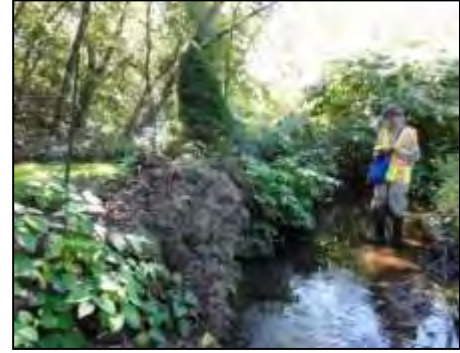
Dumping was documented at 25 sites adjacent to the stream. 24 of the sites were piles of grass clippings and brush. One site was used for dumping sand and other debris was documented next to the stream adjacent to Mahoney Middle School.<sup>3</sup> There were two sites with evidence of grass clippings being dumped directly into the stream, four large neighborhood dumping sites (approximately 10 truckloads) and numerous small to medium-sized debris piles on private lots. In terms of severity of the sites, there were 14 medium, 10 low and zero high severity sites. As mentioned above, many of these sites were also associated with bank erosion and inadequate buffers since the piles tended to smother natural vegetation and leave areas vulnerable to erosion. It would be relatively easy to remove all of the accumulated debris; however, landowner education and alternatives would need to be provided to help change the long term behavior.

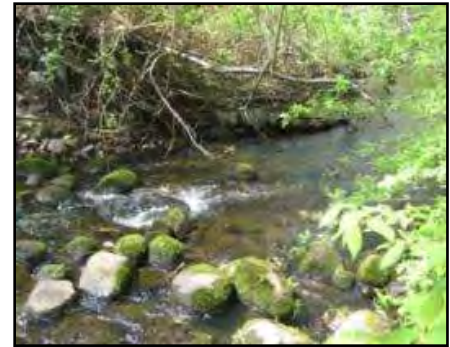
Cobble dam in Trout Brook Preserve.

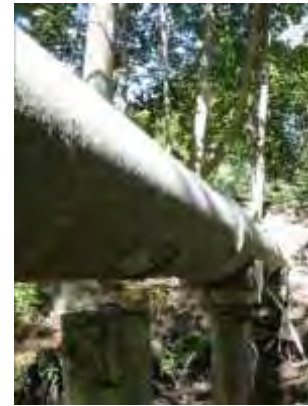
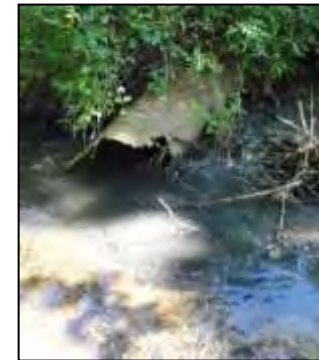
The SCA survey evaluated the condition of stormwater pipes that discharged into or near the stream and sewer pipes that crossed over or adjacent to the stream. No discharges were noted from most of the pipes during the survey, so this information is not summarized in the Plan. However, three sites of concern were identified near the bottom of the watershed. A gray-colored, sewage-smelling substance was flowing out of a stormwater outfall (lower right photo) into the stream. Potential problems were also noted at two sewer and combined sewer pipes that cross the stream. One of these pipes was missing several supports between the pipe and pilings, which could make it vulnerable to failure and future discharges into Trout Brook (above right photo). Liquid was dripping from a second pipe directly into the stream. These issues were brought to the attention of the City of South Portland, and the City addressed all three issues in 2012.<sup>6</sup>

<sup>6</sup> Following the discovery of sewage discharge from stormwater outfall TB-3 during the SCA survey, City staff confirmed an inadvertent cross connection between the sewer and stormwater systems through bacteria testing and televising. In April 2012, the City installed a new catch basin and section of pipe to separate the sewer and stormwater systems; the supports for the insulated sewer line crossing the stream near this location were also repaired. Total project cost was just under \$11K.
