# Needs Assessment Presentation

## Cape Elizabeth Schools

### October 29, 2019

# Failing Precast Window Sills

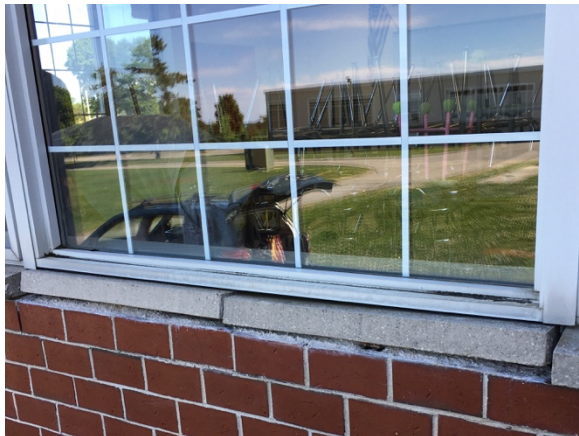
The 1960 addition to the Middle School utilizes a window combination that consists of (2) double-hung windows with a fixed picture window between. The combinations are set in composite brick wall construction with precast concrete sills that are composed of (4) individual pieces. The team witnessed locations where the embedded anchors in the precast sills have lost their anchorage causing the sills to come loose, dislodge, and partially move into the wall cavity. At locations where the sills have not lost their anchorage, the mortar between the sill pieces is no longer present. This condition must be immediately remedied as it presents the following concerns:

- Water entry and damage to interior finishes.
- Freeze/thaw spall of brick and/or precast concrete.
- Potential for loose precast sills to fall out of opening.

Dislodged precast window sills

Remove the existing window units at each location. Remove existing sill construction to level of flashing (1 brick course below). Replace flashing, damaged masonry, and membrane flashing to create water tight condition with weeps. Install new window units.

At 10 locations, remove existing windows and associated masonry and flashing at sill condition. Reconstruct sill condition and install new window units. As a temporary measure, re-set and anchor loose precast window sills. Install backer rod and sealant at the ends and joints between precast sill pieces. Re-point missing / damaged mortar joints as required.

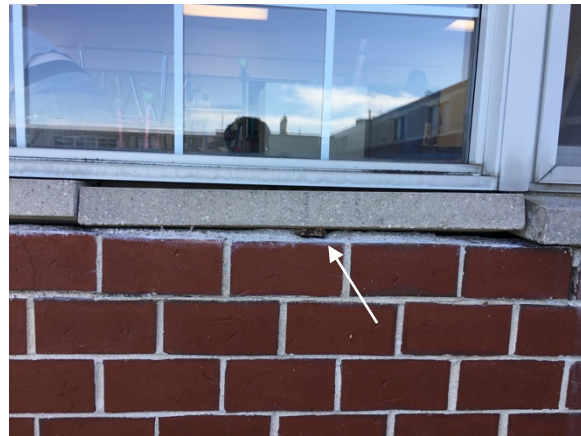
Embedded anchor no longer attached to backup
