Re: Greenbelt Trails Maintenance Report – 2012

2012 Greenbelt Trail Work Summary

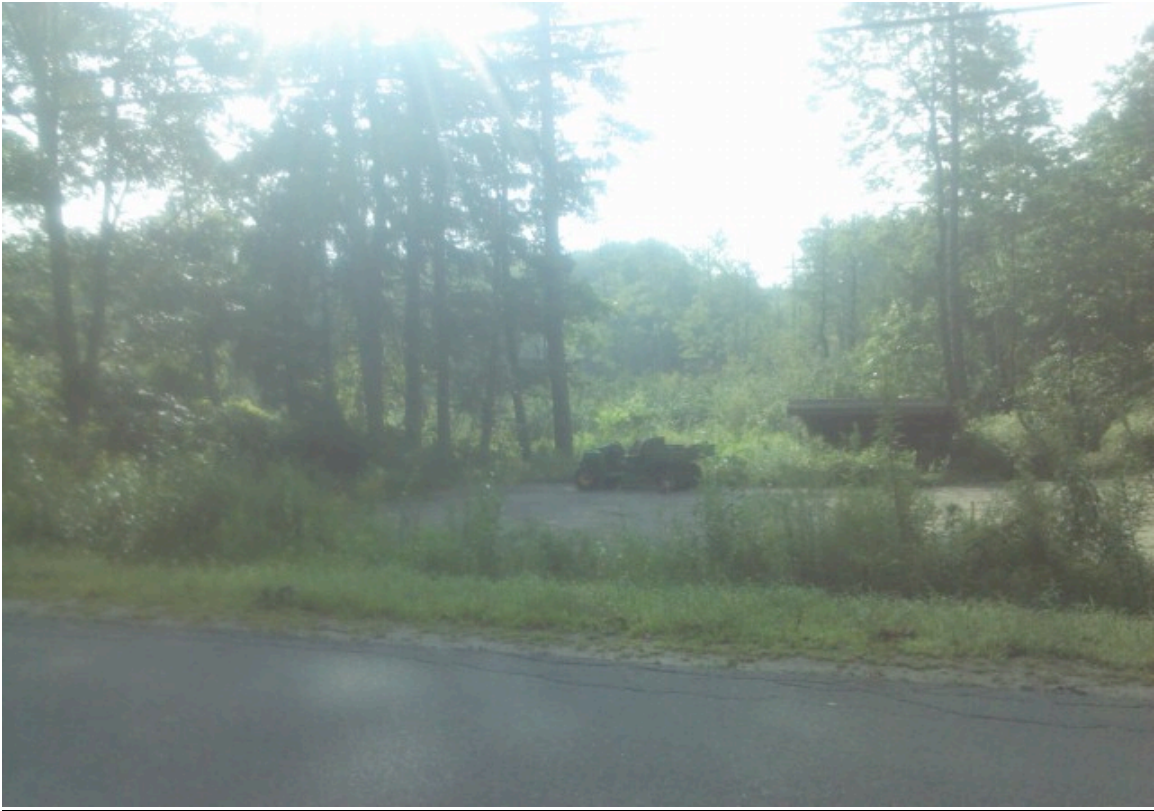
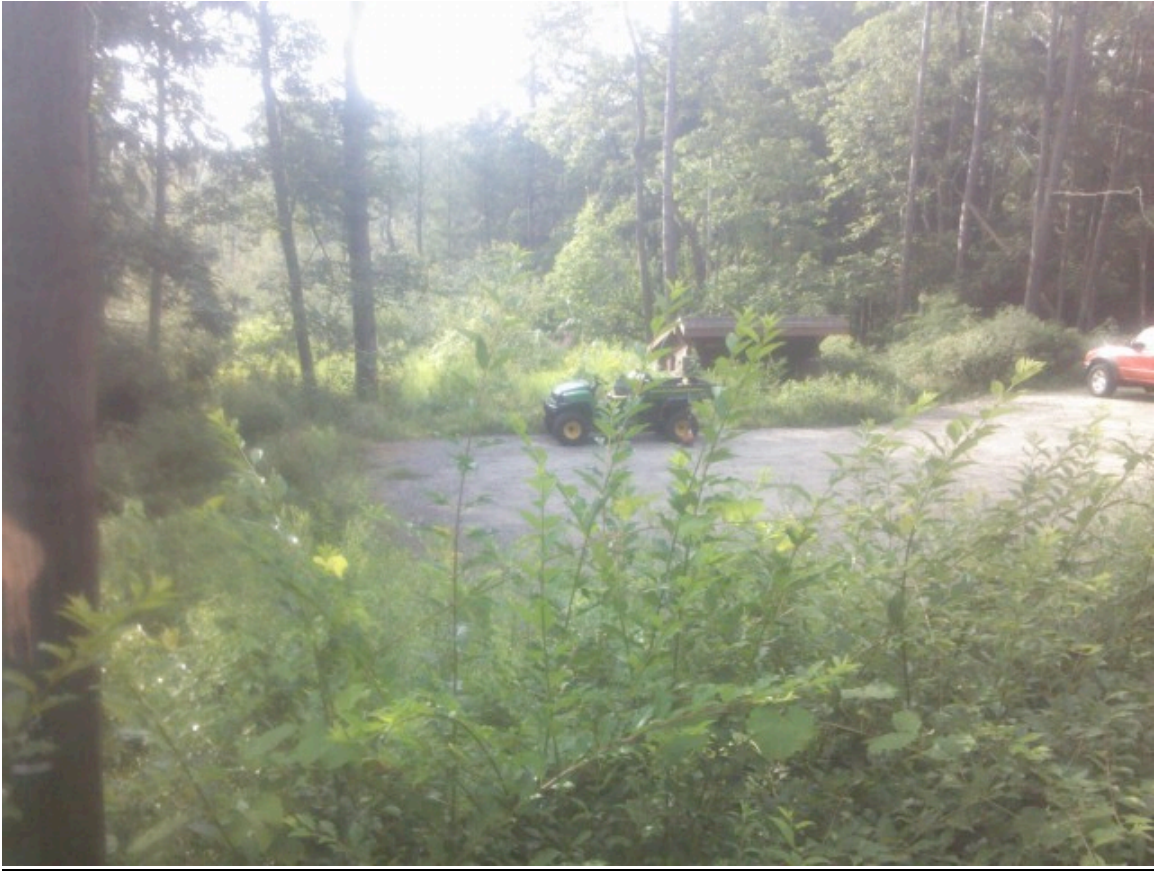
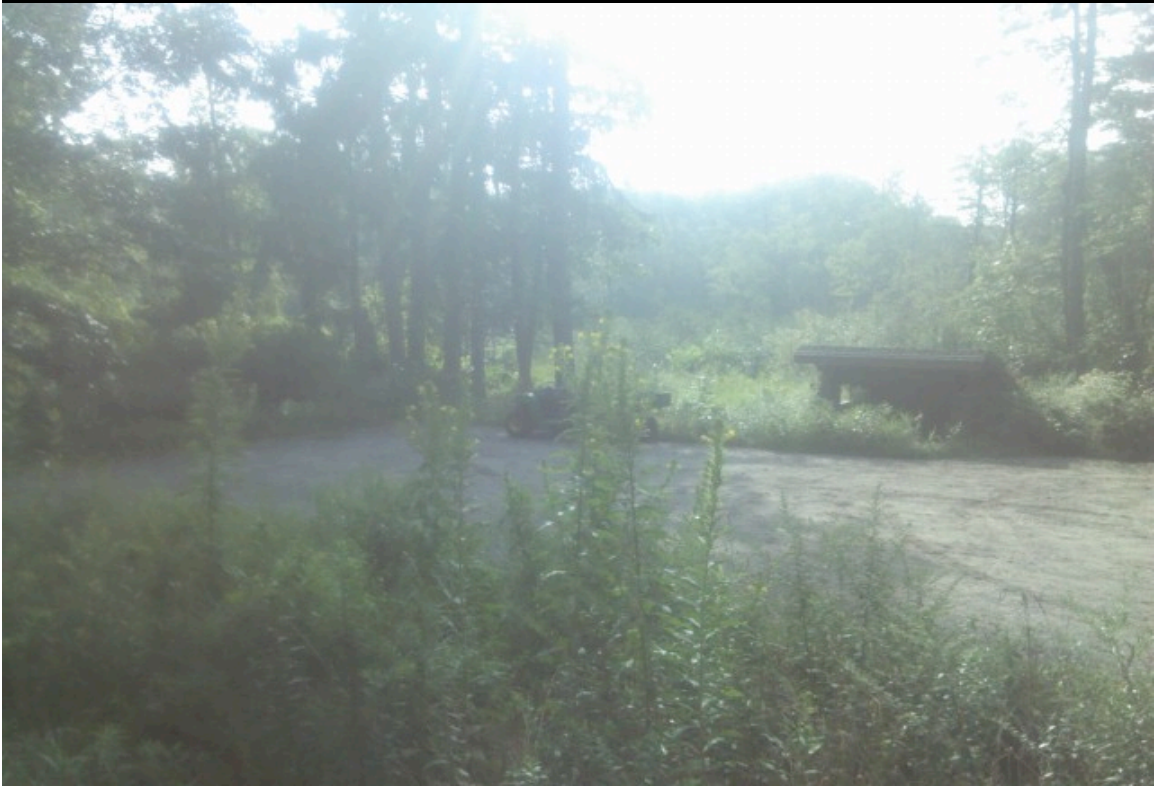
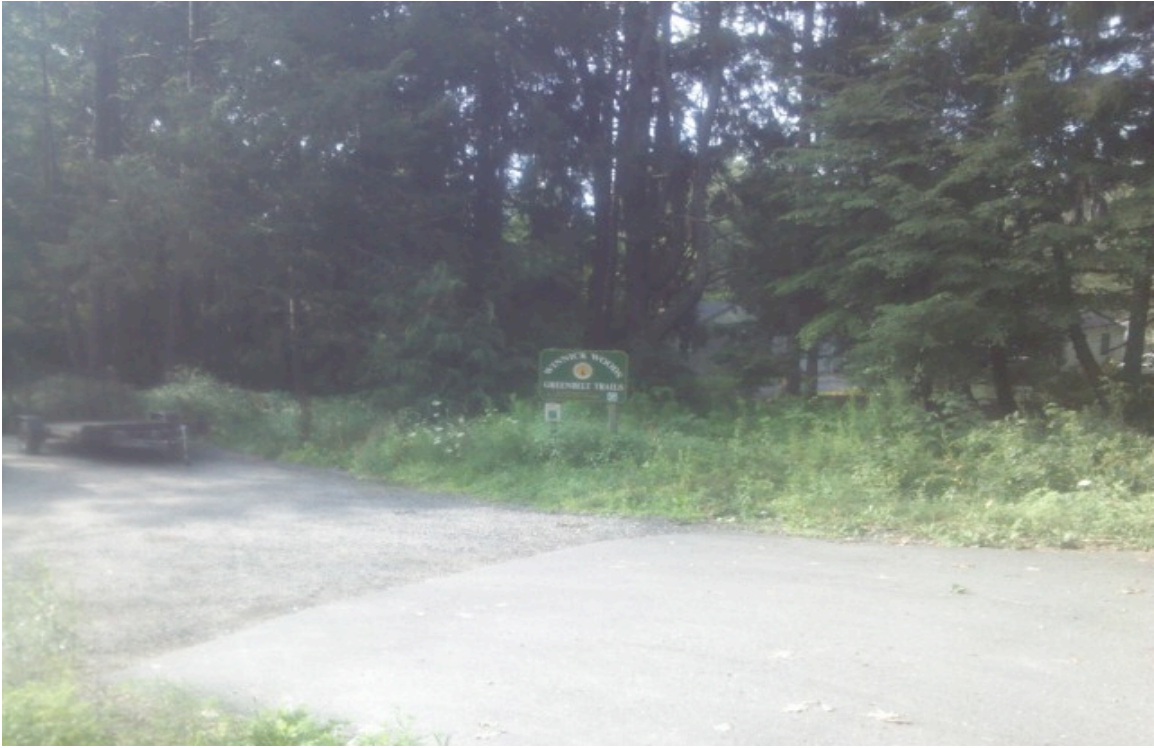
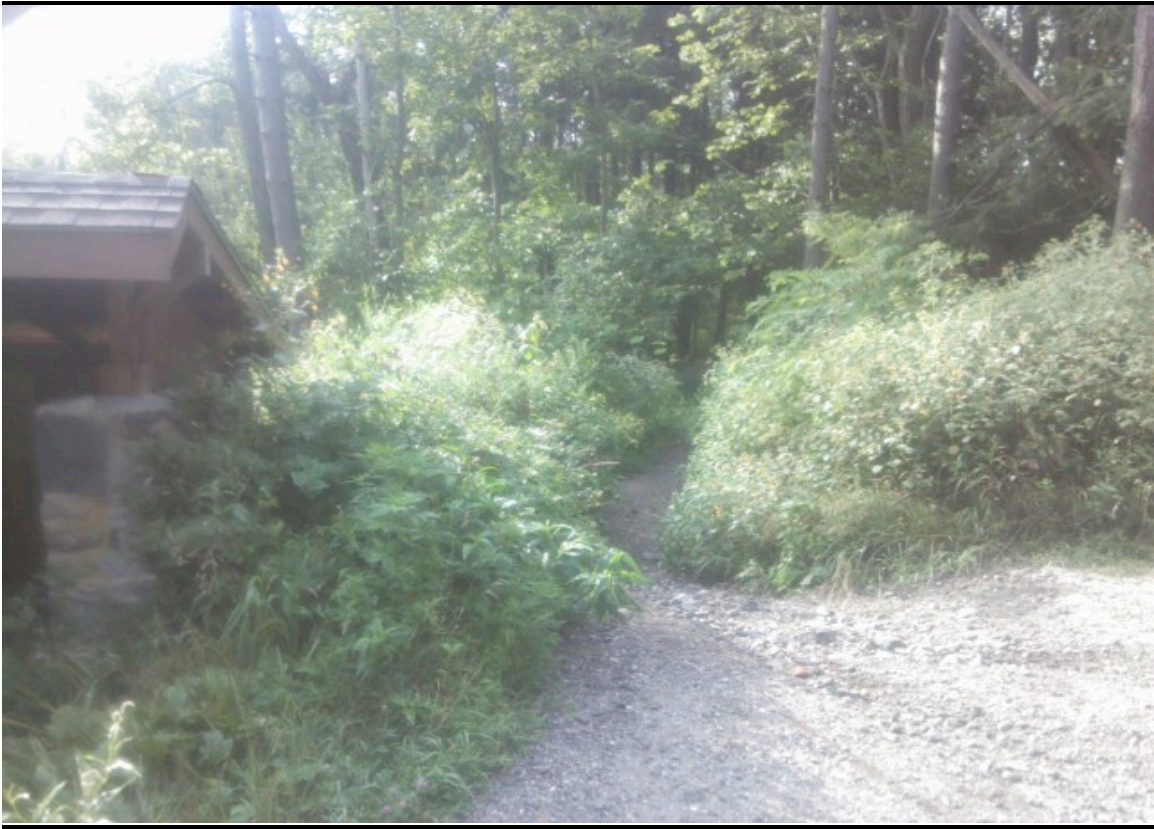
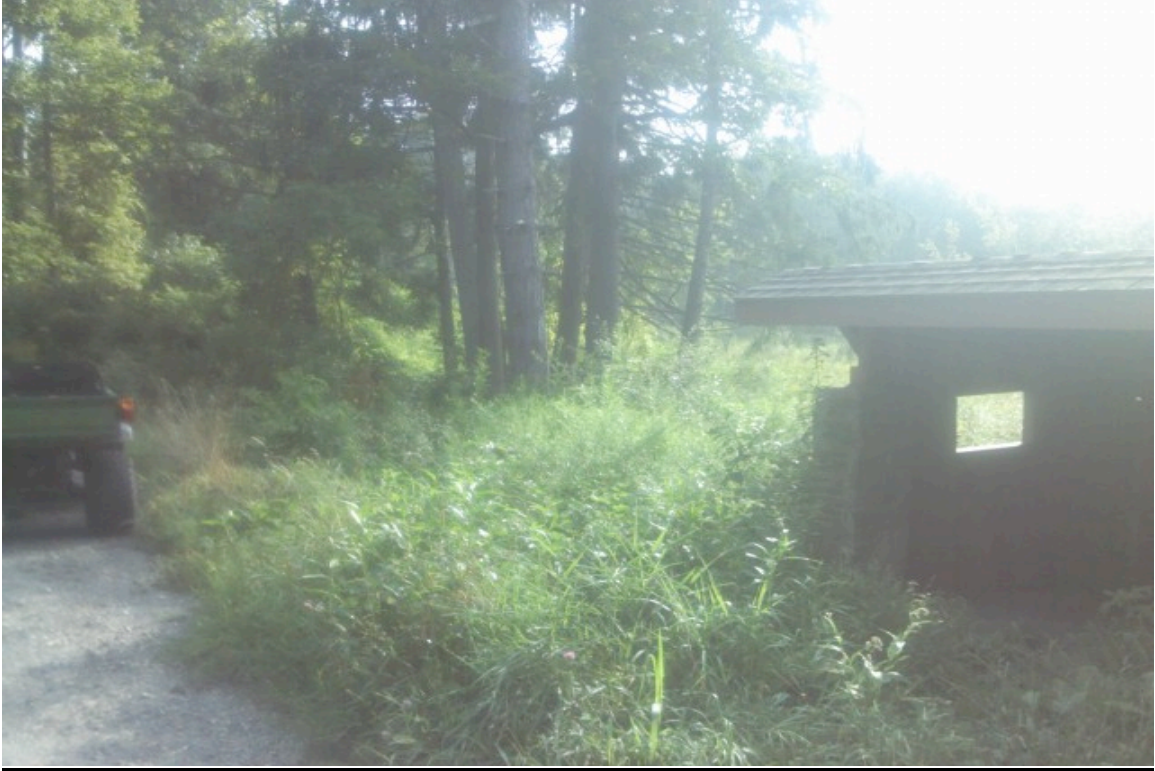
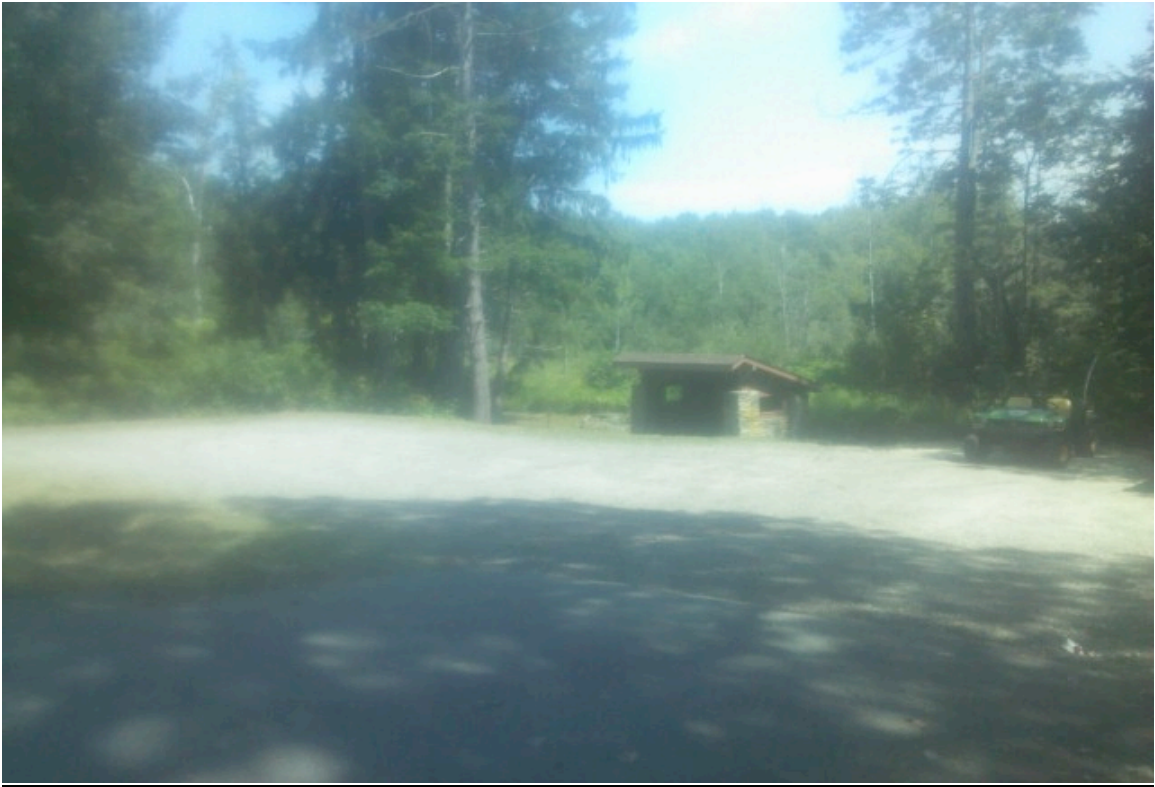
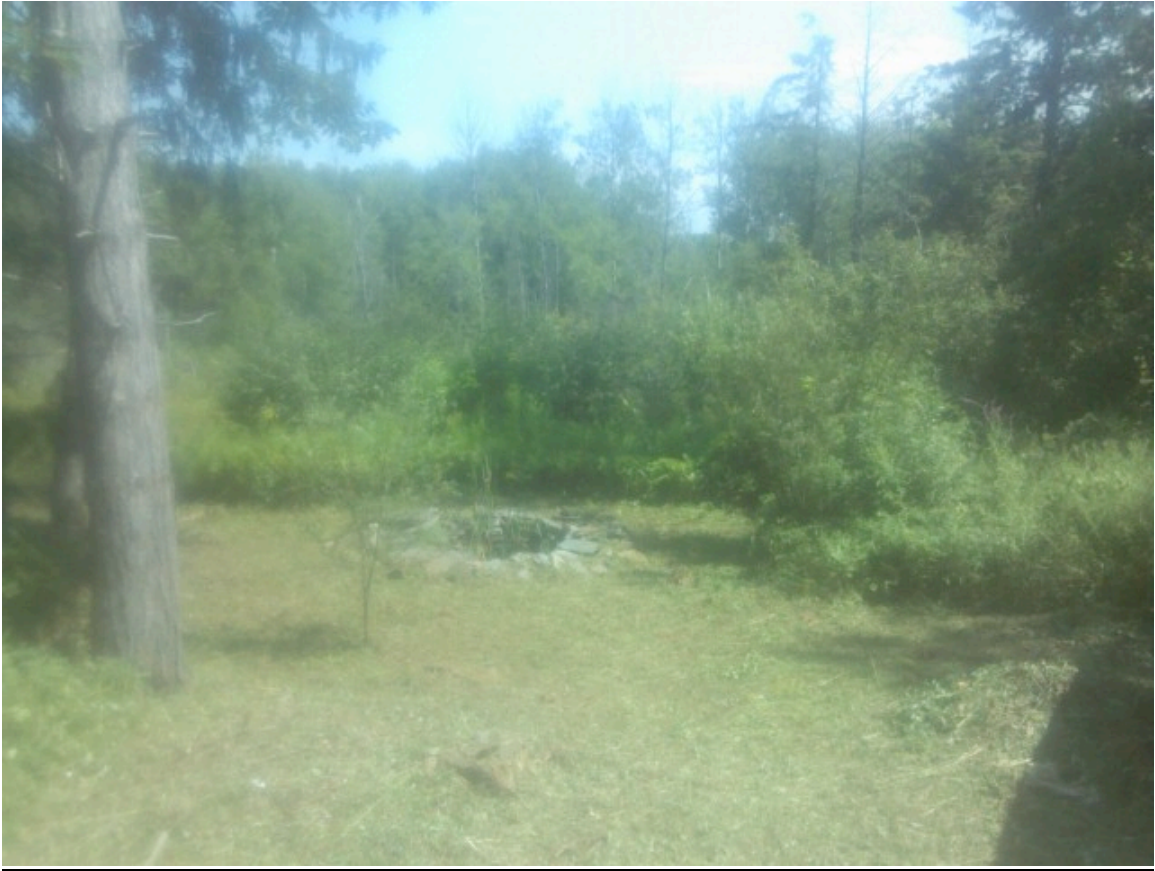
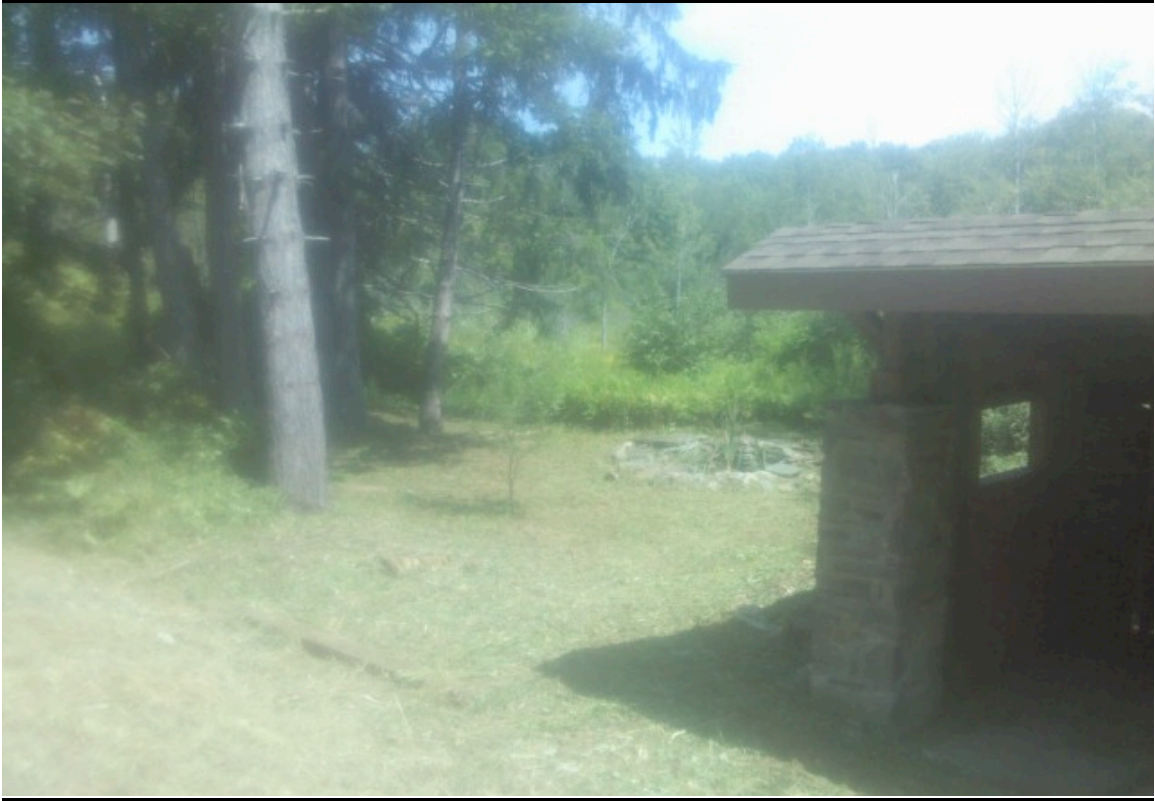
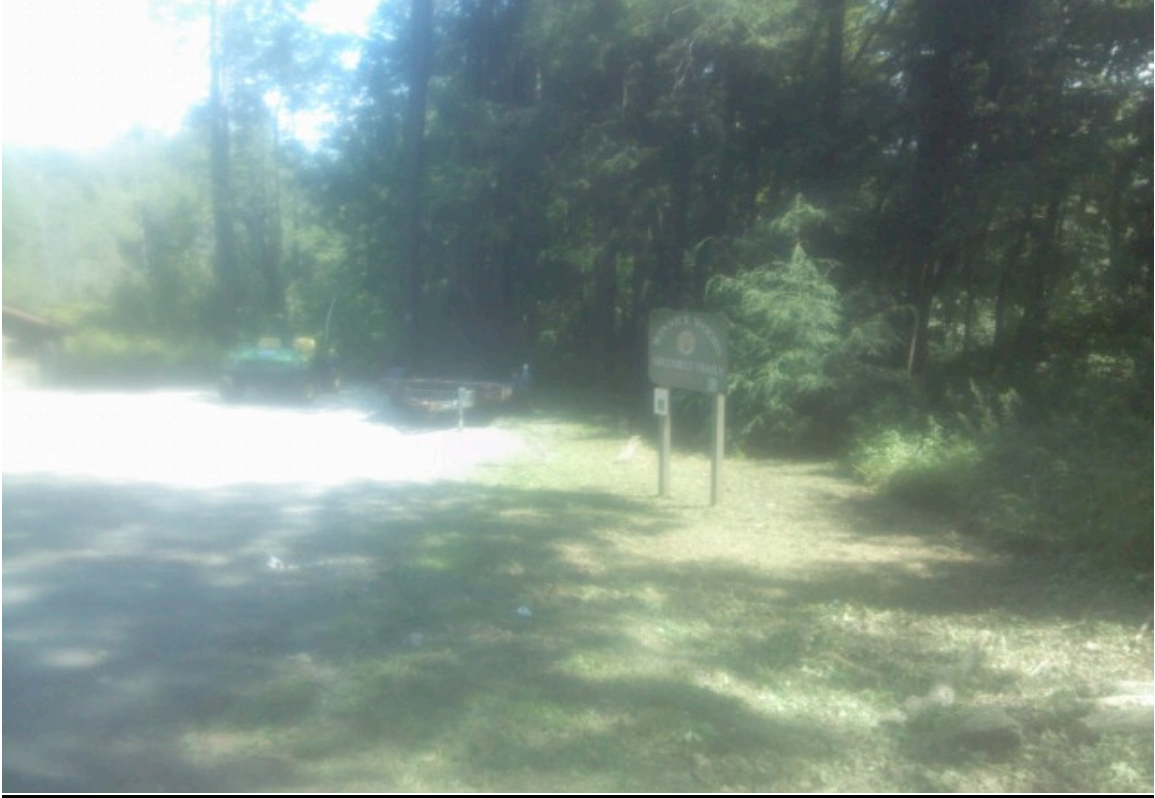
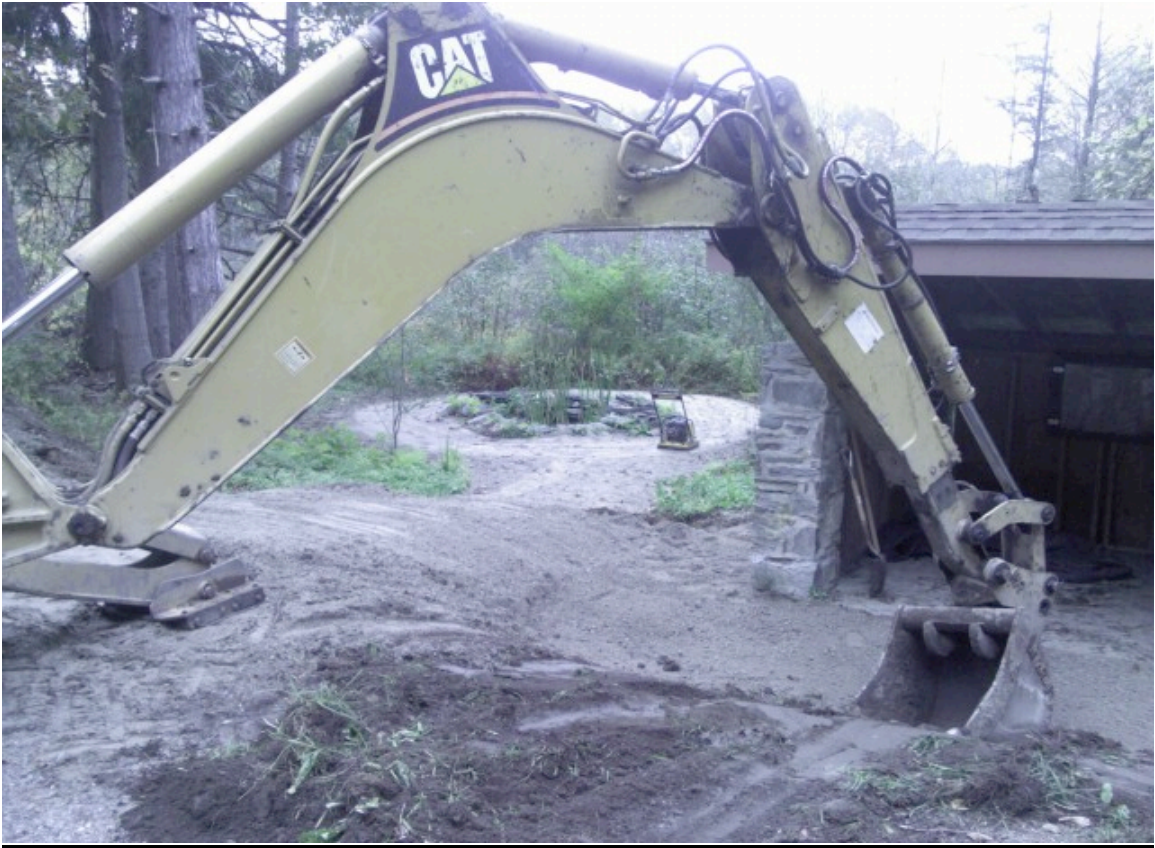
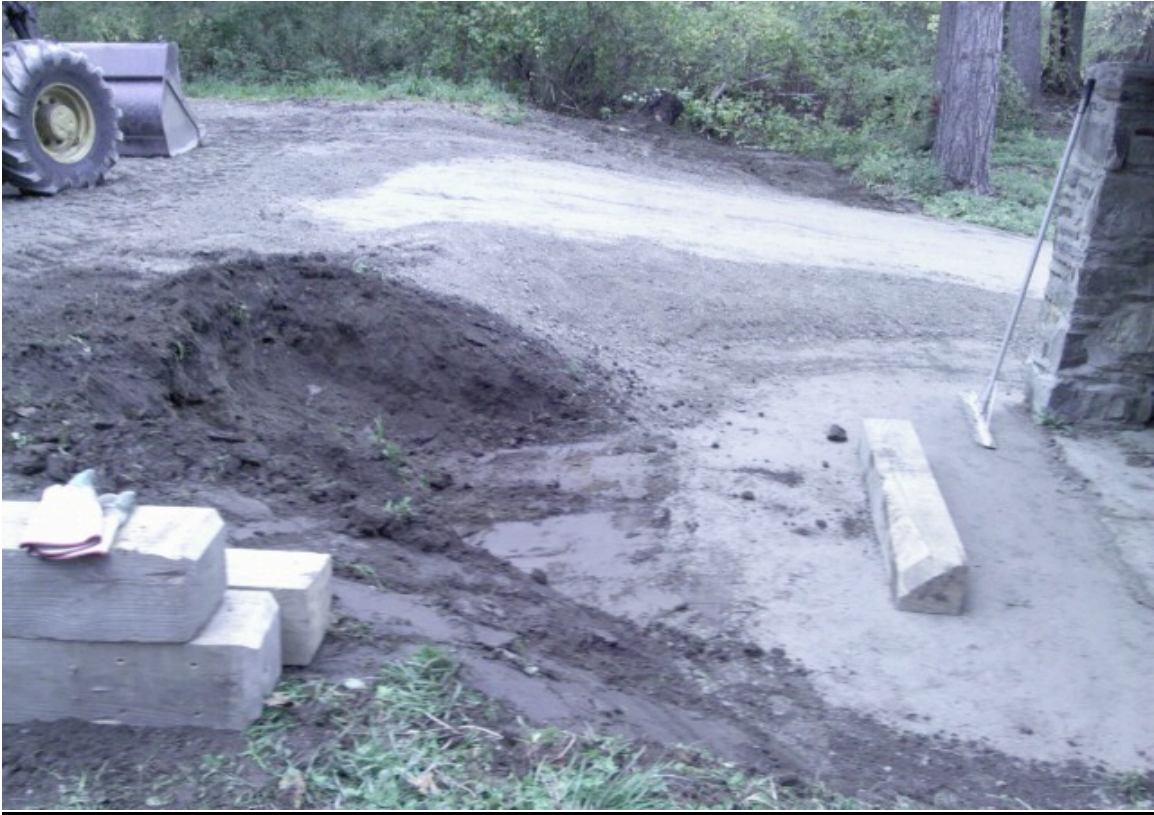
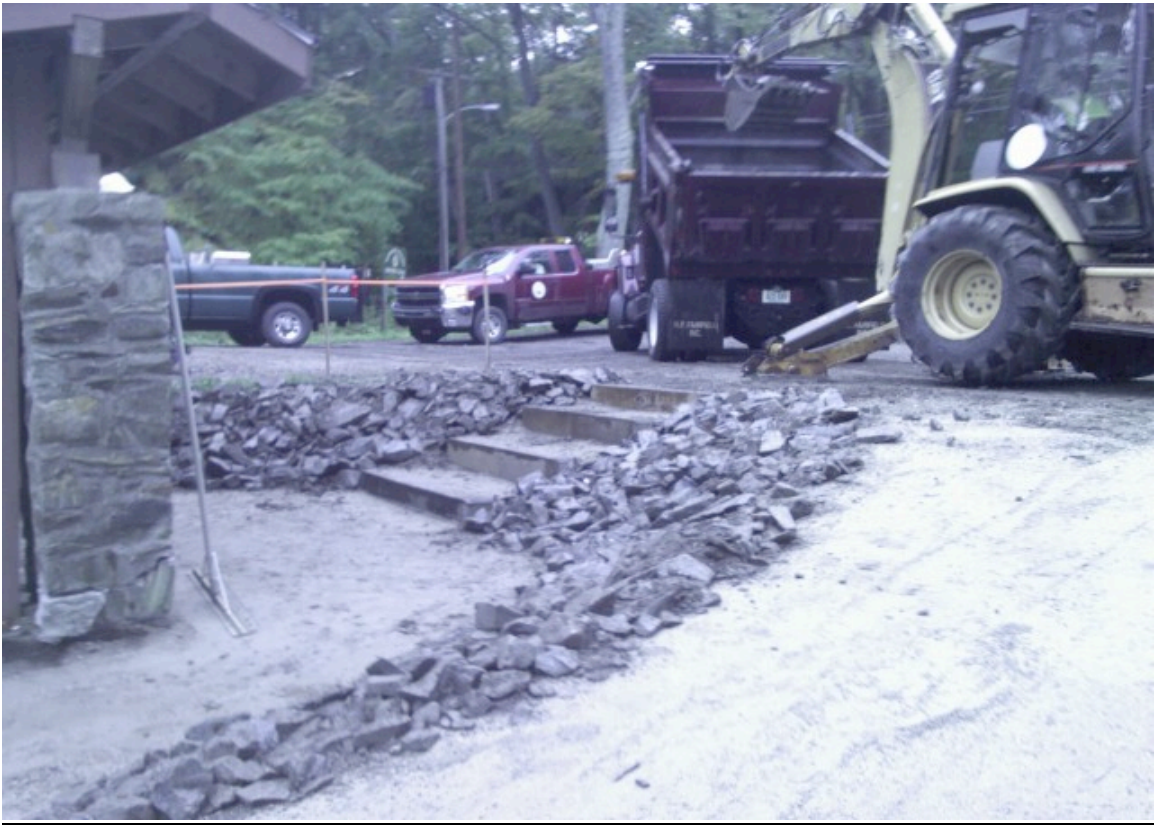
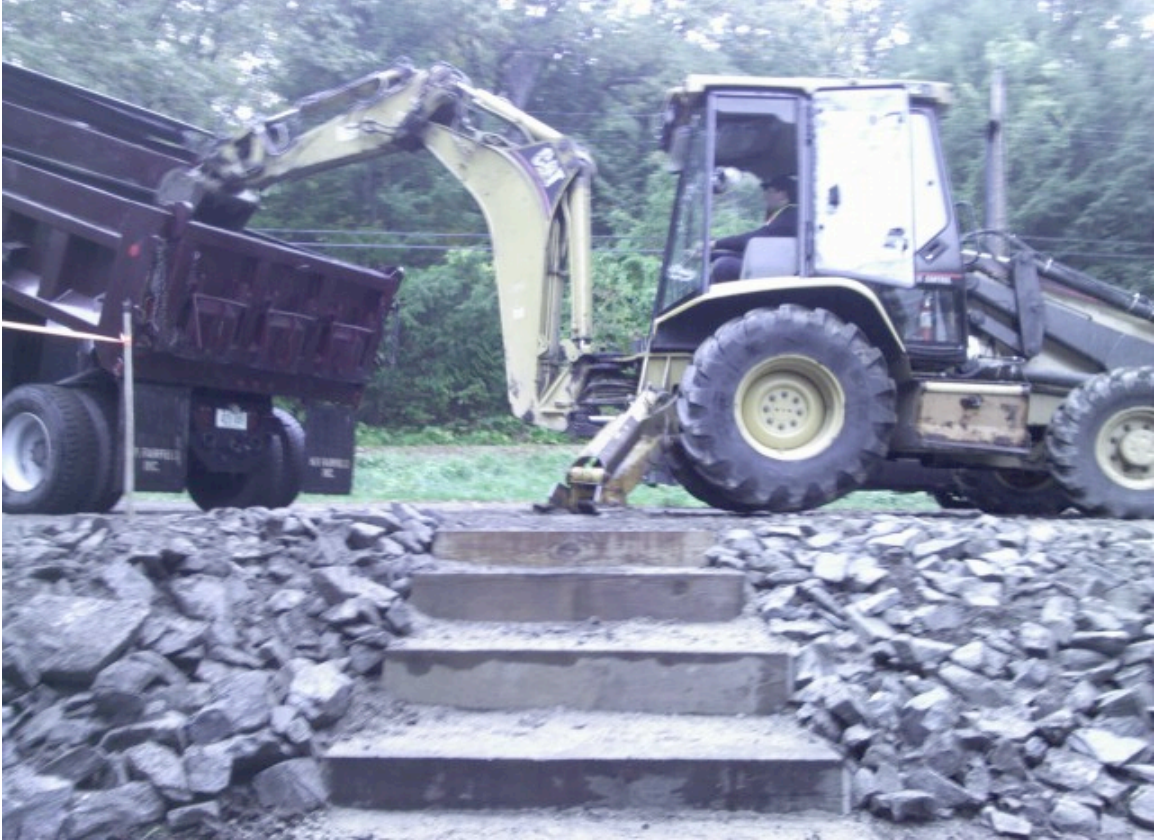
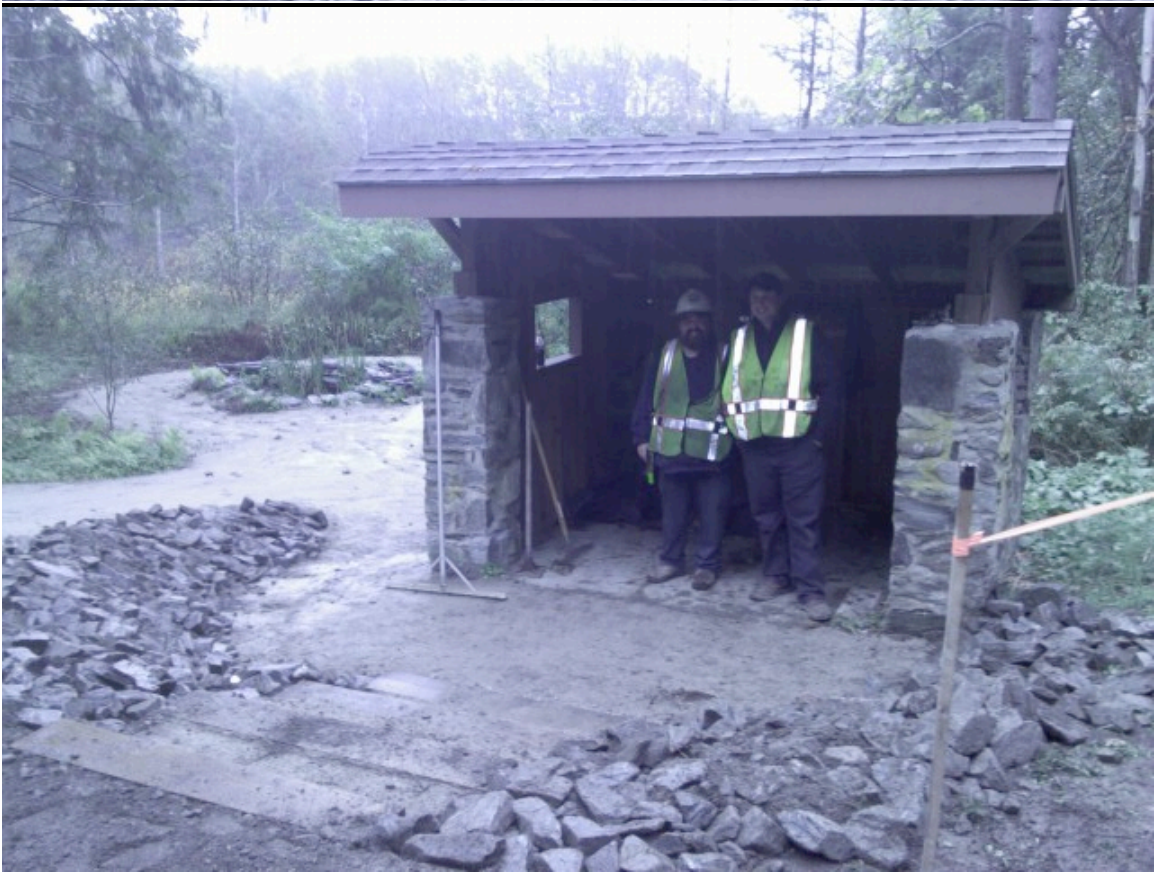
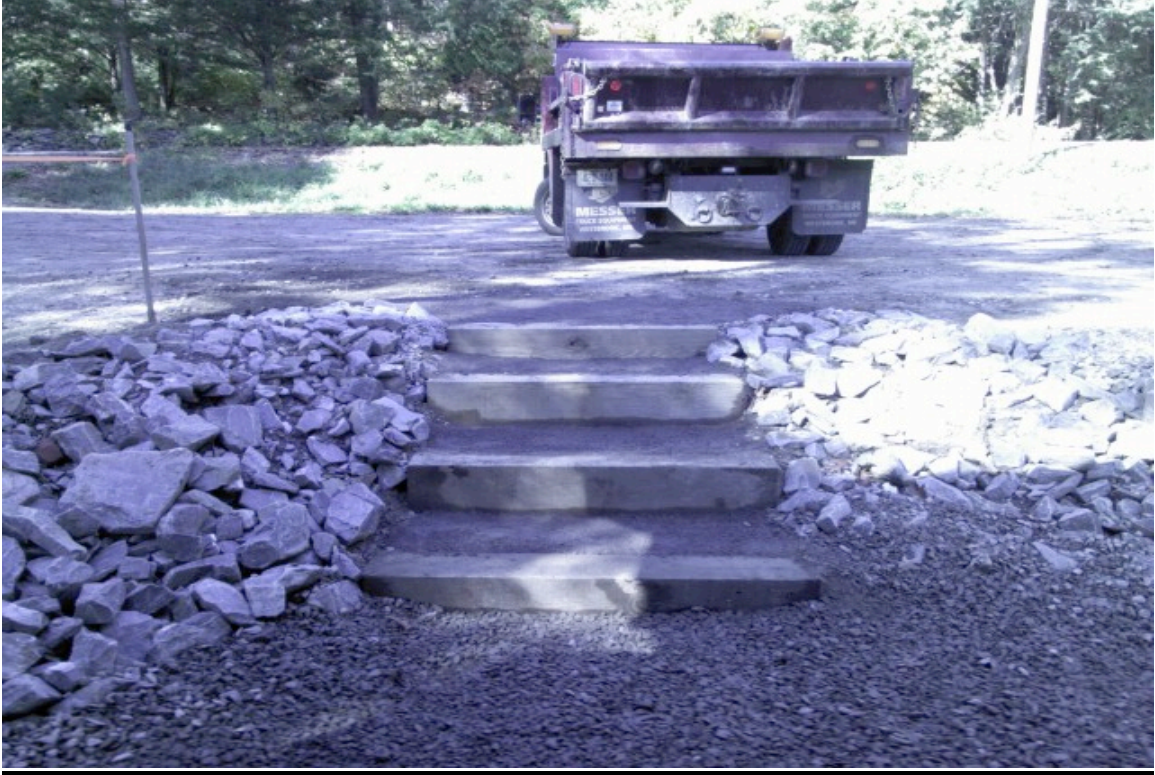
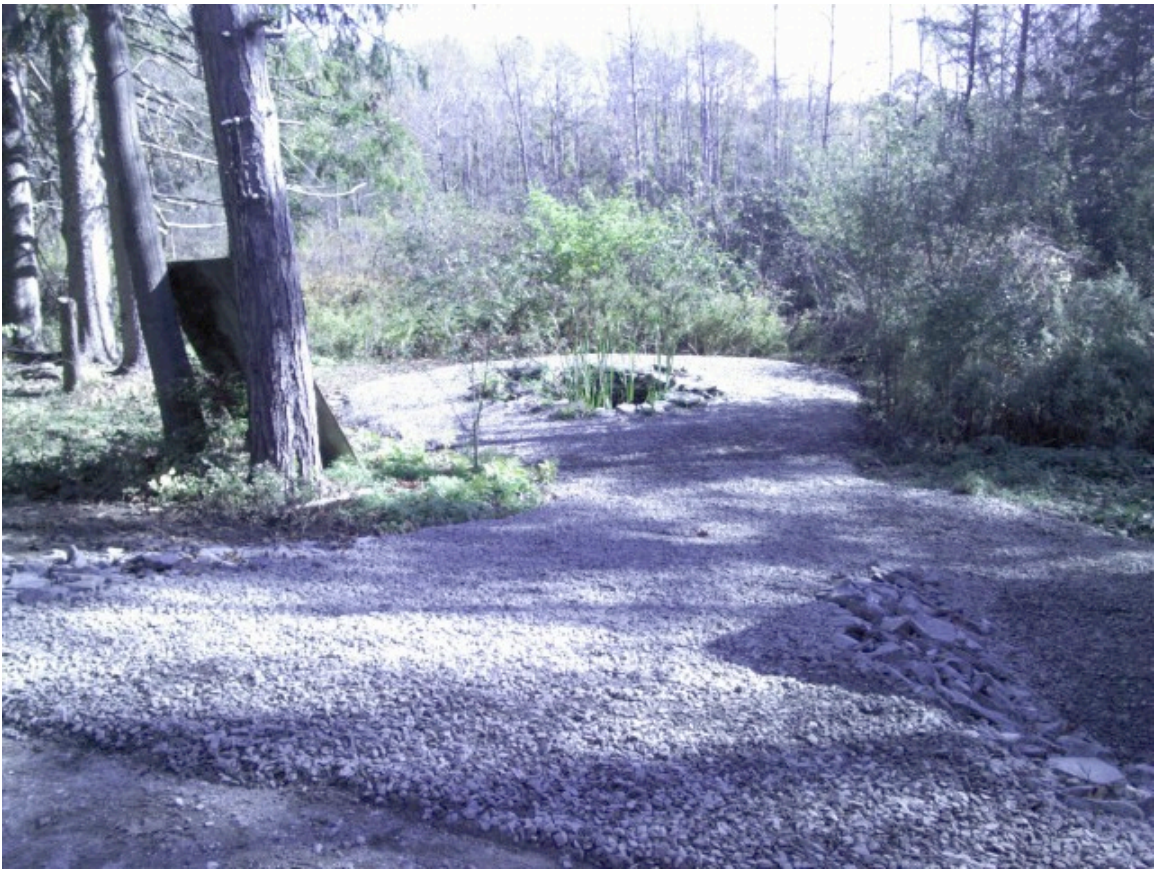
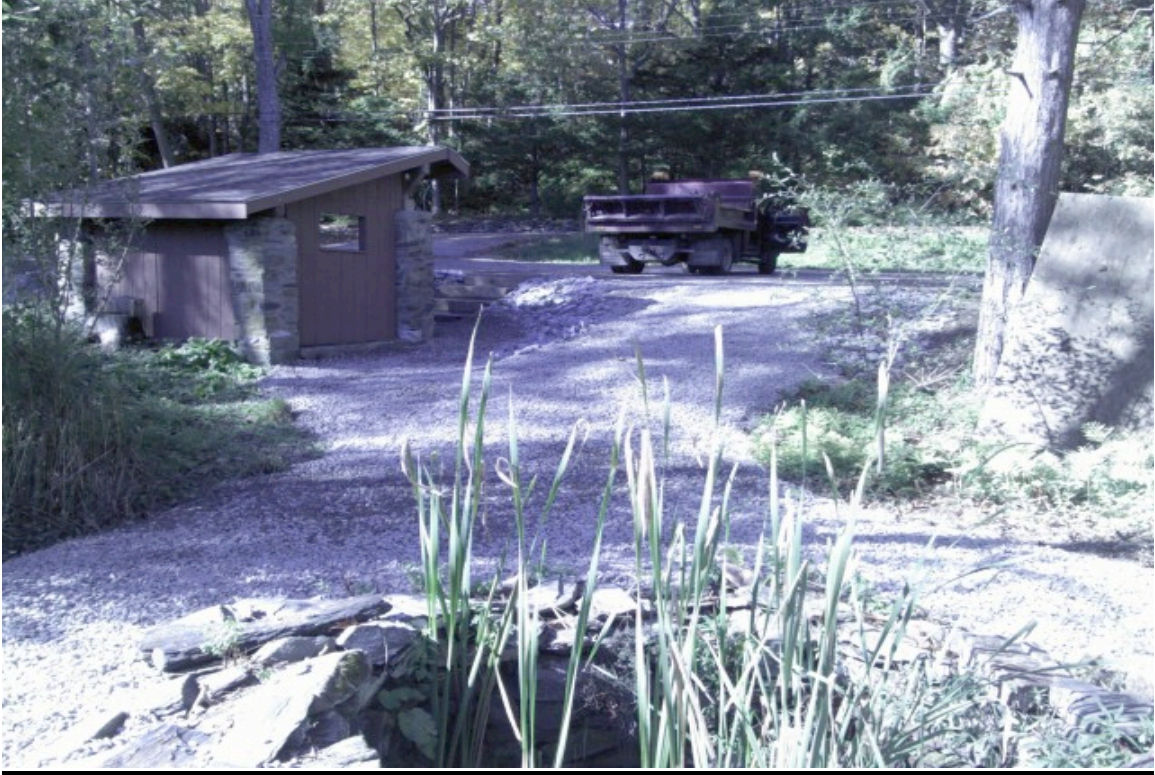
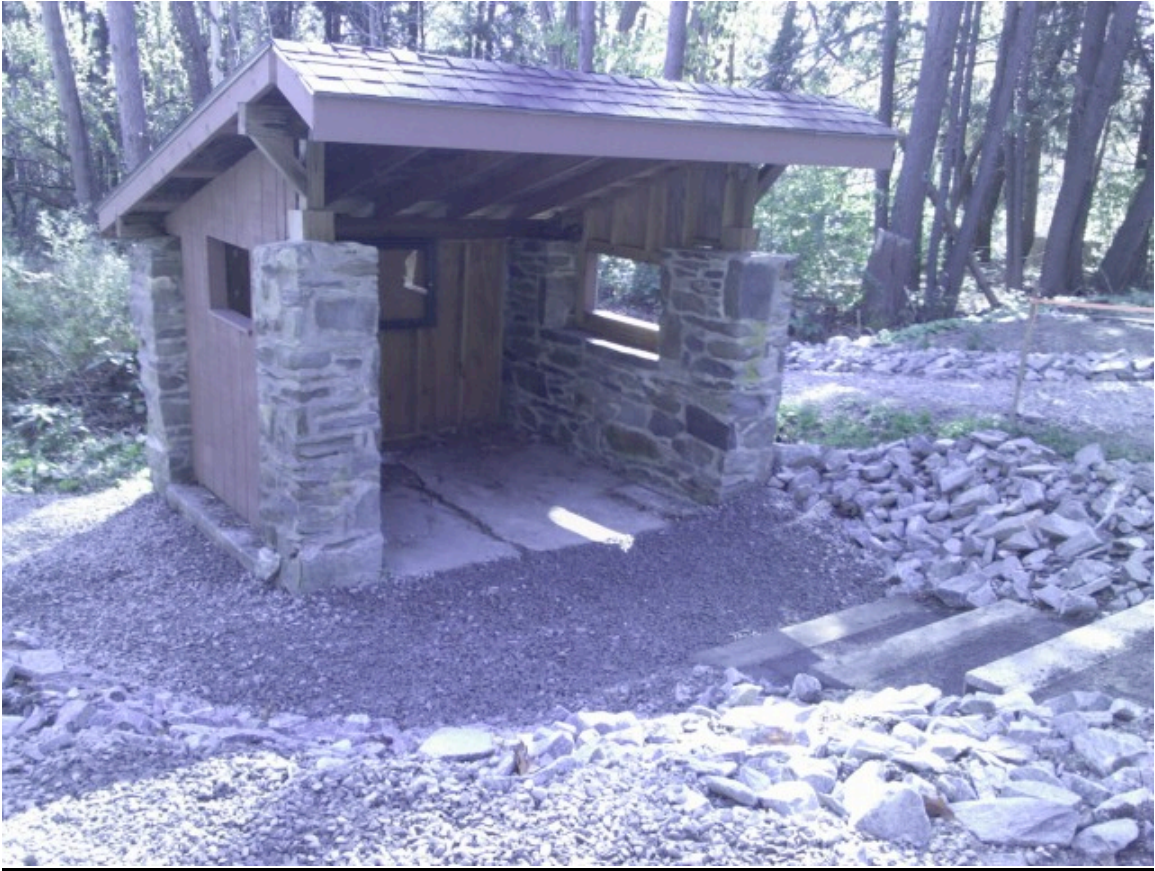
The story of Winnick Woods

100 hours seems like a lot of time on one trail but it was time well spent. The trail head and parking lot received a total face lift this year starting with the main path way into the trail. Heavy rains washed out the entry way repeatedly with every passing storm. This led to continued grading and scraping of the path and loss of material. I then asked to do a drainage project, which was accepted. I dug down at the top of the path creating a funnel that would lead water to an underground pipe and discharge it to the left side of the path. To keep erosion down I buried 2 wooden parking barriers that divert the water off or to the buried pipe. The remaining gravel was graded smooth and not at too much of a slope and covered with $\frac{3}{4}$ inch stone. Along the right side of the path larger rocks were set in place to control looser soils from eroding and keep it from washing onto the path. Fill was brought in and bucketed over the left side of the path to keep soils and gravel from washing out and off the path. More fill was used to create a smooth transfer from the gravel trail to the grass trail, (more could be added in the future).

Next, more gravel was brought in and used to create a ramp that led to the parking lot down to the lower grass area and around the existing well. This was then compacted many, many times to ensure it was solid. The ramp was adjusted to make sure there was adequate room to get into the existing building. A square was then dug directly in front of the building where four, 8 x 8 posts were set as steps from the parking lot to the building. Finally loads of $\frac{3}{4}$ inch stone were brought in and spread to put the final touches and stop the gravel from washing away. I then fabricated a wooden guard rail and set it in place to the right of the stairs for safety. We don't want anybody falling. All the old plywood was removed from the area and leaves and debris were picked up or blown out from the building and surrounding area. The map case has now been fixed and re-placed back inside the building. All we need now is a map.
