Re: Town of Cape Elizabeth Transfer Station Safety Assessment

On behalf of the Town of Cape Elizabeth, Woodard & Curran has prepared the following safety assessment for the Town's transfer station, located at 21 Dennison Drive. Although the Town had proposed to the Town Council that a comprehensive Solid Waste Disposal Option analysis be conducted in the spring of 2015, the tragic accident that occurred on November 24, 2014 prompted the Town to take immediate action with a facility safety review.

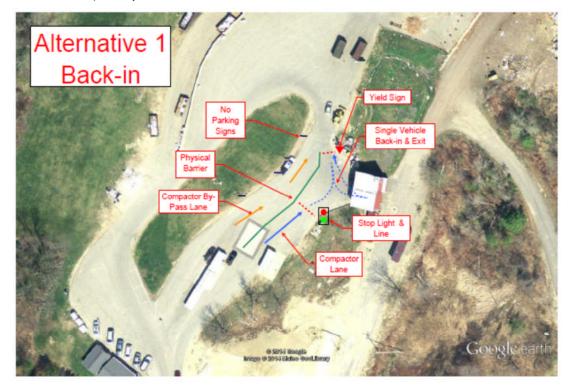
Alternative 1: Evaluation of Back-in Access for Compactor

<u>Alternative 1 – Back-in Access for Compactor</u>: This alternative allows users to continue to back into the compactor building to drop-off solid waste; however, this alternative recommends the installation of a stop light and stop line to restrict drop-offs to only one user at a time. A physical barrier is recommended to provide for two travel lanes: a compactor lane and a compactor by-pass lane. The physical barrier, individual lanes, and additional "No Parking" signs along the loop road interior grassed island will discourage users from parking outside the compactor building and walking their solid waste into the compactor building. Below is a conceptual layout of this alternative.

Safety	 <u>Advantages</u> Eliminates the congestion of vehicles and pedestrians both within the compactor building and on the loop road. Provides dedicated traffic flow patterns, reducing vehicle congestion within the loop road. Eliminates pedestrian crossing within vehicle travel lanes. <u>Disadvantages</u> Does not eliminate the fall risk associated with users standing in pickup truck beds adjacent to the compactor.
--------	--

Level of Service	 <u>Advantages</u> Continues to allow users to back-up close to the compactor to drop-off
OODARD		solid waste, meaning users only have to transport solid waste a small distance and is practical for users with heavy loads. Disadvantages
		 Reduces the number of vehicles accessing the compactor at one time from three to one, most likely creating a long vehicle queue possibly extending down Dennison Drive during times of high user volume. Likely increases user frustration due to decreased efficiency at the compactor building

Since it is anticipated that this alternative will decrease the level of service of the facility, it is recommended that commercial haulers either be prohibited from use of the transfer station or restricted to use only outside the high user volume periods. Commercial haulers drop-off large solid waste loads, requiring more time at the compactor than the average facility user. Eliminating or restricting commercial hauler use will improve the overall efficiency of this alternative.

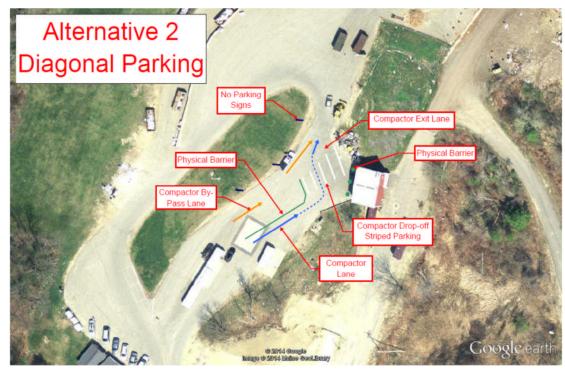
Alternative 2: Diagonal Parking for Compactor Access

<u>Alternative 2 – Diagonal Parking Access for Compactor</u>: This alternative does not allow users to back into the compactor building, but instead allows them to park in front of the compactor building. As with the previous alternative, a physical barrier is recommended to allow for two travel lanes. The compactor lane will have dedicated parking spaces, marked with pavement striping similar to an angled parking lot, for users to park their vehicle and walk their solid waste into the compactor building. The users will then pull their vehicle out of the parking space and merge into the compactor by-pass lane. The physical barrier, individual lanes, and additional "No Parking" signs along the loop road interior grassed island will discourage users from parking outside of the marked parking spaces and walking their solid waste into the compactor building. Physical barriers are also recommended in front of the compactor building to prevent vehicles from backing in. Below is a conceptual layout of this alternative.

Safety	 <u>Advantages</u> Eliminates the congestion of vehicles and pedestrians both within the compactor building and on the loop road. Provides dedicated traffic flow patterns with vehicles traveling only in a forward direction, reducing overall vehicle congestion within the loop road. Eliminates the fall risk associated with users standing in pickup truck beds adjacent to the compactor. <u>Disadvantages</u> Requires pedestrian crossing of a single vehicle traffic lane, similar to a parking lot scenario.
Level of Service	 <u>Advantages</u> Increases the number of vehicles accessing the compactor at one time from three parking spaces currently within compactor building to four parking spaces in front of the compactor building. <u>Disadvantages</u> Eliminates the convenience of backing up to the compactor; users will be required to carry solid waste from their vehicle to the compactor over a longer distance and is not as practical for users with heavy loads.

Since backing in would not be permitted in the alternative, it is recommended that commercial haulers be discouraged from use of the transfer station. It is anticipated that commercial haulers would travel back and forth between their vehicle and the compactor multiple times to dispose of their large loads of solid waste, resulting in many more trips than the average

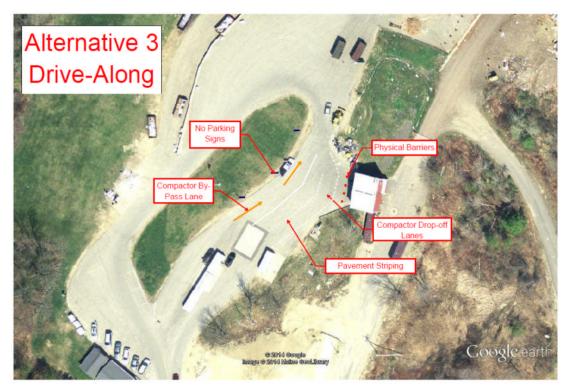
Alternative 3: Drive-Along for Compactor Access

<u>Alternative 3 – Drive-Along Access for Compactor</u>: This alternative also does not allow users to back into the compactor building, but instead drive and park in the front of the compactor building. In this alternative, three lanes will be striped: two compactor drop-off lanes and a compactor by-pass lane. Residents will be able to park in either of the compactor drop-off lanes and walk their solid waste into the compactor building. With this alternative, "No Parking" signs are recommended along the loop road interior grassed island, and physical barriers are recommended in front of the compactor building to prevent vehicles from backing in. Below is a conceptual layout of this alternative.

<u>Advantages</u>		
	 Eliminates the congestion of vehicles and pedestrians within the compactor building. 		
Safety	 Provides dedicated traffic flow patterns with vehicles traveling only in a forward direction, reducing overall vehicle congestion within the loop road. 		
	 Eliminates the fall risk associated with residents standing in pickup truck beds adjacent to the compactor. 		
	<u>Disadvantages</u>		
	 Requires pedestrian crossing of vehicle traffic lanes. 		
Level of	<u>Advantages</u>		
Service	Allows multiple vehicles from the two compactor drop-off lanes to access

the compactor at one time as compared to three parking spaces currently provided within compactor building.

- Eliminates the convenience of backing up to the compactor; users will be required to carry solid waste from their vehicle to the compactor over a longer distance and is not as practical for users with heavy loads.
- Potentially increases user frustration while waiting for other users to exit their particular compactor drop-off lane after they have dropped off their solid waste.

Similar to Alternative 2, it is recommended that commercial haulers be prohibited from use of the transfer station in this alternative because backing in would not be permitted. Eliminating commercial haulers will improve the overall safety and efficiency of this alternative.
