Cape Elizabeth Culvert and Habitat Assessment Study

March 22, 2019

This report was prepared for the Town of Cape Elizabeth by Sebago Technics, Inc., the Wells National Estuarine Research Reserve, the Casco Bay Estuary Partnership and the Town of Cape Elizabeth under award CZM NA17NOS4190116 to the Maine Coastal Program from the National Oceanic and Atmospheric Administration, U.S. Department of Commerce. The statements, findings, conclusions, and recommendations are those of the authors and do not necessarily reflect the views of the National Oceanic and Atmospheric Administration or the Department of Commerce.

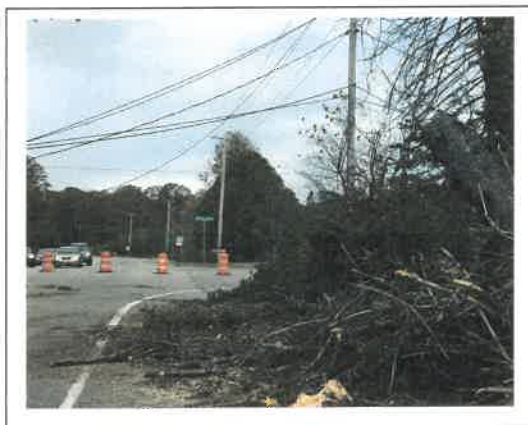
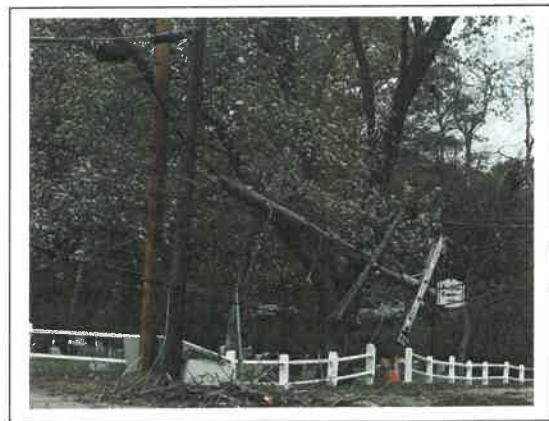
Route 77 closure October 2017, resulting in access to southern end of town limited to Sawyer Rd.

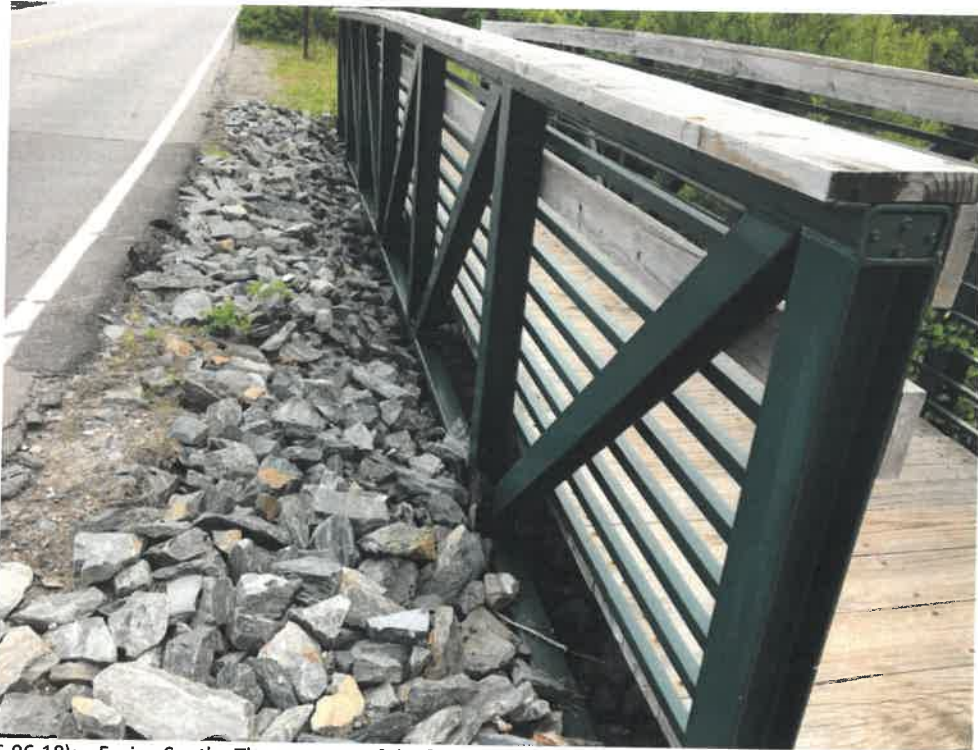
Photo 3 (06-06-18): Facing South. The presence of the footbridge directly over the culvert inlets and stone rip rap make inlet maintenance a challenge

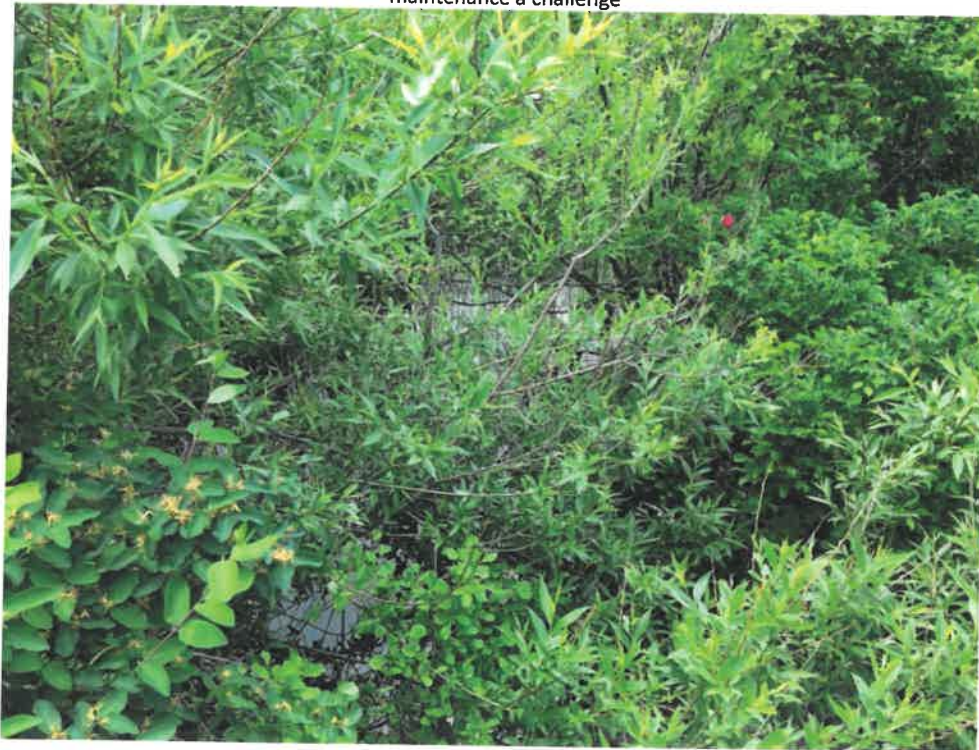
Photo 4 (06-06-18): Facing west. Thick vegetation and berm controlling ponded water up gradient of the culvert inlets.

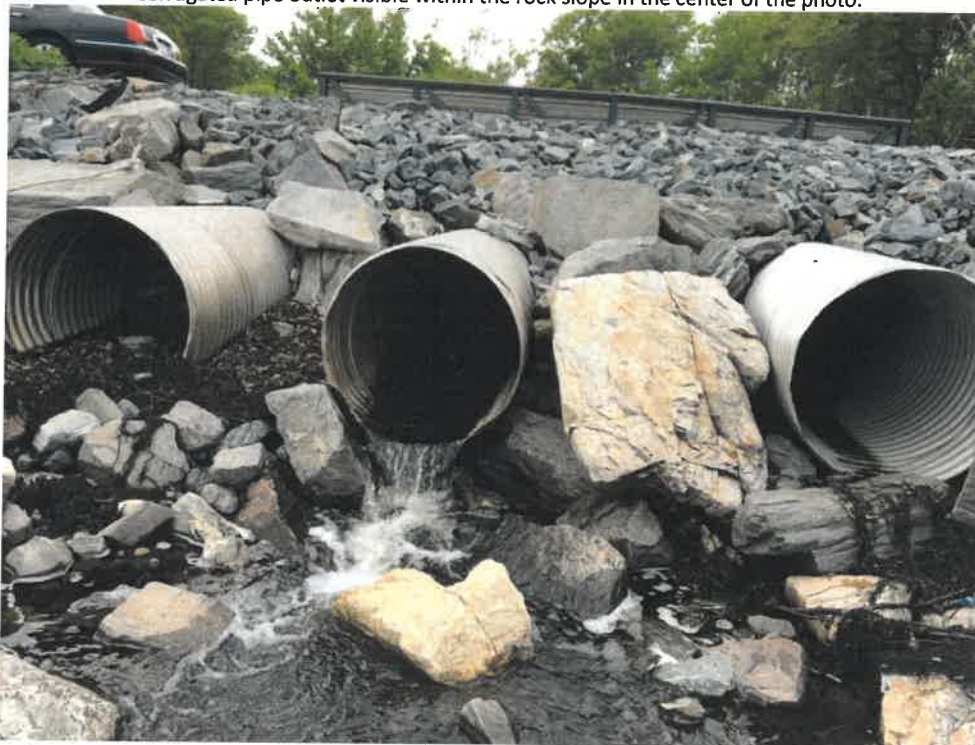
Photo 6 (06-06-18): Looking east at hanging outlet of the three, 36-inch aluminum corrugated pipe outlets on the west side of Shore Road. Seaweed and other debris frequently compromise the culverts' capacity as exemplified by only the center culvert flowing freely despite all three culverts being installed at roughly the same elevations.

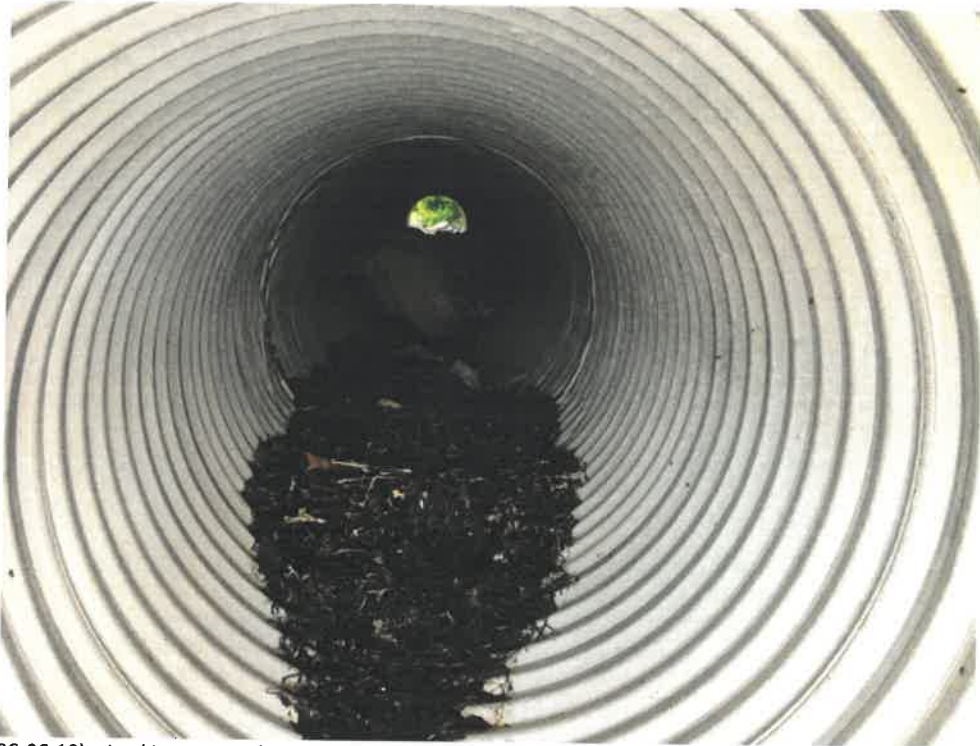
Photo 7 (06-06-18): Looking west at large rock and other ocean debris inside of northerly culvert. Being exposed directly to Casco Bay, ocean surges often push debris inside of these pipes creating an ongoing maintenance issue for the Town.

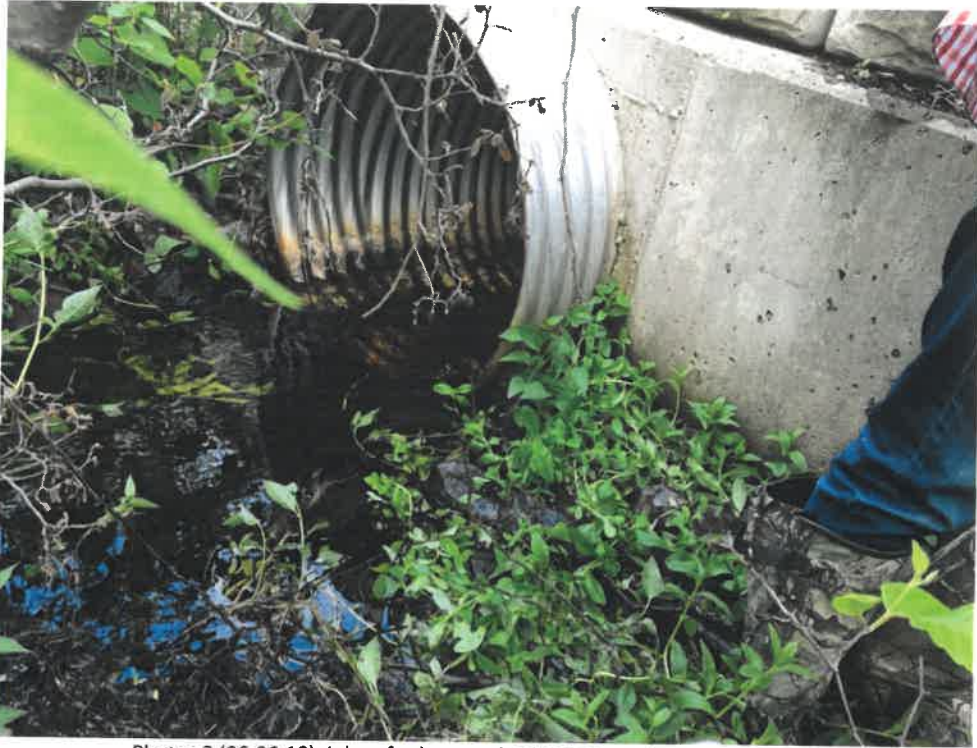
Photos 3 (06-06-18): Inlet of submerged culvert on west side of Shore Road.

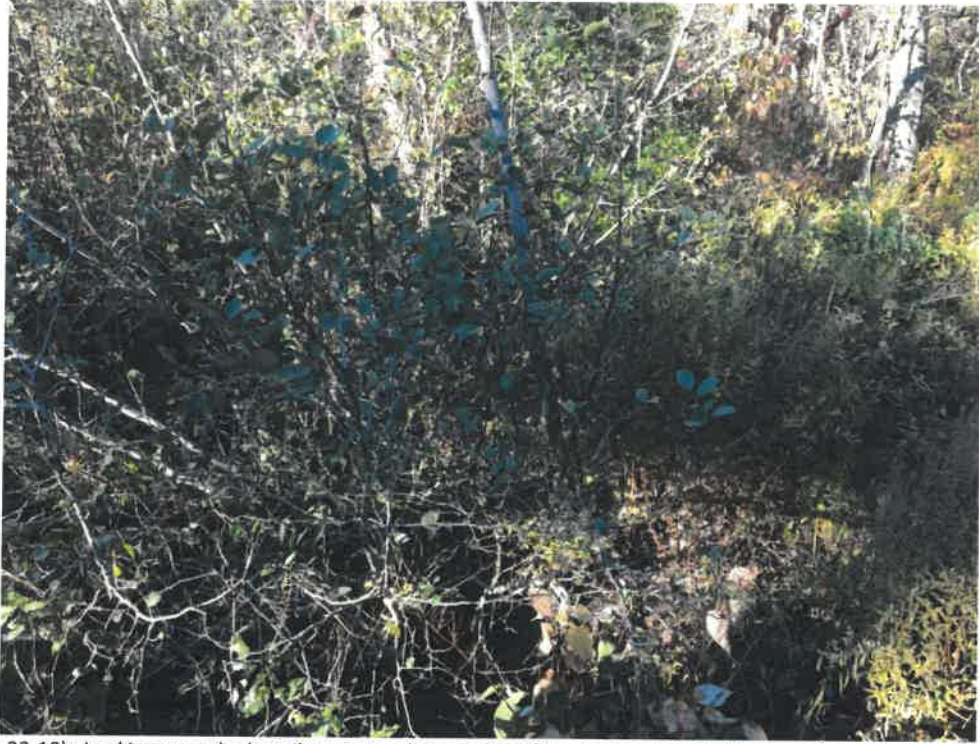
Photo 5 (10-22-18): Looking west the heavily vegetated up gradient flow to the inlet of culvert on Shore Road.

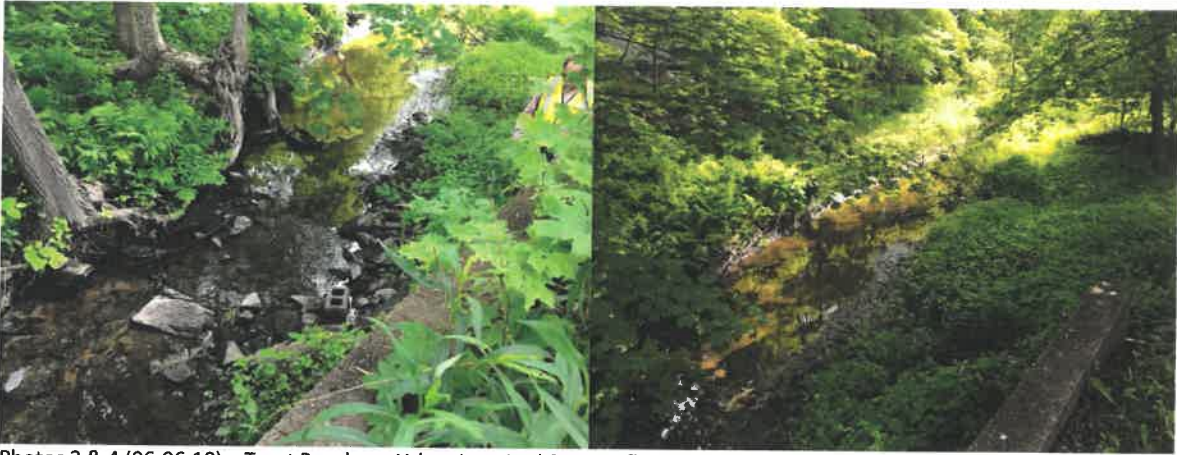
Photos 3 & 4 (06-06-18): Trout Brook, an Urban Impaired Stream, flowing to the culvert inlet on east side of Route 77. Photo 3 is taken adjacent to the inlet and shows eroded areas at the base of the mature trees lining the northern bank. Photo 4 depicts a more uniform and stable channel further upstream from the culvert inlet.

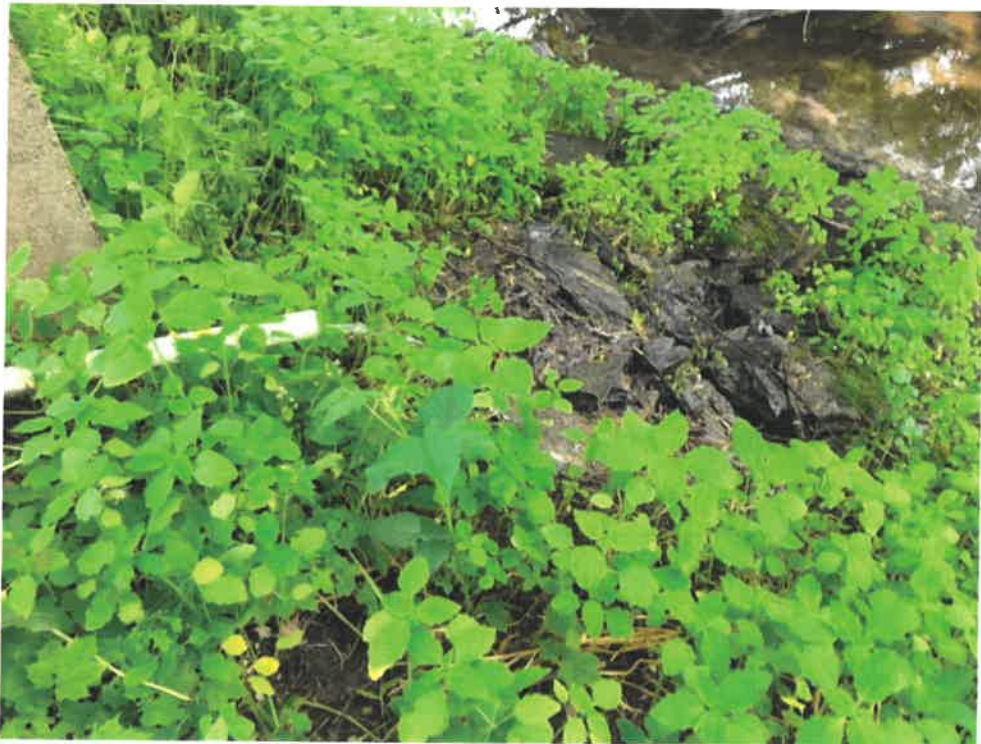
Photo 5 (06-06-18): Facing west at the east end of the concrete wingwall on the south side of the culvert inlet. Small diameter white pvc pipe is conveying groundwater flow directly into Trout Brook despite being a relatively dry weather period. Trout Brook receives surface flow and groundwater flow from residential neighborhoods and other developed areas in close proximity to the stream.

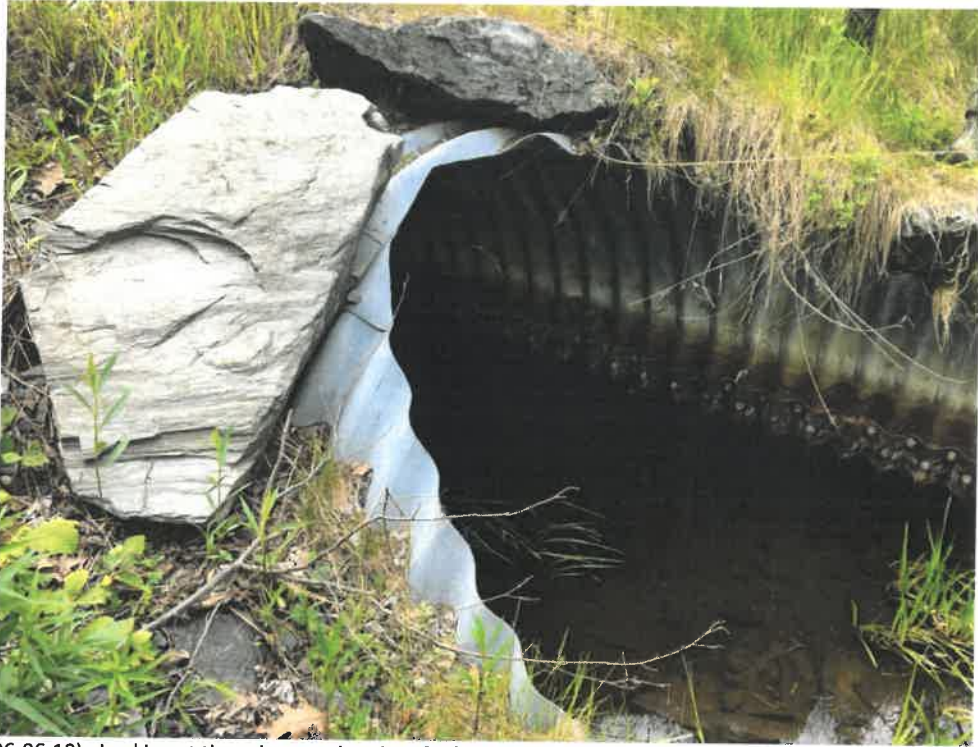
Photo 6 (06-06-18): Looking at the submerged outlet of 8 foot, 2-inch-wide by 5 foot, 9-inch-high steel plate pipe arch cross pipe. Rip rap stones are sparse, but provide a headwall.

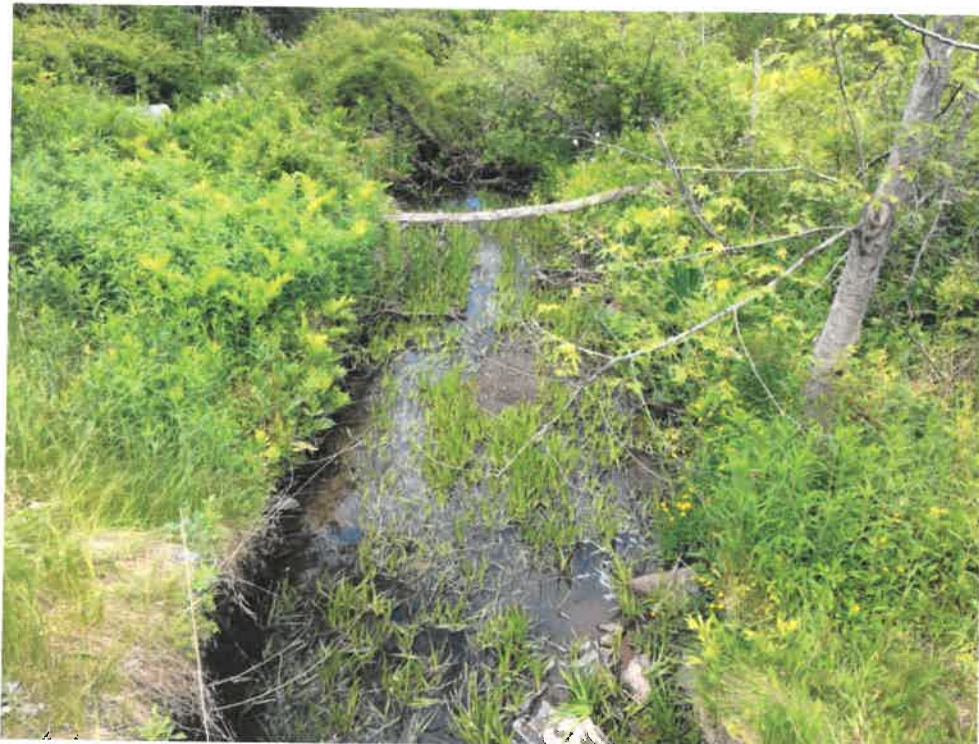
Photo 9 (06-06-18): Looking further downstream at the outlet of the steel plate pipe arch cross pipe. Vegetation and sediment deposits are present within this channel.

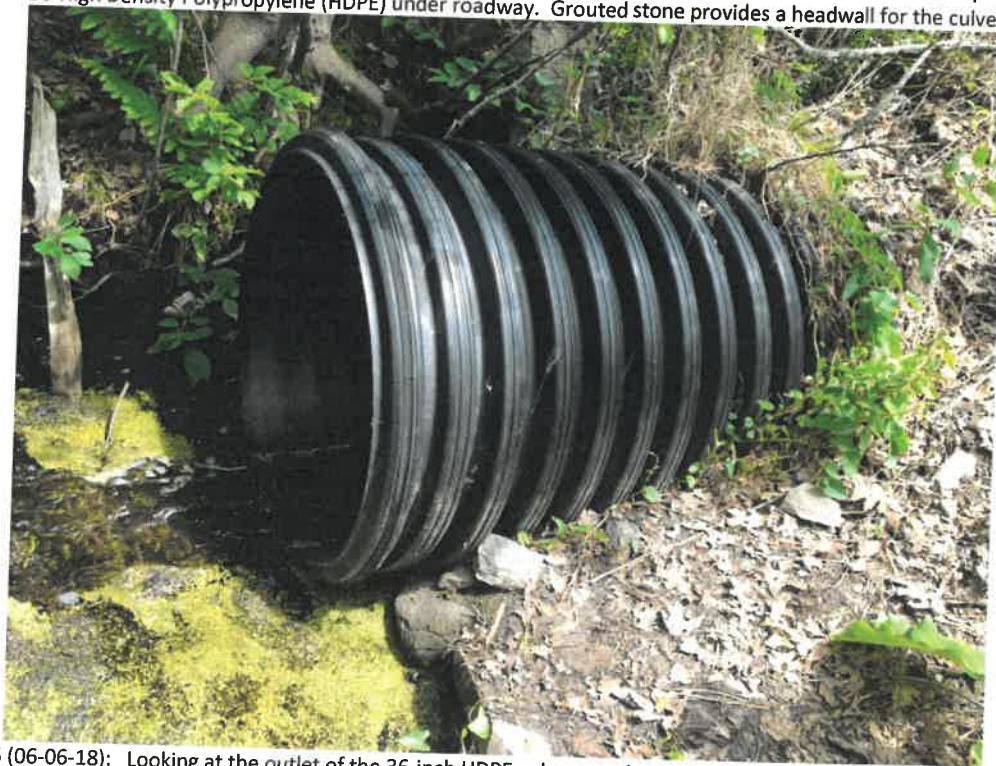
Photo 6 (06-06-18): Looking at the outlet of the 36-inch HDPE culvert on the north side of Spurwink Avenue. No formal headwall or apron at the outlet.

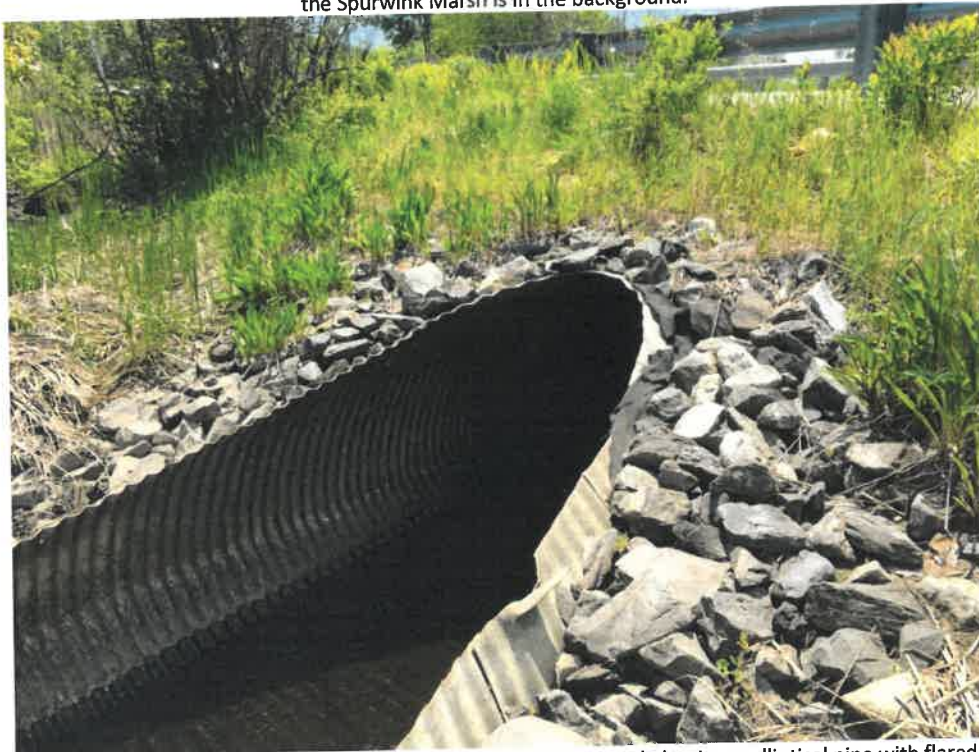
Photo 2 (06-06-18): Submerged inlet of 6-foot wide by 5-foot high corrugated aluminum elliptical pipe with flared end and rip rap headwall. Additional headwall rip rap should be added to the headwall.

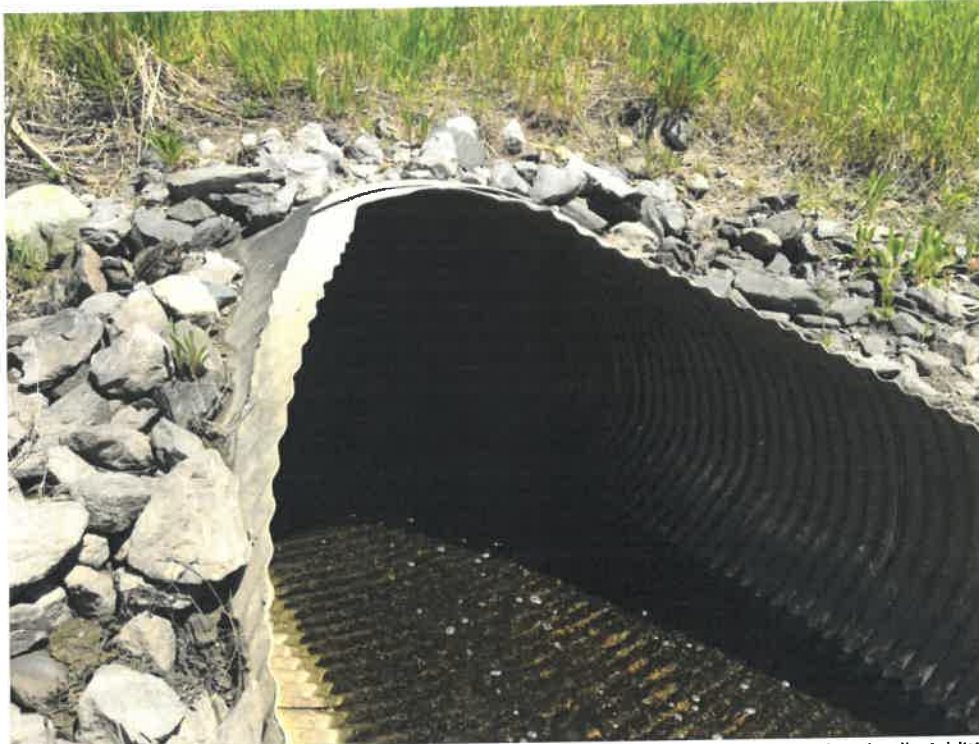
Photo 5 (06-06-18): Submerged outlet of the aluminum elliptical pipe with flared end and rip rap headwall. Additional rip rap would be desirable to bolster the area around the culvert.

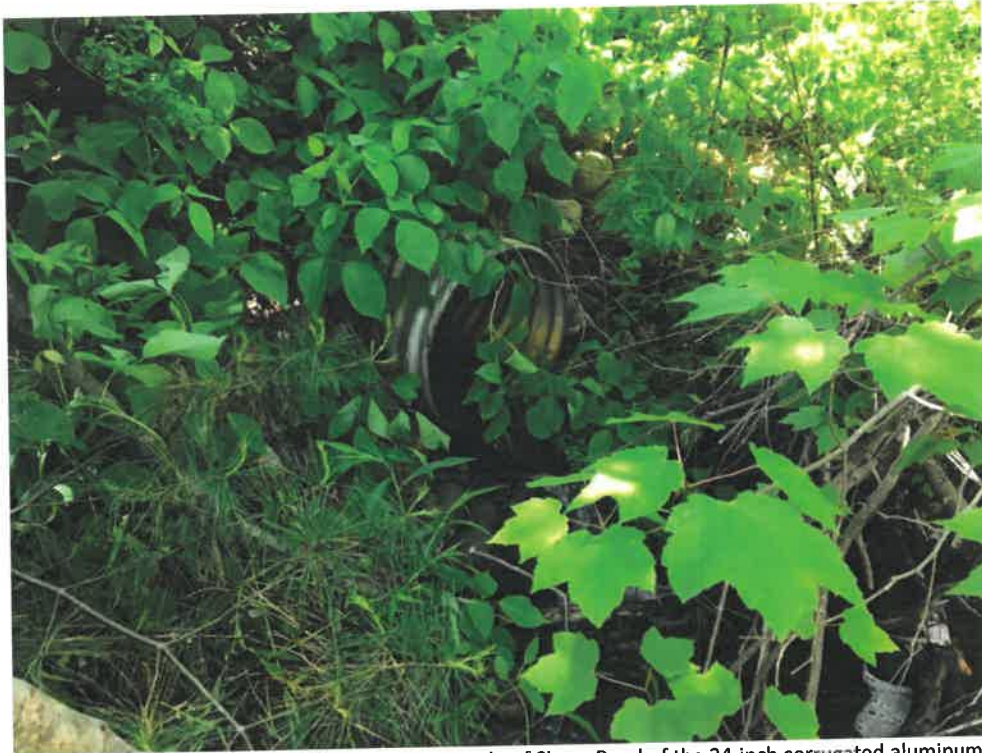
Photos 3 (06-06-18): Hanging culvert outlet on east side of Shore Road of the 24-inch corrugated aluminum pipe.

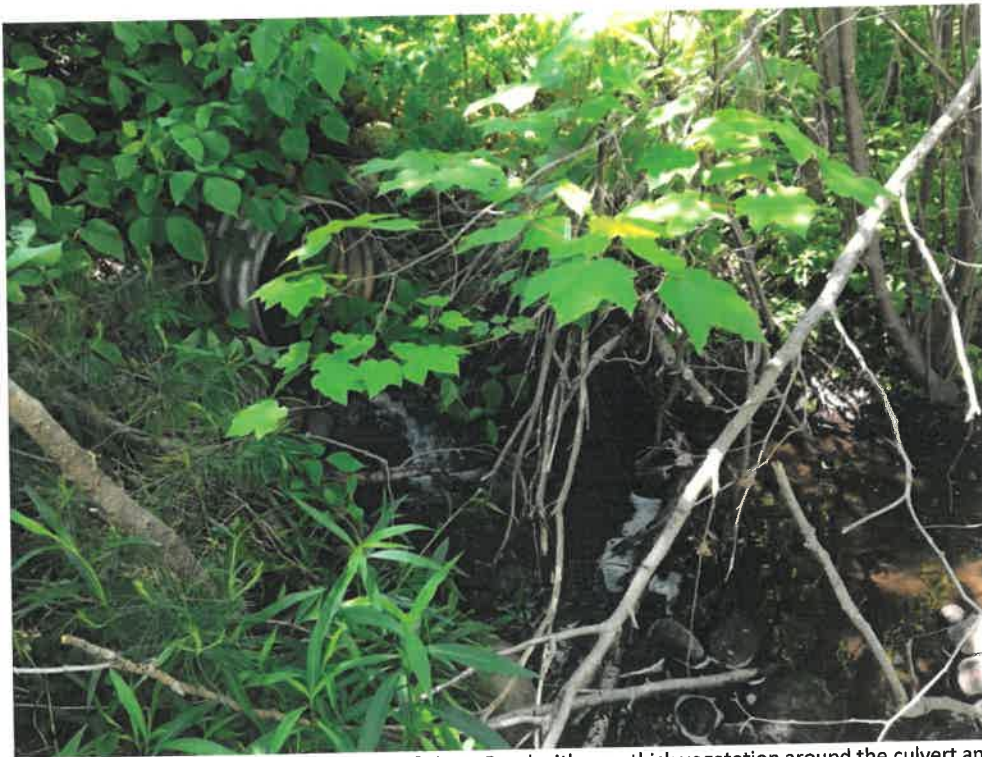
Photo 4 (06-06-18): Culvert outlet on east side of Shore Road with very thick vegetation around the culvert and in the downstream channel.

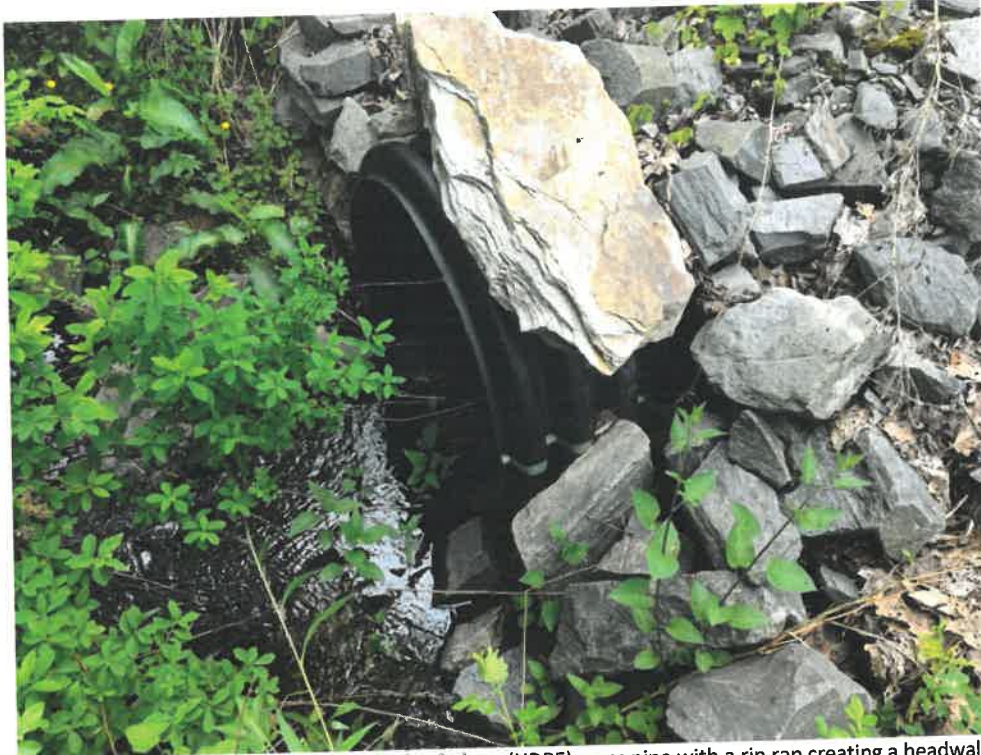
Photo 3 (06-06-18): Inlet of 30-inch High Density Polyethylene (HDPE) cross pipe with a rip rap creating a headwall and apron. Inlet is on the east side of Spurwink Avenue. Access to the culvert and the area around the inlet is relatively clear of vegetation.

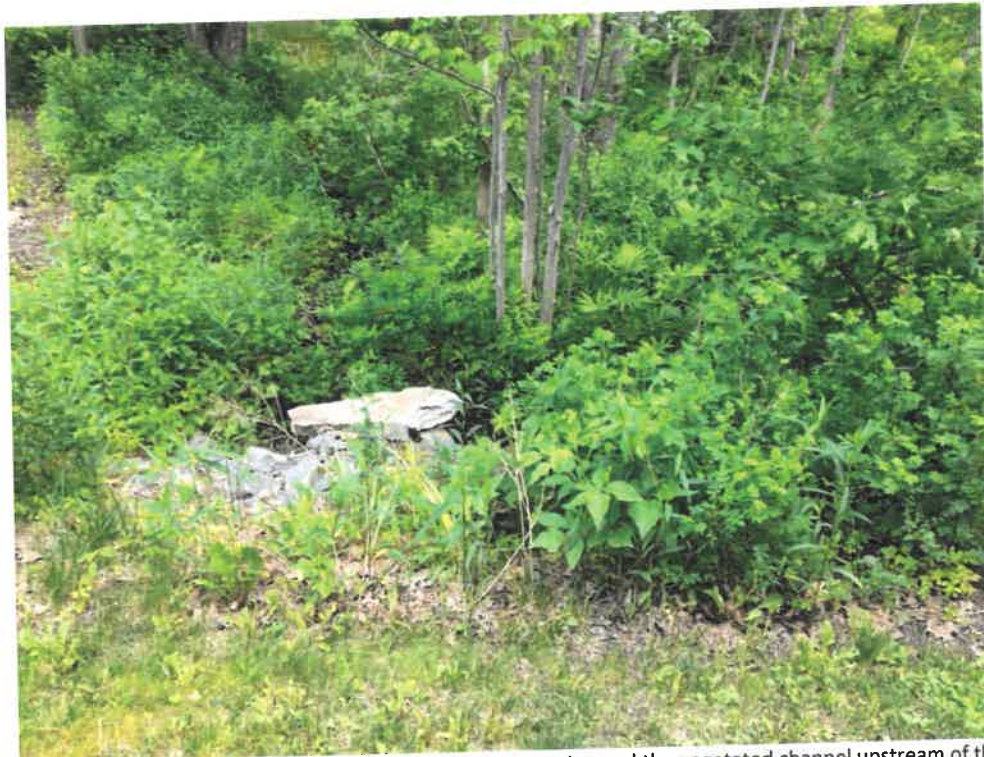
Photo 4 (06-06-18): Facing east at the inlet of 30-inch HDPE cross pipe and the vegetated channel upstream of the culvert crossing.

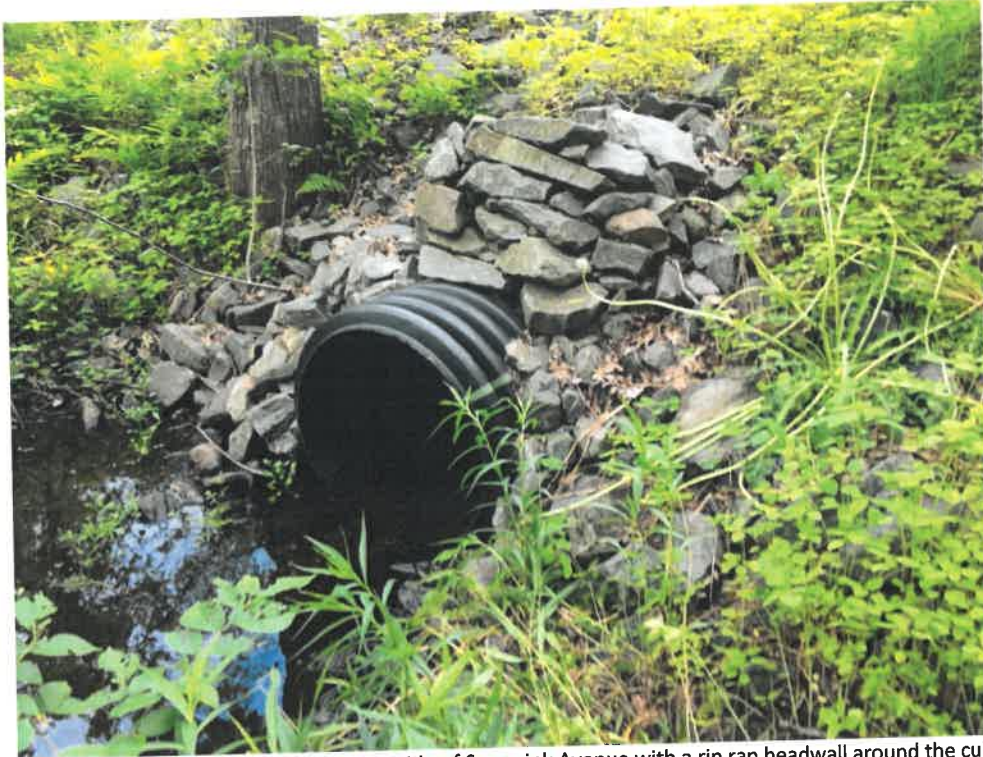
Photo 5 (06-06-18): Culvert outlet on west side of Spurwink Avenue with a rip rap headwall around the culvert.

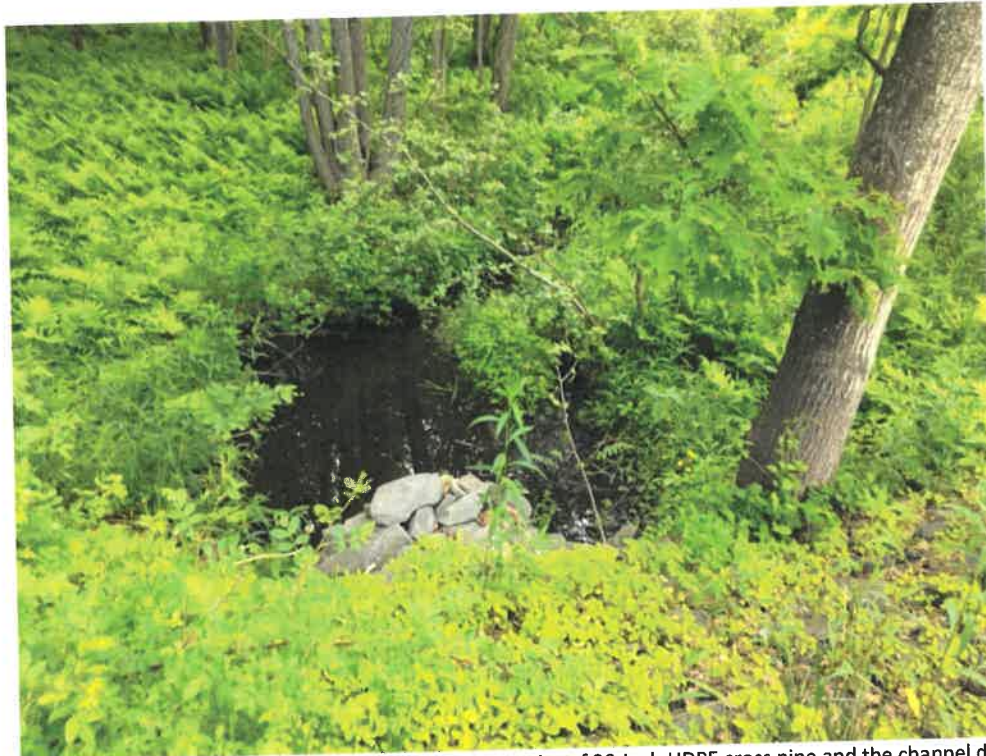
Photo 6 (06-06-18): Facing west at the stone headwall for the outlet of 30-inch HDPE cross pipe and the channel downstream of the culvert crossing. The downstream channel turns to the north (i.e., the right in this photo) as it approached the vegetation beyond the visible pool of water beyond the outlet of the culvert.

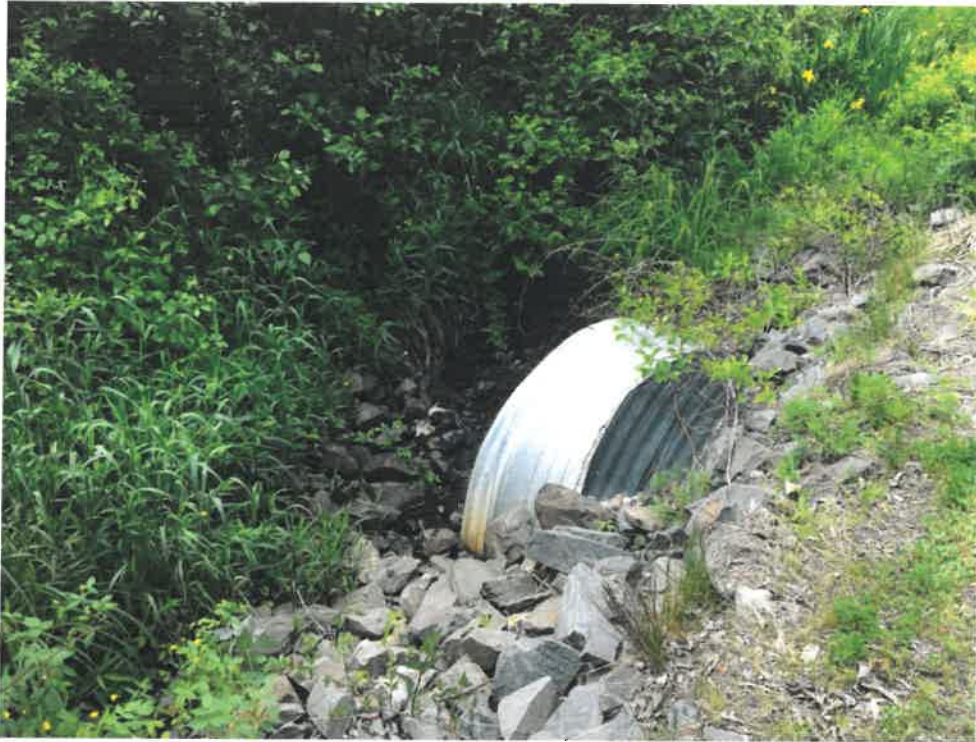
Photos 3 (06-06-18): Culvert inlet on west side of Spurwink Avenue is submerged within the corrugated aluminum pipe. Upstream vegetation obscured channel at the time of the photo.

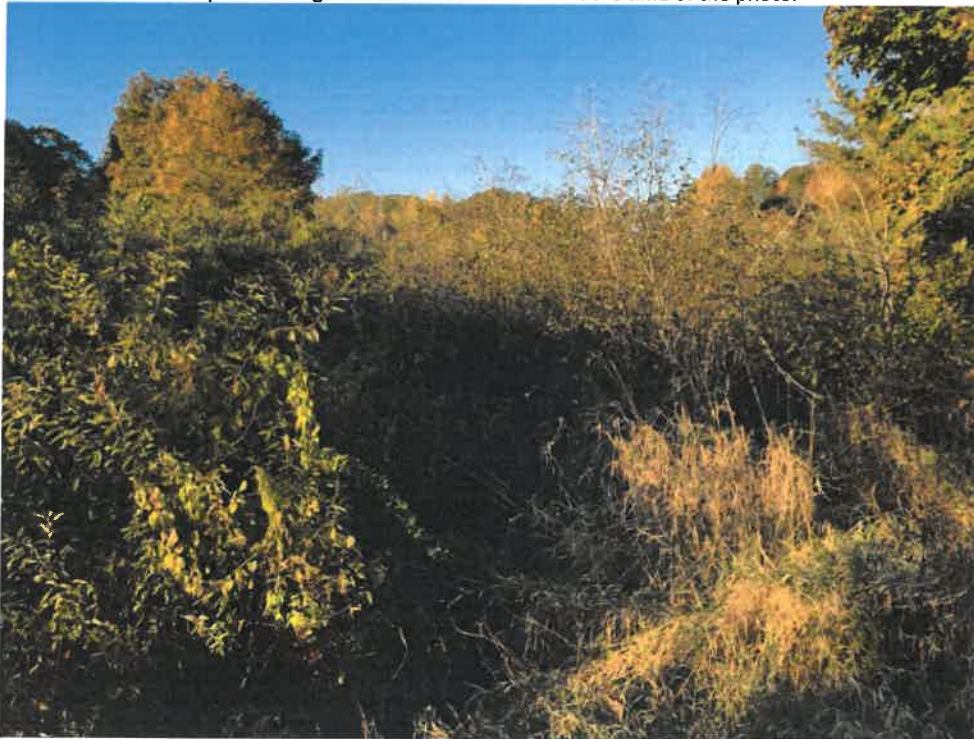
Photos 4 (10-22-18): Looking up gradient at the heavily vegetated area flowing to the culvert inlet on west side of Spurwink Avenue. Upstream vegetation obscured channel at the time of the photo.

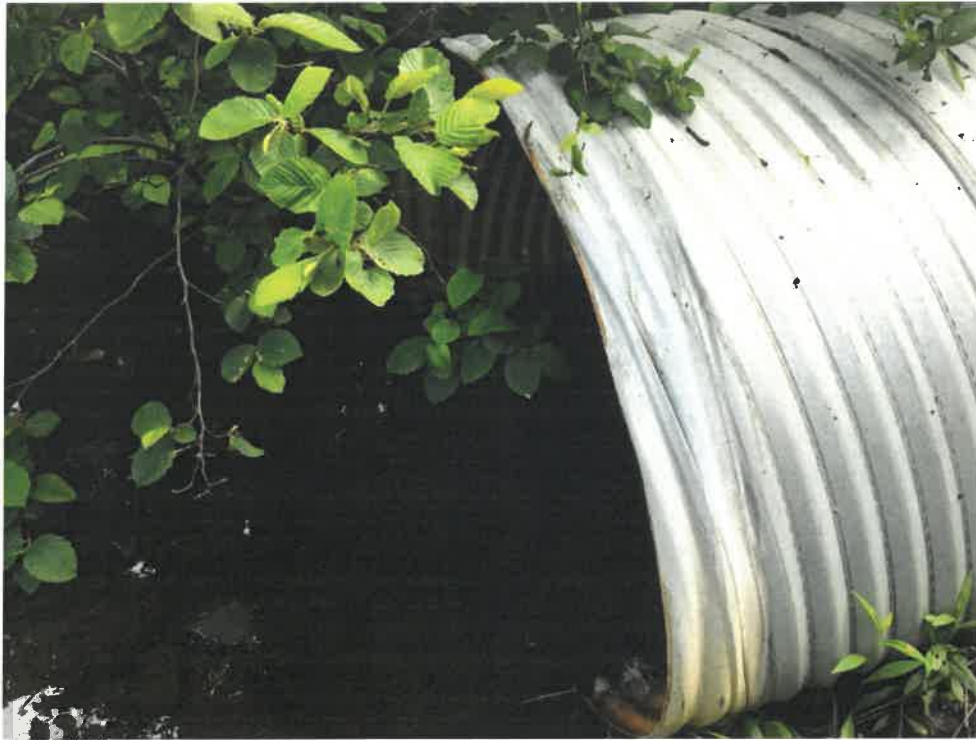
Photo 5 (06-06-18): Culvert outlet on east side of Spurwink Avenue is submerged within the corrugated aluminum pipe. Downstream vegetation obscured channel at the time of the photo.

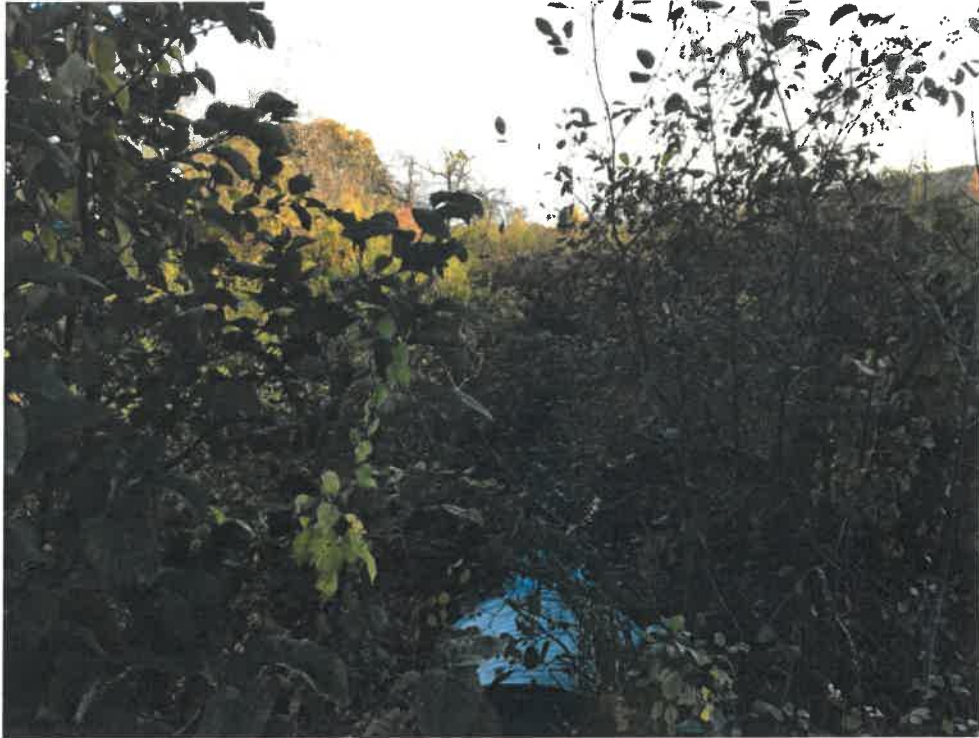
Photo 7 (06-06-18): Looking northeast at the flow from the culvert outlet on east side of Spurwink Avenue. Downstream vegetation obscured channel at the time of the photo.

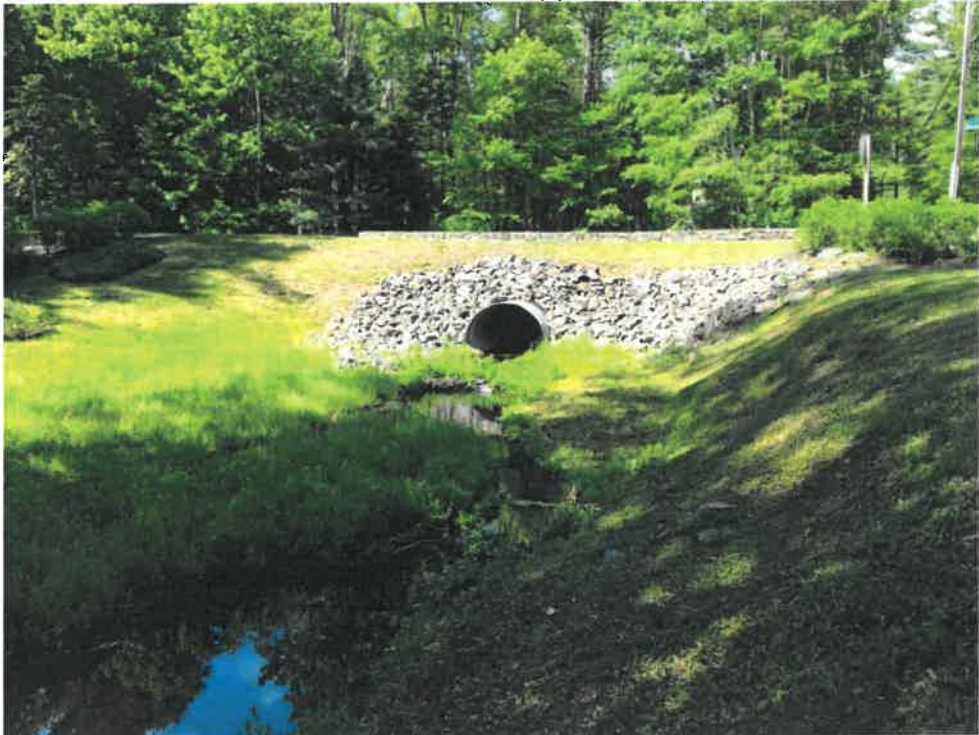
Photo 4 (06-06-18): Facing northwest from the Mitchell Road culvert toward the 3-feet tall by 4-feet wide elliptical culvert under nearby Hobstone Road with channel of the Pond Cove Brook upstream of the Mitchell Road culvert inlet.

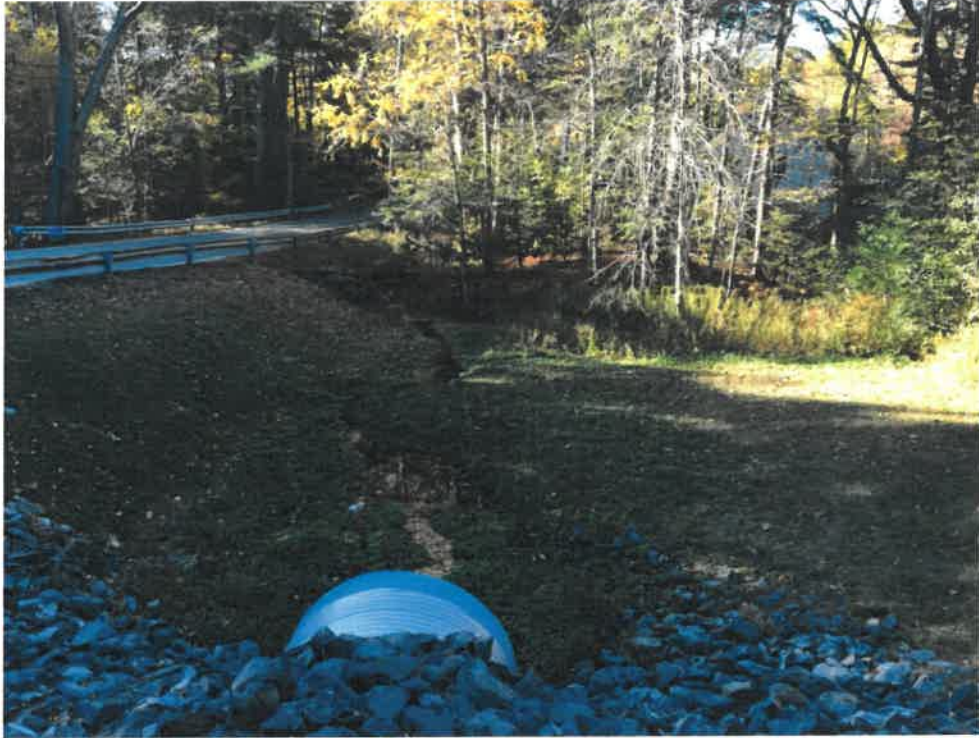
Photo 5 (10-22-18): Facing southwest at discharge flow channel of Pond Cove Brook from elliptical culvert under Hobstone Road to the Mitchell Road culvert inlet.

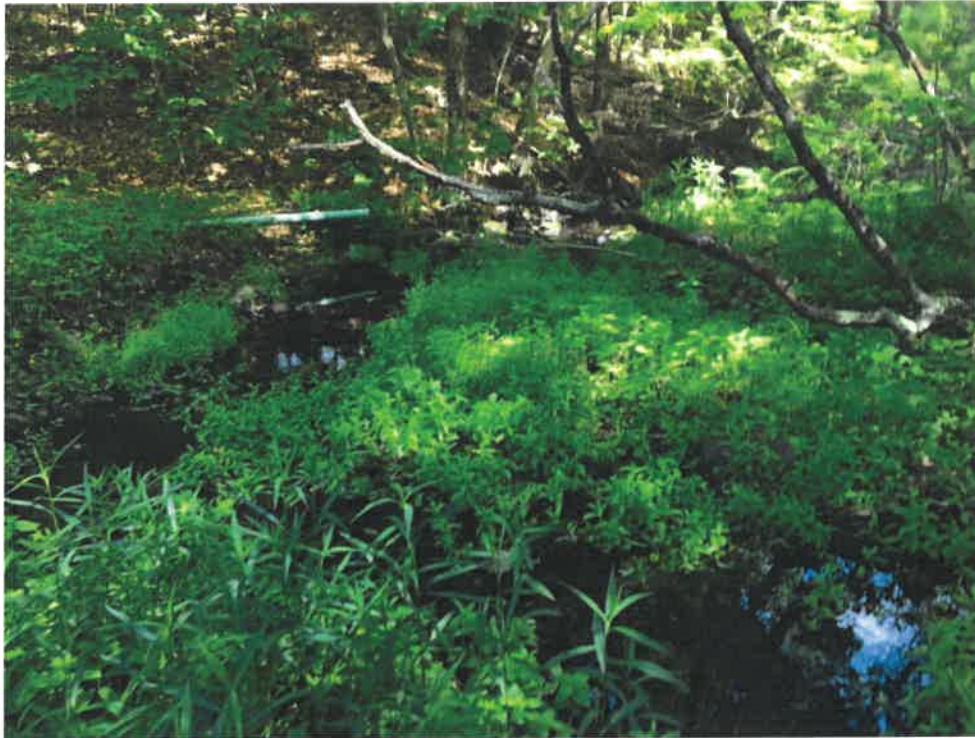
Photo 9 (06-06-18): Downstream flow of Pond Cove Brook from the Mitchell culvert outlet flows through the ponded area upstream of the multiple Shore Road culverts which convey flow to Pond Cove and Atlantic Ocean.

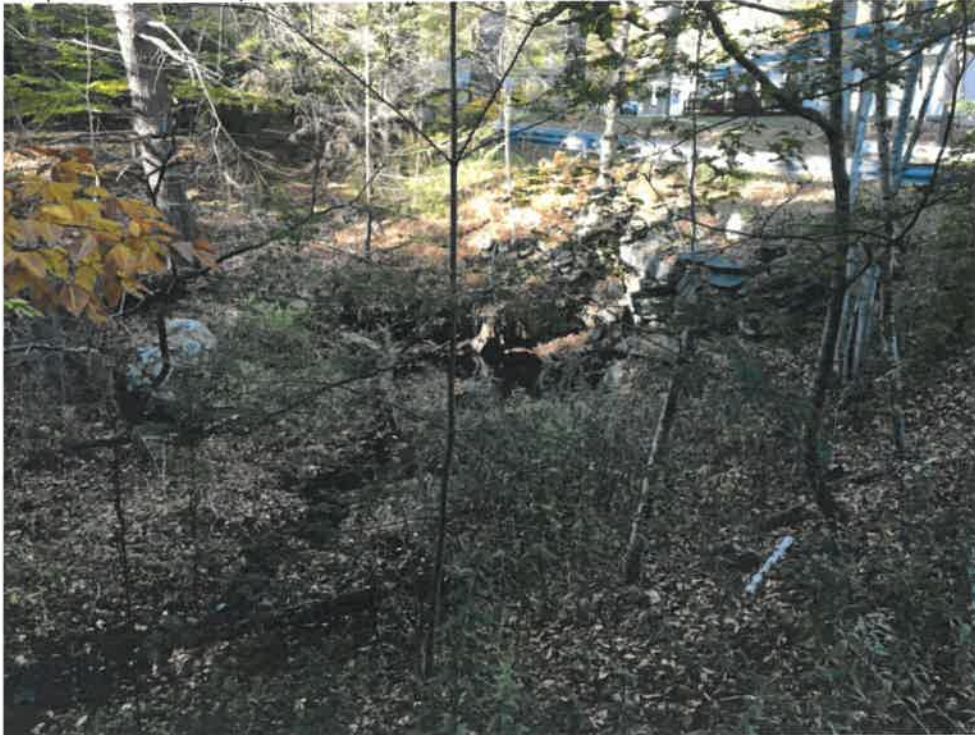
Photo 10 (10-22-18): Facing south from the nearby pump station at the downstream flow of Pond Cove Brook from the Mitchell culvert outlet.

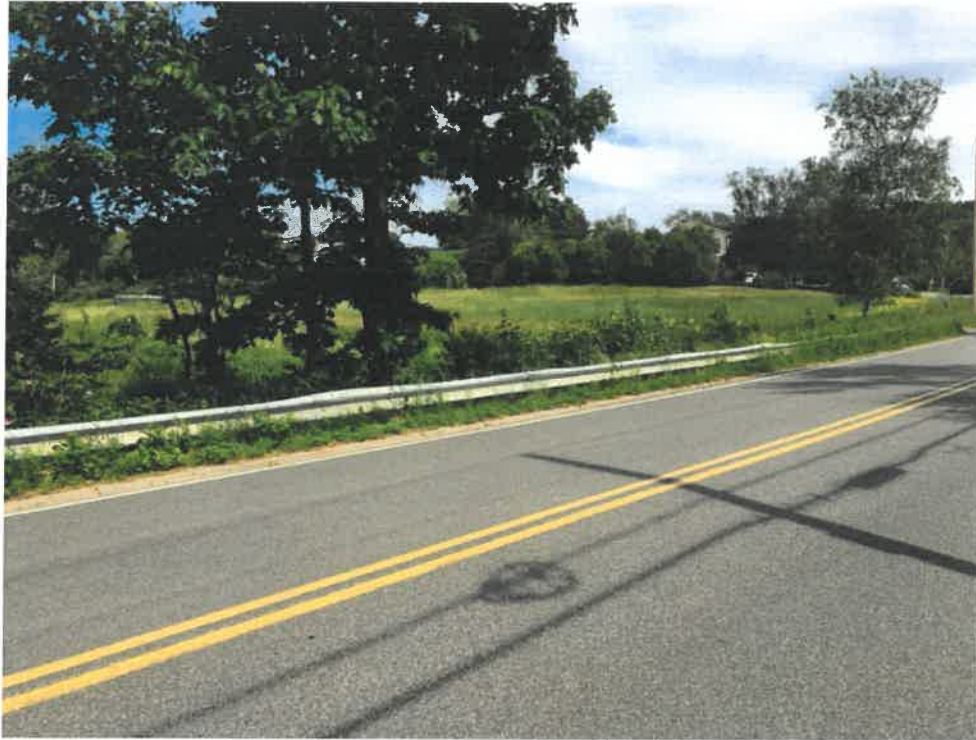
Photo 1 (06-20-18): Facing southeast at Old Ocean House Road crossing of Alewife Brook. Culvert are located relatively deep in relation to the road surface elevation with a steep roadway embankment.

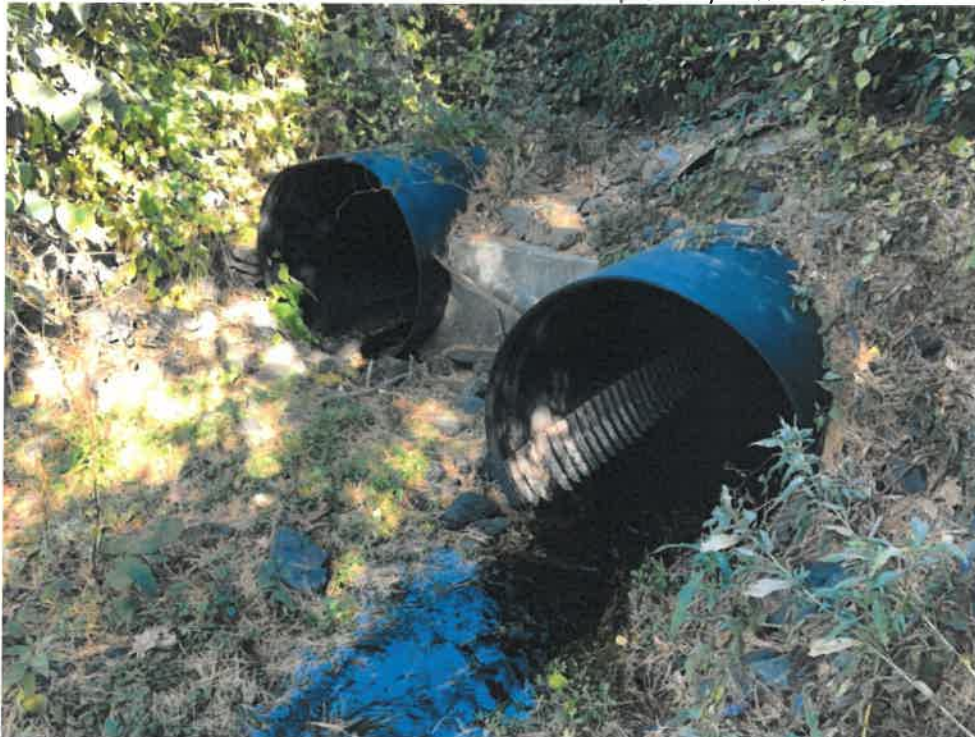
Photo 2 (10-22-18): Inlet of two 48-inch high density polyethylene liner pipes within the original corrugated aluminum cross pipes. Southerly culvert on the right-hand side conveys main flow of Alewife Brook with left-hand side culvert available for overflow capacity.
