Cape Elizabeth Culvert and Habitat Assessment Study

March 22, 2019

This report was prepared for the Town of Cape Elizabeth by Sebago Technics, Inc., the Wells National Estuarine Research Reserve, the Casco Bay Estuary Partnership and the Town of Cape Elizabeth under award CZM NA17NOS4190116 to the Maine Coastal Program from the National Oceanic and Atmospheric Administration, U.S. Department of Commerce. The statements, findings, conclusions, and recommendations are those of the authors and do not necessarily reflect the views of the National Oceanic and Atmospheric Administration or the Department of Commerce.

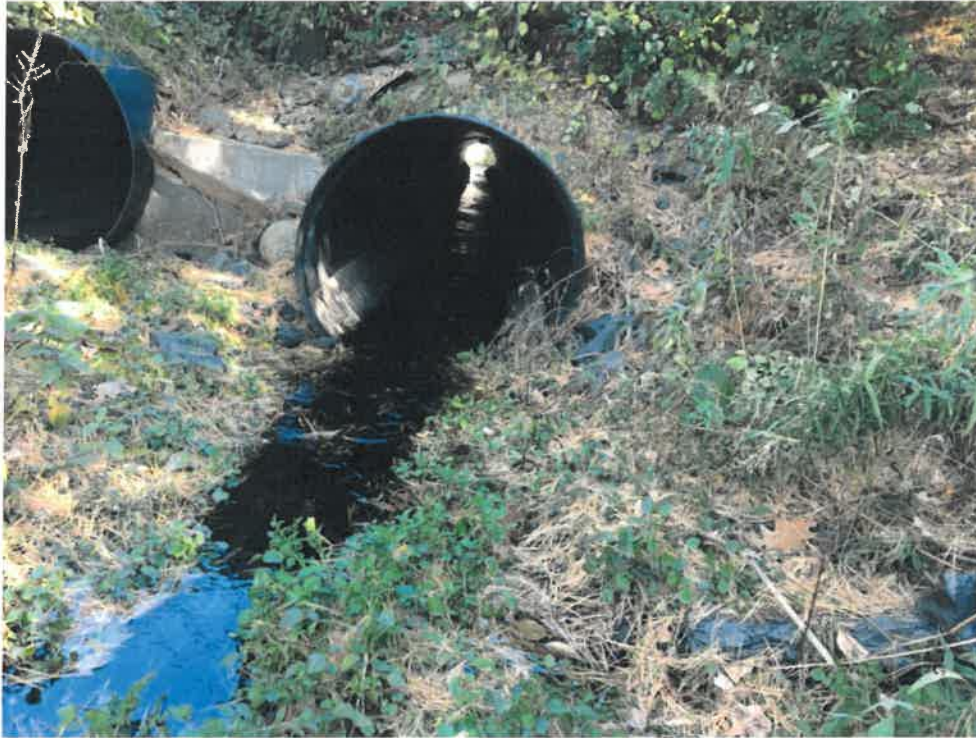
Photo 3 (10-22-18): Looking northerly through the inlet of one of the two 48-inch high density polyethylene liner pipes within the original corrugated aluminum cross pipes. The invert of the main carrying pipe is lined with a corrugated metal pipe section to reduce the velocity of flow through the pipe.

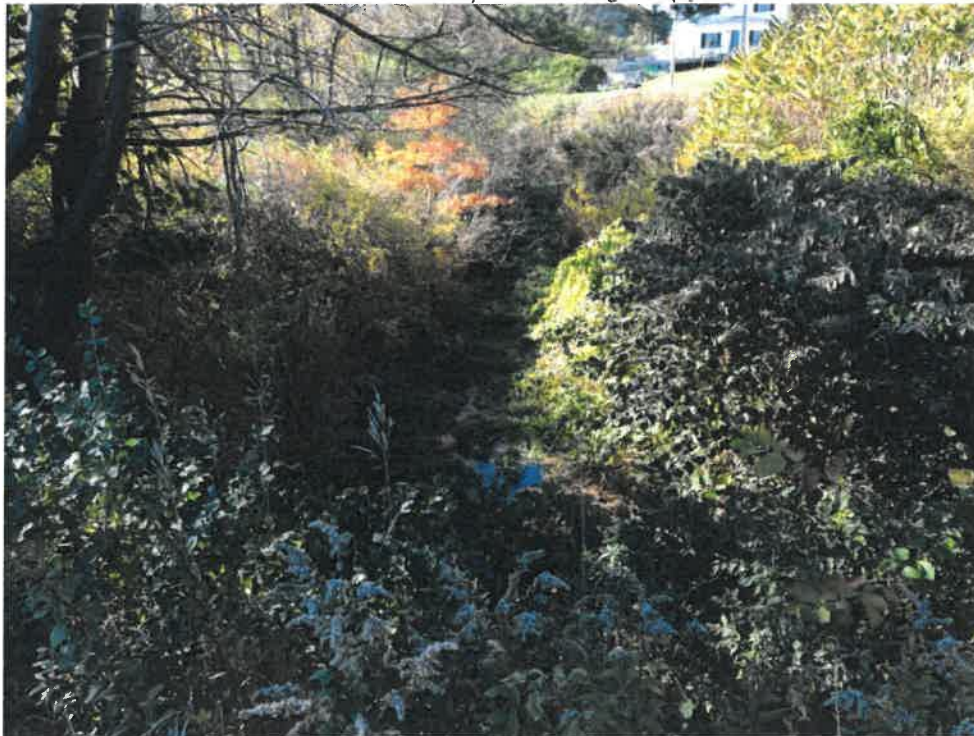
Photos 4 (10-22-18): Looking northwesterly from top of embankment at the upstream channel flowing to the two culverts inlets on the west side of Old Ocean House Road.

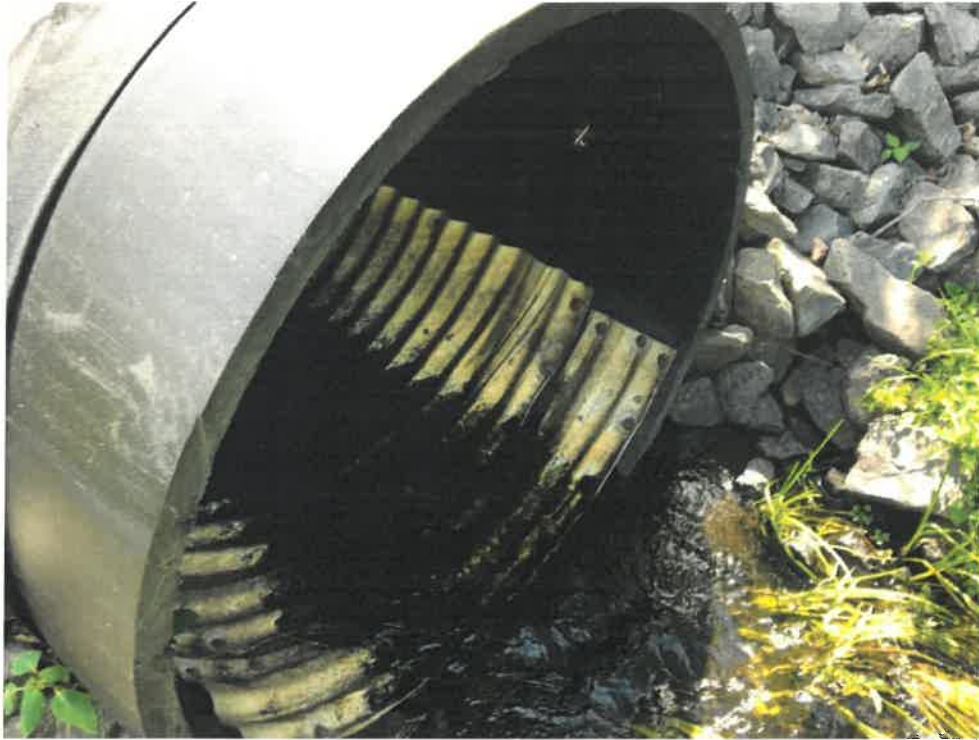
Photo 5 (06-20-18): Submerged outlet of main flow carrying culvert with corrugated metal pipe invert to slow the flow velocity through the pipe to allow fish passage.

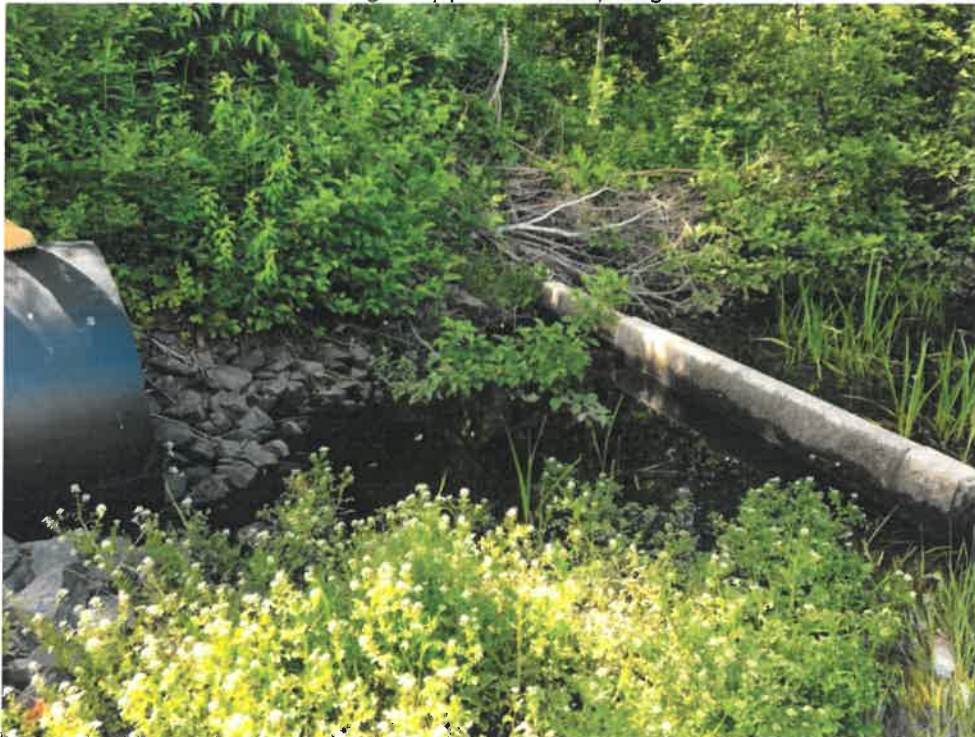
Photo 6 (06-20-18): Outlet of culverts on the east side of Old Ocean House Road. Outlet has a rip rap lined plunge pool and headwall. Concrete weir at outlet was installed to create a submerged outlet to allow alewife fish passage.

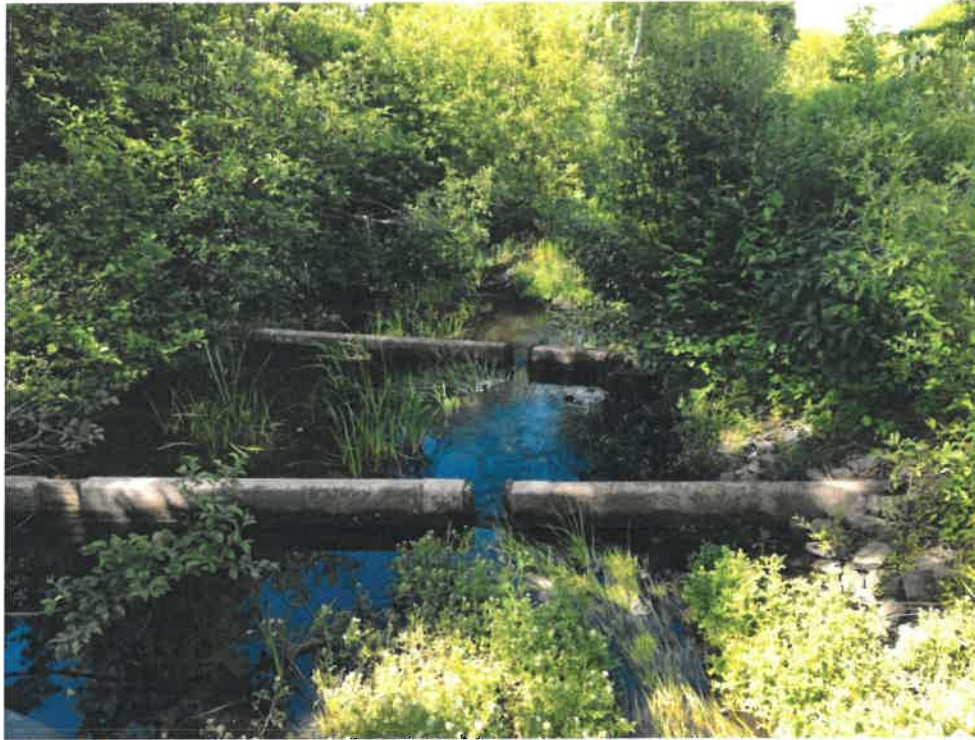
Photo 7 (06-20-18): Downstream channel of the culvert outlet flow with two concrete weir walls with slotted weirs to control elevation and flow from the culverts to dissipates energy of the outfall and reduce the velocity of the outflow to the receiving channel. The weirs also create pool areas within the channel.

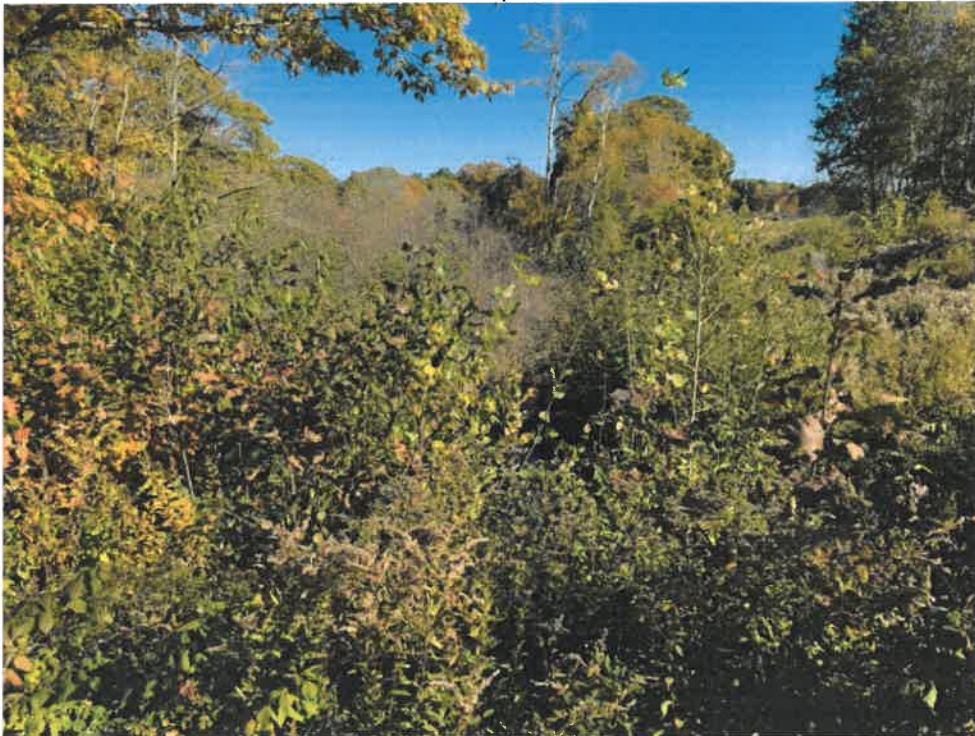
Photo 8 (10-22-18): Looking northerly at the heavily vegetated downstream channel of Alewife Brook from the culvert outlet flow.

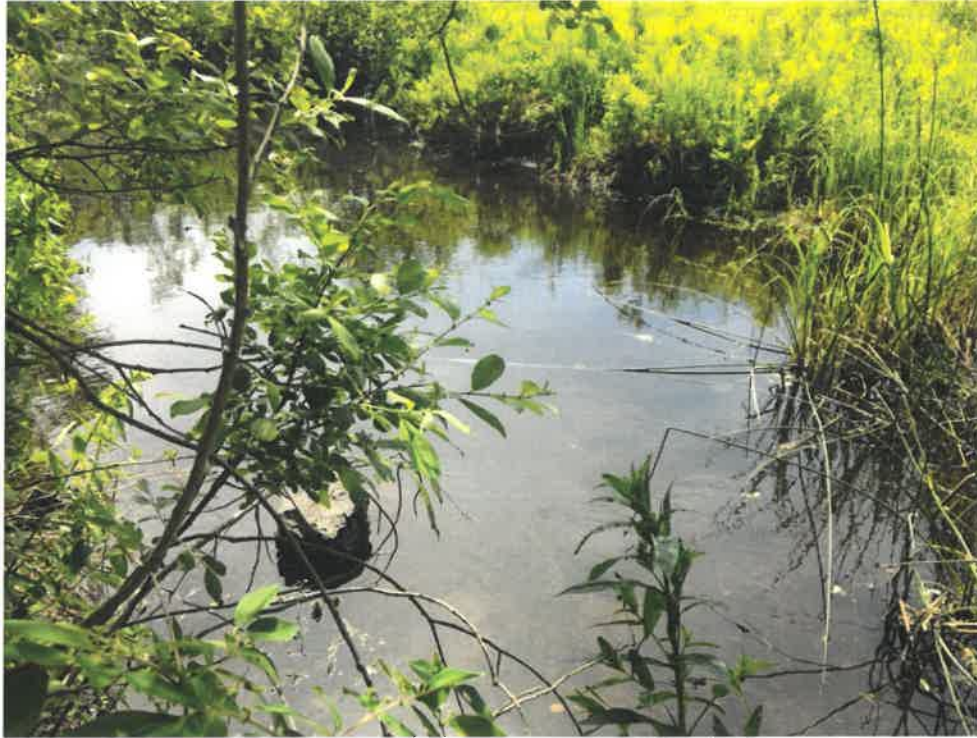
Photos 3 (06-20-18): Looking upstream at the Alewife Brook flow to the Inlet of the culvert on west side of Ocean House Road (Route 77). Alewife Brook hydraulically connects Great Pond to Casco Bay.

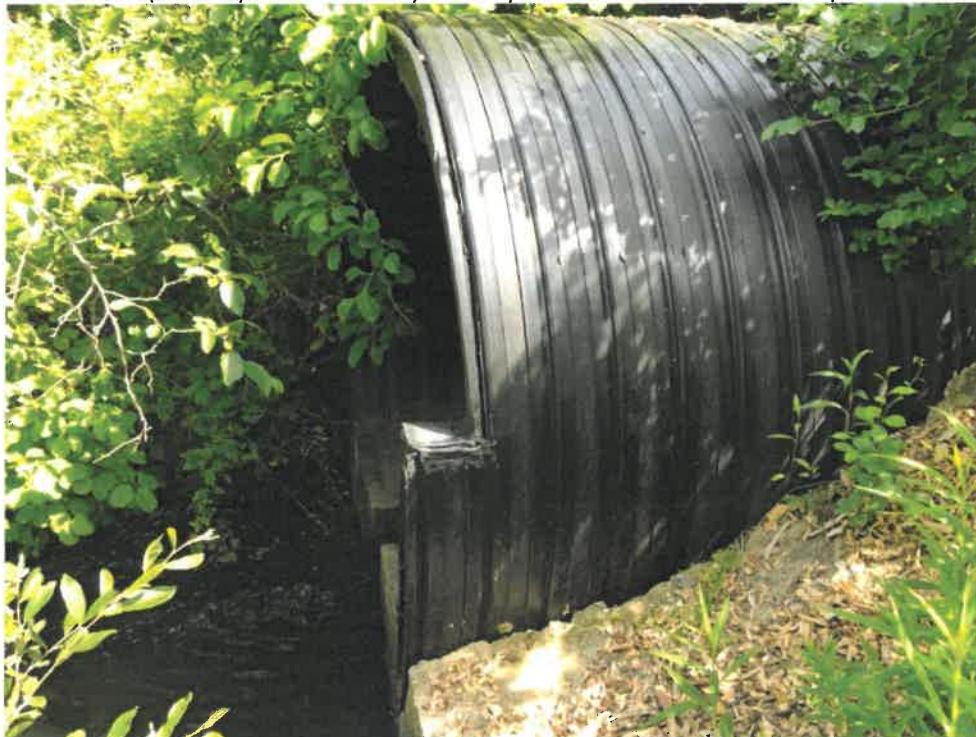
Photo 4 (06-20-18): Submerged outlet of culvert with slotted weir invert to slow the flow velocity through the pipe to allow fish passage. Culvert outlet is supported by concrete saddle.

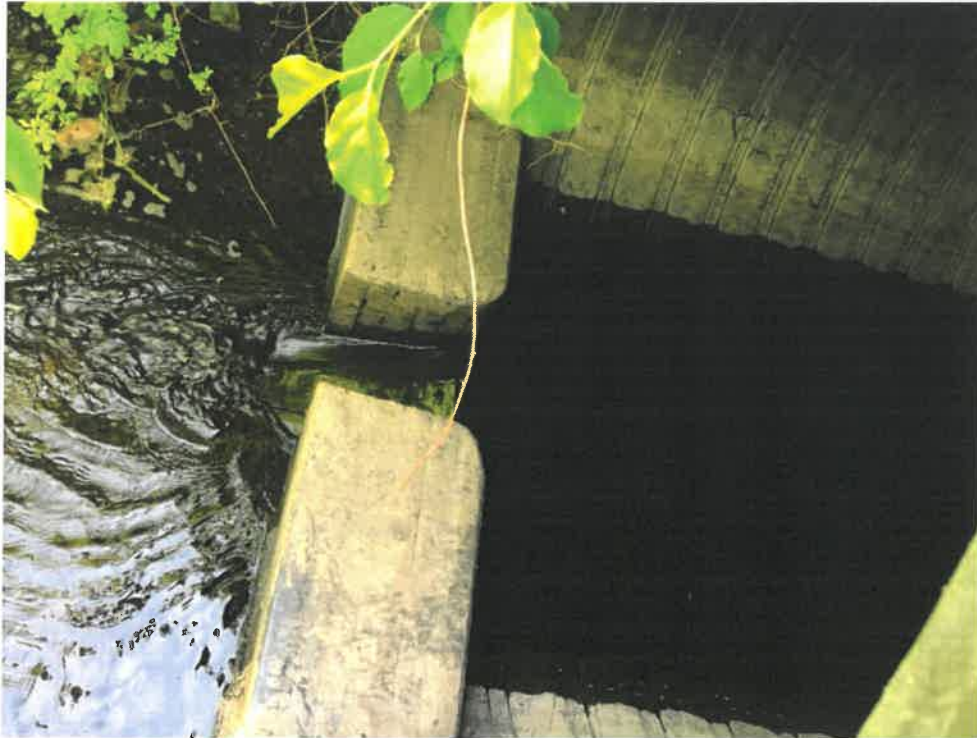
Photo 5 (06-20-18): Weir in outlet of culvert on the east side of Ocean House Road. Weir at outlet was installed to create a submerged outlet to allow Alewife fish passage.

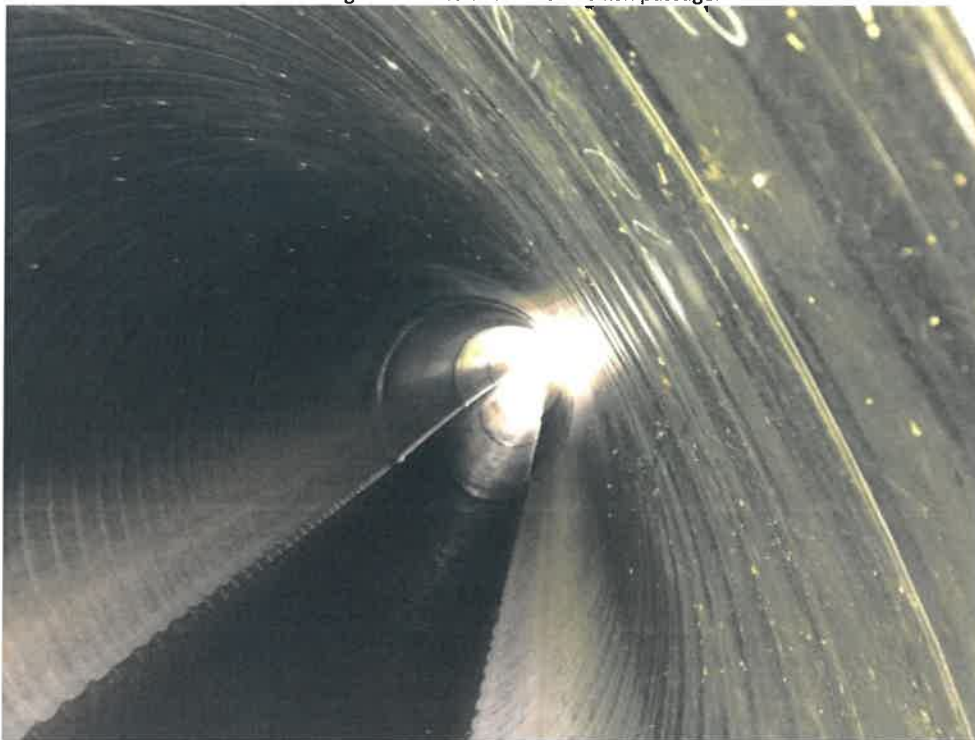
Photo 6 (06-20-18): View of the interior of the HDPE liner from the outlet toward the inlet of the pipe. Invert of the culvert is submerged.

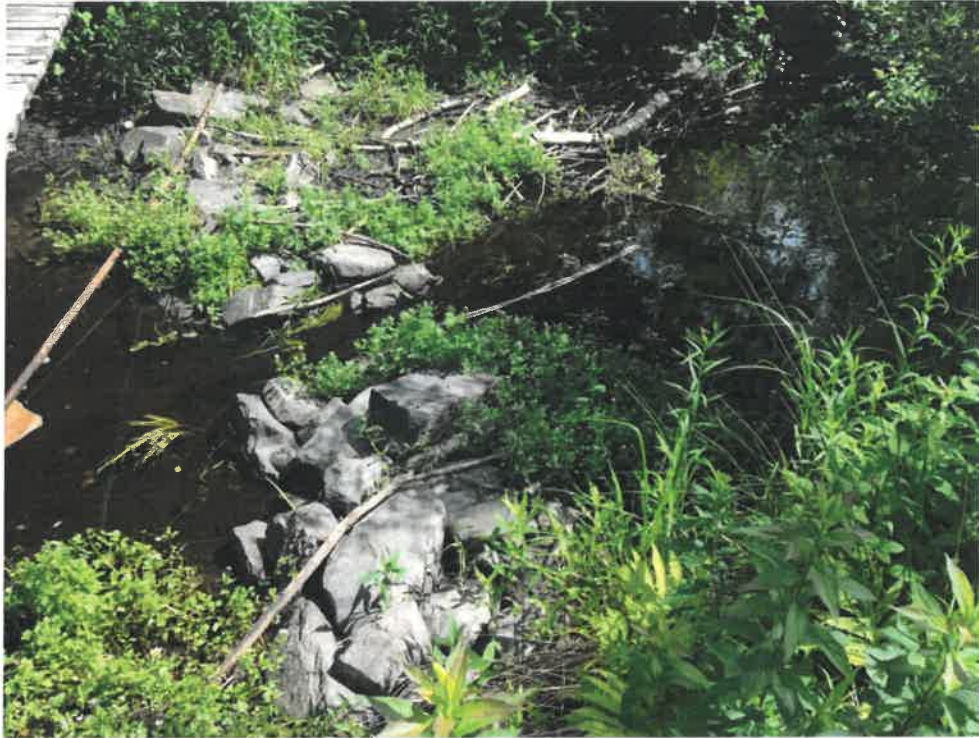
Photo 7 (06-20-18): Downstream channel of the culvert outlet flow with stone weir wall with center opening to control elevation and flow from the culverts to dissipate energy of the outfall and reduce the velocity of the outflow to the receiving channel. The weir also creates a pool area within the channel.

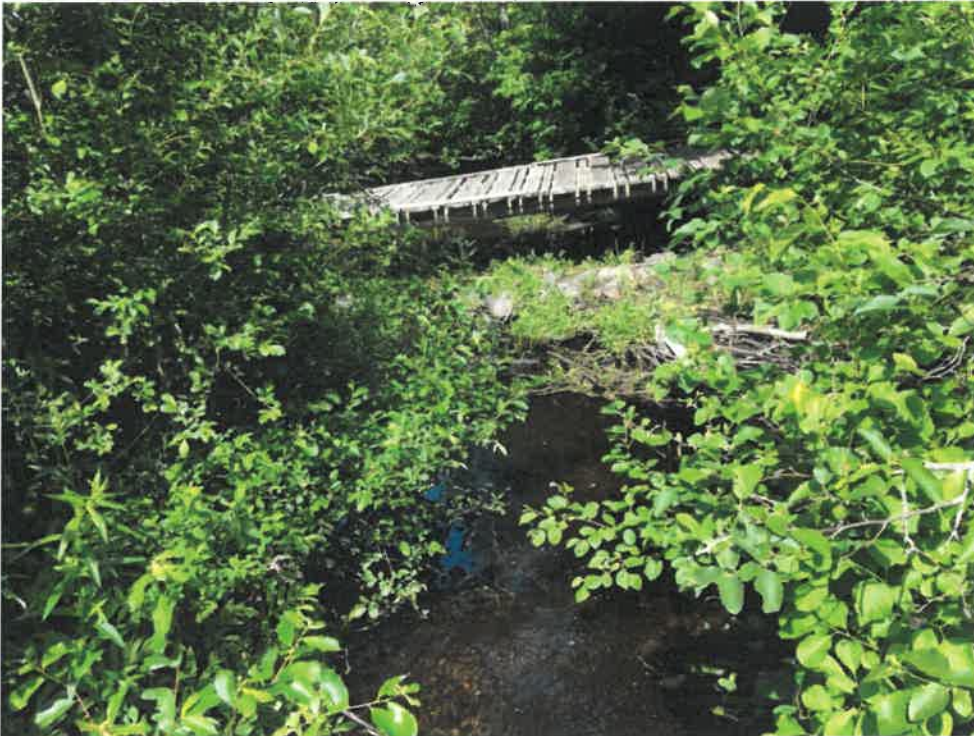
Photo 8 (06-20-18): Downstream view of Alewife Brook from outlet area of the culvert. Stone berm is upstream of a wooden footbridge crossing over the stream in the background of the photo.

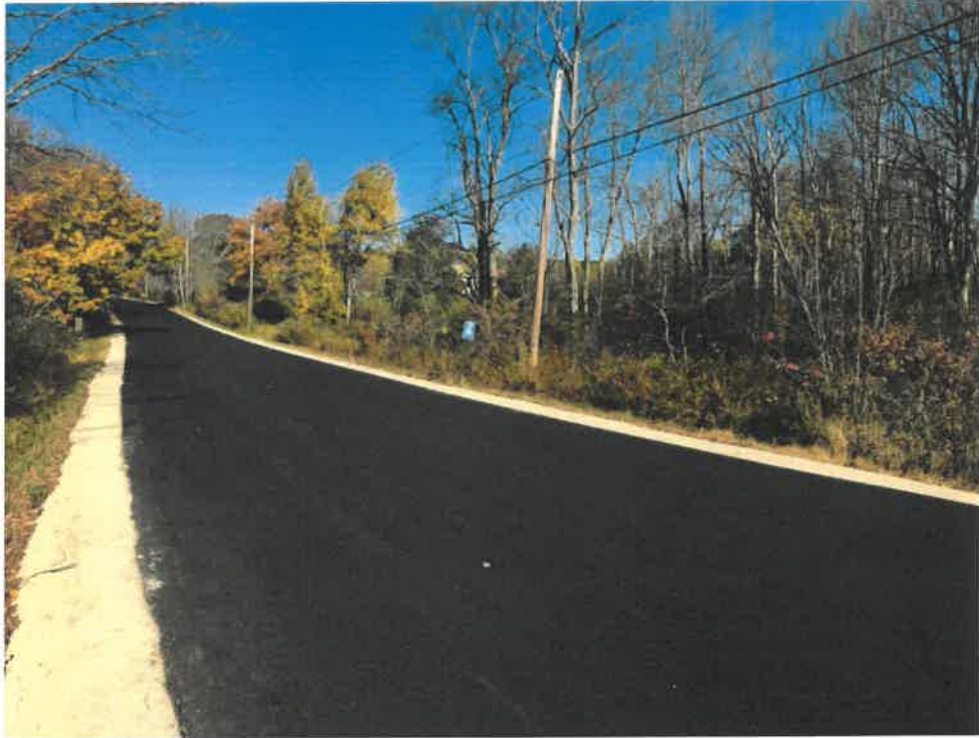
Photo 1 (10-22-18): Facing north at Eastman Road crossing of Trout Brook. Blue sign indicates that the culvert is within the Trout Brook Watershed which is an Urban Impaired Stream. Road freshly paved with new gravel shoulders.

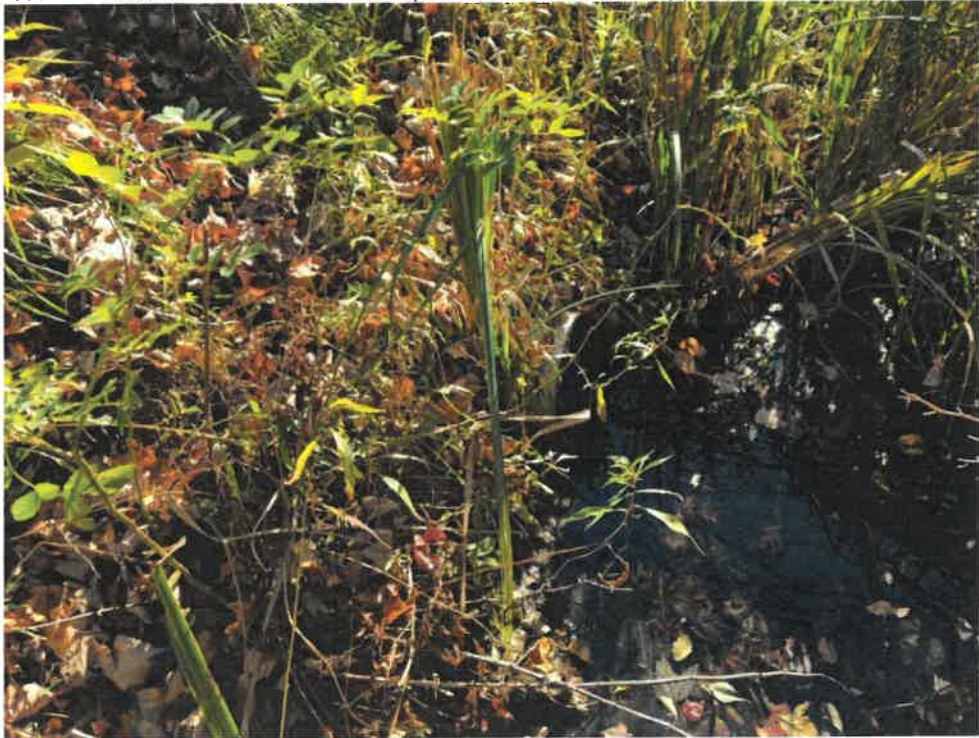
Photo 2 (10-22-18): Submerged inlet of 10-inch polyvinylchloride (pvc) culvert is barely visible due to the standing water and the vegetation surrounding the pipe. No rip rap apron or headwall. Pipe is very shallow and flat which compromises its capacity.

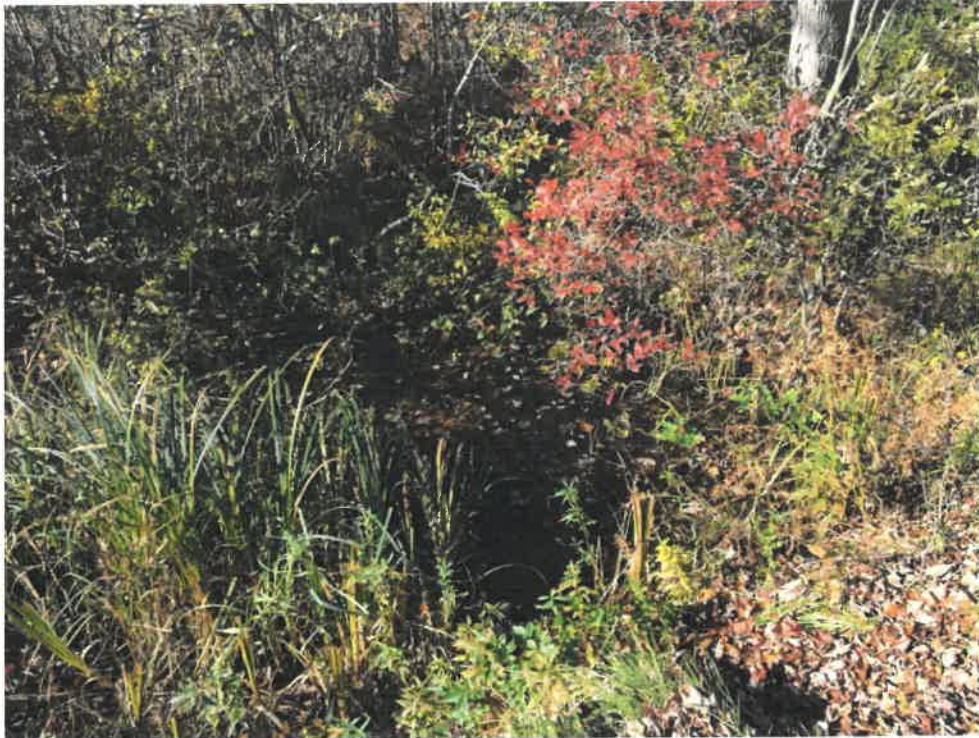
Photos 3 (10-22-18): Facing west at inlet of submerged culvert on west side of Eastman Road and up gradient area flowing toward culvert.

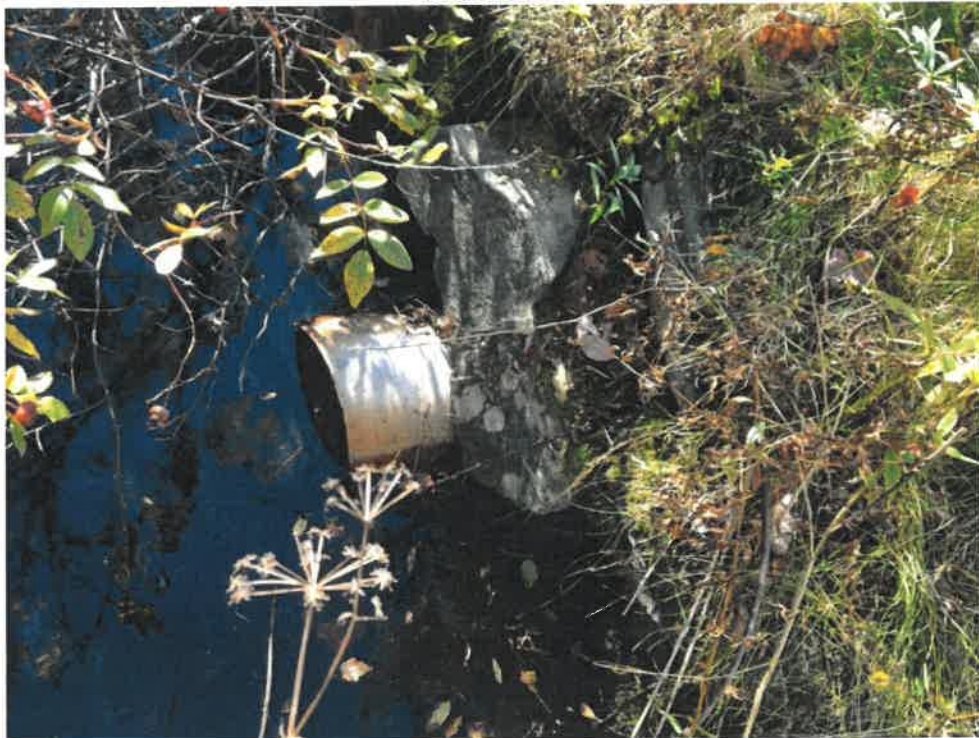
Photo 4 (10-22-18): Submerged outlet of culvert on the east side of Eastman Road. No rip rap apron has been provided. Area around the outlet has thick vegetation and standing water and is not draining well.

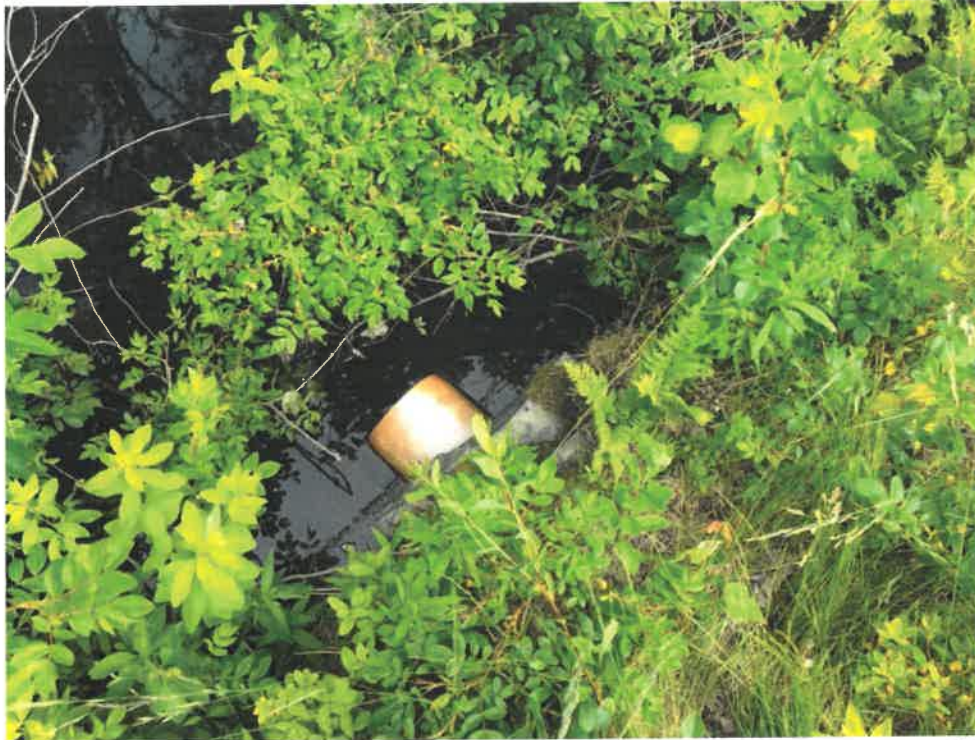
Photo 5 (06-20-18): Overhead view of submerged culvert outlet with a stone placed over the pipe to act as a headwall. Pipe is discolored due to years of exposure to sunlight.

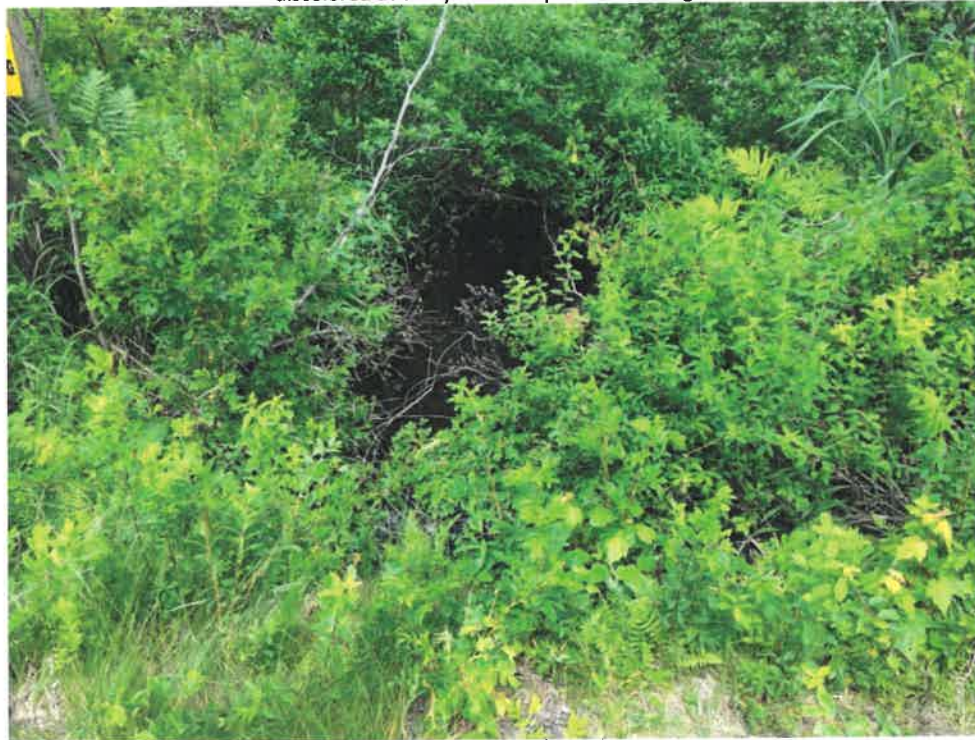
Photo 6 (06-20-18): Facing northeast at the downstream channel of the culvert outlet. Thick vegetation and likely deposited sediment within the channel create standing water with a very slow flow rate.

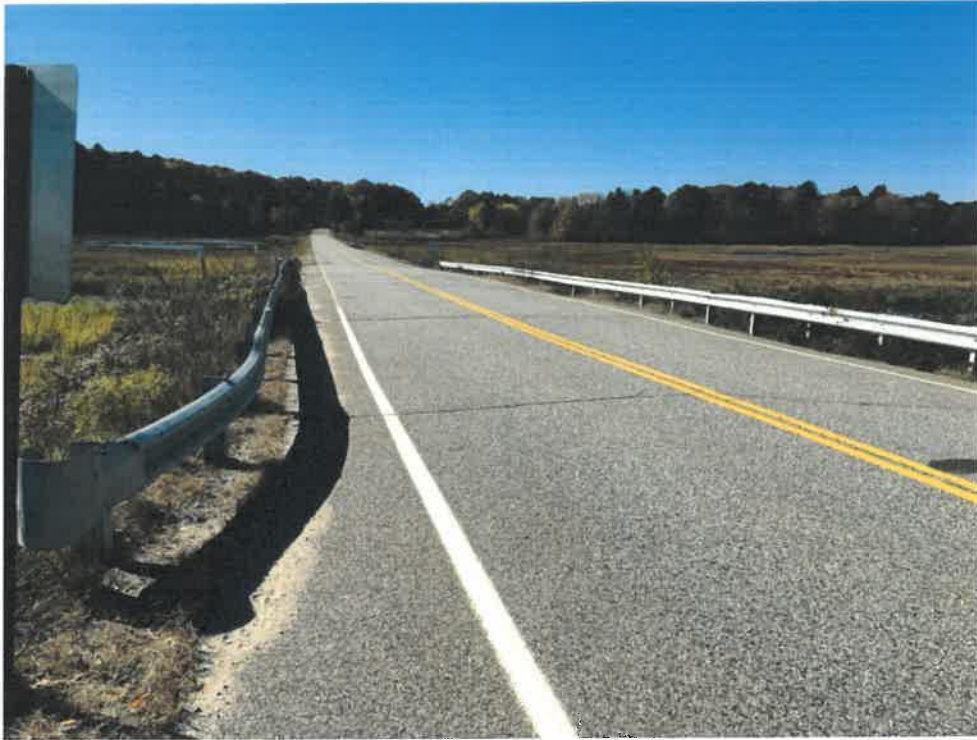
Photo 1 (10-22-18): Facing southwest at Sawyer Road culvert crossing. Road routinely floods beyond culvert crossing at low area of roadway elevation.

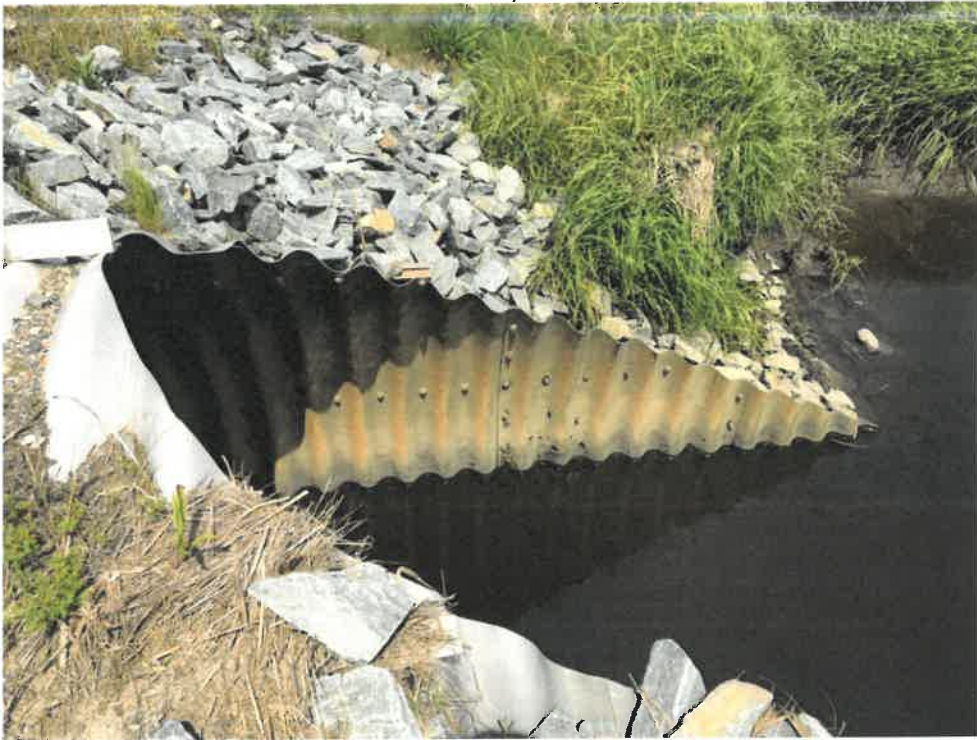
Photo 2 (06-20-18): Submerged inlet of 10.5-foot wide by 11.5-foot tall corrugated aluminum elliptical pipe with flared end and rip rap headwall on east side of Sawyer Road. Additional headwall rip rap should be added to the headwall.

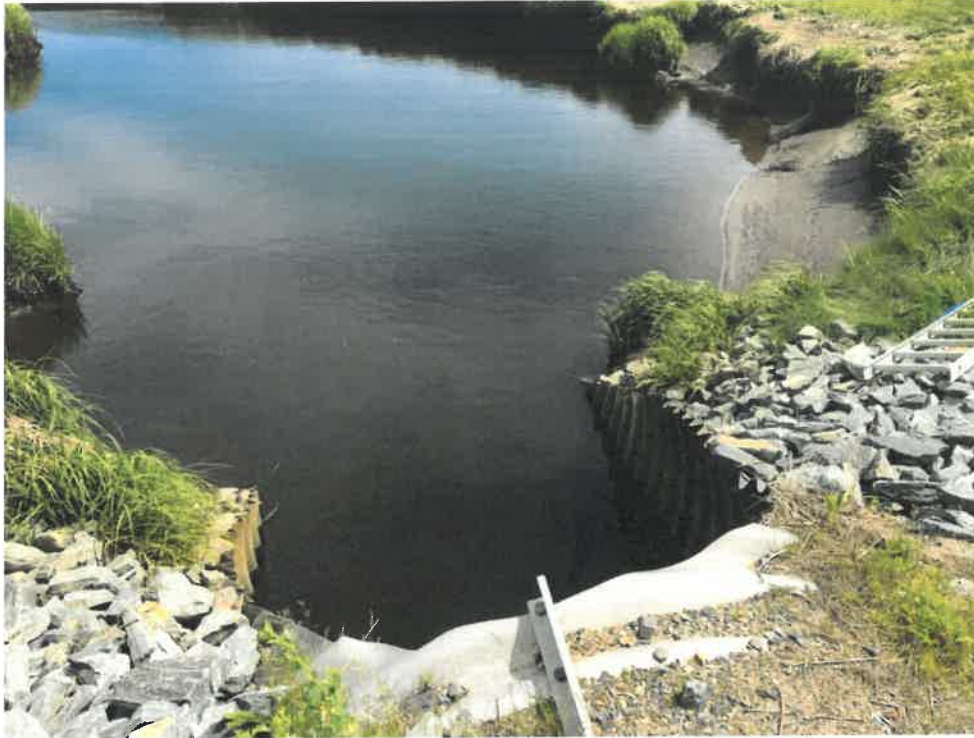
Photo 3 (06-20-18): Overhead view of the culvert inlet with tidal channel flow of the Spurwink River upstream of the culvert.

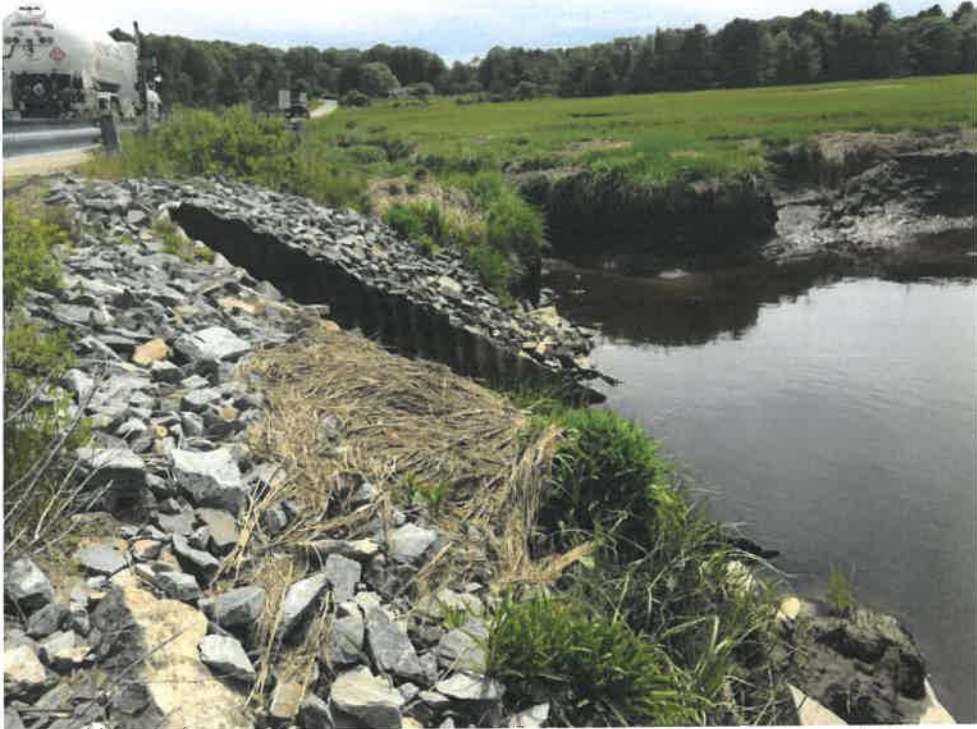
Photo 5 (06-06-18): Submerged outlet of the aluminum elliptical pipe with flared end and rip rap headwall on the west side of Sawyer Road. Quantity of rip rap appears to be sufficient on the outlet area around the culvert.

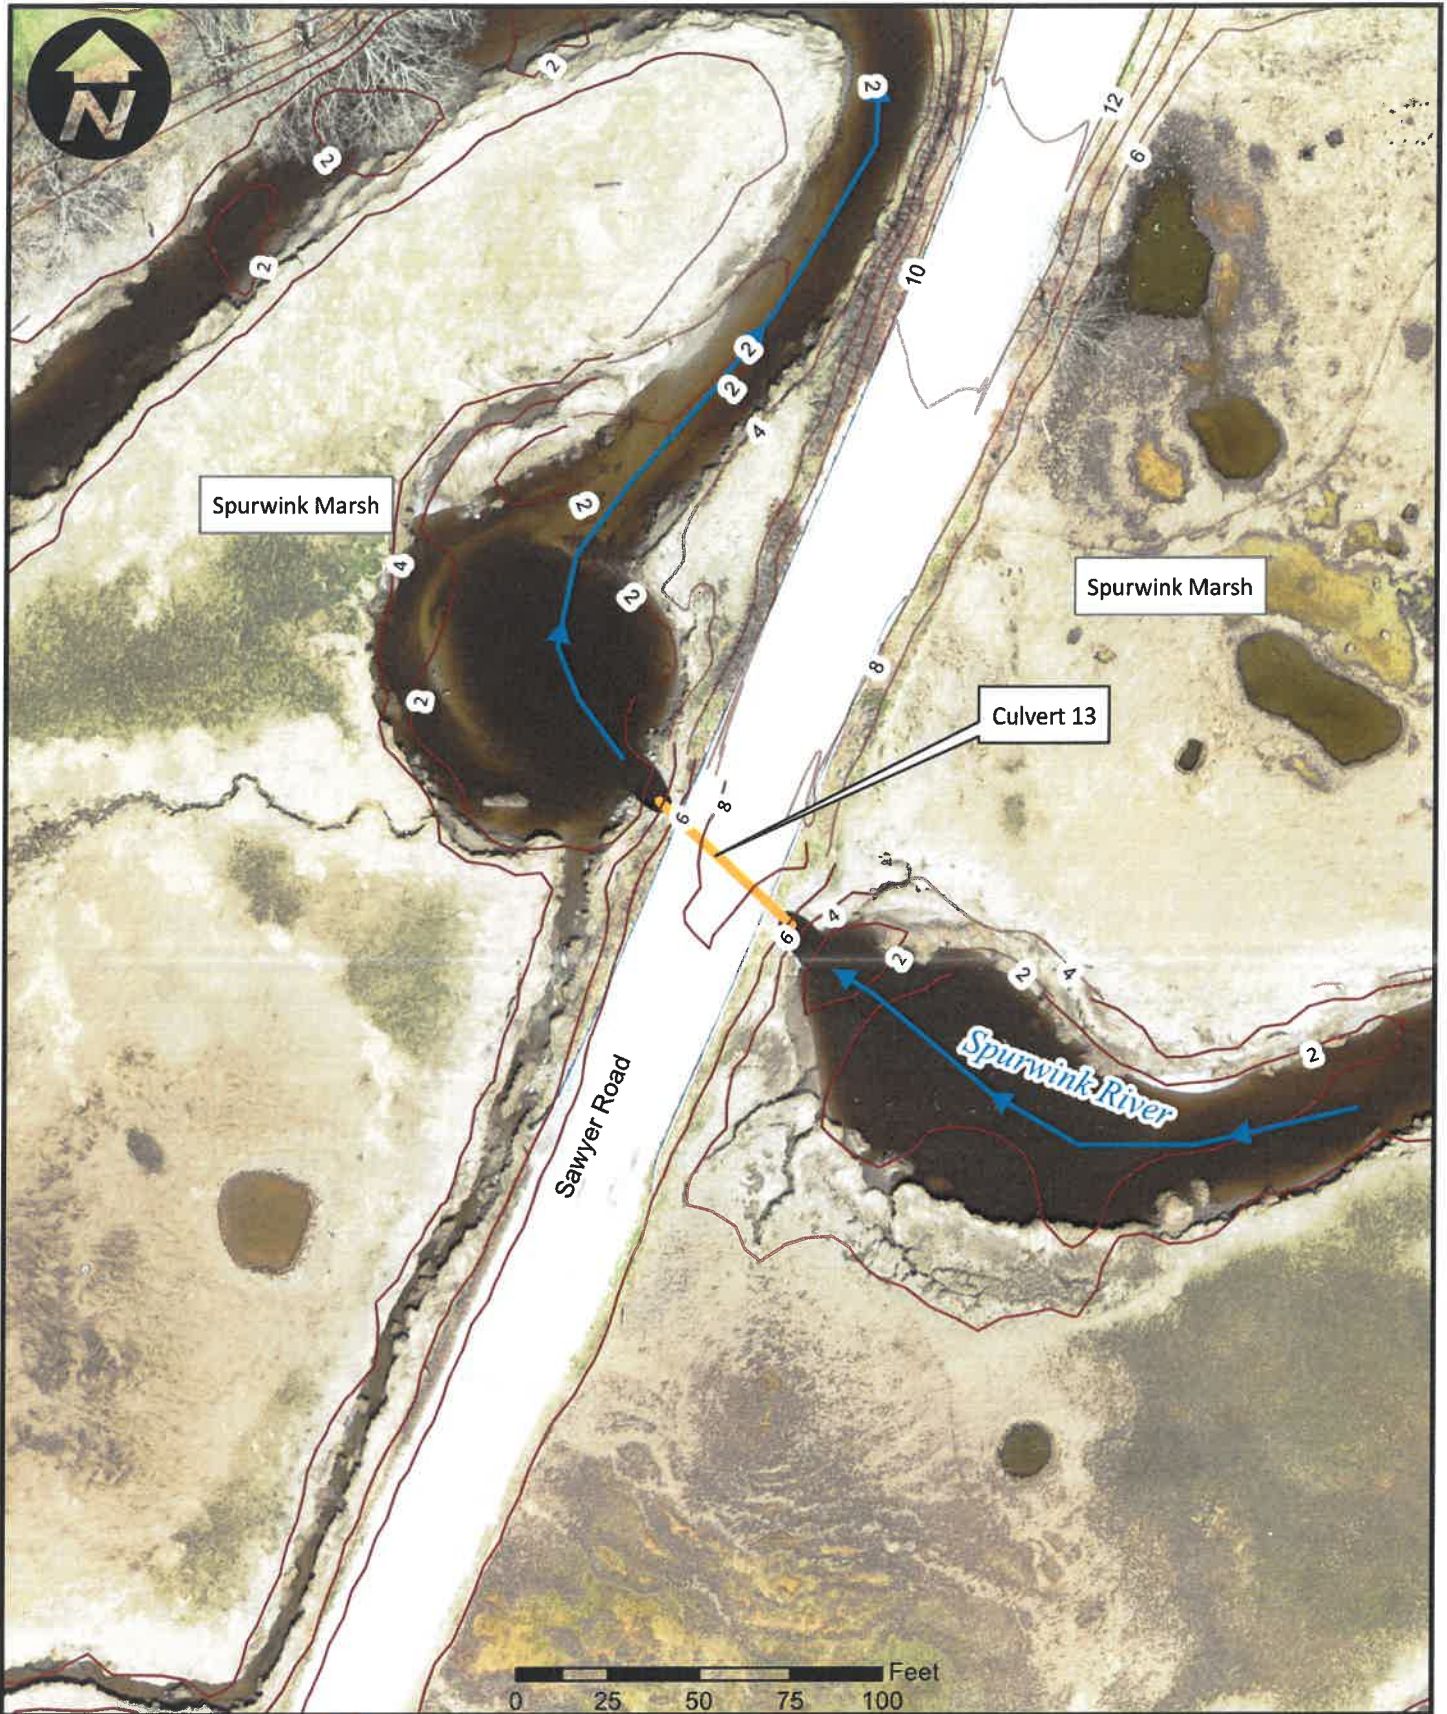
Photo 9 (10-22-18): Facing north during high tide of the Spurwink Marsh pooling on both side of Sawyer Road. Sawyer Road floods often during intense weather and tide events in the foreground of the photo as the road elevation is lower than at the culvert crossing which the inlet to the Spurwink River culvert is visible on the right side (east) of Sawyer Road.

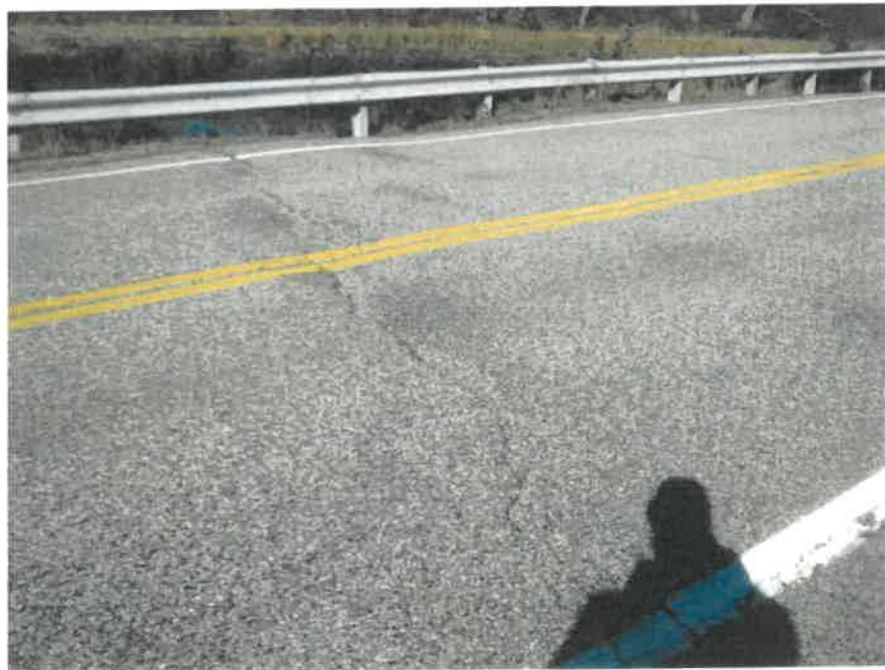
PHOTO 4

Pipe itself in generally fair condition w/minor deflection of southerly side. corrosion along bolt line. Dive inspection found holes along top plate. Embankments have both eroded, beginning to effect shoulder pavement (photo). Pavement is cracked and opened up over center line of pipe. Fill has washed away from sides of pipe making it a high point allowing the pavement to break over the top. Additional rip rap is necessary to prevent further erosion. Pavement is worn and may need replacement over pipe. Too deep to wade see latest dive report.

Description View showing crack in pavement above pipe

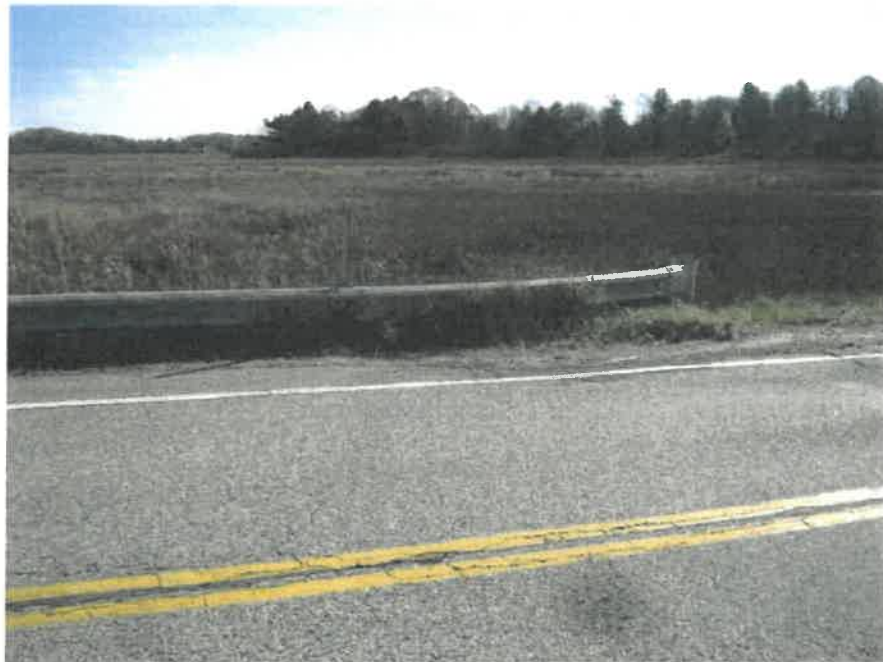
PHOTO 6
Description View showing low approach rail

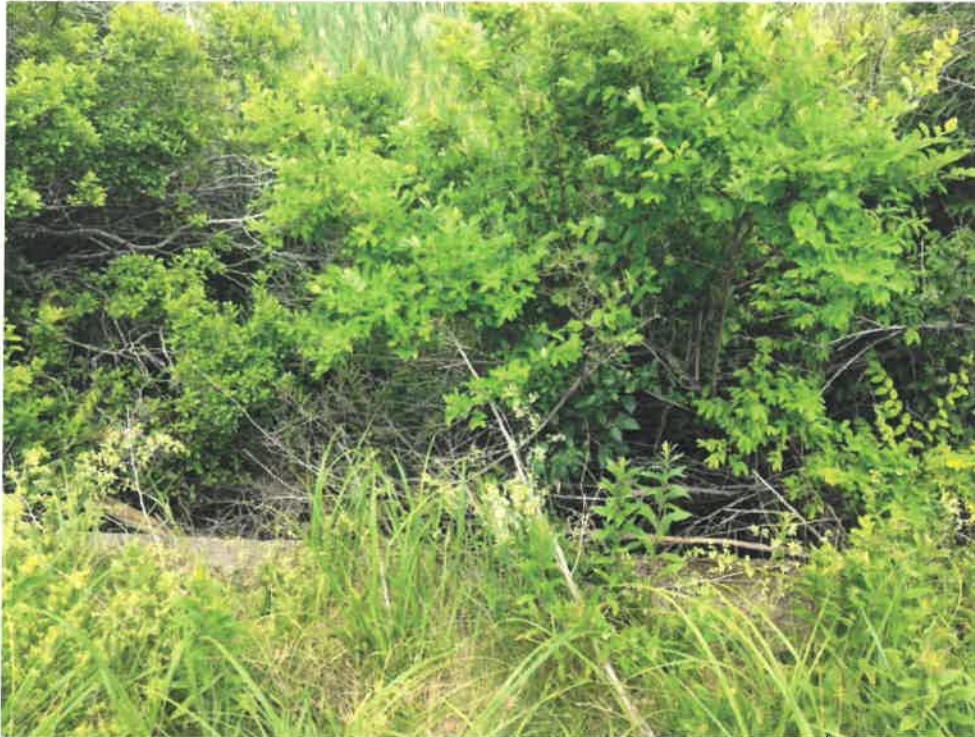
Photo 3 (06-20-18): Facing east at granite headwall of the culvert inlet with thick vegetation blocking the inlet area of the culvert. Providing a rip rap apron at the inlet would control vegetation from blocking the inlet.

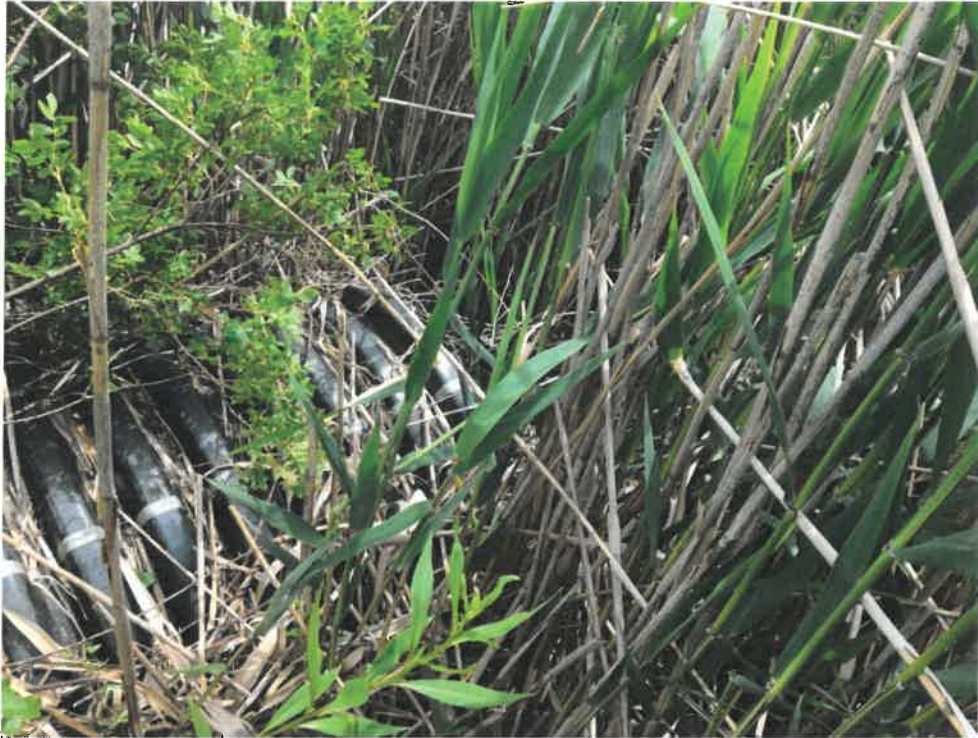
Photo 5 (06-06-18): Submerged outlet of the HDPE pipe on the west side of Sawyer Road. Thick vegetation around the end of the culvert could be better controlled with a rip rap apron.
