Cape Elizabeth Culvert and Habitat Assessment Study

March 22, 2019

This report was prepared for the Town of Cape Elizabeth by Sebago Technics, Inc., the Wells National Estuarine Research Reserve, the Casco Bay Estuary Partnership and the Town of Cape Elizabeth under award CZM NA17NOS4190116 to the Maine Coastal Program from the National Oceanic and Atmospheric Administration, U.S. Department of Commerce. The statements, findings, conclusions, and recommendations are those of the authors and do not necessarily reflect the views of the National Oceanic and Atmospheric Administration or the Department of Commerce.

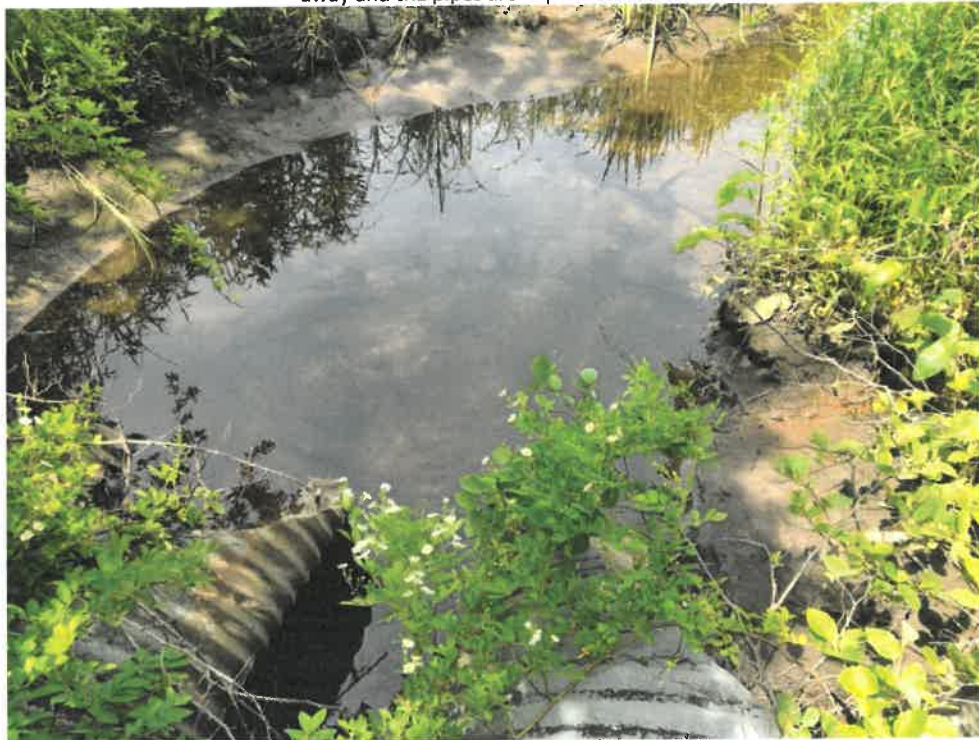
Photos 3 (10-22-18): Looking down the barrel of the westerly inlet of the two Inlet culverts. Culverts' inlet invert has rusted away and the pipes are in poor condition.

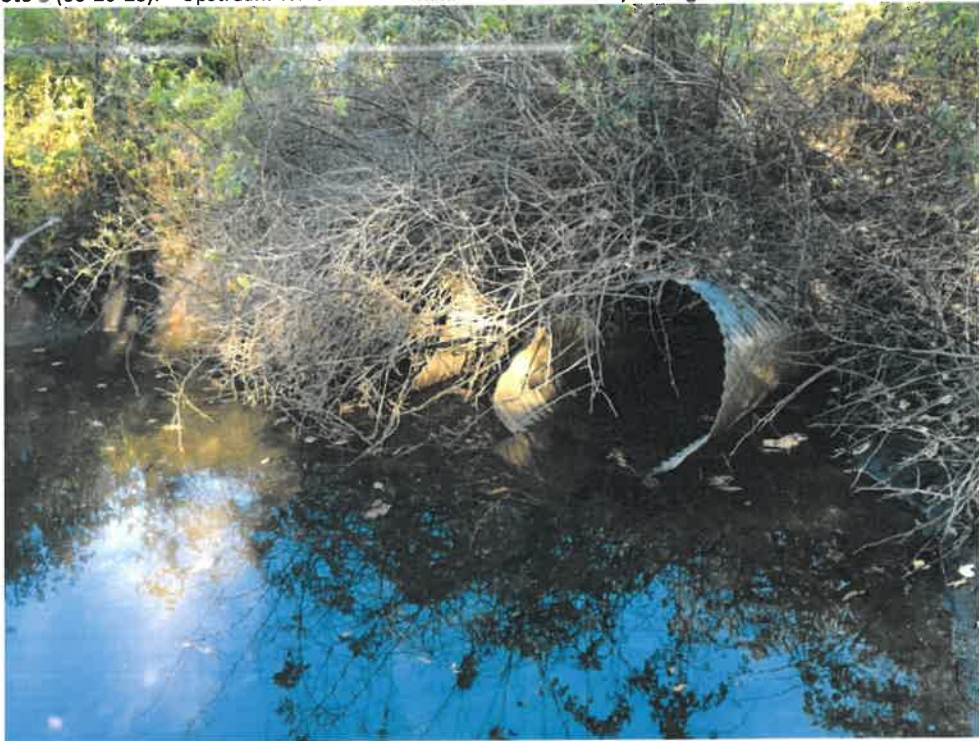
Photo 6 (10-22-18): One of the outlets of the culverts on the south side of the embankment is obscured by vegetation and partially buried in sediment. Outlet has some stone in the channel, but no formal plunge pool or visible headwall.

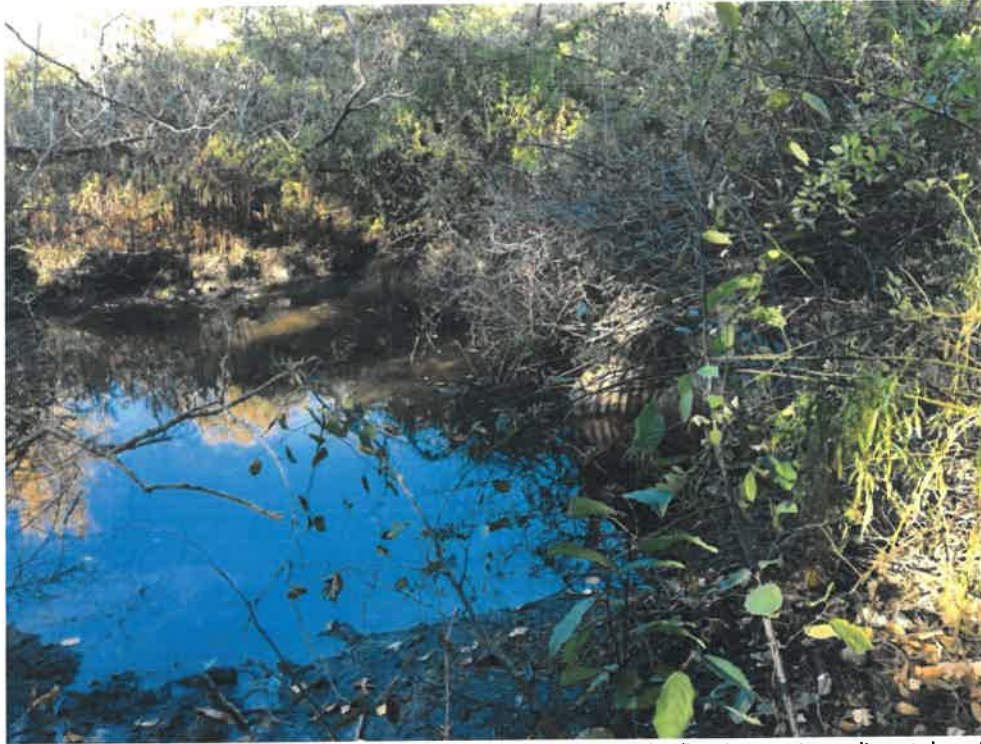
Photo 7 (10-22-18): Downstream channel of Willow Brook from the culvert outlet flow has marine sediment deposits from the tidal marsh.

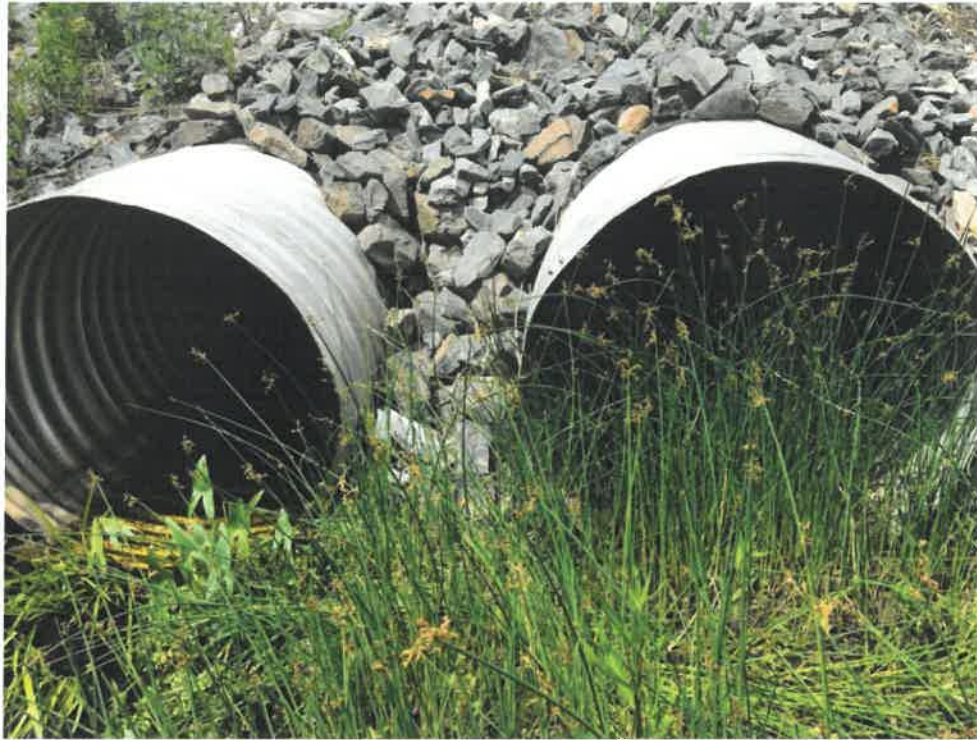
Photo 5 (06-20-18): Outlet of culverts on the south side of Scott Dyer Road. Westerly (left) pipe is set lower and carries the primary flow. Easterly culvert is partially blocked by vegetation.

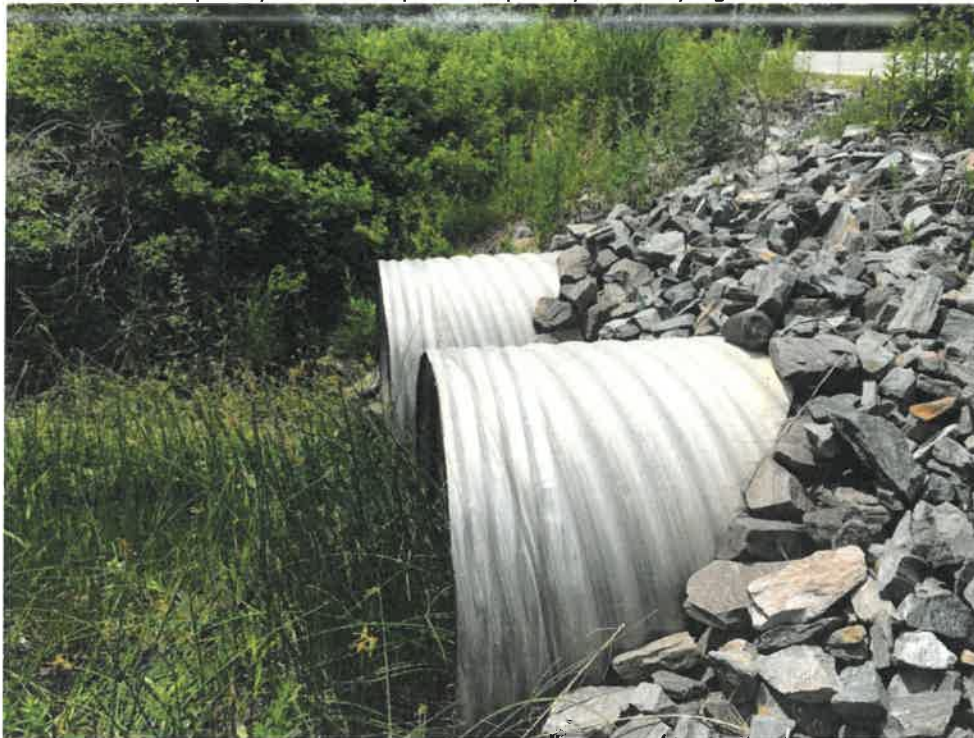
Photo 6 (06-20-18): Culvert outlet discharge of Willow Brook on the south side of Scott Dyer Road. Some limited vegetation removal and rip rap at the end of the easterly pipe would ensure that its capacity is not compromised by additional vegetation growth.

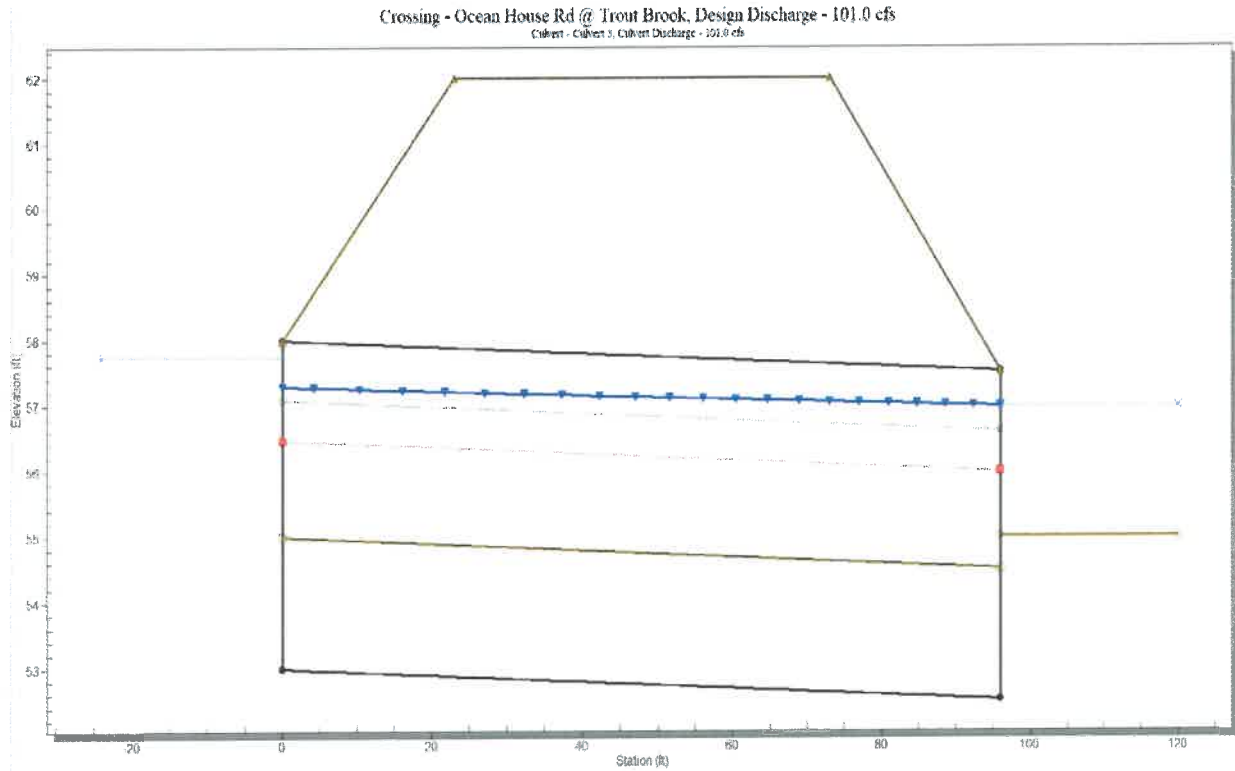
Figure 1. Q100 Headwater (Hw) elevation relative to culvert Depth (D).

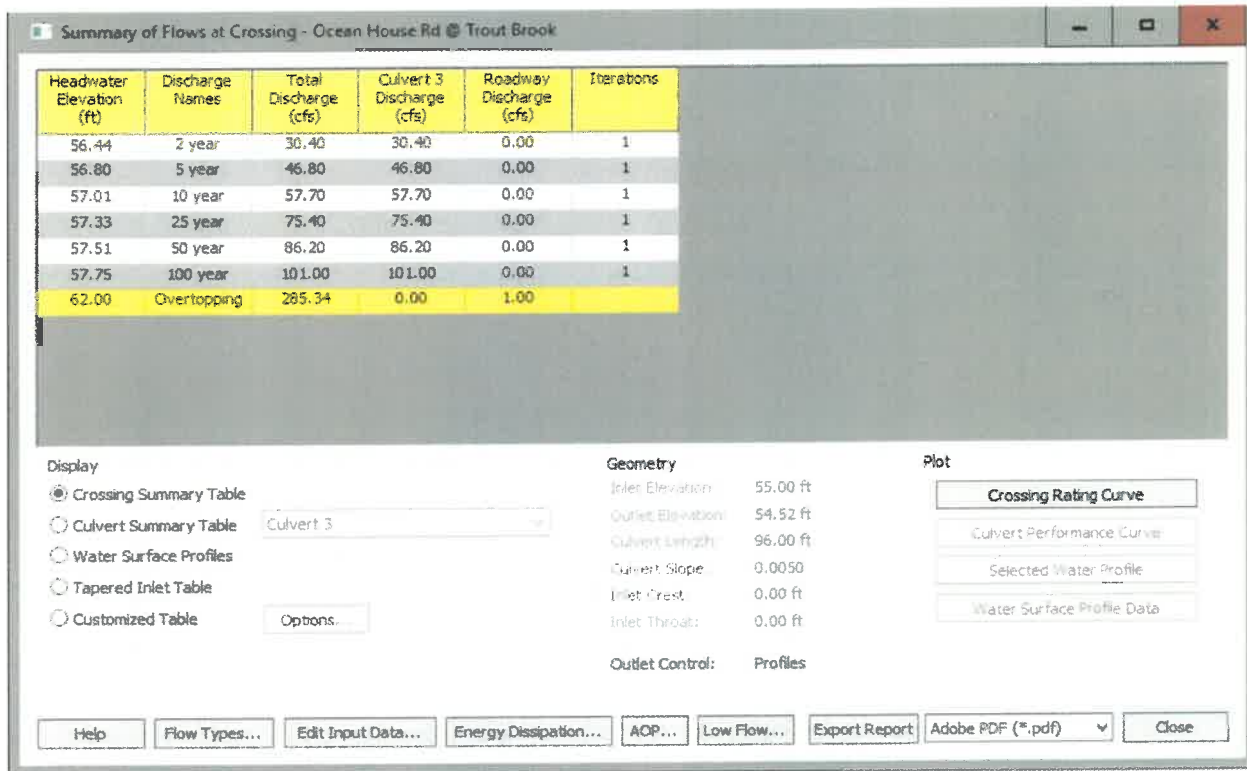
Figure 2. Summary of Flows at crossing.

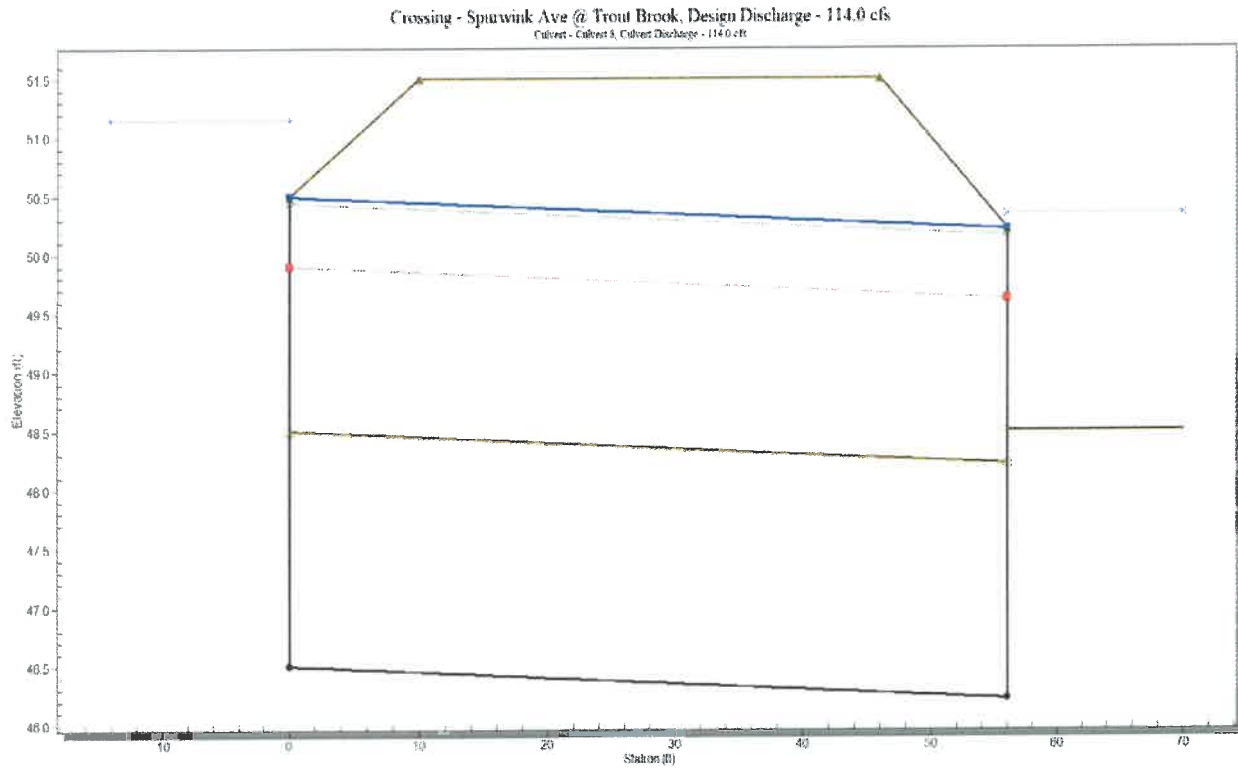
Figure 1. Q100 Headwater (Hw) elevation relative to culvert Depth (D).

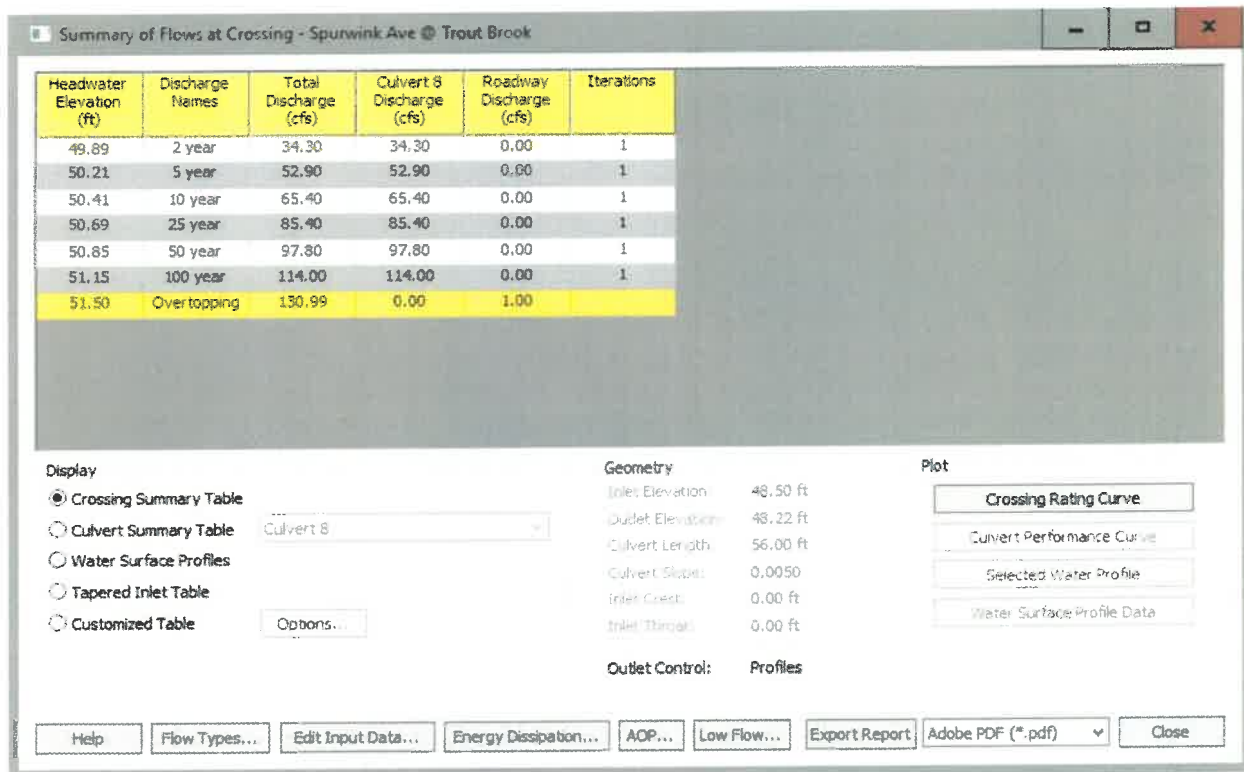
Figure 2. Summary of Flows at crossing.

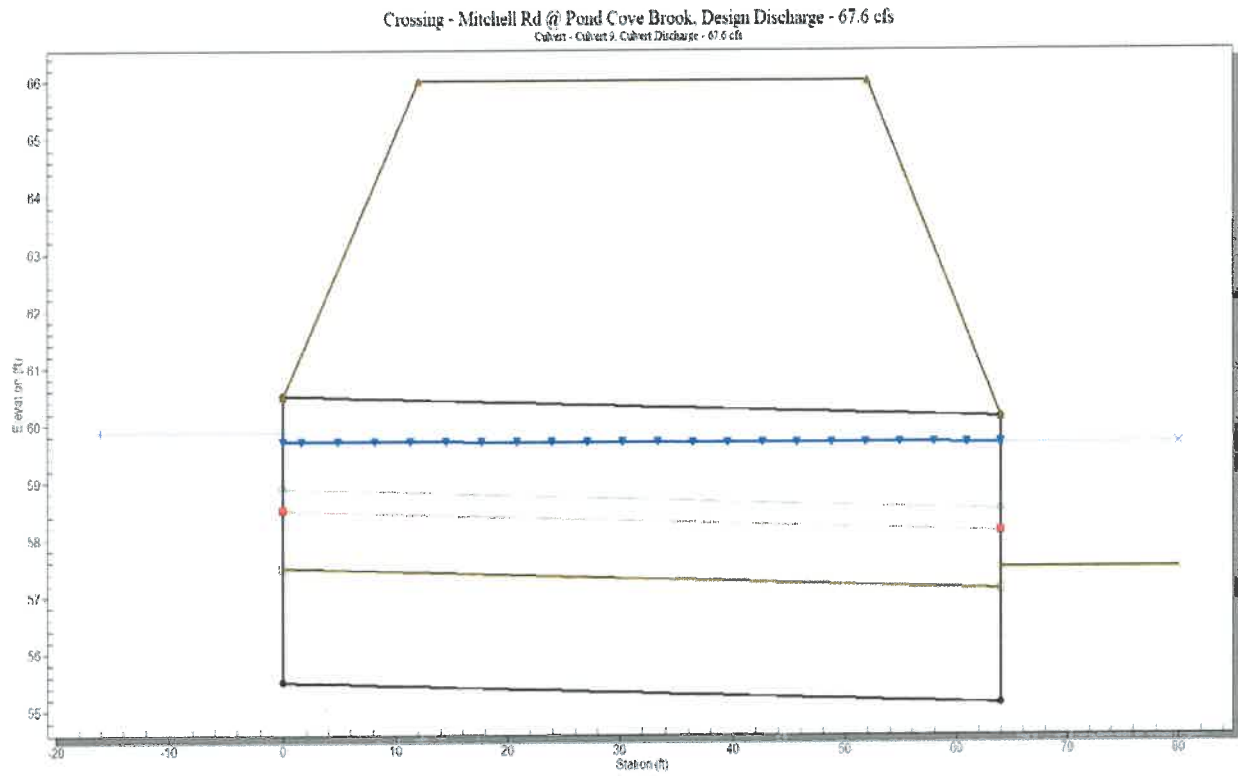
Figure 1. Q100 Headwater (Hw) elevation relative to culvert Depth (D).

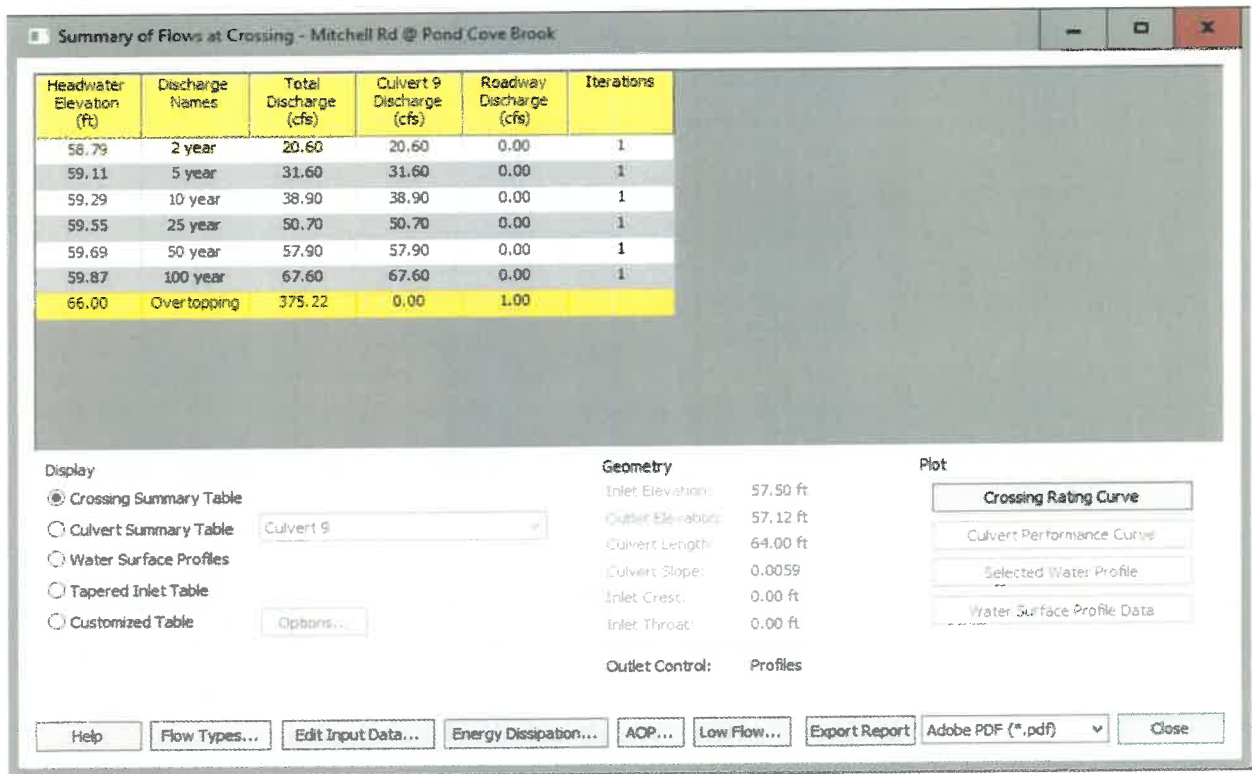
Figure 2. Summary of Flows at crossing.
