Fort Williams Projects Final Report

**Main Entrance Gate
Interpretive Signs at Battery Knoll
Bleachers
Batteries
Goddard Mansion**

March 26, 2009

Re: Fort Williams Projects – Final Report

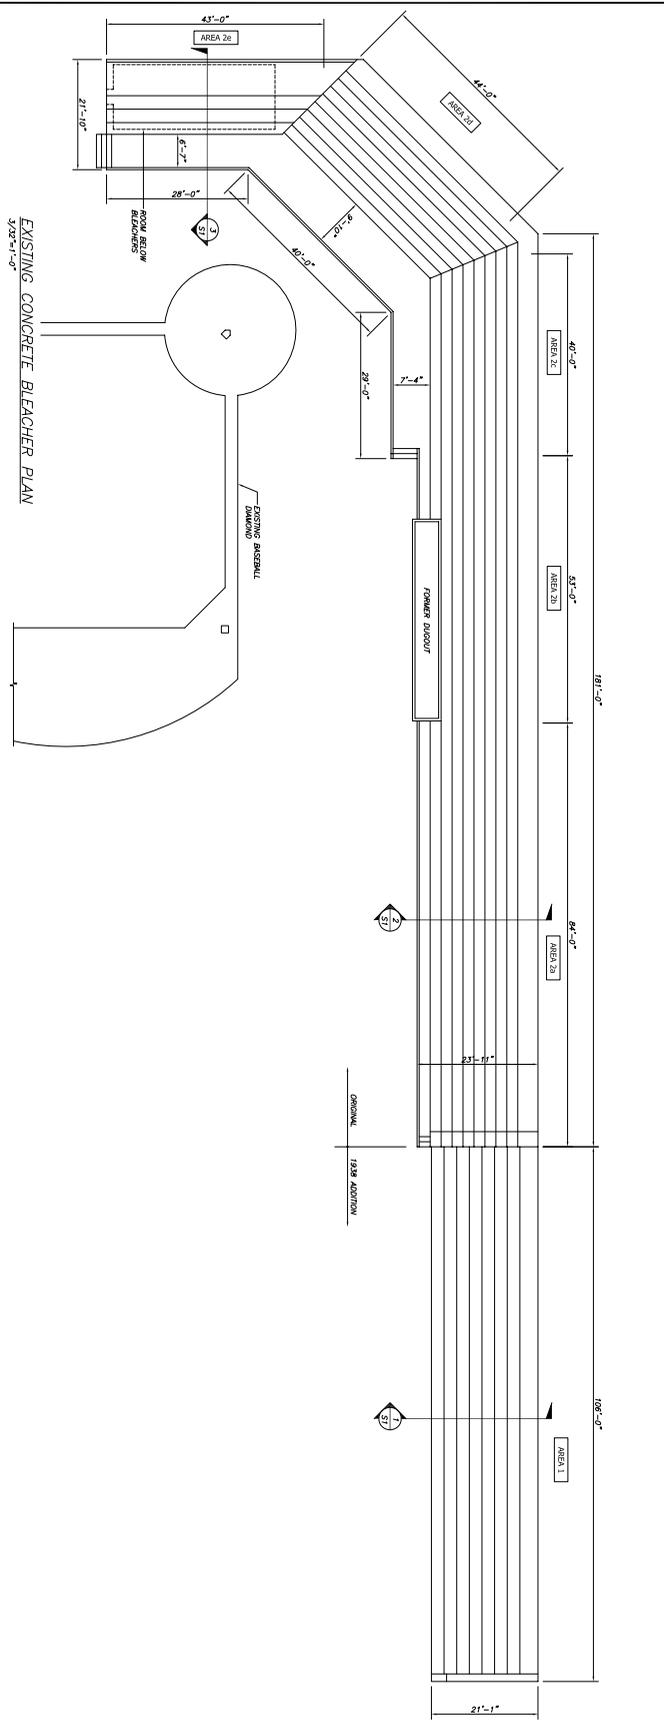
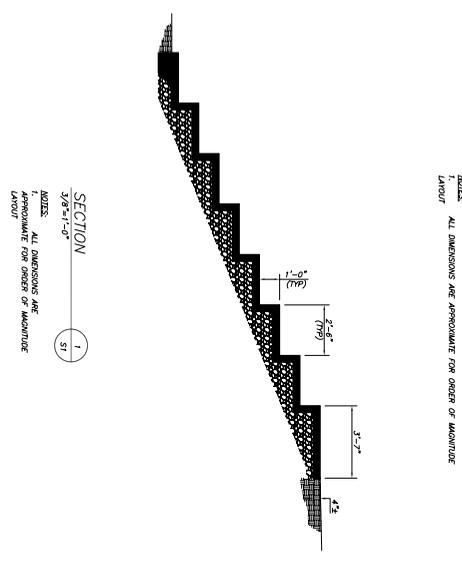
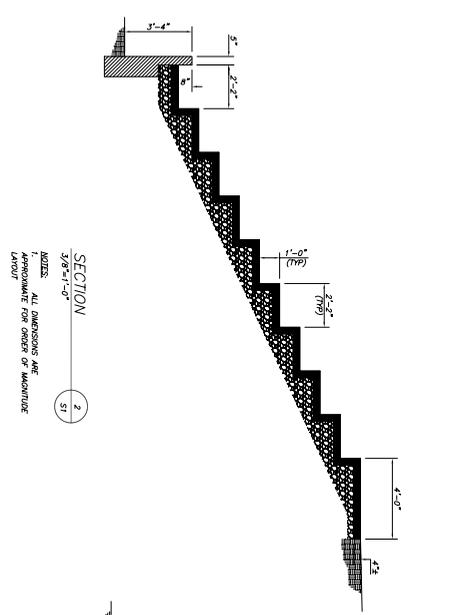
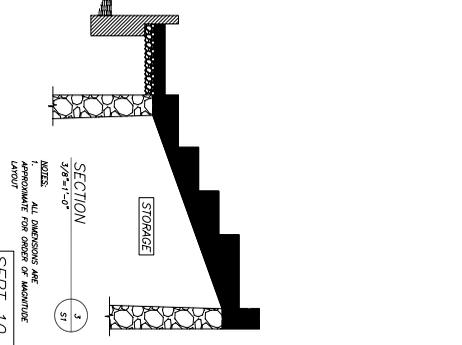
CONCRETE BLEACHERS - EXISTING CONDITIONS

We have concluded our field evaluation of the existing concrete bleachers at the site of the former parade grounds. The former parade grounds have been converted to a Little League baseball field. Our evaluation was directed at determining the practical and economical viability of repairing the existing concrete elements to provide a safer and more enduring feature.

Our field investigation included visual observations of the concrete section, probing of the cementitious coating applied approximately 10 years prior, and consultations with concrete repair contractors with whom we have collaborated on other projects, specifically the repair of concrete parking structures. Open parking structures are subjected to continuous exposure to the elements, thermal gradients and high levels of de-icing salts; some of the most severe long-term conditions a structure may face and this experience flavors our perspective regarding the bleacher evaluation. In addition to our observations and discussions we removed three concrete cores from the riser portion of the bleachers. One core was broken in the lab to evaluate the strength of the concrete. Another core was sent to a laboratory in Ohio for petrographic analysis. The core is sliced wafer thin and analyzed under a high powered microscope to evaluate the properties of the existing concrete.

In considering the removal and replacement option, the extent of replacement is also in play. It seems the existing bleacher can be demolished and a new smaller bleacher constructed in its place. The extent of the new bleacher would include the area surrounding the ball field backstop and include replacement of the underground storage room. The balance of the old bleacher, extending to the water can be left as a graded and grass covered slope which could serve as an on ground seating area for amphitheatre type events.

Based on our initial cost evaluation, it will be less costly or perhaps the same cost to pursue the removal and replacement option which will provide an enduring, relatively maintenance free seating option which can incorporate ADA accessibility and improved safety and access.

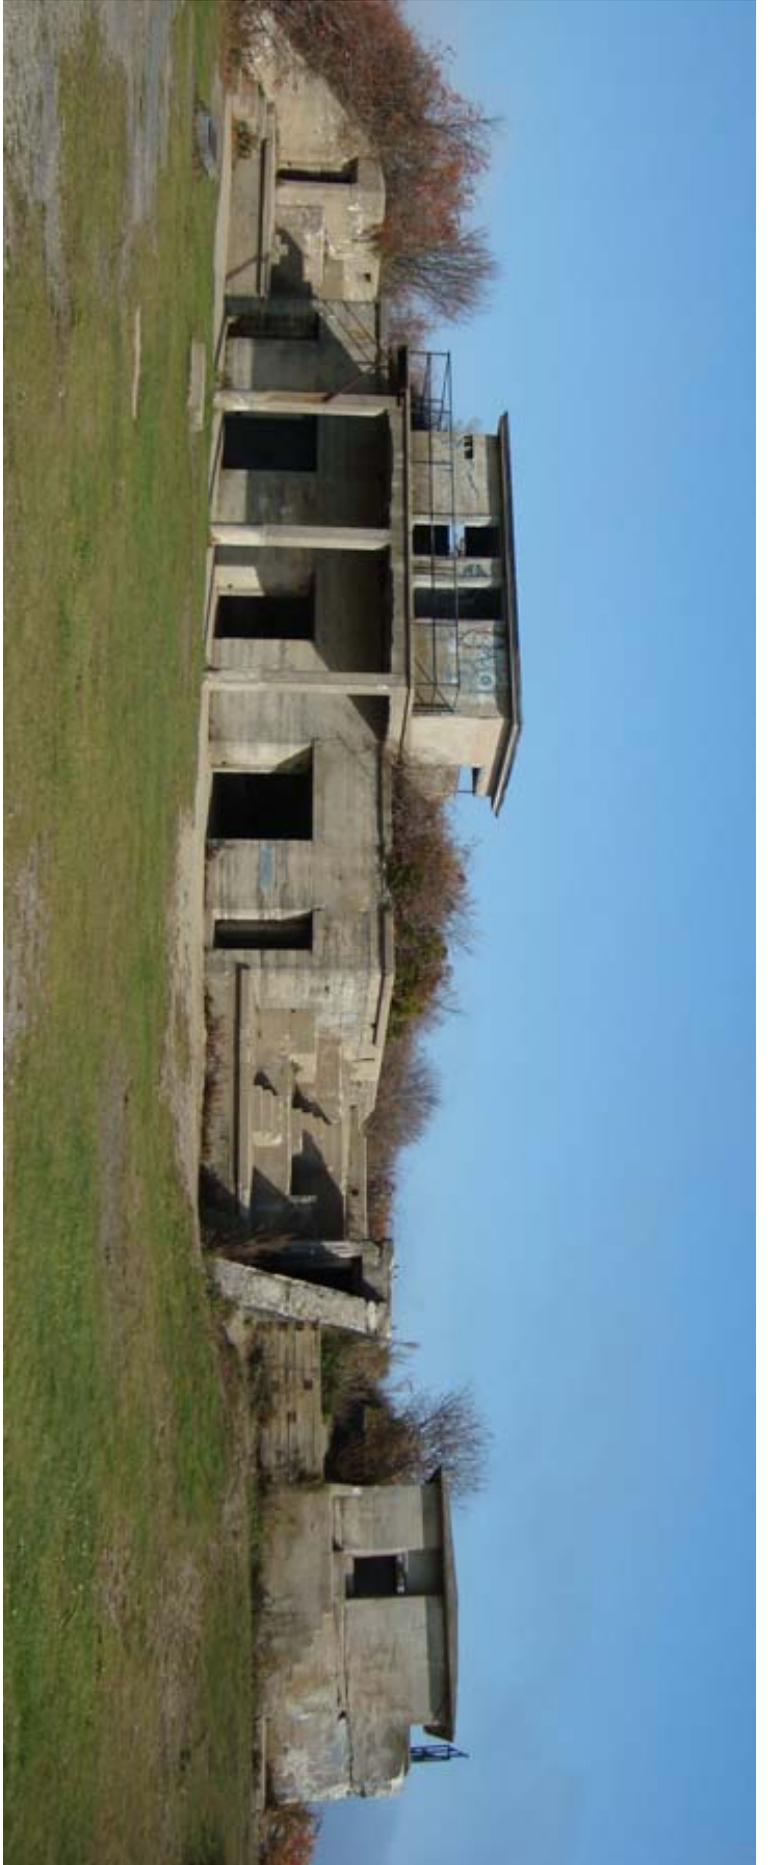
BATTERY KEYES

Observation began to the right (when viewed from roadway) of the Battery complex at the CRF Station building. The roof of the building was found to be a sloped monolithic steel reinforced concrete slab supported by steel beams on 3 sides and concrete bearing wall on 1 side. The drip edge of the slab was observed to be spawled and extremely weathered with exposed reinforcing steel. A crack in the slab was observed to extend the entire width and thickness of the slab. The crack was located where the bearing transitions from steel beam to concrete bearing wall.

Steel I-beams supporting the roof slab were found to be extremely corroded. Severe scaling of the flanges and webs was observed over the majority of the beam spans with numerous locations of holes present in the beam web. Gaps were observed between the beams and the roof slab around a majority of building. Steel beams were found to be supported by small diameter steel pipes at two locations and concrete bearing walls at two locations. Steel pipes were observed to be skewed from plumb and extremely corroded at the top and bottom with the field of the pipe showing no significant signs of corrosion. Beams appeared to be mitered at corners supported by pipes with the connection between beams exhibiting severe corrosion.

Exterior bearing walls and site walls were found to be constructed of cast-in-place steel reinforced concrete. Cracks were found throughout the walls along with areas where concrete was spawled. Previously performed repairs of spawled locations were observed at numerous locations. In some cases the repairs were found to be spawling as well.

Stairs leading to the entry of the structure that were 30 inches above grade or more were found to lack a railing creating a safety concern. Also, at the retaining wall to the side of the station building, intermediate balusters to restrict a 4 inch diameter sphere from passing per applicable codes were observed absent. The entry itself was found to possess spawling concrete in the threshold and cracks were observed at the lintel over the entry. The steel casing at the entry was found to be completely corroded in locations such that no casing remained at all.

The Mine Observation Station was observed atop the original Battery. The observation station is comprised of two unique structures; the station building and a deck that wraps around the building to provide access.

The station building roof structure was not able to be observed at the time of the visit. The roof appeared to be supported by walls on 3 sides and a beam of unknown size or material that spans over an opening on the Oceanside. A post at one end and center of the opening were observed with the post at the other end observed to be missing with nothing supporting the roof corner. Below the opening on the Oceanside wall of the building appeared to be a cast-in-place concrete retaining wall from which the two posts are supported. The balance of the buildings' walls appears to be constructed of wood studs with a cementitious finish on metal lathe both interior and exterior. Access to the wood studs was limited, however the studs observed were found to be weathered and exhibited possible signs of deterioration. The cementitious finish was found to be cracked over a majority of the wall surface.

The cast-in-place reinforced concrete deck slab appeared to possess numerous cracks running between supporting members. Supporting members consist of five equally spaced reinforced concrete beams. The bottoms of the beams are severely spawled with corroded reinforcing steel exposed at four beams and the deck reinforcing is exposed and corroded at many locations. The concrete beams are supported on one end by the battery wall and by reinforced concrete girders on the other. Corroded reinforcing steel is exposed at both girders due to severe spawling as well. Girders span between reinforced concrete columns that are presumably founded on ledge. Columns appeared to be sound with no significant damage.
