**Town of Cape Elizabeth**  
Seven Building Facility Study  
*Cape Elizabeth, Maine*

HARRIMAN | Architects + Engineers

**Introduction****Town of Cape Elizabeth Facilities Study**

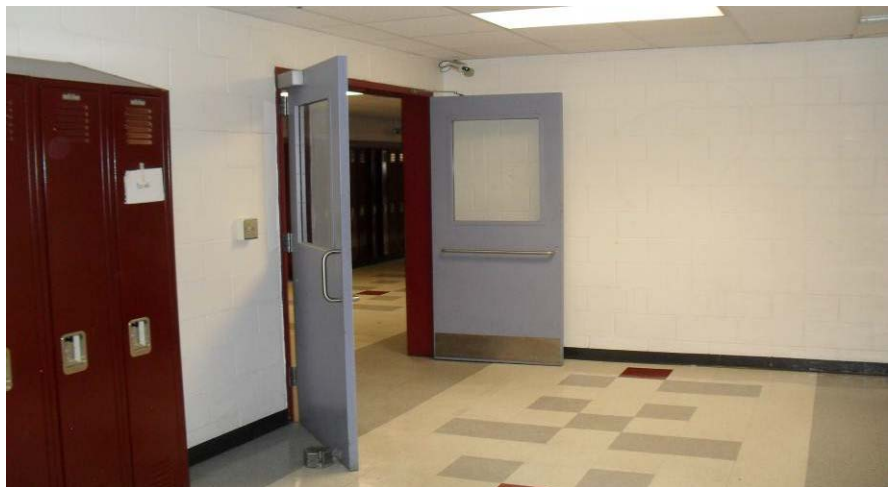
*Cross Corridor Doors*

On the second and third floor corridors at the midpoint of the floor there is a set of cross corridor doors that swing in one direction. As they are constructed they constitute a dead corridor from one direction and violate the Life Safety Code for egress in a northerly direction. Recommend removal of the doors and leave frame to eliminate code violation.

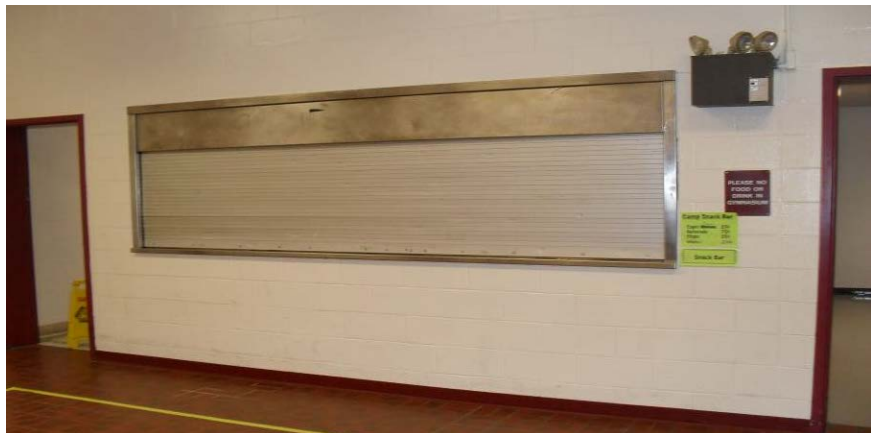
*Concession Serving Window*

Concessions serving window is not ADA compliant, existing is too high. Maximum height to counter line should be 34". Recommend lowering existing unit in place or install a new unit at a lower height.

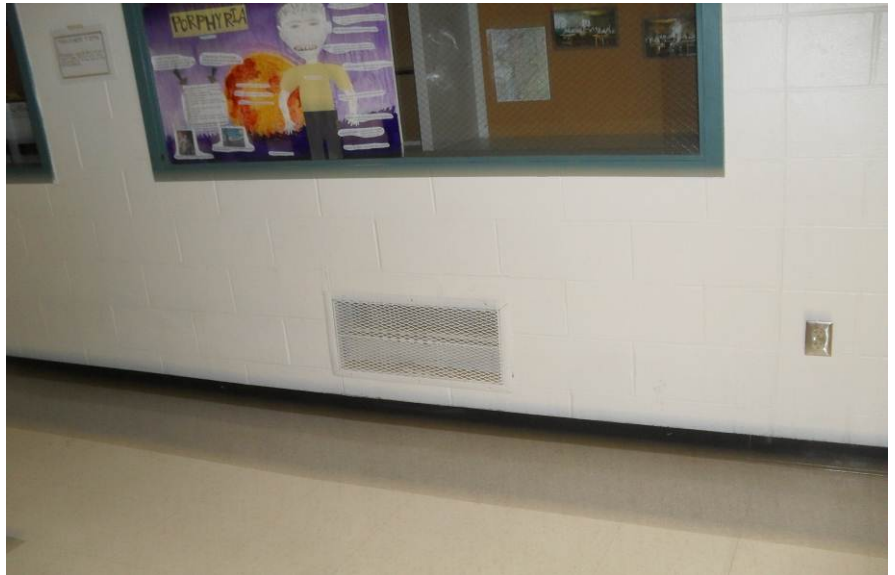
*Wall Transfer Grille*

Transfer grilles through walls and doors. Transfer of make-up air for exhaust through this type of grille installation is no longer allowed by Life Safety Code from a means of egress corridor. The through wall grille has a fire damper with a fusible link on it. We would recommend the installation of a smoke damper tied to the fire alarm system as a correction method. The grille in the door would have to be blocked up and a new transfer installed overhead with a smoke damper.

The Life Safety Code puts a lot of emphasis on protecting the exit access corridors from smoke penetration.

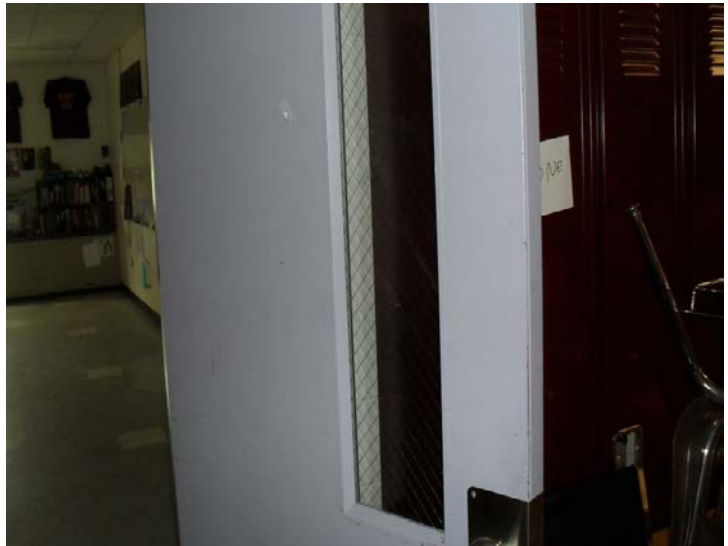
*Doors – Glazed Panels  
of Wire Glass*

Most of the existing glazed panels in the doors have a polished wire glass panel. This type of wire glass in doors and or borrowed lite panels is not allowed per current IBC Building Code. At the time of replacement, new glazing should be laminated glass tempered as required by current code.

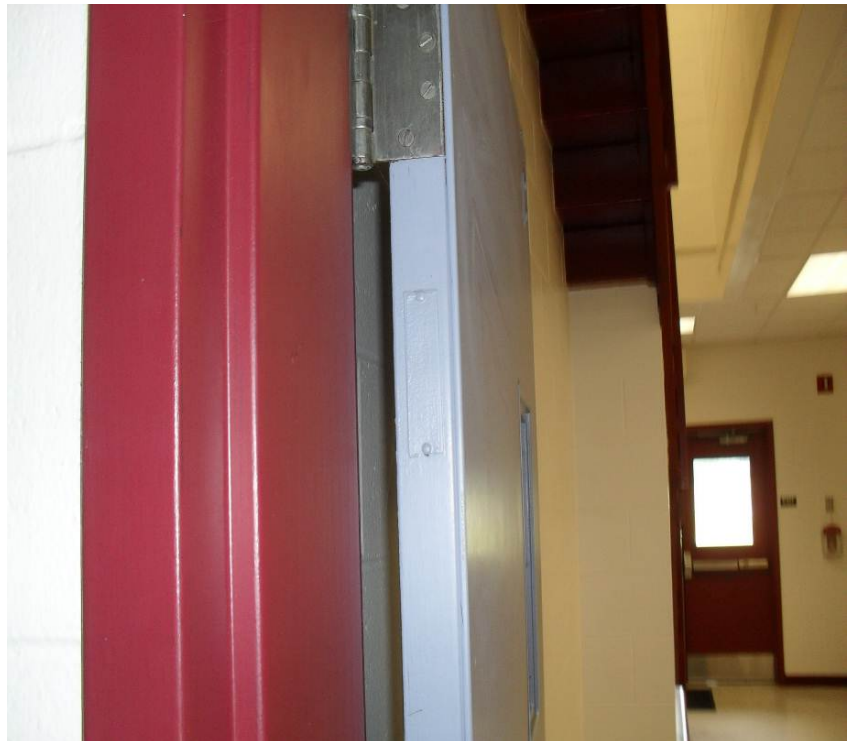
*Doors – Painted Fire  
Rating Label*

Most of the rated door assemblies on stairwells and other locations had the Rated Fire Label painted over. IBC Building Code and fire departments require that these labels not be painted over for inspection purposes.

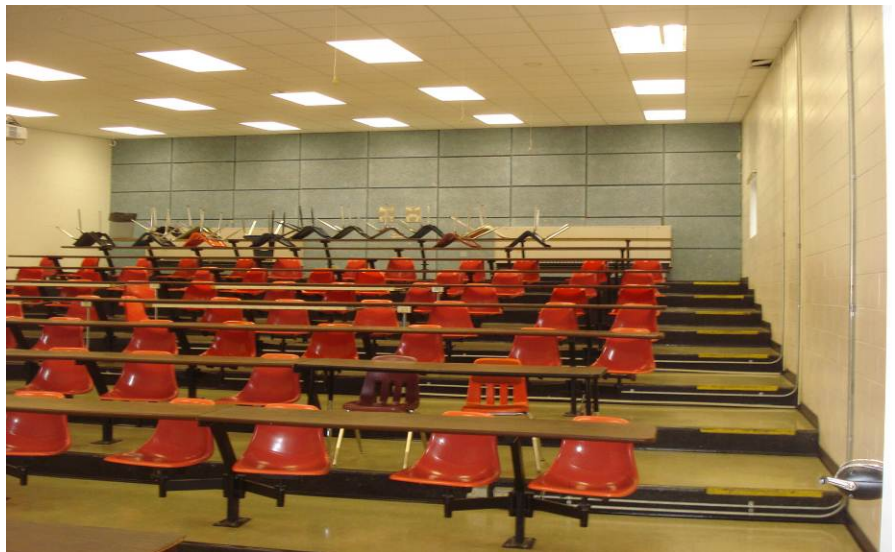
*Lecture Room – Raised Seating Area*

Third floor lecture room is not in compliance with ADA for wheelchair accessibility to raised seating areas. Recommend modification of low stepped seating area with ramp and platform accessibility by a wheelchair.

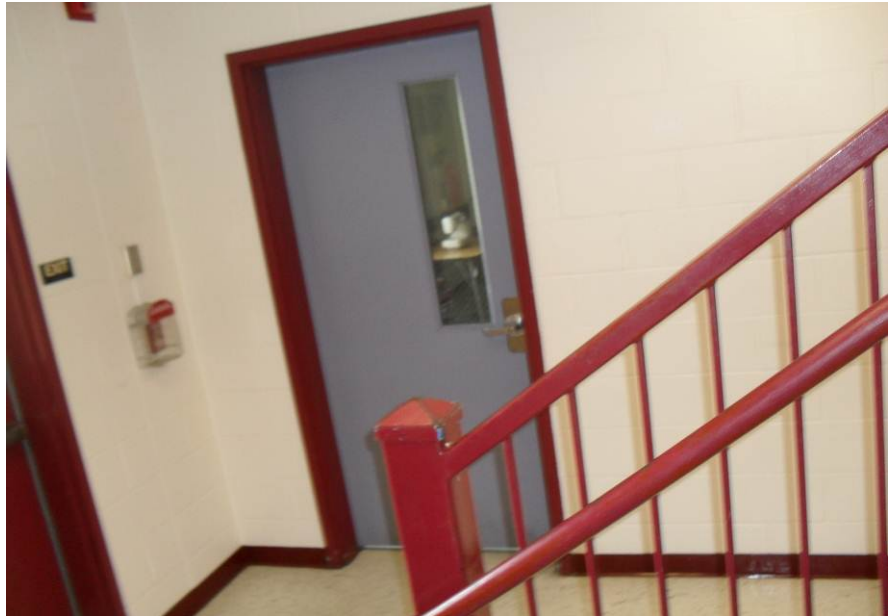
*Door to Room Exits  
Into Stairwell*

In means of egress stairwells – door openings from adjacent rooms are not allowed to exit into a stairwell. This opening was constructed in this manner and is a rated door assembly. Potential that local code may eventually require the school to block this opening.

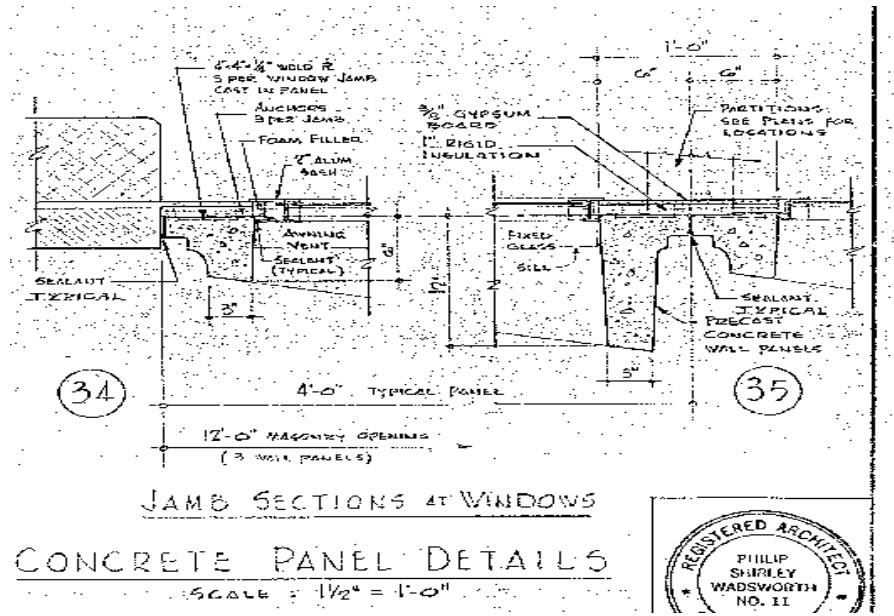
Detail 1 –  
Plan of Existing  
Windows at Precast  
Panels

Viewing the interior drywall panels around the windows it is apparent that water penetration around the windows and panels is the direct cause of the paint peeling and drywall failures and cracks you are witnessing. The window system is as originally constructed, a narrow-line non-thermally broken aluminum window frame and sash with a single glazed panel. Most of the window units have had the single pane glazing replaced with an insulated window glazing panel that appears to be around 3/4" thick.

Even though there are benefits to replacing the glazing, the unit is installed in a non-thermally broken aluminum frame system. The sill frame of the unit does not have a sill flashing under the frame. The jambs are directly anchored to the precast panel with the frame mechanically attached to this anchor.

We would recommend to the Cape Elizabeth School Department that this becomes a very high priority on your Capital Improvement Project list. The potential for mold build-up behind the drywall is very high and in the present school environment of constantly minimizing health and safety risks the potential liability exposure could be become very serious.

We would recommend a forensic analysis to verify and confirm our suspicions and an appropriate plan of action be put in place to repair this condition.

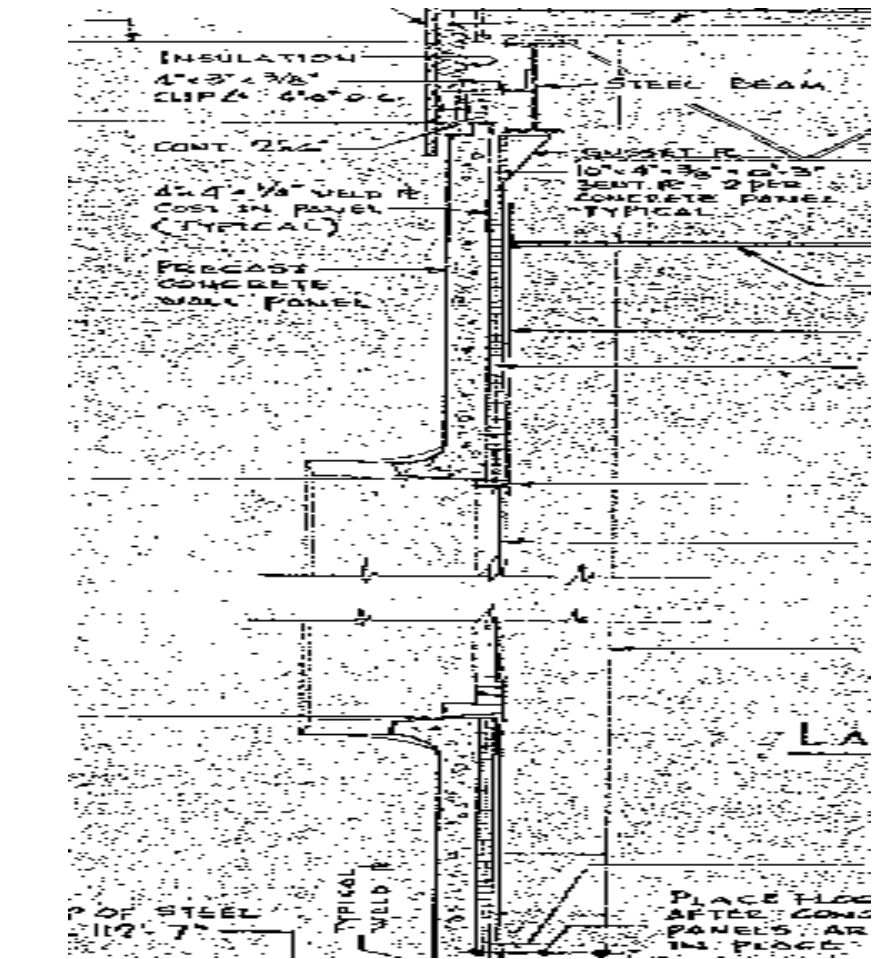
Detail 2 –  
Section Through  
Window/Concrete Panel

The precast concrete window panel system is anchored to the structure through a series of connection angles and weld plates. On the back of the precast panels a layer of insulation and drywall was installed directly to the precast panel. No information could be found on the drawings indicating how the drywall was attached to the precast panel or to any direct framing behind it.

There are areas above the suspended ceiling where the back of the panel is un-insulated or a layer of insulation is applied without a drywall layer. The manner in which this whole assembly is constructed provides an environment for condensation to build over time. Even though every room with this assembly was not observed, the rooms viewed shows signs of cracking and peeling or recent repair due to previous damage.

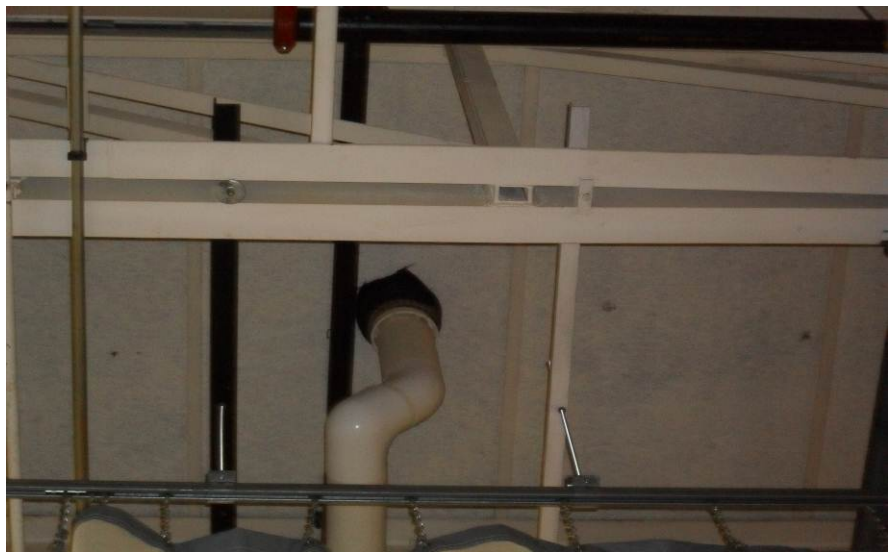
*Gymnasium Roof Drain*

Roof drain body and covers were modified with new retro-fit drains as part of the 2004 renovation project when the roof was replaced. When the roof was constructed the drain boot and roof leader would have been cast iron. With the installation of the retro-fit drain we can see that a flexible boot and drain body was attached to the existing roof leader drain pipe. The concern lies with the lack of pipe hangers to support the roof leader especially when large volumes of water enter the line and the weight could cause a failure at this connection. It is unknown how they connected the drain and flexible boot together and we would consider this connection as a potential failure point during a heavy rainstorm.

This condition occurs at all roof drain locations in the gymnasium. There were four roof drains at the time of construction and two additional roof drains were added as part of the 2004 renovation project.

We would recommend adding hangers at the elbow connection and along the horizontal leader to its vertical drop at the inside corner. At the time of roof replacement we would recommend replacement of these drains and connections.

The drain replacement will more than likely occur as part of the removal of the wood fiber roof panel and installation of a new metal deck.

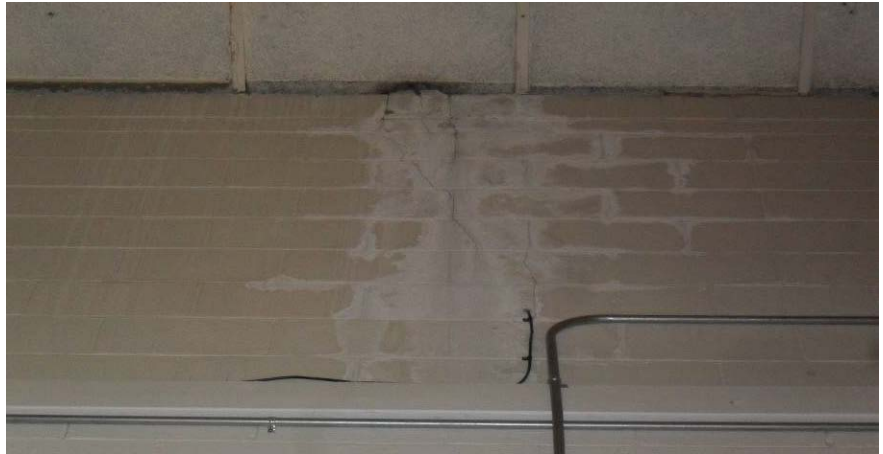
*Damaged Wall in Gymnasium*

Existing concrete block wall – interior surface and block is cracked from water entry. Recommend block repair and painting to maintain wall.

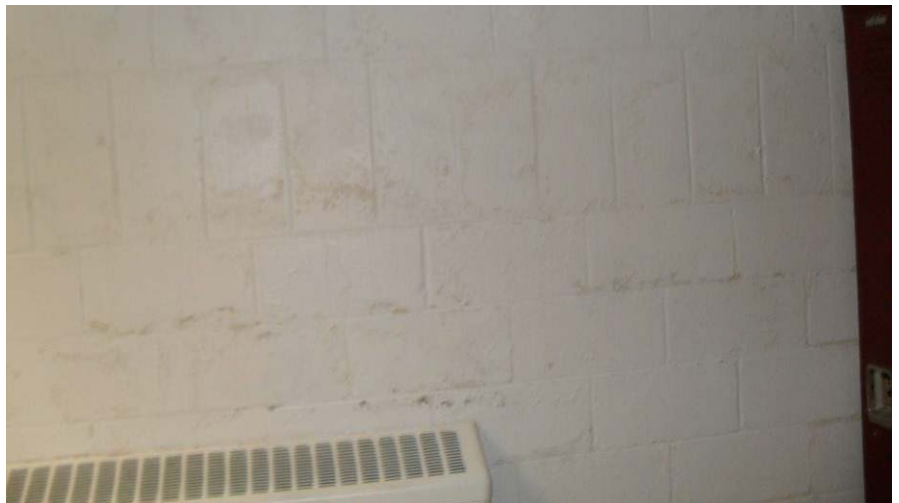
*Exterior Wall – Corridor Water Damage*

Observed some locations where water entry in the concrete block back-up wall has ruined the finish on the face of the walls. In order for this level of damage to occur, it is reflective of a large amount of water having entered into the block cell. Tracing the damage up the wall it appears that the water entry point is somewhere near the roof line. The damaged wall in the first photo is from the third floor corridor. Damage to the wall on the second floor corridor directly below was also found.

If the source of water entry is unknown then we would recommend a forensic study to find and correct your water entry source before you repair the walls and repaint.

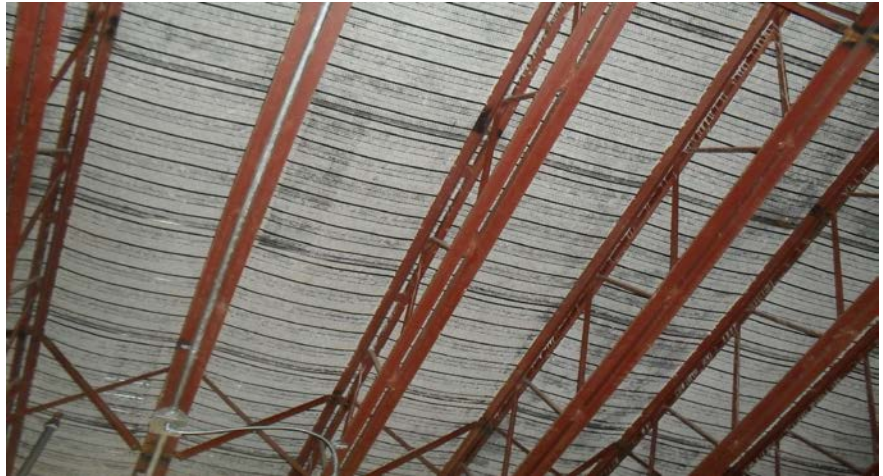
*Wire Mesh Floor Deck*

The elevated concrete deck floor systems were constructed of wire mesh and concrete slab. When walking the corridors of the building there are highs and lows in the floor line visible through the floor tile. These valleys are a result of the way the system was installed. A wire mesh deck of this type is not rigid enough to maintain a straight level surface when wet concrete is applied. Sagging most likely occurred during the placement operation. The system is structurally sound and any attempt to correct would be of substantial cost.

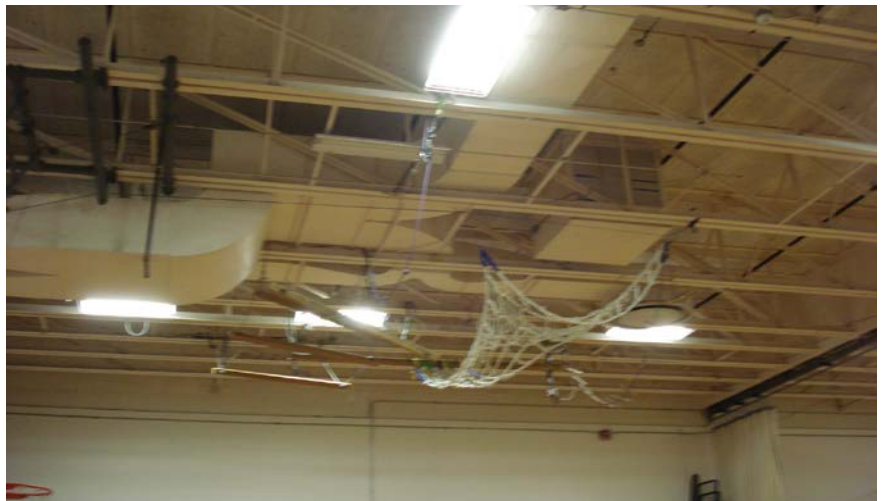
*Gymnasium Climbing System*

During the course of our observations, installation of climbing ropes and nets suspended from the lower chord of the steel joist in the gymnasium was noted. As a minimum precaution, we would recommend that all of these rope systems be attached from the top chord. The bottom chord of a steel joist is not designed to take bottom load action as currently being applied with the suspension of these ropes. These connections should be relocated to a joist panel on the top chord and a minor structural review conducted to ensure that the loads of two to five students are not overstressing the joist bottom chord.

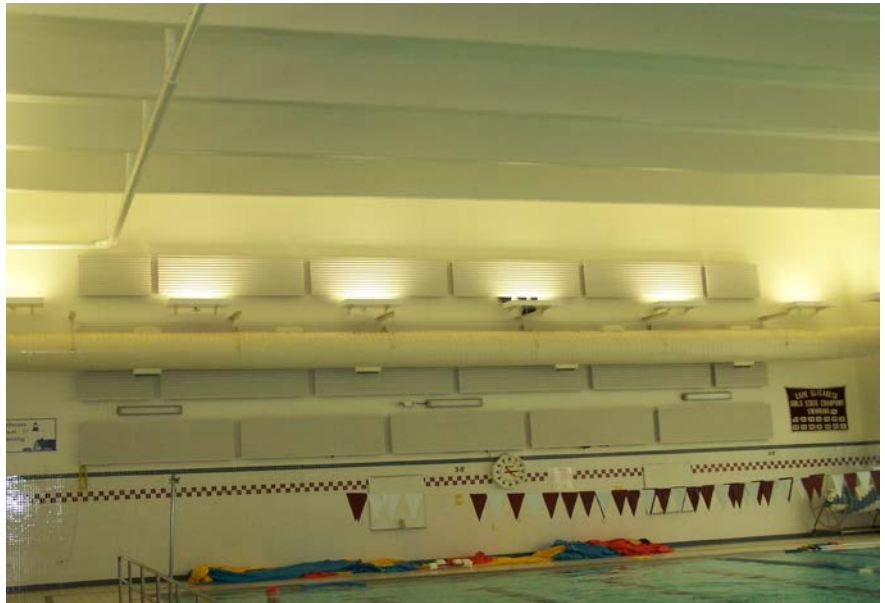
During our site visit it was noted that the issue of ADA Accessibility to the pool and spa was noted, as the facility is non-compliant relative to access. There are products that can assist with accessibility issues. There is concern with adapting the spa pool. The spa pool has no physical room to mount these systems, and we would not recommend a wall mounted unit unless a structural upgrade to the wall is conducted.

The lack of ADA accessibility has become an issue for the town.

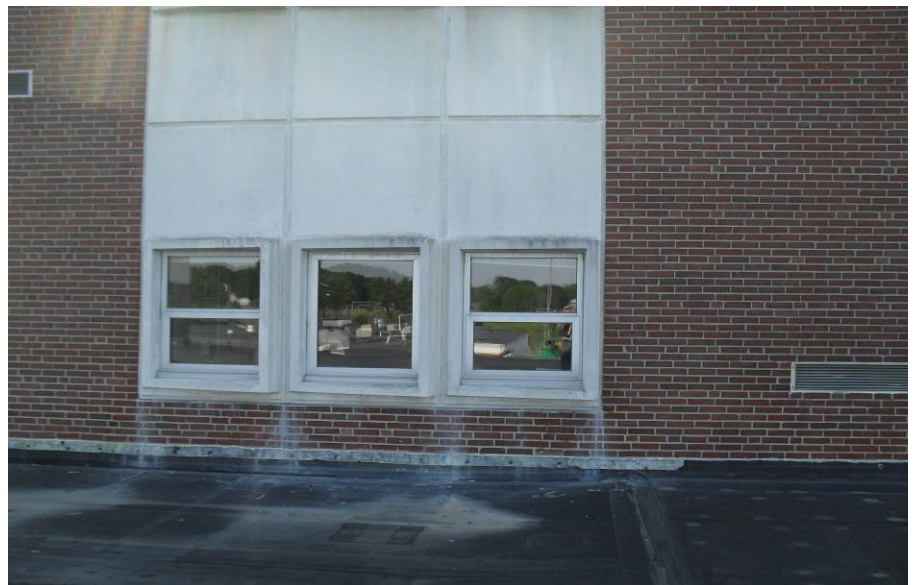
*Window Panel Requiring  
Work*

There are wall panels that need the same maintenance rework and we recommend continuance of this program until all the panels have been revamped. As noted earlier in this report the potential of cold and water infiltration thru these joints on these panels is a contributor to your condensation issue on the inside of the panels.

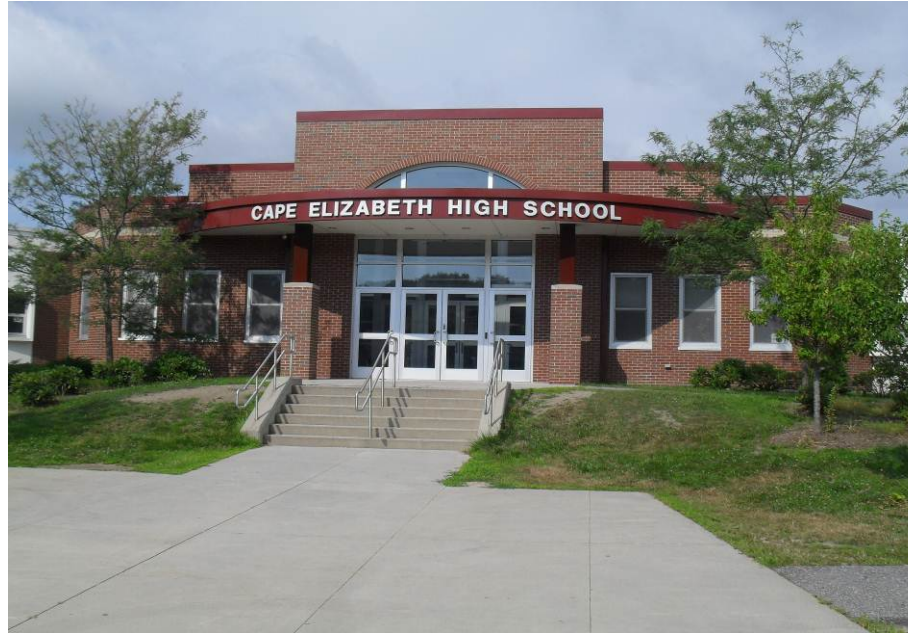
*Front Entrance –  
Existing Stairs and  
Ramp*

We would recommend construction of a new compliant ADA ramp to the doors and possible reconstruction of the front steps to work with the new ramp.

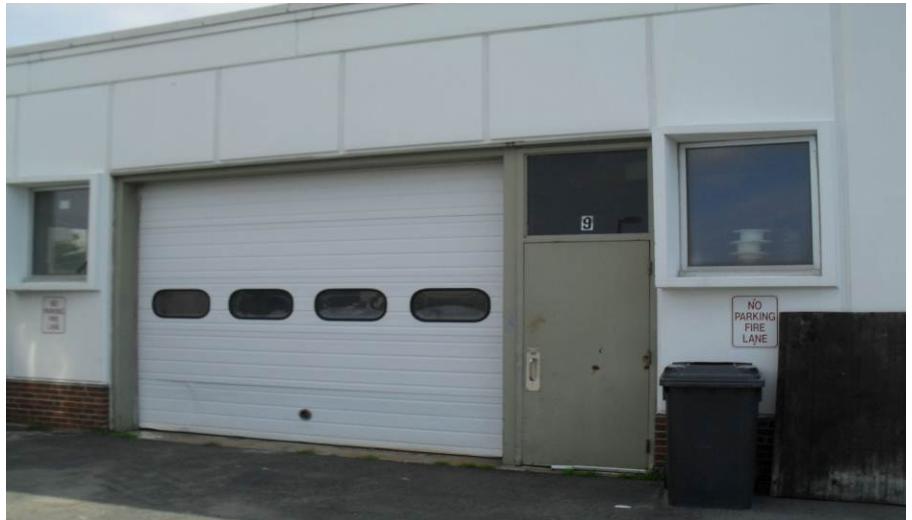
A quantity of the hollow metal exterior doors and frames on the building are showing signs of extensive rust at the bottom of the doors and frames as well as the hinge location. We understand as part of your yearly maintenance program these openings are being replaced. We also understand that the overhead doors at the IA shops are being replaced this year as part of that maintenance program.

*Personnel and Overhead  
Doors*

We would recommend replacement of hollow metal doors and frame entrances be done as part of your yearly maintenance program. For long term durability we would recommend replacement doors and frames be ordered as galvanized units and primed with a good alkyd primer and alkyd enamel coatings.

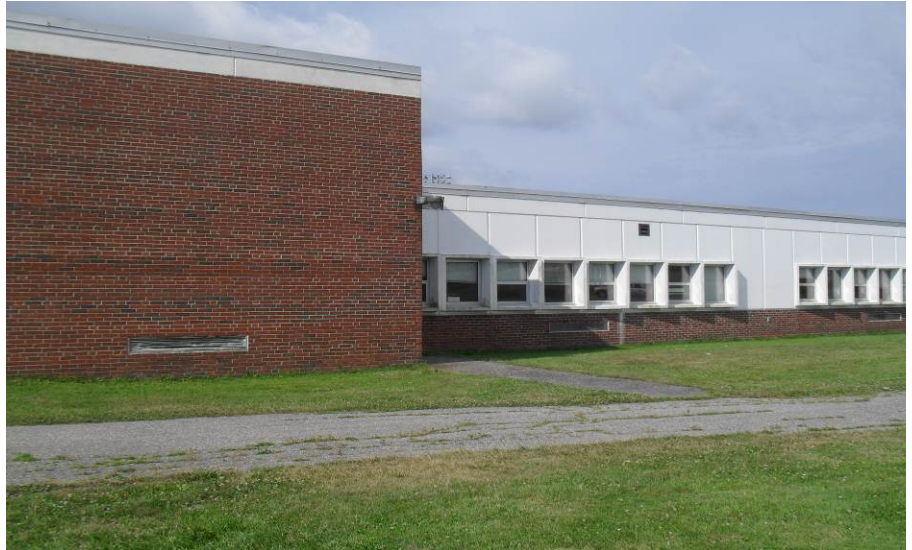
This picture shows that the brick and precast concrete walls panel system have been well maintained. We would recommend replacement of the fresh air-intake louvers at some point with a more durable louver system.

*Exterior Wall with  
Intake Louvers*

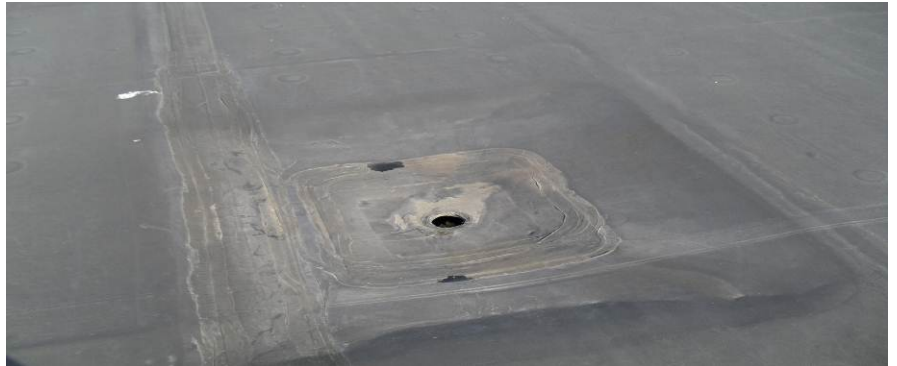
*Roof Drain - No Cage*

1. Provide drain cover at two drain locations – Industrial Arts roof.

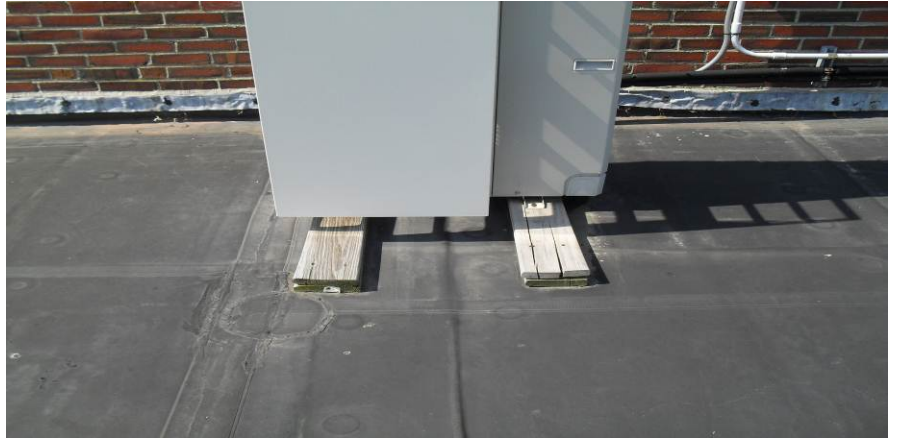
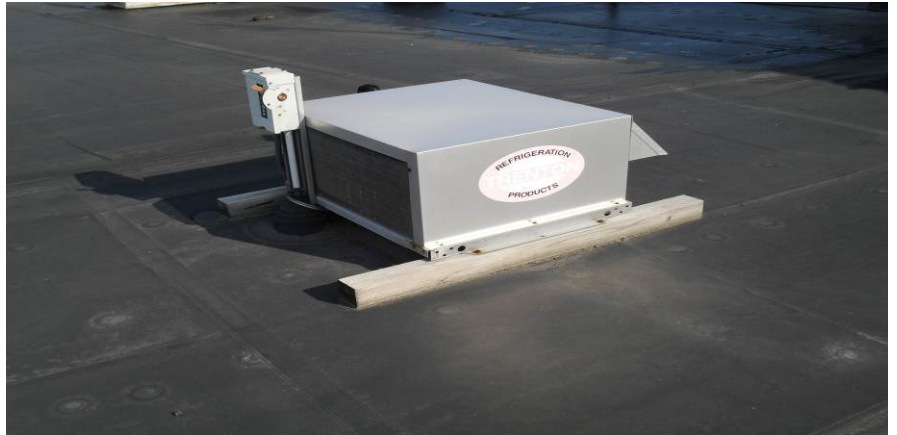
2. Provide secondary membrane under all rooftop condenser curb locations. There are some curbs that need replacement. Weight of unit will allow curb to cut into membrane causing leak location.

*Roof Curb - No Flashing Under*

*Roof Curb – No Flashing Under*

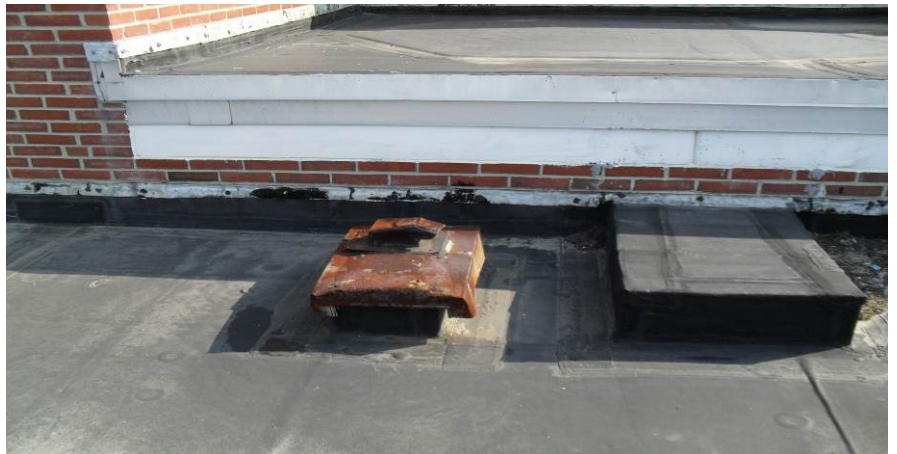
3. Remove old metal cap and provide new permanent EPDM cap flashing. Potential roof leak location.

*Replace Old Roof Curb Cap*

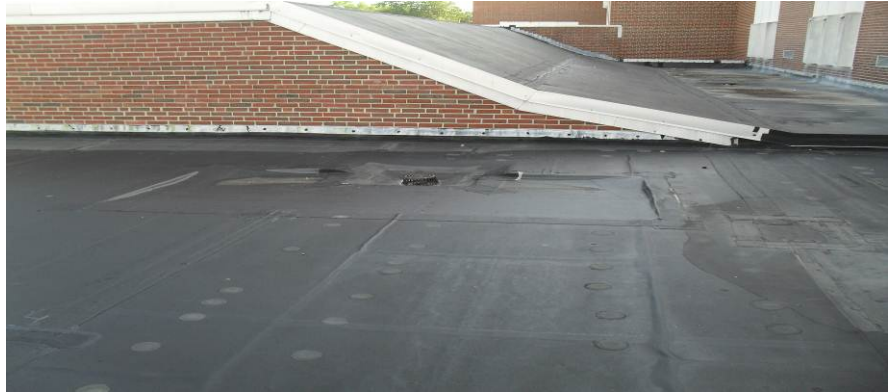
4. Rework membrane flashing to some drains – membrane is stretched over insulation with gap under – not laying flat on insulation and following insulation profile – constant stretching will cause early seam failure at drain locations. Air space between membrane and insulation can easily be punctured with foot traffic.

*Roof Flashing at Drain*

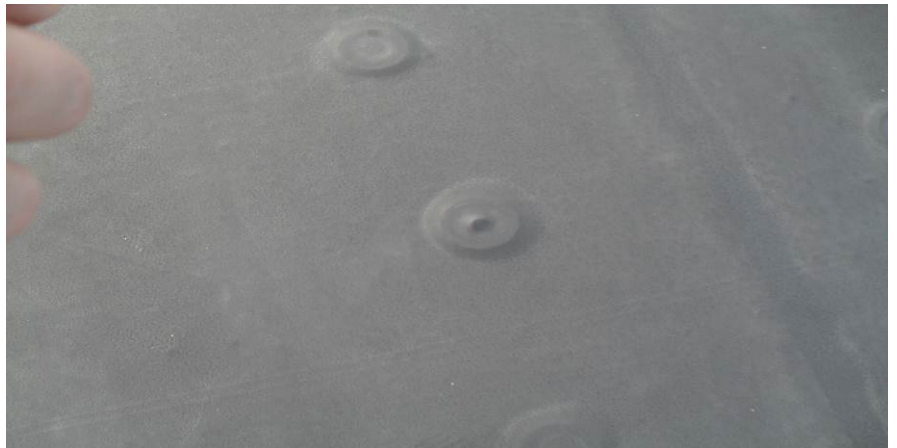
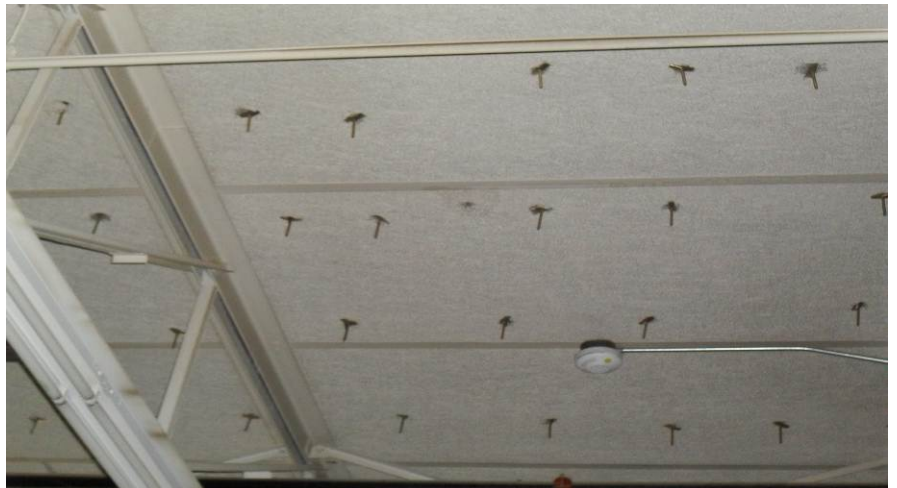
The molly bolts as shown through the deck in the lower picture have had the wings drawn up into the panel to various depths – visual inspections where the deck is exposed has shown that some wings are loose as a result of their attachment process. The result means that the amount of fasteners required to hold the roof board will be less than required by wind uplift codes thus adding to the observation about the amount of fasteners required to hold the roof system down properly.

*Pressure Plate Raised  
Up*

*Roof Insulation  
Fasteners Through  
Plank*

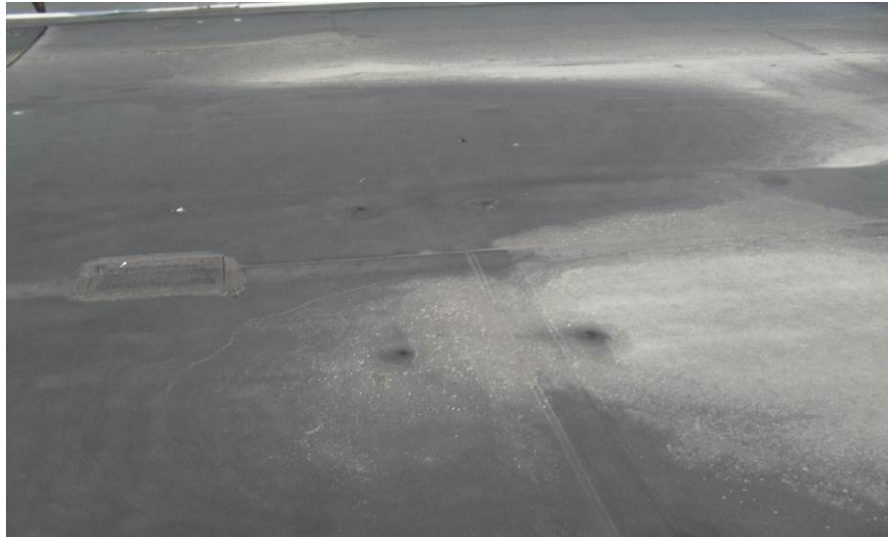
2. Lower locker room roof membrane has a number of locations where foreign material under the roof membrane is causing large dimples in the surface. Foot traffic over these locations can cause holes in the roof membrane and leaks.

*Material Under Membrane*

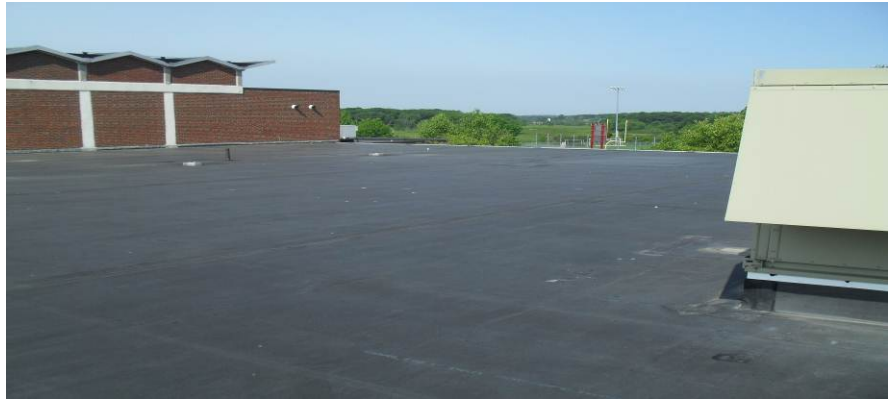
Per the IBC Code 2003 it is required as part of that code that single membrane roofs be installed at 1/4” per ft slope. There is an exception in the code that replacement roof systems do not need to meet this requirement. There is a state statute through the Bureau of General Services on public school buildings that supersedes the code requirement saying replacement roofs will meet the 1/4” per ft single membrane low slope pitch without exception. In regards to this statute the state also requires that an analysis of the roof structure be conducted and that the roof structure and roof system be brought up to current live and drift loads. We can offer no explanation as to why the replacement roofs were not installed according to the state statute.

The current 1/8" per ft slope and the inconsistent drain locations is creating large ponding areas on all roofs that will have a long term effect on the membrane and lap seams. The large ponding areas where they occur could also present an issue if a roof drain were to plug, the pond could increase in depth and cause the wood fiber deck to be over stressed from the load and fail.

*Low Slope to Roof  
Drains*

As part of a future roof replacement project the wood fiber plank deck should be removed and a new metal roof deck installed. With this existing combustible material in your ceiling cavities and with the replacement of this material with a new metal deck it should raise the classification of the building to a Type II B rating per IBC Code.

We would recommend the replacement roof system be specified with a Class A rating and a 1/4" per ft tapered board system and new roof drains to meet current code requirements.

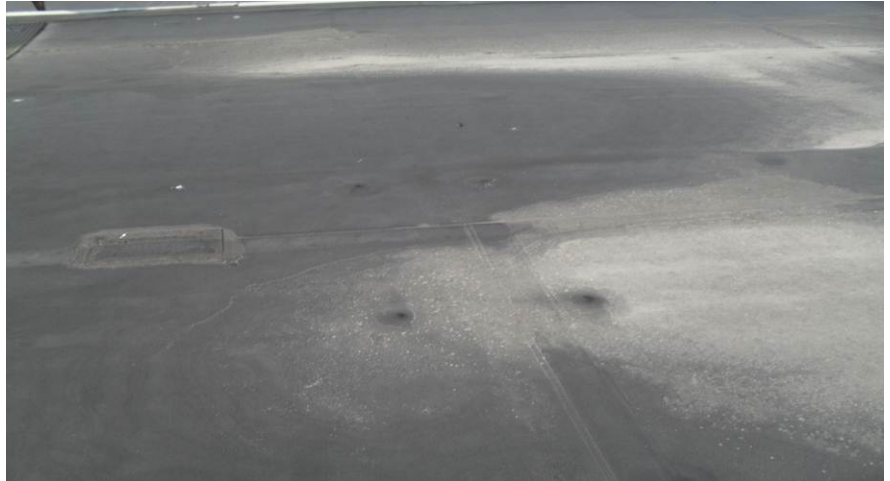
1. Numerous locations with foreign material under the roof membrane causing large dimples on the surface. Roof areas with these light colored or collection areas are indicators of ponding on the roof and the inability of surface water to be properly sloped to a roof drain. These ponding areas have a long term effect on your lap seams.

*Dimples and Light Colored Areas of Ponding*

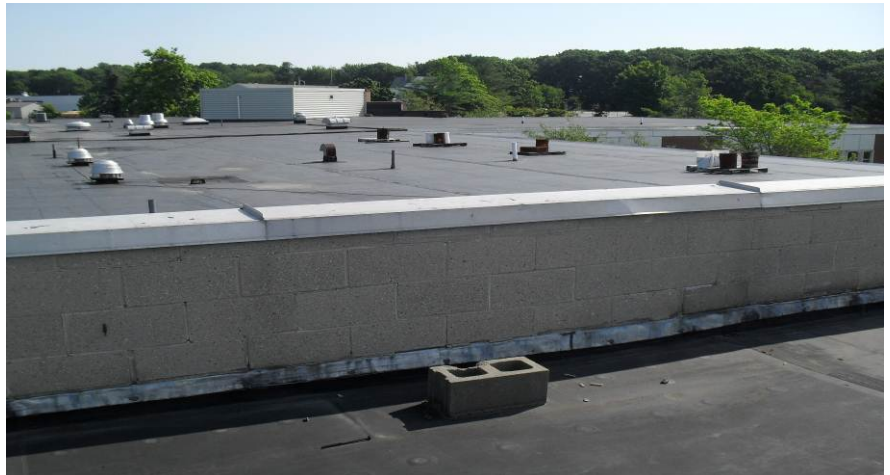
2. Parapet CMU walls above classroom wing roof are showing signs of block joint cracking and overall deterioration due to weather exposure. Water entry has entered into the block system and has caused some spalling of the grout joints and the potential issue of water entry through these joints below the roof line to the rooms below is occurring.

*Parapet Wall - CMU Failing and Cracking*

Recommend temporary waterproof system application over surface and full height flashing installation and cap at the time of replacement.

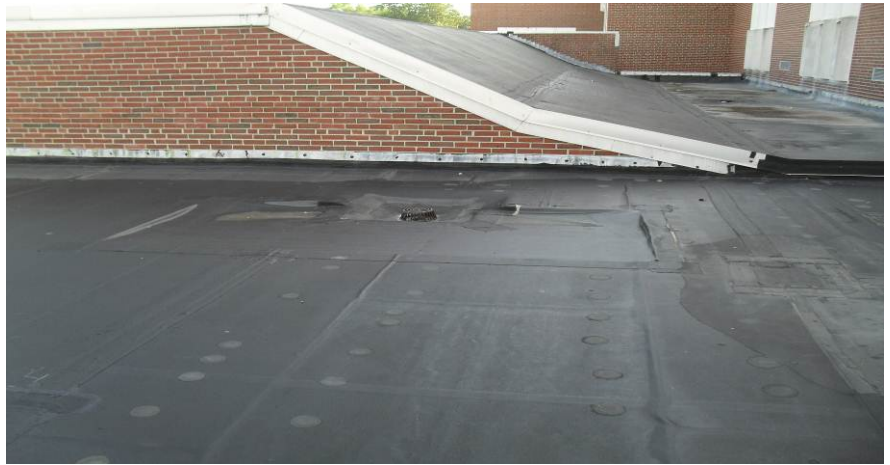
This through wall flashing is consistent around the perimeter where a lower roof adjoins a high exterior wall. The flashing used appears to be a lead coated copper flashing which is consistent with the type of flashing used for this age period. It may require special removal at the time of roof replacement and we would recommend installation of a new metal flashing that is more compatible with a new EPDM roof system.

*Metal Flashing at Base of Wall*

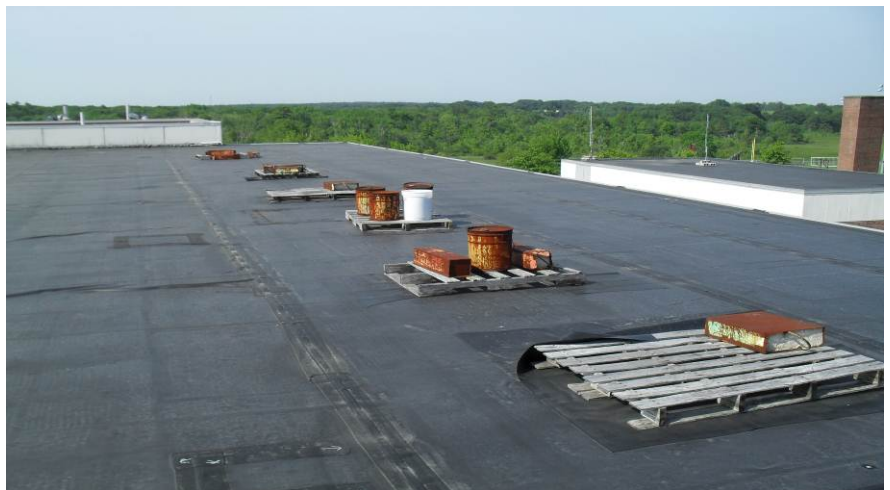
4. Under the 2004 project this area of roof was replaced. We recommend removal of leftover roofing product, weights, and pallets.

*Materials Left on Roof*

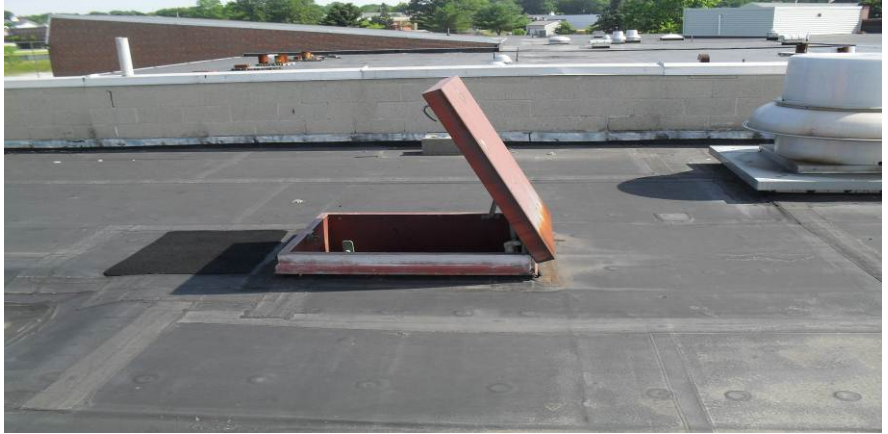
5. Existing roof hatch does not meet current OSHA Standards. Recommend installation of new scuttle hatch, ladder and safety railings.

*Existing Roof Hatch*

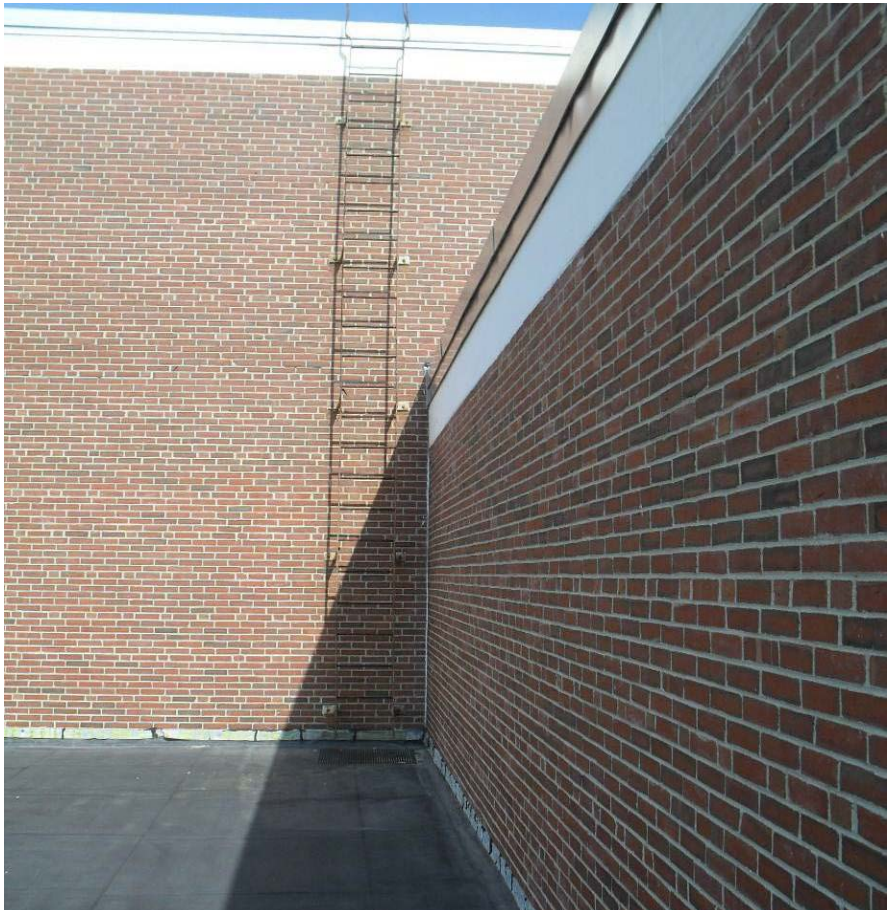
6. Existing exterior access ladder does not meet OSHA standards. Recommend installation of a new OSHA compliant vertical ladder and cage.

*Non-Compliant Ladder*

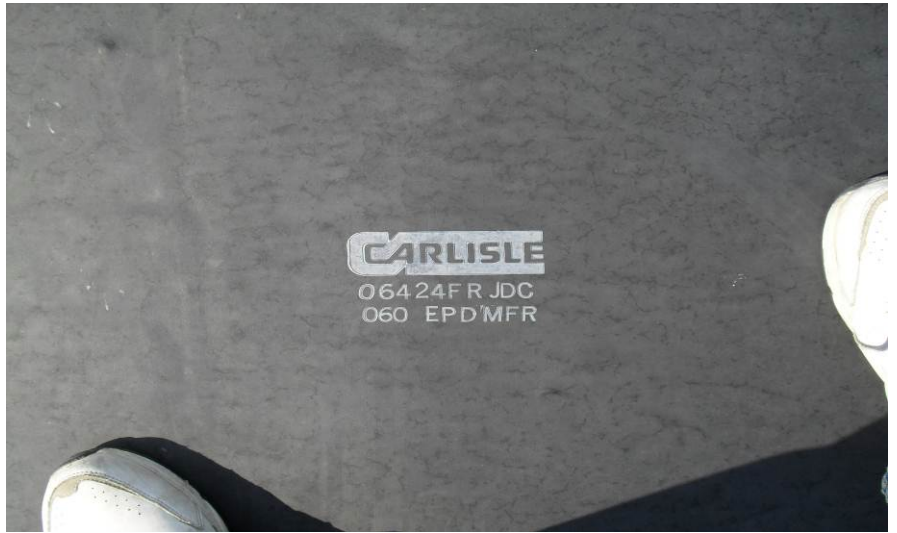
7. As part of the 2004 roof replacement we observed some sheets installed with the product label up. This type of roof membrane product is manufactured with the membrane surface on each side having two different functions. The surface applied to the insulation provides better bonding with the adhesive. The exposed surface is provided with a coating to help protect it from UV exposure. The label up indicates to us that the sheet was installed with the wrong surface up which may cause premature failure of the sheets in this area.

*Product Label Facing Up*

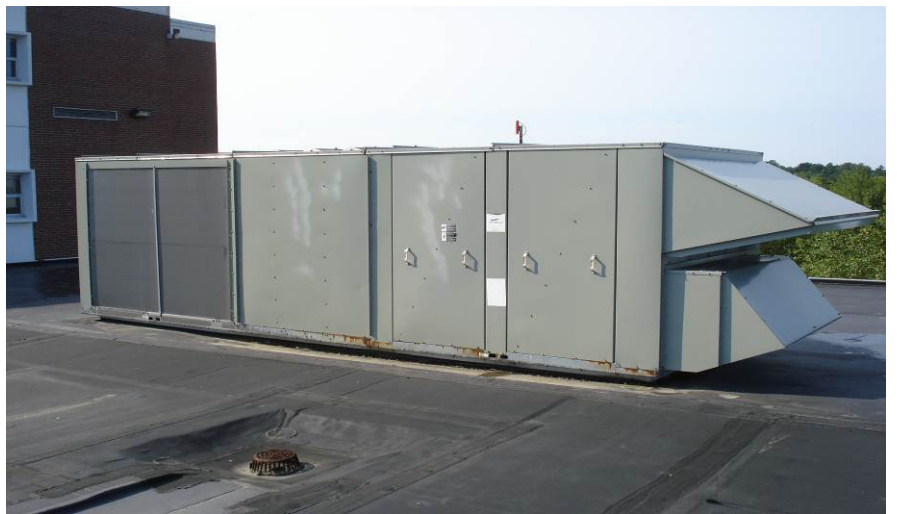
8. Base flashing for AHU unit not at recommended height.

*AHU Unit Base Flashing*

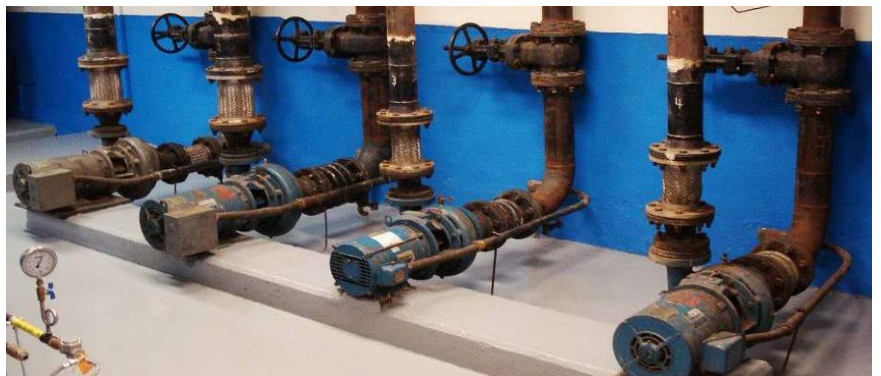
The heating hot water is circulated through the building by the Weinman base-mounted circulating pumps located adjacent to the boilers. One pair of pumps (left two) provides the hot water through the majority of the building. The other set of pumps circulate heating hot water through to the pool section of the building. The insulation on the hot water piping contained asbestos and was abated as part of the boiler project.

*Piping is Not Insulated*

We would recommend insulating all of the heating hot water piping and accessories in the boiler room.

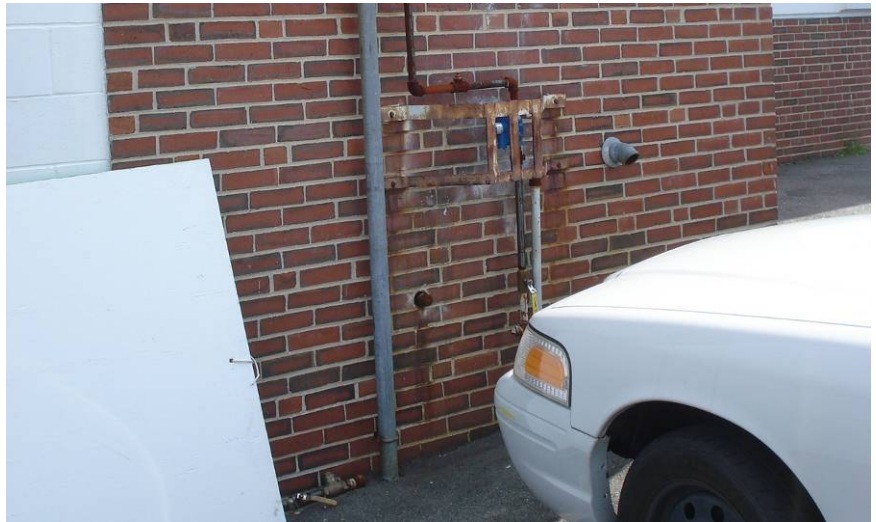
The propane gas piping is installed along the exterior wall of the Boiler Room. The gas valve is protected. The piping from the parking lot level to the gas valve appears to be exposed to potential damage.

*The gas piping is exposed to potential damage.*

We would recommend the installation of protective barrier devices in front of the gas piping.
