**Town of Cape Elizabeth**  
Seven Building Facility Study  
*Cape Elizabeth, Maine*

HARRIMAN | Architects + Engineers

**Introduction****Town of Cape Elizabeth Facilities Study**

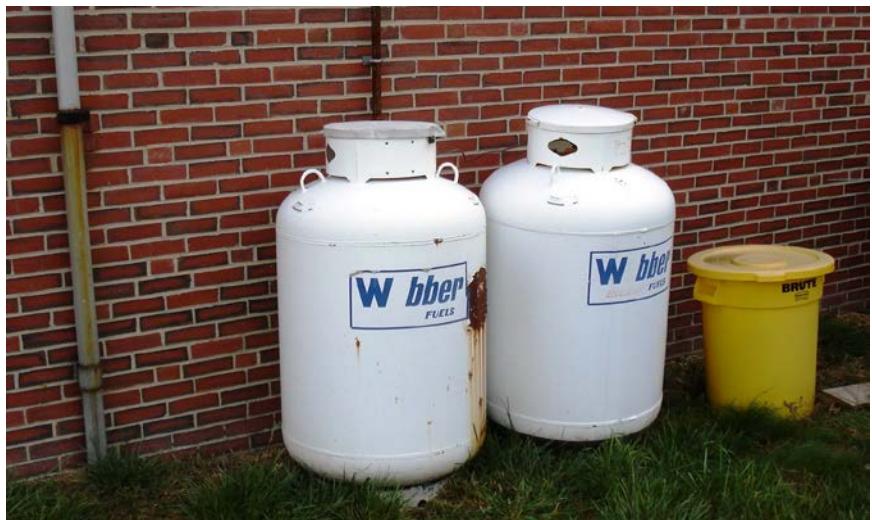
*LP Gas Tanks Serving the Kitchen Equipment*

We would recommend relocation of the LP propane tanks in accordance with codes.

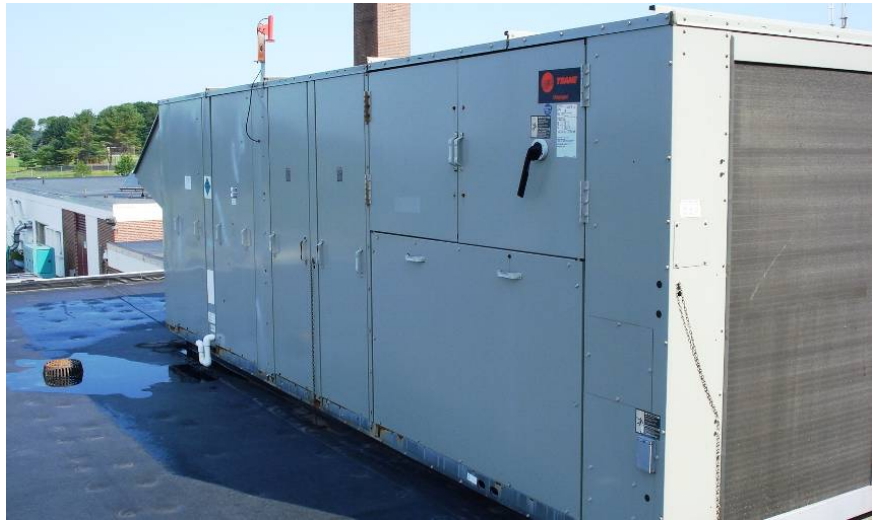
Ventilation and air conditioning for the cafeteria is provided from the Trane packaged rooftop air conditioning unit located directly above the cafeteria. The unit was installed as part of the 2004 renovation project and identified on the drawing as AC-1.

*Trane Rooftop Air Handling Unit Serving the Cafeteria and Kitchen Areas*

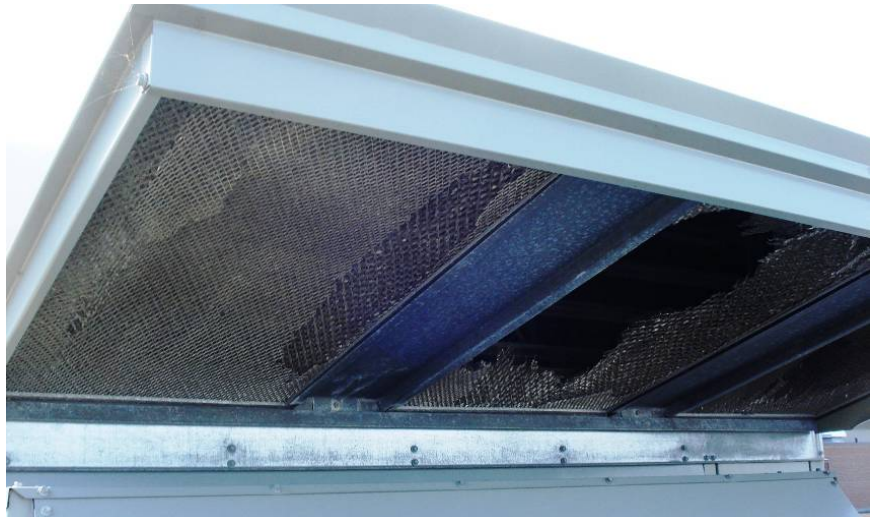
At the time of review, the unit was operating with the intake dampers 100% open, the relief fan was off, and the mechanical cooling running. At such warm ambient conditions, one would expect the intake dampers to be closed down to the minimum position. The unit-mounted intake filters are damaged.

*Damaged Packaged AC Rooftop Unit Outside Air Intake Filter*

We would recommend replacement of the filters and verification of system operations.

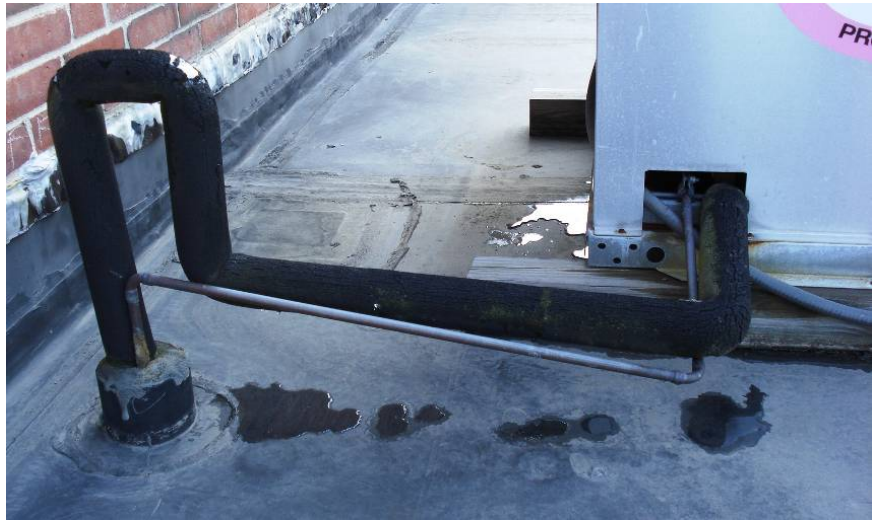
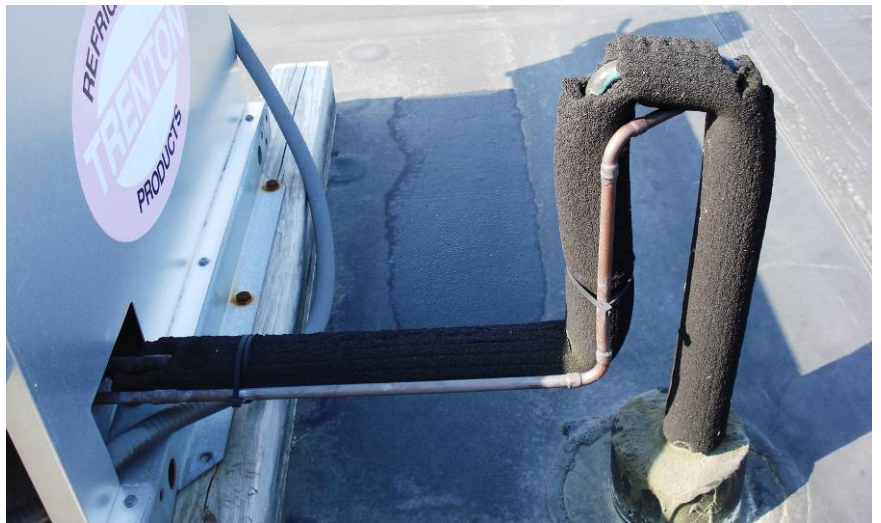
In general, the rooftop condensing units appear to be in good condition with the exception of some of the refrigerant piping and associated insulation. At many of the units, the insulation on the suction lines is showing signs of age and breaking down.

*Rooftop Condensing Unit  
Refrigerant Piping*

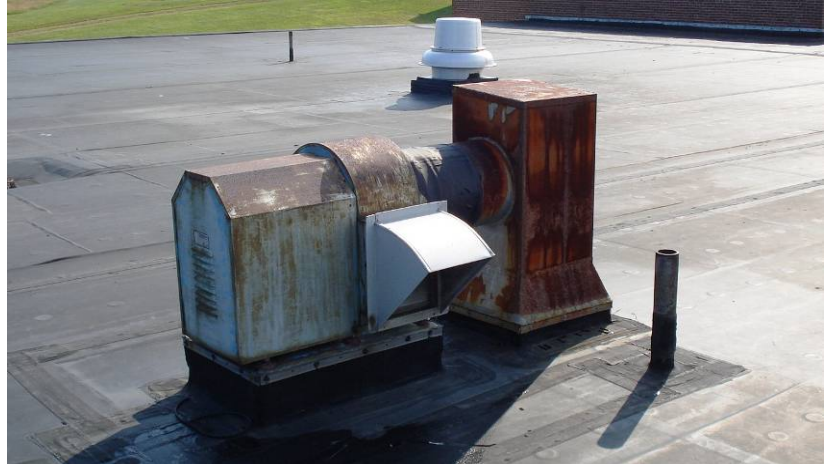
Many of the rooftop exhaust fans are showing signs of age. At the time of review, many of the exhaust fans were not operating. It is unknown which units were supposed to be running and which ones were in the off mode.

*Rooftop Exhaust Fan*

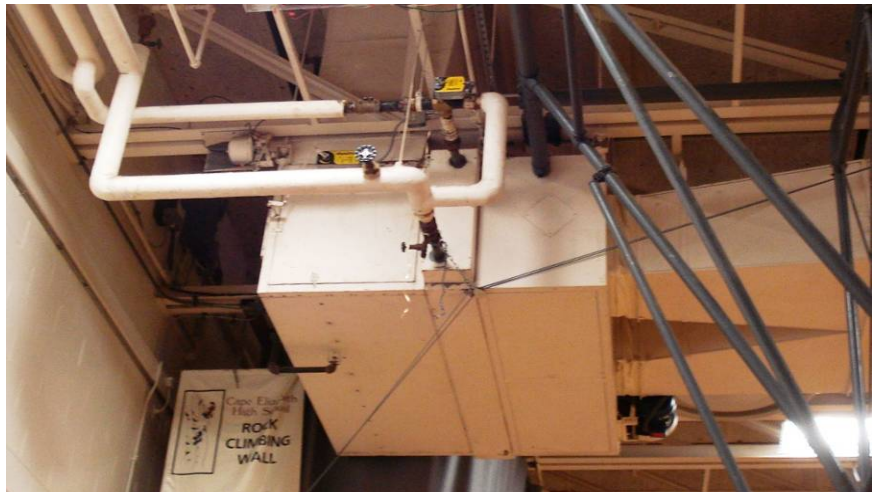
The gymnasium ventilation is provided through four air handling units suspended from the roof structure. The units appear to be original to the 1968 construction project. According to the 2004 renovations construction documents, the four existing units were scheduled to be removed and replaced with two new units. The units were not removed or replaced. During this review the units were not operating. The automatic controls and fan motors have been upgraded and variable frequency drives have been installed.

*Gymnasium Ventilation Units (Typical of Four Units)*

We would recommend replacement of the 4 units.

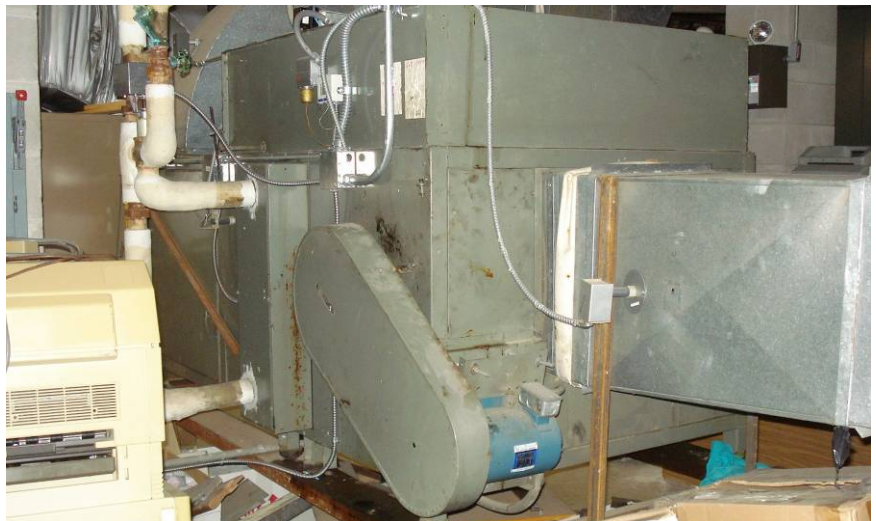
The ventilation unit HV-3 was installed during the 1968 construction project and appears to be in operation. The original pneumatic automatic temperature controls have been replaced and upgraded with DDC controls with electronic actuation. The unit originally provided conditioned ventilation air to two areas on the second floor and one area on the third floor. During the 2004 renovations project, minor changes were made to the system distribution.

*American Air Filter, Inc. Ventilation Unit HV-3 Located in "The Attic"*

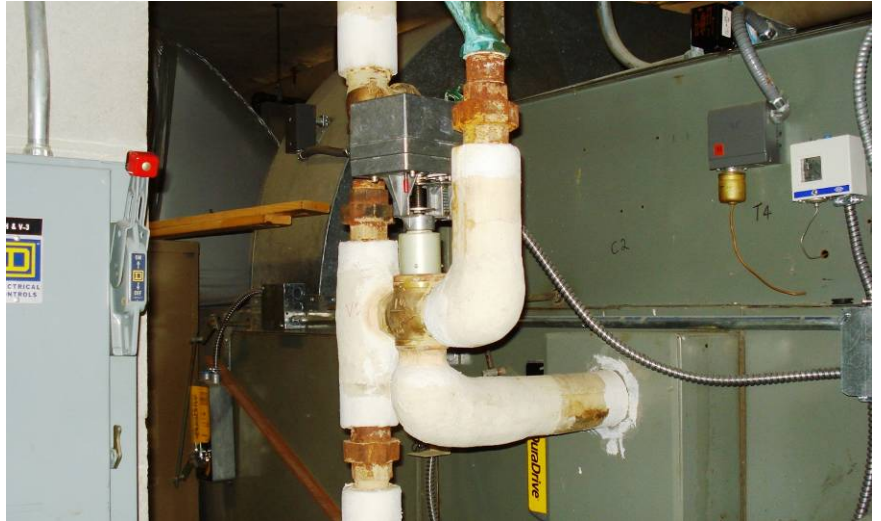
The current 3-way valve actuator replaced the original pneumatic valve actuator and was retrofitted to the original 3-way control valve. The insulation on the piping appears to be original and may contain asbestos.

*3-Way Control Valve  
and Pipe Insulation of  
HV-3 Multi-Zone Unit*

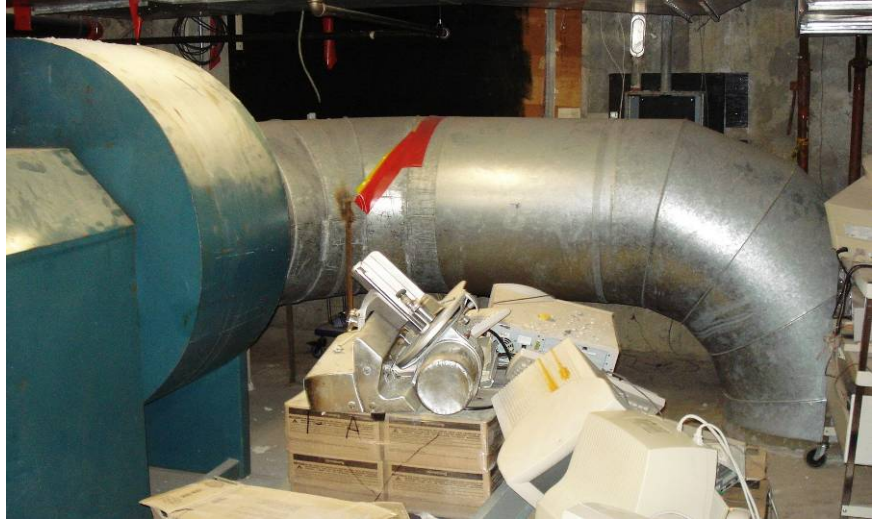
The 36" return air duct for HV-4 is installed in a floor trench. Operation of the fan is unknown. According to the 1968 drawings, the trench follows the outside perimeter of the library and provided the return air through floor-mounted return grilles located above the trench.

*36" Duct Installed in  
Floor*

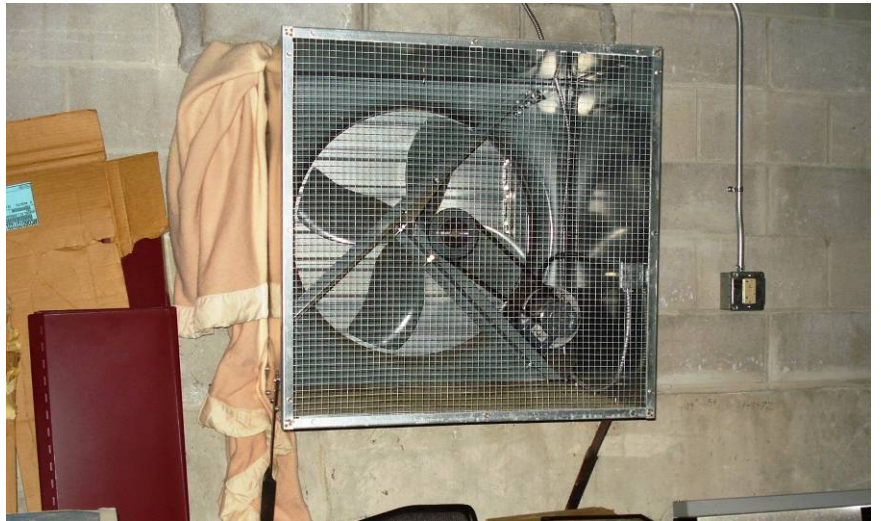
*Storage Room (Attic)  
Ventilation Fan*

The ventilation for the storage room or attic is provided through a wall-mounted propeller type exhaust fan. Recommend sealing the fan enclosure.

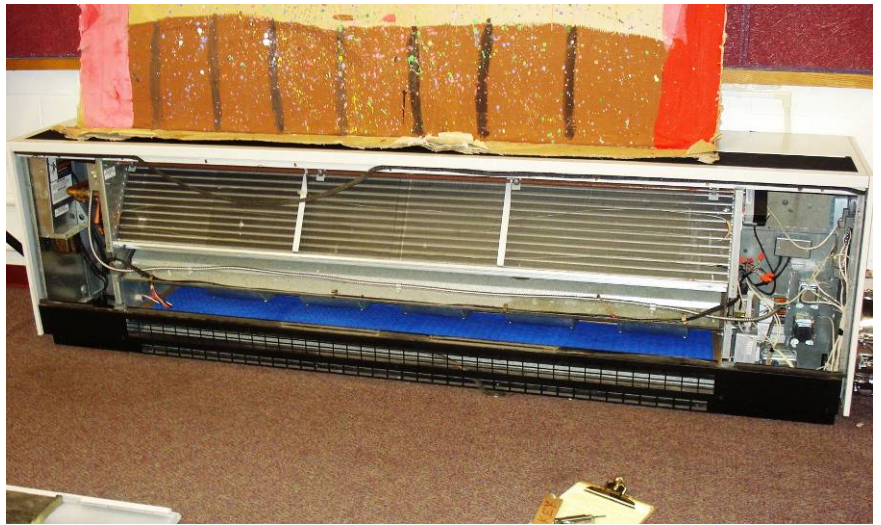
Many classrooms are served through individual classroom unit ventilators (UV). The UVs appear to be in relatively good condition for their age. The unit ventilator system may no longer meet the state requirements for Classroom Ventilation.

*Trane Unit Ventilator  
Located in the Music  
Classroom (Typical of  
Many Classrooms)*

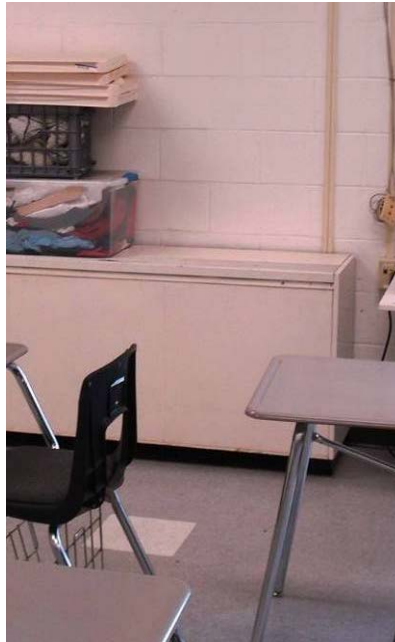
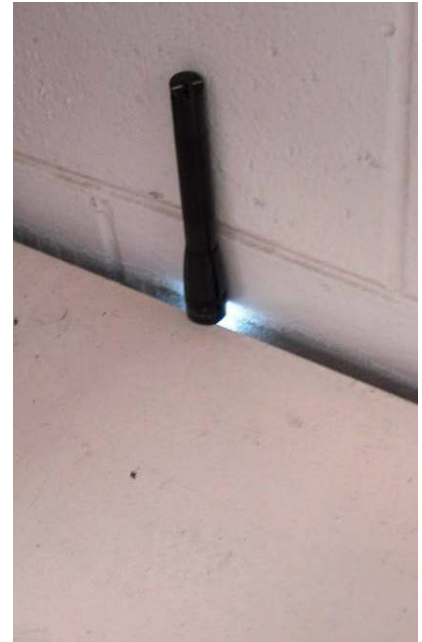
In Classroom 208, the unit ventilator has moved away from the wall creating an air gap between the unit insulation and the opening in the wall allowing for infiltration of outside air into the classroom.

*Unit Ventilator in Classroom 208. Photo on Right Shows the Gap Between the Unit and the Wall*

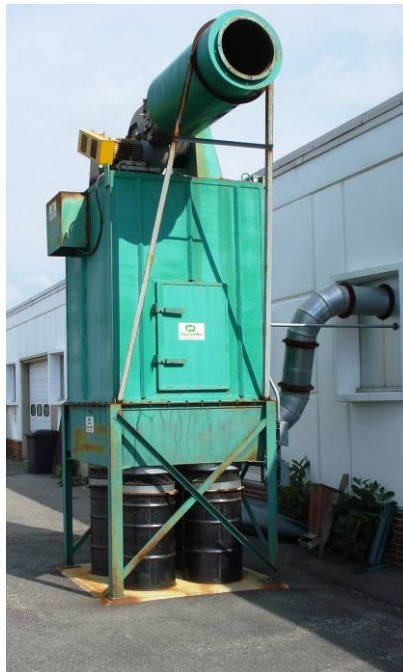
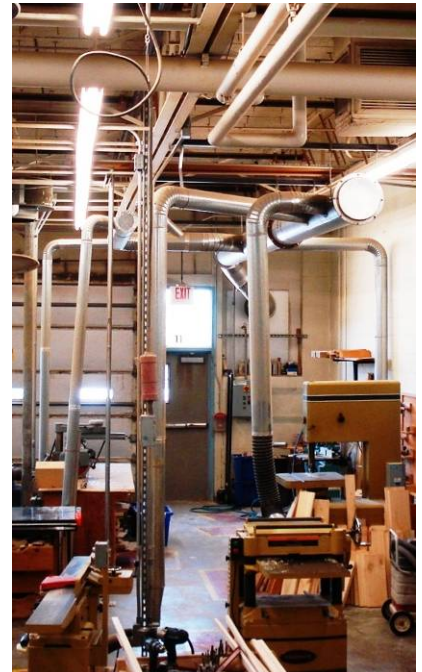
A dust collection system is provided for the Wood Shop. Operation of the dust collection system is unknown. According to construction documents, the dust collection system was provided during the 2004 renovations project.

*Exterior and Interior Views of Dust Collection Exhaust System in the Wood Shop*

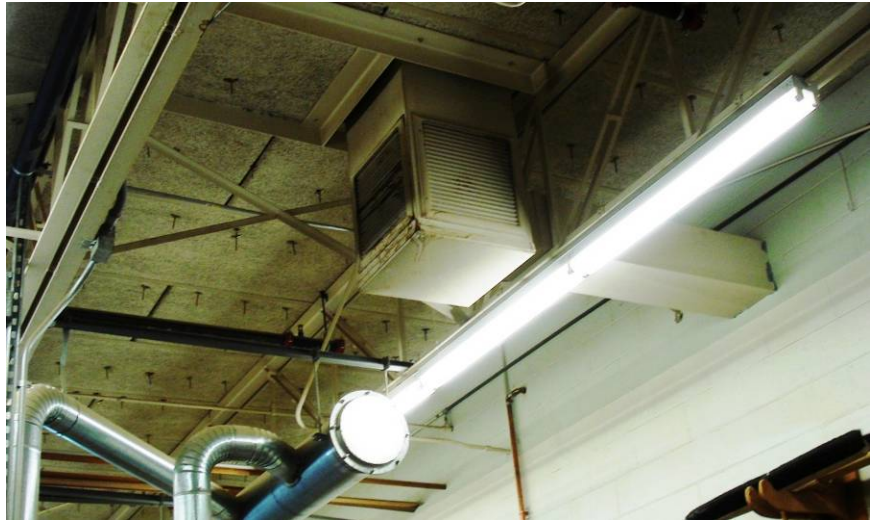
It appears general exhaust is provided to each of the Wood Shop spaces. The make-up air for the exhaust systems is unknown and may be insufficient.

*Roof-Mounted Exhaust  
Fan Louvers*

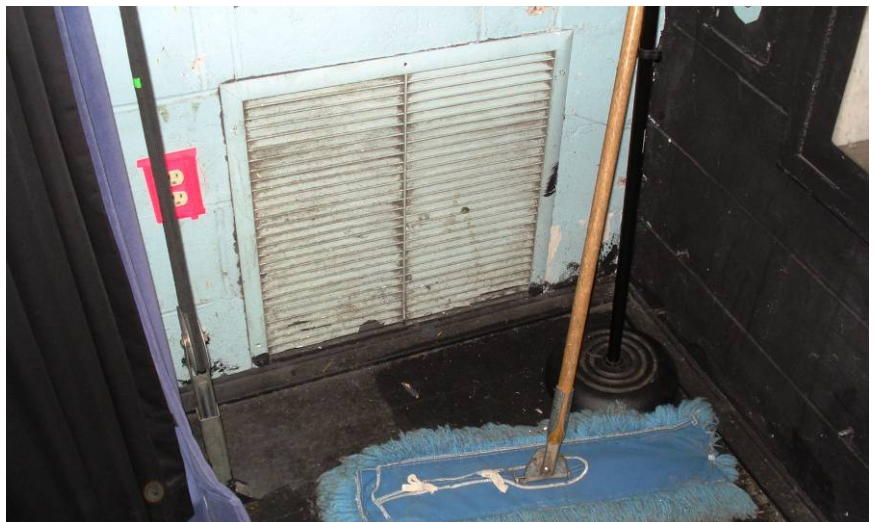
Return from the stage is provided through two return grilles located at the floor level. The return may be susceptible to excess dust and dirt as evident by the location of the dust mop. The return grilles serving the Auditorium are located along the back wall. The return grille, located adjacent to the door, is not obscured.

*Ventilation Return Grille Serving the Stage Areas*

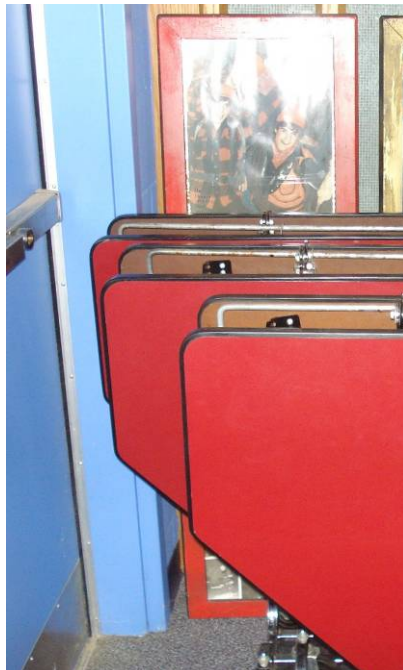
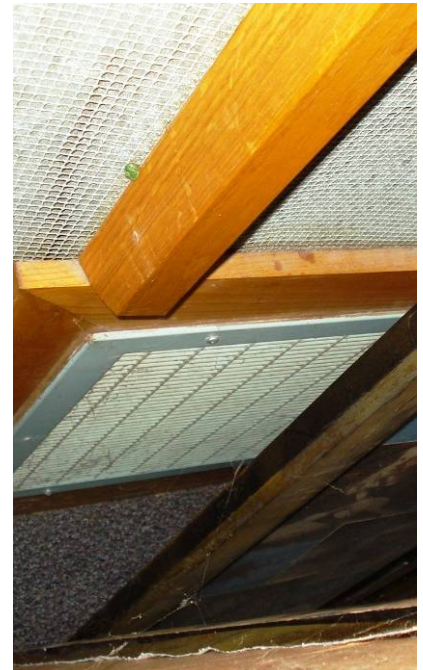
The return grilles serving the Auditorium are located along the back wall. The return grille, located adjacent to the door, is not obscured. The return grille located on the left side (shown in above photo) is completely blocked by tables and show posters lining the back wall. The photo on the left shows the exterior door and the tables and posters blocking the grille. The photo on the right shows the blocked grille behind the posters.

*Location of Return Grille at the Left Side of the Auditorium Back Area*

We would recommend maintaining.

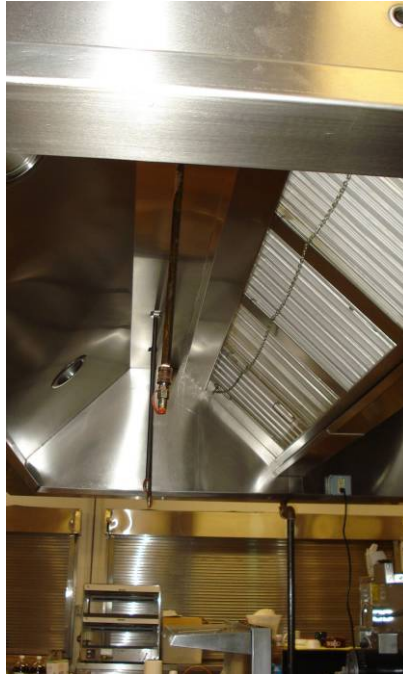
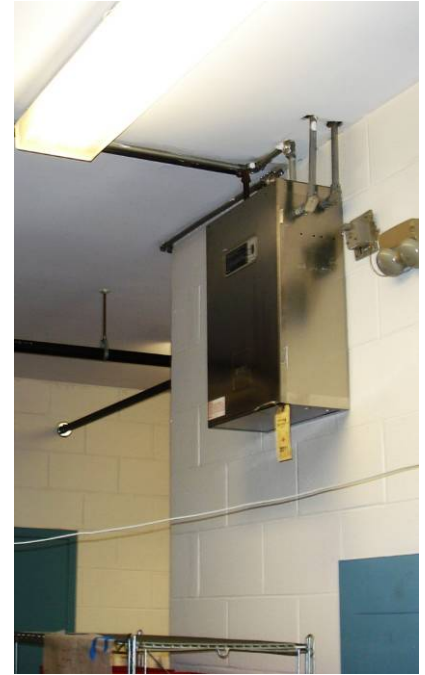
The kitchen hood system appears to be in good condition. Overall, the condition of the hood appeared to be good. Fire suppression system is provided. At the time of review, all of the hood light bulbs and globes were missing.

*View Under Hood and Fire Suppression System Panel*

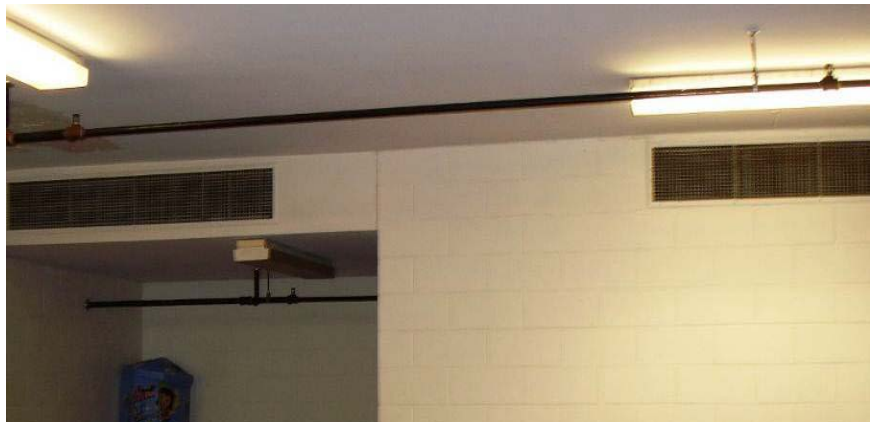
According to the 1968 drawings, the ventilation for the kitchen is provided through a heating and ventilation unit located in a machine room above the adjacent corridor.

*Kitchen Ventilation Vents*

We would recommend further review of the kitchen exhaust and ventilation systems to verify proper interlocks between the exhaust systems and the heating and ventilation systems to ensure proper pressure and airflow control.

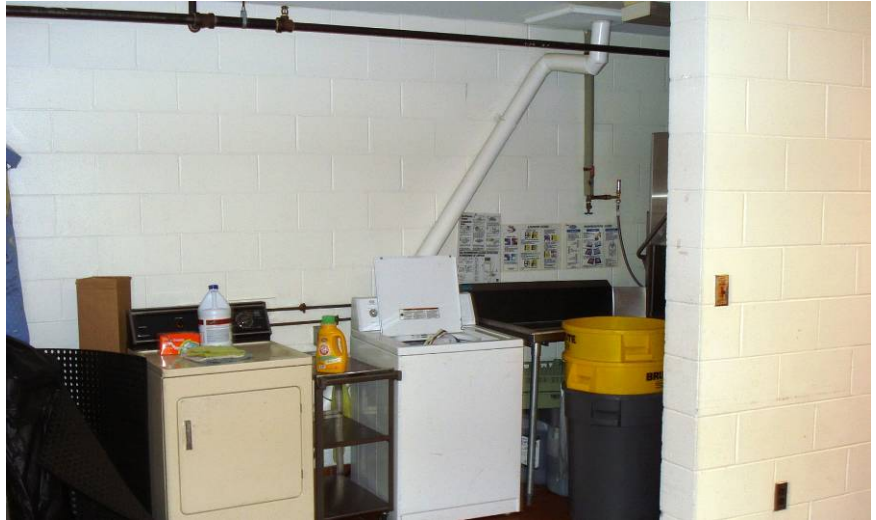
The dishwashing unit and laundry equipment share a space off the kitchen. The dryer vent is not installed in accordance with current codes. Exhaust is not provided for the dishwasher.

*Kitchen Laundry and Dishwashing Area*

We would recommend the installation of proper dryer exhaust ducting and the installation of proper exhaust for the dishwasher equipment.

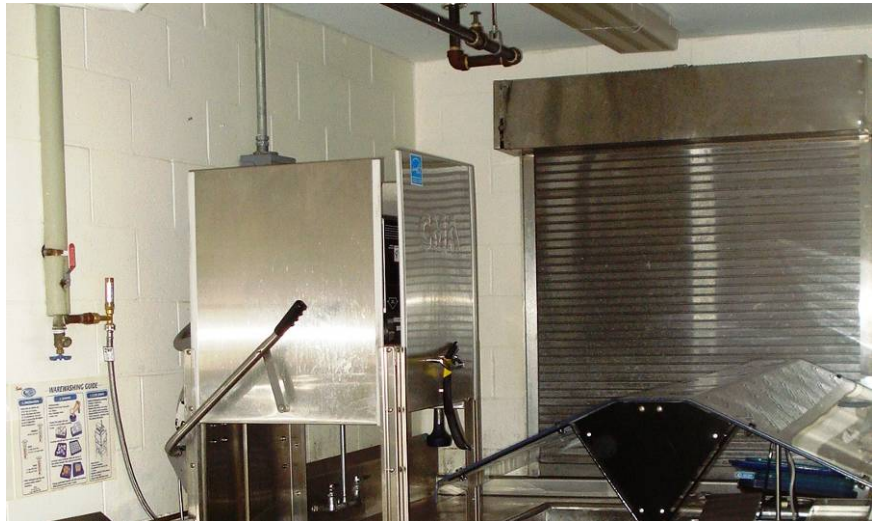
*Dishwasher Area*

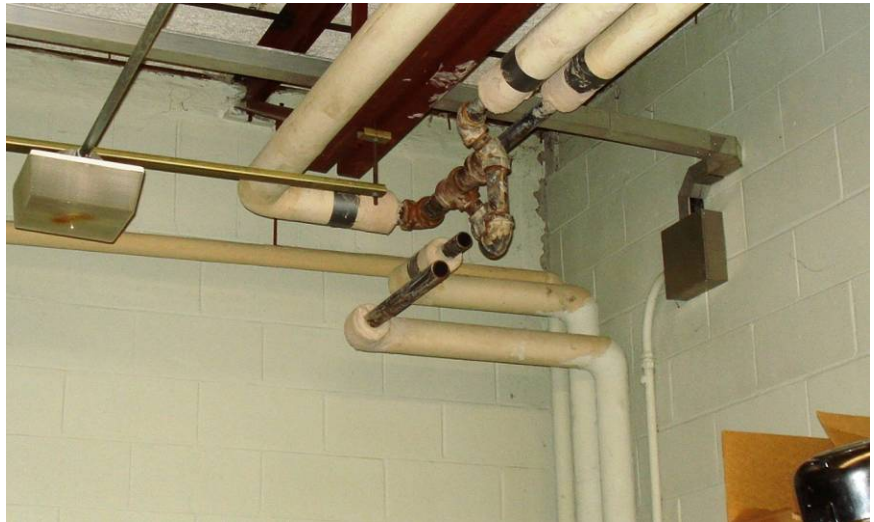
In the corner of the dry storage room, it appears some of the original heating pipes have been cut and abandoned open-ended. The piping insulation material is unknown due to the inaccessibility to the piping.

*Piping in Corner of Dry Storage Room*

We would recommend a review of the existing pipe insulation and determine proper action for pipe removal.

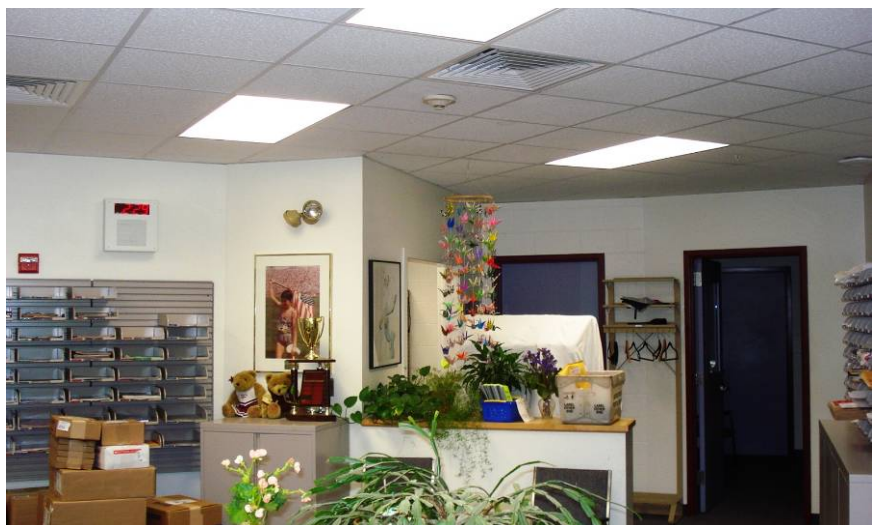
Heating, ventilation, and air conditioning is provided for the office areas through the air handling unit AHU-15 installed as part of the 2004 renovations project. During our review, the spaces felt very cool. Perhaps the setpoint is set too low. Perimeter heating is provided through baseboard radiation.

*Main Office*

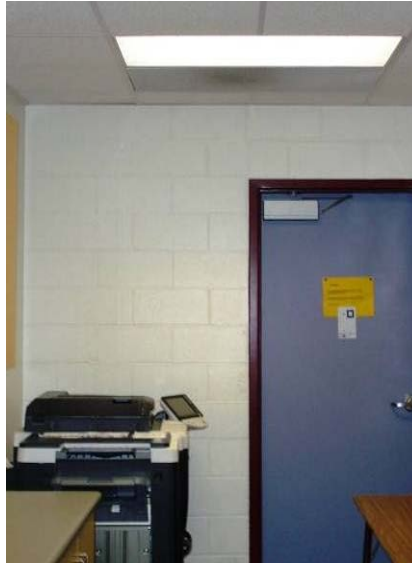
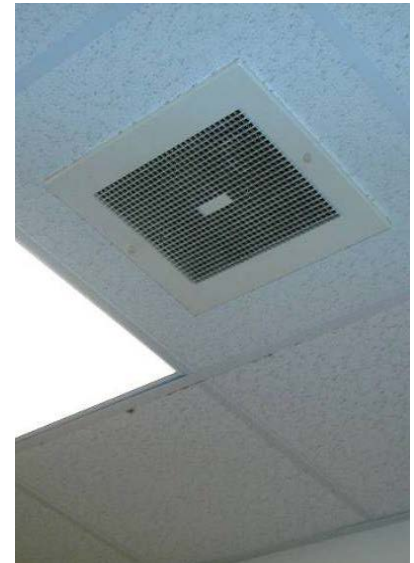
Ventilation in the print room is provided through a return air connection to AHU-15 and a separate exhaust air grille connection to the ceiling-mounted exhaust fan EF-10. The return grille is shown in the photo below. The exhaust fan/grille is located directly above the door opening. If the ventilation in this space is an issue, perhaps the return grille and exhaust fan could be relocated.

*Print / Copy Room Off Main Office. Copier and Return Grille Shown at Left. Exhaust Fan Shown at Right*

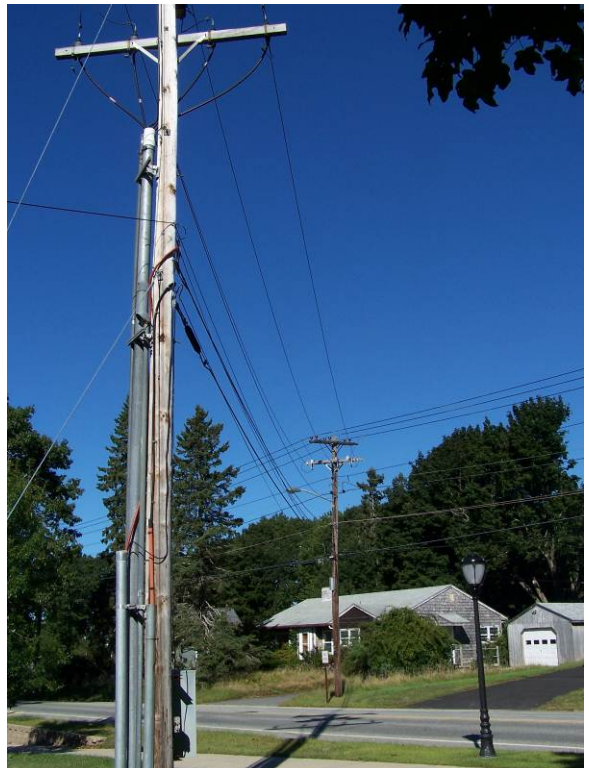
Primary service is supplied by a radial 15kV underground primary service feed. Primary conductors originate at a CMP riser pole located on the Scott Dyer Road near the Cape Elizabeth Middle School. The conductors travel to the middle school pad mount transformer in PVC conduit where they are tapped to supply the Middle School and High School transformers. From the Middle School transformer, conductors continue in PVC conduit to a splicebox at the edge of the middle school parking area. Cables then run direct buried under the ball field and tennis courts to a manhole at the edge of the high school parking area. The cable transitions to PVC conduit for the remainder of the distance to the high school 500kVA 3 phase pad mount transformer. Secondary service voltage is supplied at 120/208 volts.

There have been multiple problems with the direct buried cable resulting in lost phases and multiple outages.

*Primary Service Riser Pole  
and Meter at Scott Dyer  
Road*

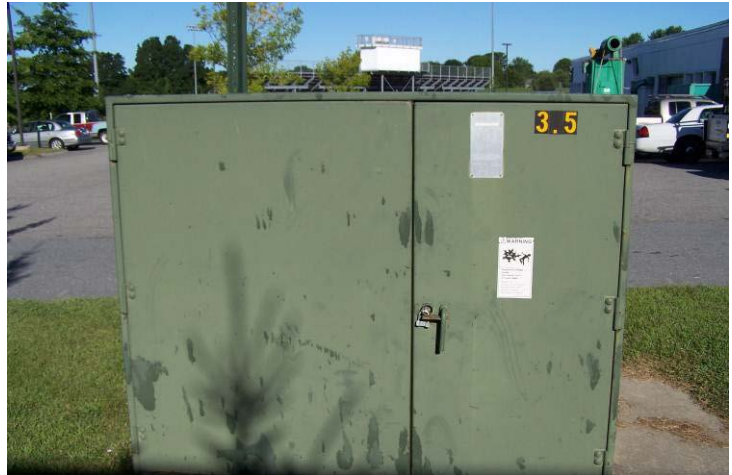
There is no peak demand data for this service as there is one primary meter for the High School and Middle / Pond Cove Elementary Schools; however, the 500kVA transformer appears undersized for the square footage of the building.  $500,000\text{VA} \div 162,630 \text{ sq ft} = 3.1\text{VA/sq ft}$  (typical design  $\text{VA/sq ft} \approx 8\text{VA/sq ft}$ ). As technology requirements increase it is likely that energy usage will increase also.

*Primary Service  
Transformer*

| ITEM | System | System Status | Assessment of System | Recommended Maintenance System Replacement | Probable Cost | * Priority |
|---|---|--|---|---|---|---|
| E1.1 | Primary Service | Primary underground is largely direct buried and has had multiple failures. Pad mount transformer is 500kVA. | Poor reliability in direct buried cable. Transformer is undersized for building load. | Replace existing primary underground service with new primary underground service from Ocean Street. | \$250,000.00 | 1 |

It is recommended the existing primary service be disconnected from the middle school and a new service be installed originating at Ocean Street and terminating in a new higher capacity pad mount transformer.

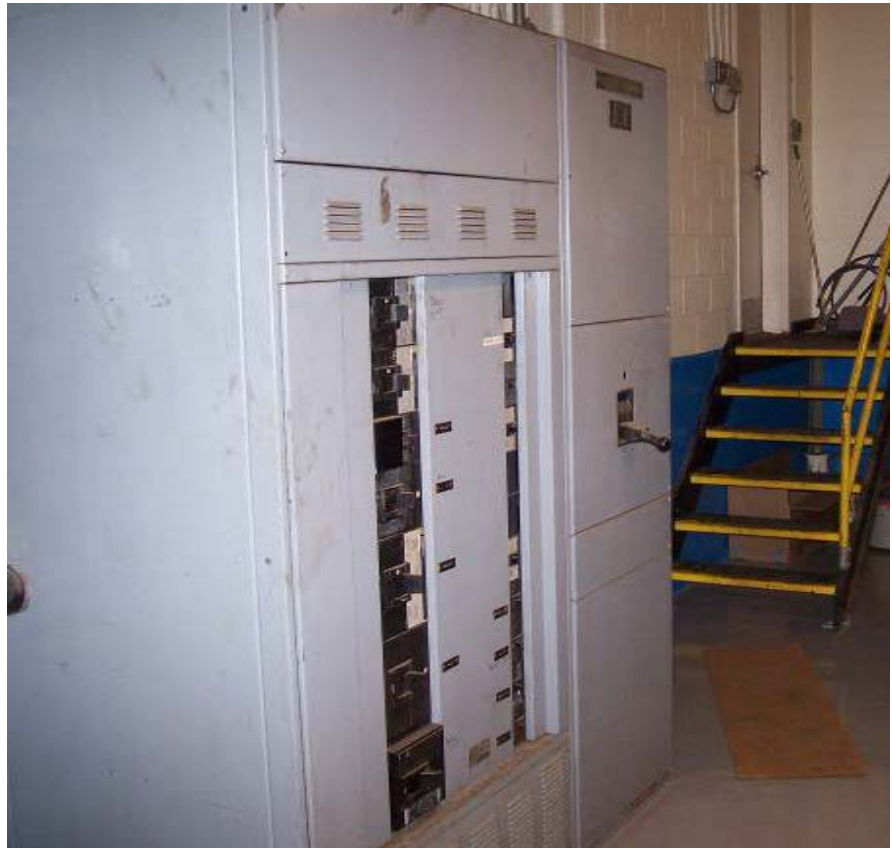
The main school service consists of secondary conductors from the exterior pad mounted transformer feeding a 2000A 120/208V 3phase 4wire Square D main switchboard located in the boiler room. The main switchboard then serves three distribution panels and multiple lighting/power panelboards throughout the school facility. Distribution equipment appears to be in serviceable condition; however, much of it appears to be original equipment (1969 - 43 years old). The distribution section of the switchboard has several spaces for future breakers.

*Main School Switchboard*

It was noted that the electrical feed to Hannaford Field is overloaded. It is recommended that this be replaced with a larger capacity service.

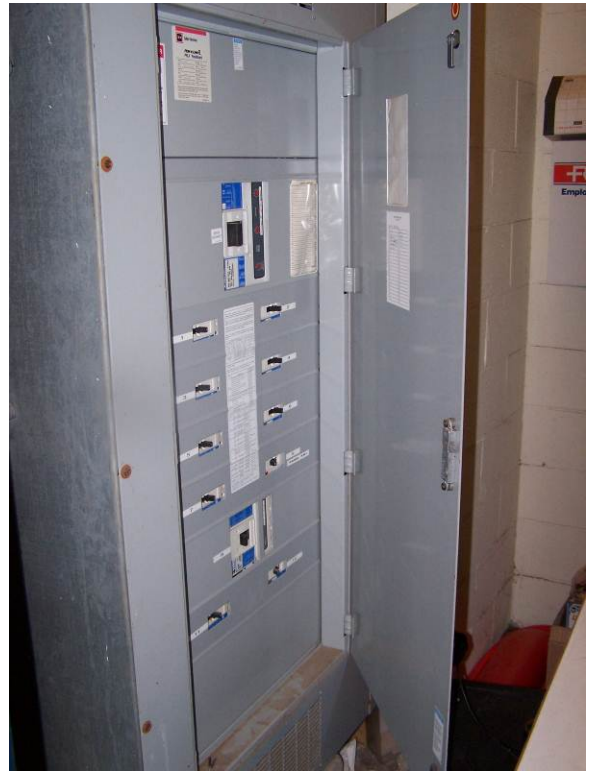
The service in the Donald Richards Pool area consists of secondary conductors from the exterior pad mounted transformer feeding an 800A Cutler-Hammer distribution panel located in the pool mechanical room. Distribution equipment was installed during the 1999 pool addition and appears to be in excellent condition. There is no space for future breakers, requiring alterations to the system for future expansion. Consideration should be given to the high humidity and corrosive environment this equipment is installed in.

*Pool Area Distribution  
Panel*

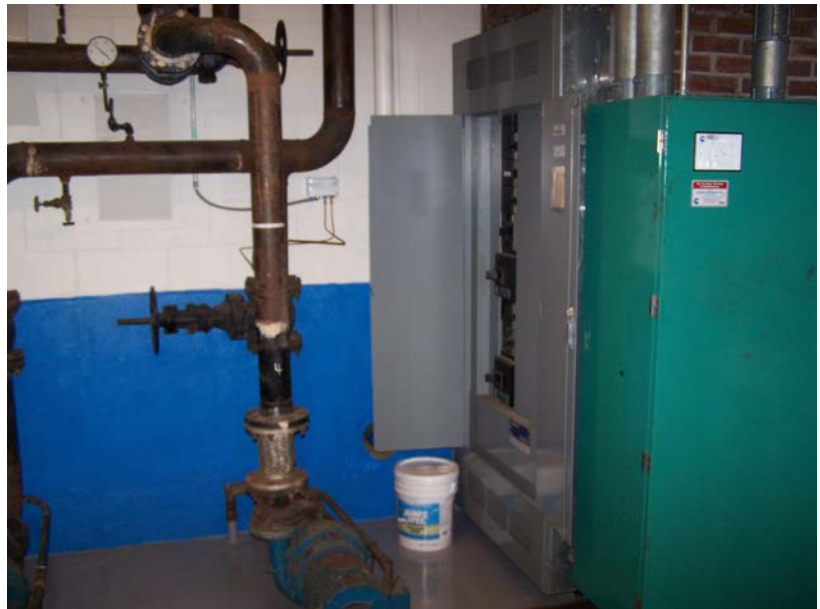
The high school is served by a standby power system. This consists of a 1000A Onan automatic transfer switch located in the boiler room. The normal side of the transfer switch is connected to a breaker in the main switchboard and the standby side is connected to an exterior self-contained Cummins-Onan diesel standby generator set rated 204kW and configured (configurable for multiple voltages) for 120/208 volts, 3 phase, 4 wire. Standby power is provided to a 1000A distribution board DP1 located in the boiler room. It was observed that the distribution board DP1 did not have code required clearances.

It appears that only mechanical loads are fed from the standby system, but the system does not incorporate the mechanical system controls. This condition renders the mechanical system inoperable during a power outage. The generator and transfer switch have ample capacity to feed many more loads in the building than are currently connected. Consideration should be given to using this system to its full capacity. This could include mechanical loads and controls, standby lighting, computer system and other non-life safety loads. With the addition of a separate transfer switch and panel, the system could be expanded as a life safety system as well.

*Automatic Transfer  
Switch and Standby  
Distribution Board*

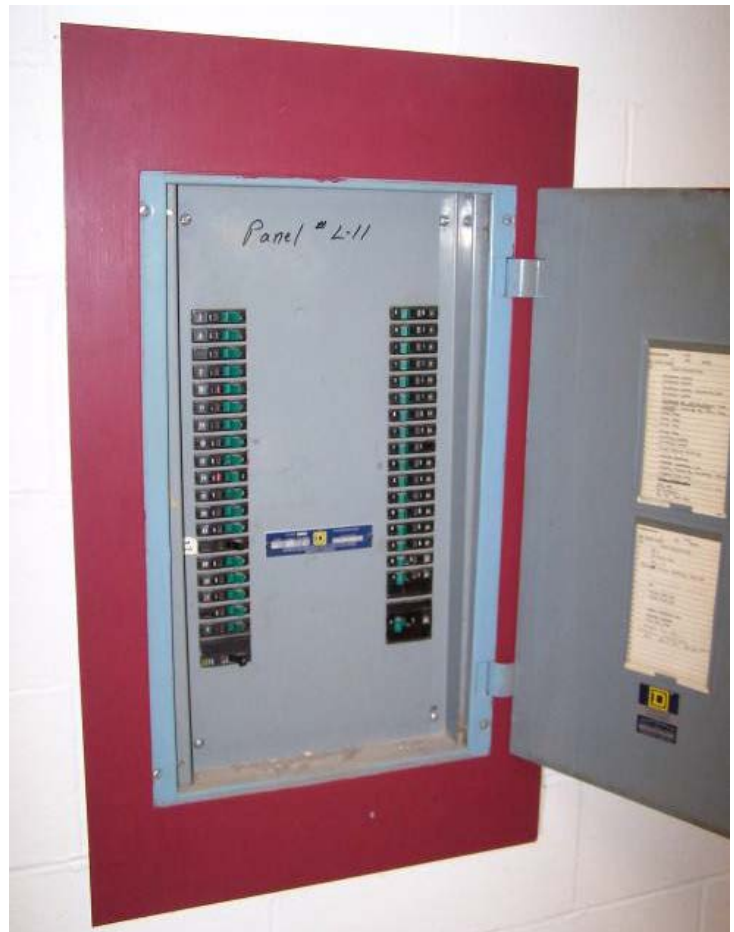
Lighting and power panelboards are located throughout the facility. Many panels located in classroom areas are filled to capacity with breakers. In areas needing additional circuit capacity, additional panels or panel replacement may be required. Panels located in the corridors and accessible to the students were not locked but should be provided with lockable hardware to prevent unauthorized access.

*Typical Lighting/Power  
Panelboard*

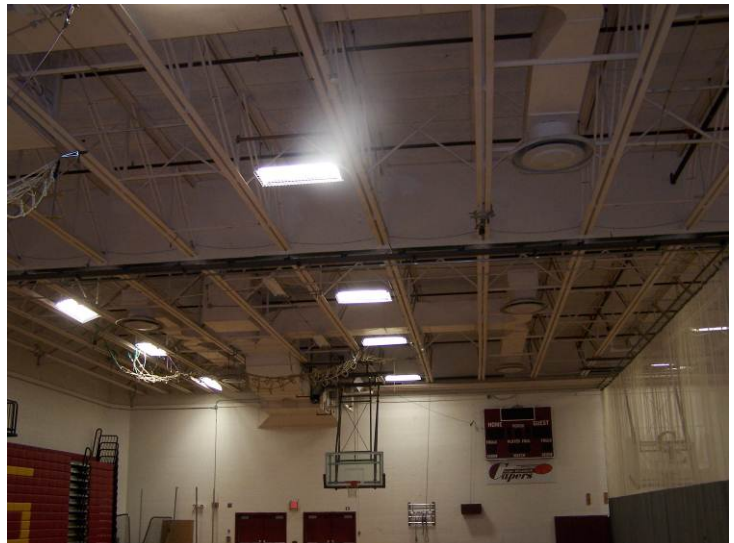
Gym lights consist of five rows of six, 6-lamp T5 high bay fixtures. Some fixtures are damaged and many need replacement wireguards. Lighting levels are fair to average.

*Gym Lighting*

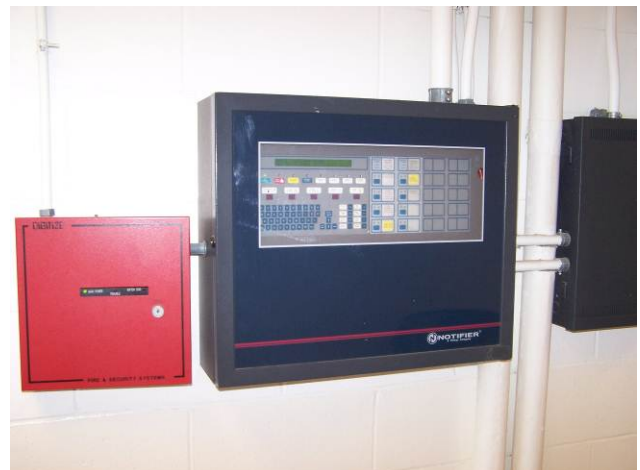
Fire alarm system is an older Notifier AFP-400 addressable system, with an associated voice evacuation system. In the event of an alarm, the system reports directly to Portland monitoring / dispatch facility. This system has had numerous device failures markedly in the pool area most likely due to moisture infiltration and corrosion.

#### *Fire Alarm System*

| ITEM | System | System Status | Assessment of System | Recommended Maintenance System Replacement | Probable Cost | * Priority |
|---|---|--|---|---|---|---|
| E1.8 | Fire Alarm System | Older Notifier AFP-400 system with voice evacuation. Notification appliances and initiating devices throughout the building. Many trouble notifications, and failures mostly with pool area devices. | System is older but functional. Some areas need additional notification appliance coverage to meet NFPA 101. Annual inspections are performed by Eastern Fire Protection Co. | Perform study of and provide additional notification appliance coverage in all areas to meet NFPA 101.<br>Replace devices in pool area to minimize system faults / trouble alarms. | \$40,000.00 | 1 |

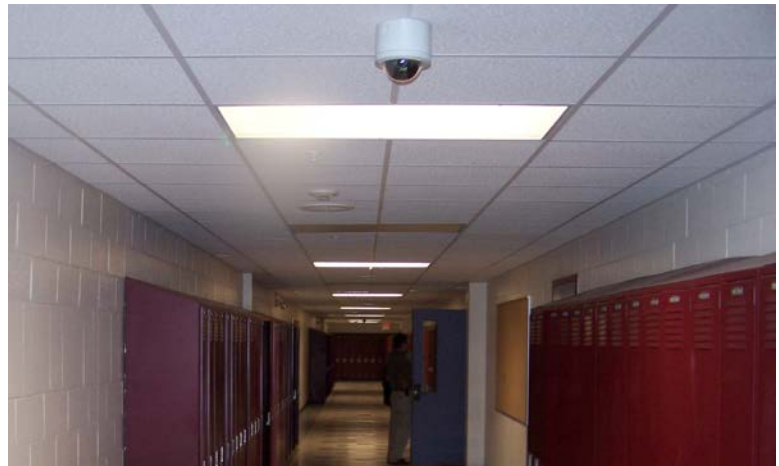
The High School is served by a video surveillance system with cameras at various locations throughout the building, mainly at building entrances. The system is an Integral Technologies system with a mixture of legacy and upgraded video platforms. The main server is based in the High School but also serves the Middle School, Pond Cove Elementary School, Police Department and Fire Department. Advance Technology is responsible for maintaining the system, and reports multiple failures of the system, with frequent database corruption and loss of camera function.

*Typical Camera*

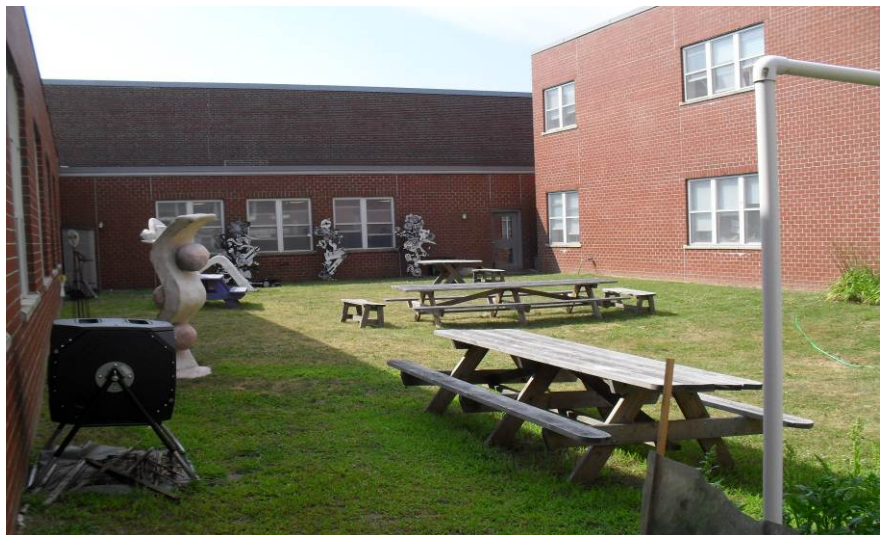
The existing courtyard is grassed and includes tables and other items that one may assume is for student use. There is only one means of egress out of the courtyard. The Life Safety Code requires minimum two means of egress diagonally across from each other. This area should be reviewed with your local fire department for approval of use as the authority having jurisdiction. Per the code, this area cannot be occupied with a single means of egress. The exit doors should have an exit sign over the top and the doors should have a proper panic device for exiting a potential of 50 people or more.

*Courtyard with One Means of Egress*

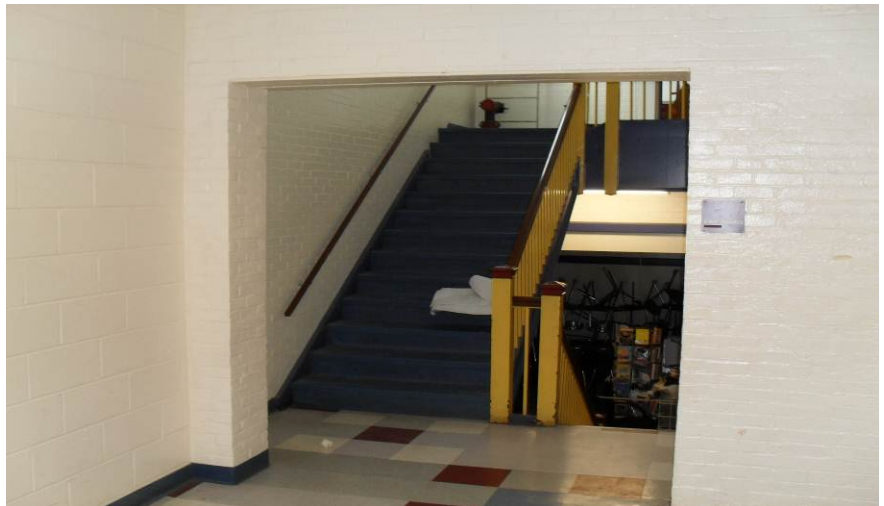
*West End Stairwell  
2nd Floor*

In the middle school building when the 1994 addition was added to the original 1934 building the floor plan oriented the new corridors in line with the 3-story stairwells of the original building. Per plan, the east stairwell exits into a protected corridor which exits to the exterior. The west end allows all

*Stairwell – Exits to an  
Unprotected Corridor*

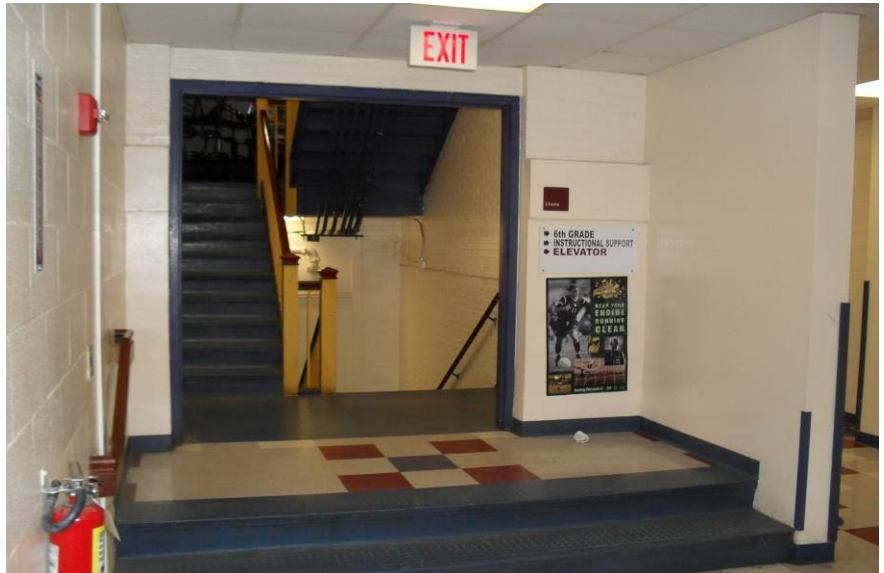
*West End Stairwell  
First Floor*

*Stairwell Opening to  
Corridor – Illegal Exit  
Sign*

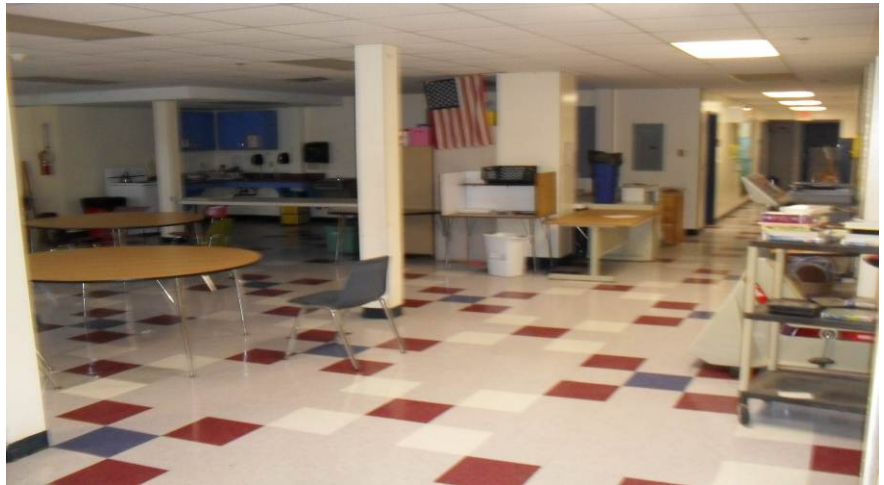
The space must be separated from the exit access corridor by a wall constructed of UL type components. The other end of this assembly space exits into the west end illegal stairwell.

*Assembly Space  
Integrated with Exit  
Corridor*

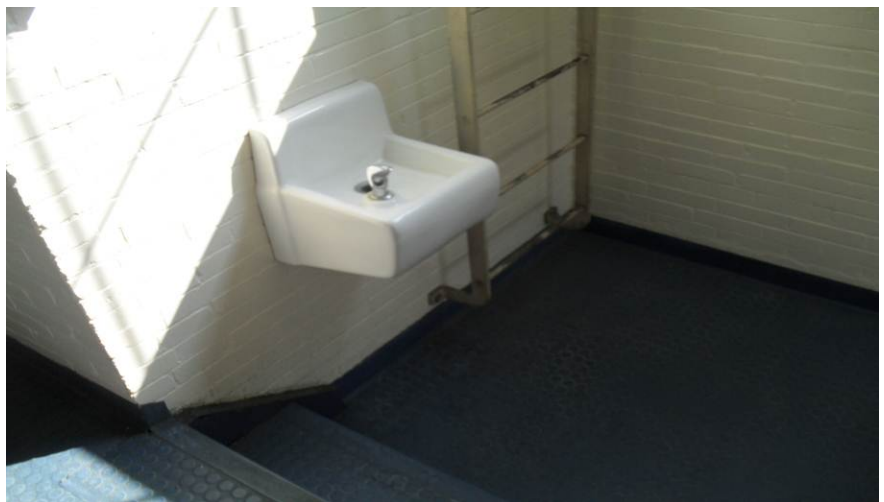
*Original 1934 Stairwell*

*Drinking Fountain and  
Ladder – Needs to be  
Removed*

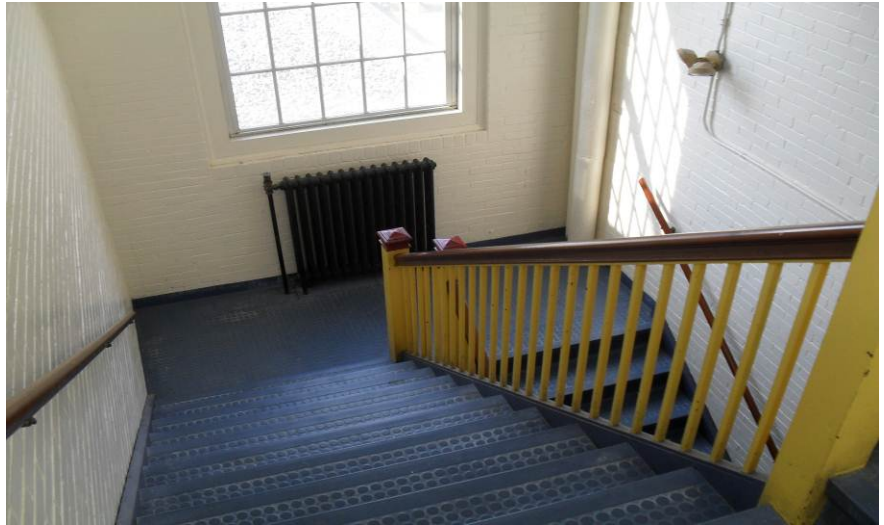
*Original 1934 Stairwell*

*Radiator Unit – Remove  
or Raise*
