**Town of Cape Elizabeth**  
Seven Building Facility Study  
*Cape Elizabeth, Maine*

HARRIMAN | Architects + Engineers

**Introduction****Town of Cape Elizabeth Facilities Study**

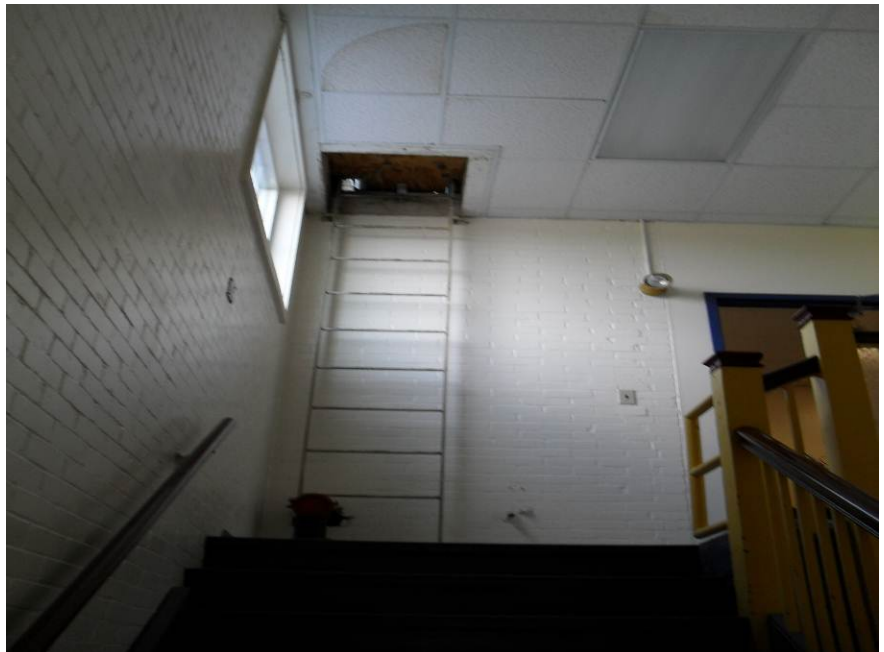
*Original 1934 Stairwell*

*Ladder – Relocate or  
Remove*

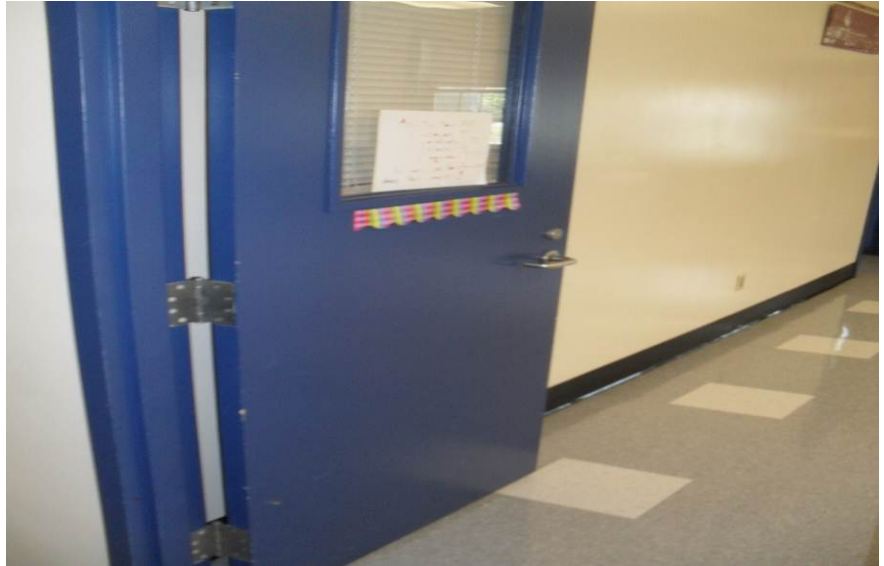
*Original 1934 Building*

Doors to the classroom have glazed panels with the bottom exceeding the allowable 42” height to the bottom per ADA.

*Bottom of Glazed Panel Exceeds 42” Maximum Height to Bottom*

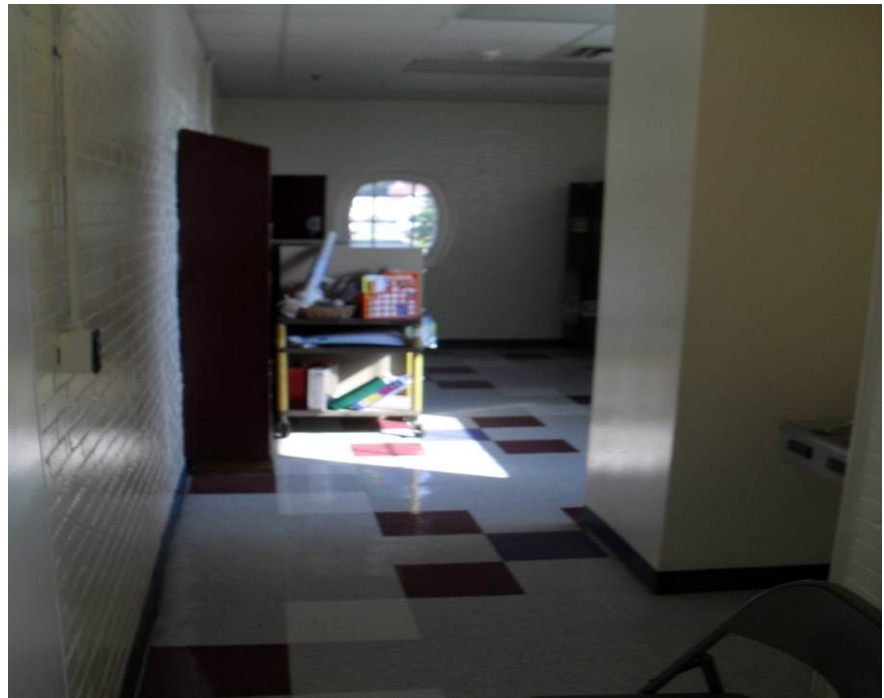
*Original 1934 Building*

In the second floor exit corridor to the stairwell there is an alcove off the east end of the corridor. This space constitutes a dead end corridor and must be separated by partition from the corridor.

*Dead End Space Off Second Floor Corridor*

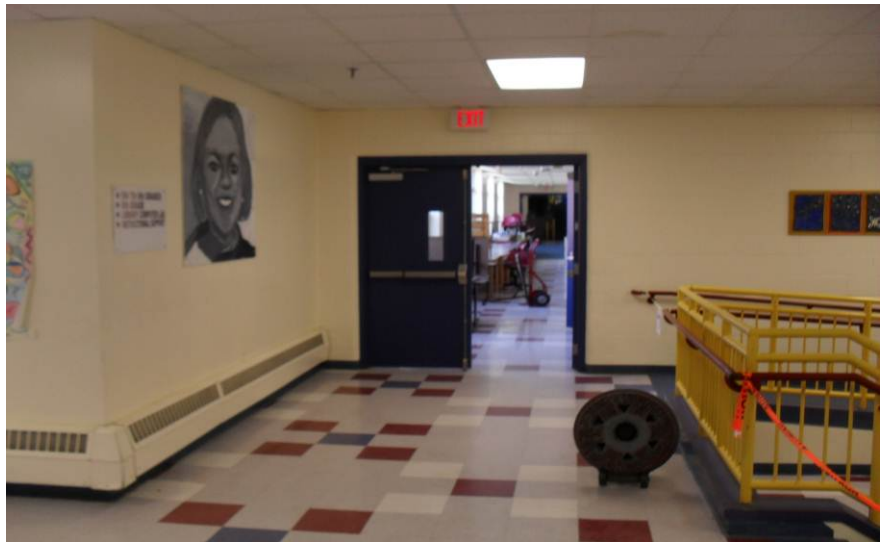
*Middle School Lobby / Corridor*

These cross corridor doors swing in the wrong direction. The exit access corridor from the library must have two means of egress out of the building. The doors swing into the exit corridor and should swing towards the lobby. The exit sign should be removed; this is a non-compliant means of egress.

*Illegal Means of Egress Door Setup at Lobby*

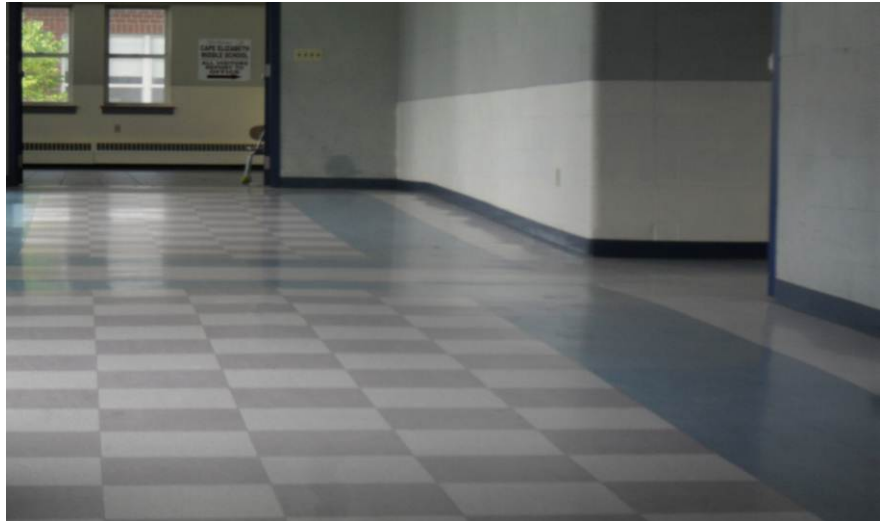
*Ramp at Cafeteria Corridor*

The corridor next to the cafeteria entrance has been constructed with a ramp to provide access to different levels of the cafeteria. The ramp transition from the upper floor level to the mid-level was not constructed to meet ADA. The ramp run was not extended long enough. The level requirements at each end and the bottom of the concrete ramp have been manually dished toward the entrance doors causing a cross slope that is non-compliant with ADA.

*Non-Compliant Ramp Entrance*

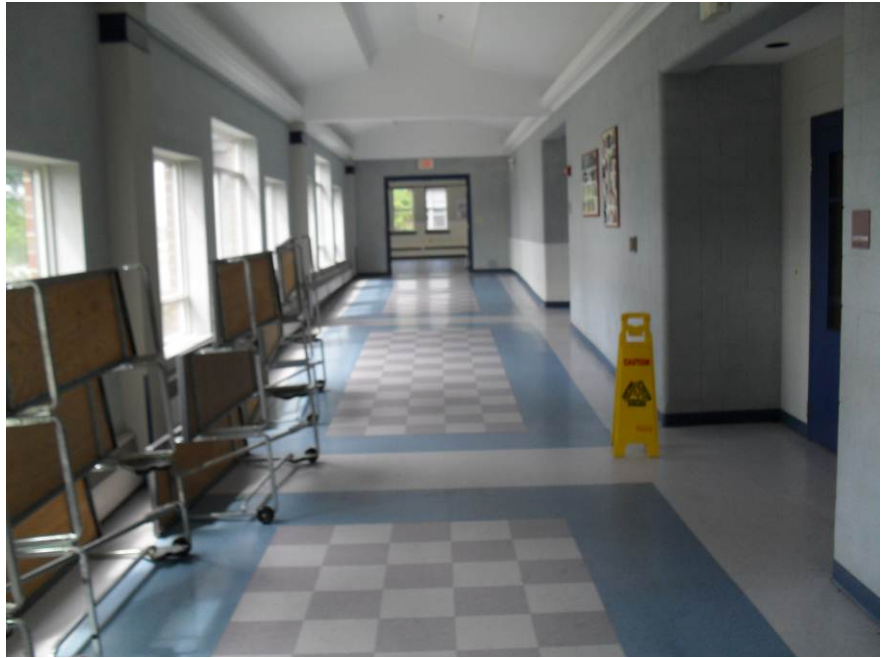
*Main Entrance Corridor  
With Ramps – Farther  
One is Non-Compliant*

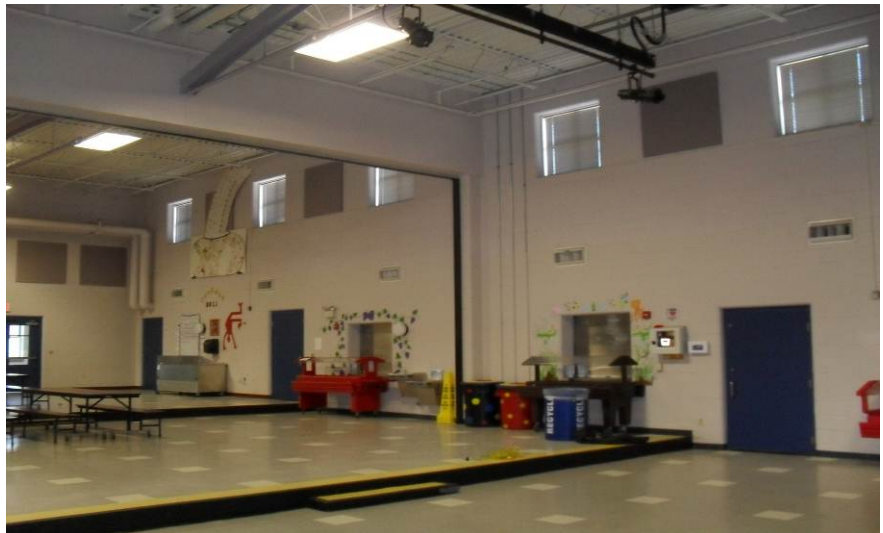
These two steps between levels are not guarded off in any manner and also present a strong tripping hazard potential and the liability that goes with these levels.

*ADA Accessible Routes  
to Serving Line –  
Change in Level – Life  
Safety Code Issue*

Recommend a design study to propose a solution to this space that would meet ADA and the life safety code. As part of this study it should involve the serving area to see if there is a solution to steps and a more efficient use to your kitchen staff.

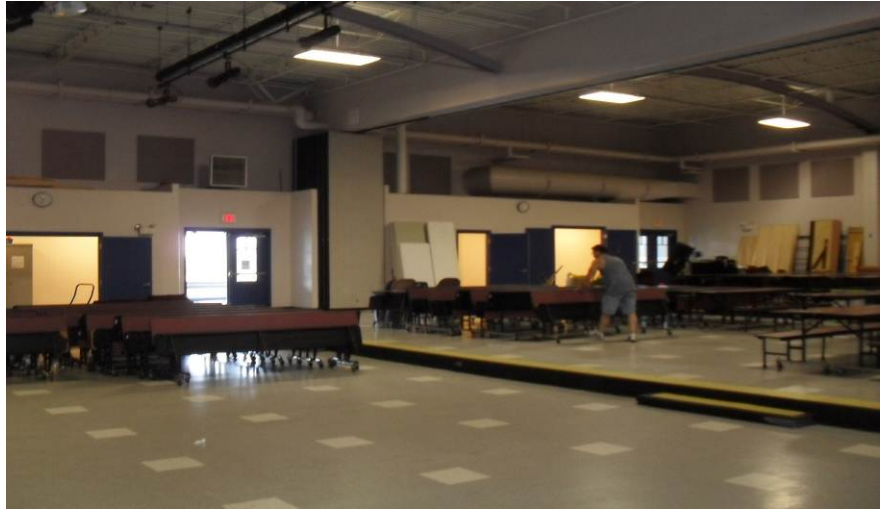
*Middle School Cafeteria*

*Low Level Lighting*

Would recommend a study and possible re-lighting to bring up light levels.

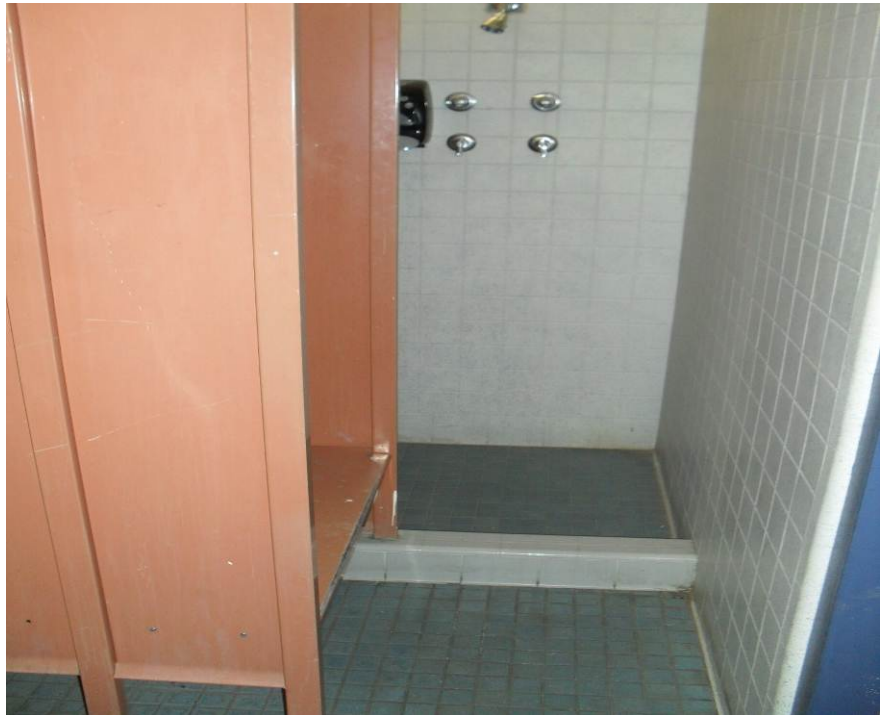
*Non-Compliant Shower  
– Girls Locker*

As a method to upgrade shower areas and bring them up to ADA code we would recommend a complete renovation of both the boys and girls locker rooms.

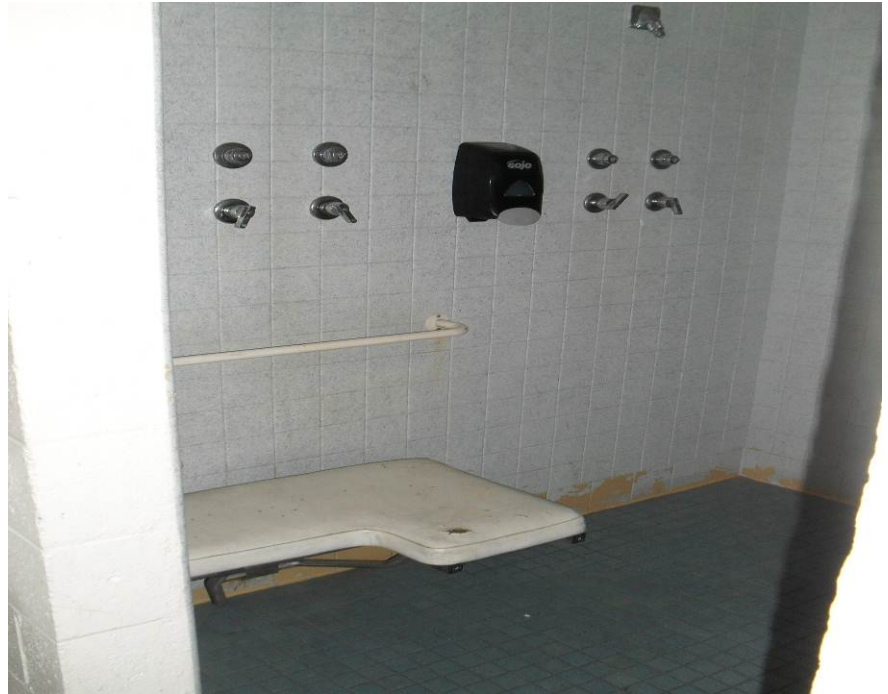
*Non-Compliant Boys  
Shower*

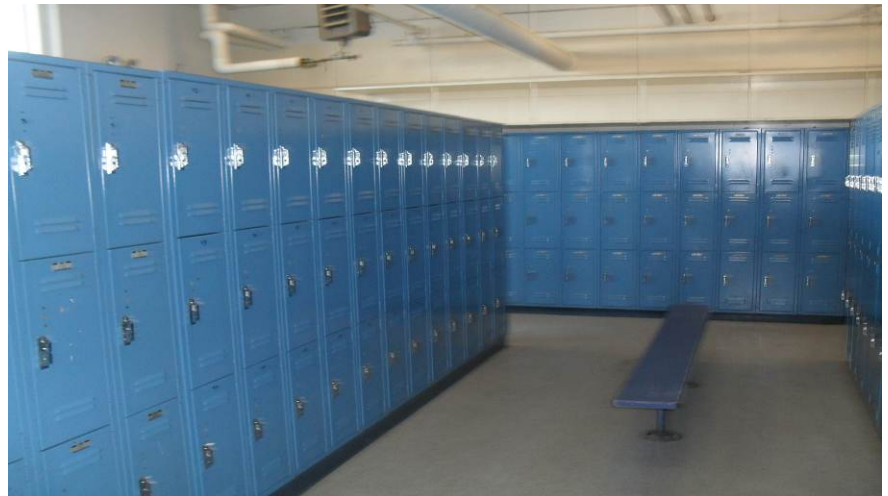
*Provide ADA  
Compliant Lockers*

We recommend adding the correct amount of ADA compliant lockers to each locker room. The number is a percentage of the schools population.

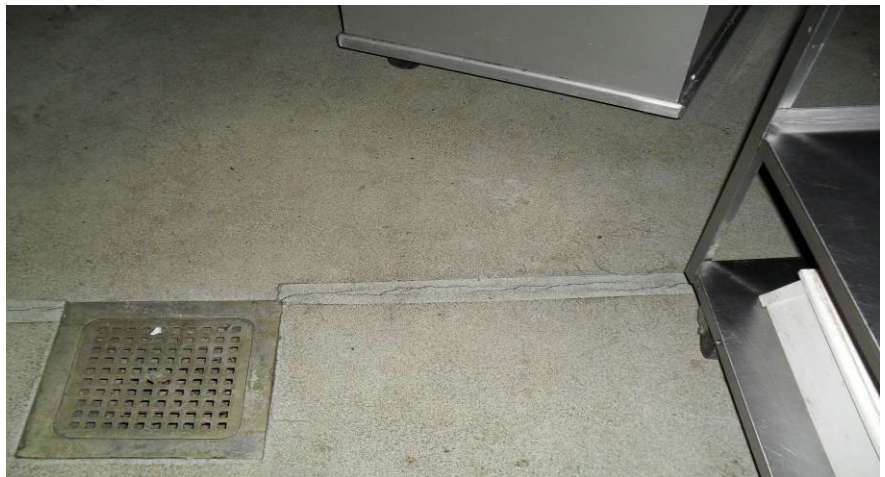
*Kitchen Floor*

The system is showing many repair areas and cracks due to the concrete slab substrate shrinking.

*Patched Kitchen Floor  
Showing New Cracks*

The system should be replaced as the cracks will allow floor washing water to enter and will only cause the system to fail further.

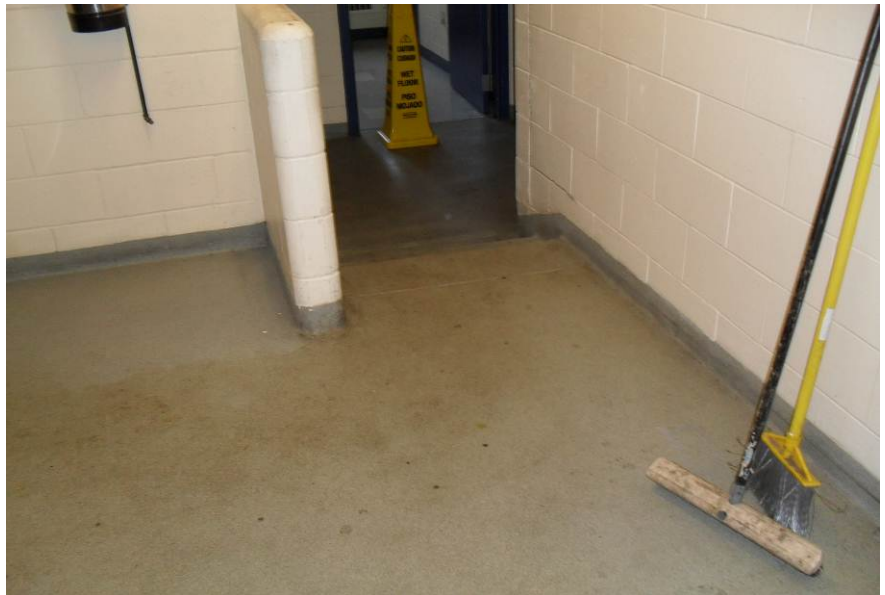
*Serving Line Area*

These steps offer liability exposure to your kitchen staff as a trip hazard.

*Steps to Serving Line*

When the decision is made to replace the floors we would recommend removal of the steps to the serving lines.

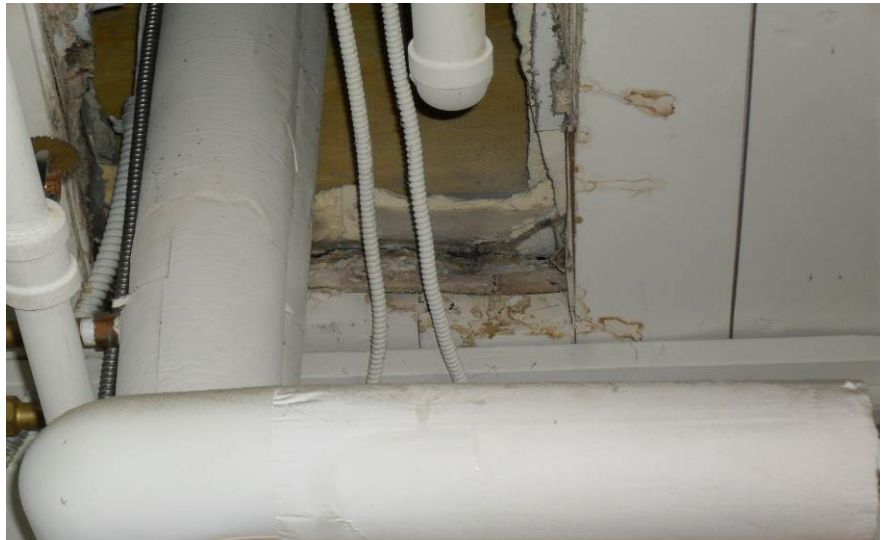
As part of a roof replacement project the new insulation was directly screwed to the wood deck over the old insulation, tar, and gravel. The picture below indicates that the roof cutout was done.

*Cutout in Existing  
Wood Deck*

As part of any new roof replacement, and if a long warranty for the new roof is desired, the wood deck will have to be removed. It is highly probable that the existing wood deck and the bearing steel frame will not meet the new IBC roof load and drift load capacities required.

This area should be considered and budgeted for a major structural upgrade as part of that roof replacement.

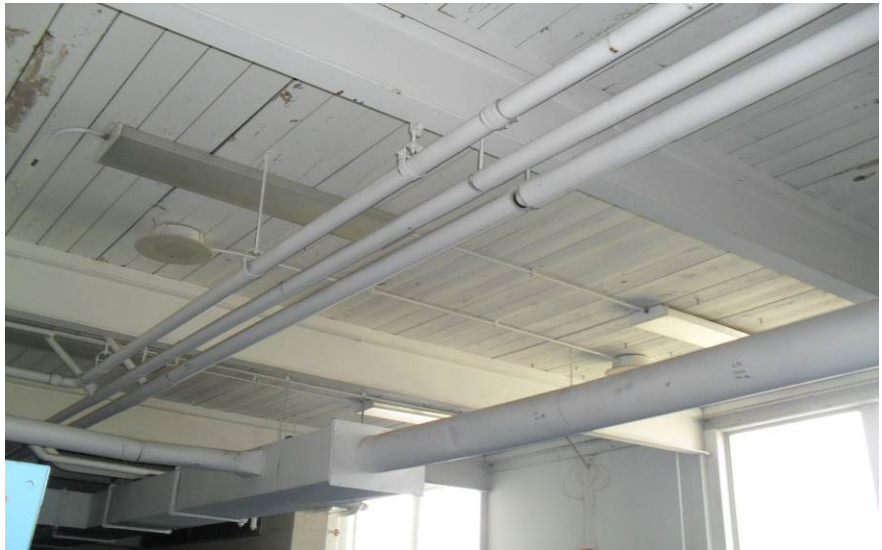
*Exposed Structure –  
Sprinkler Heads Layout*

Would recommend cutting in new heads to meet current code.

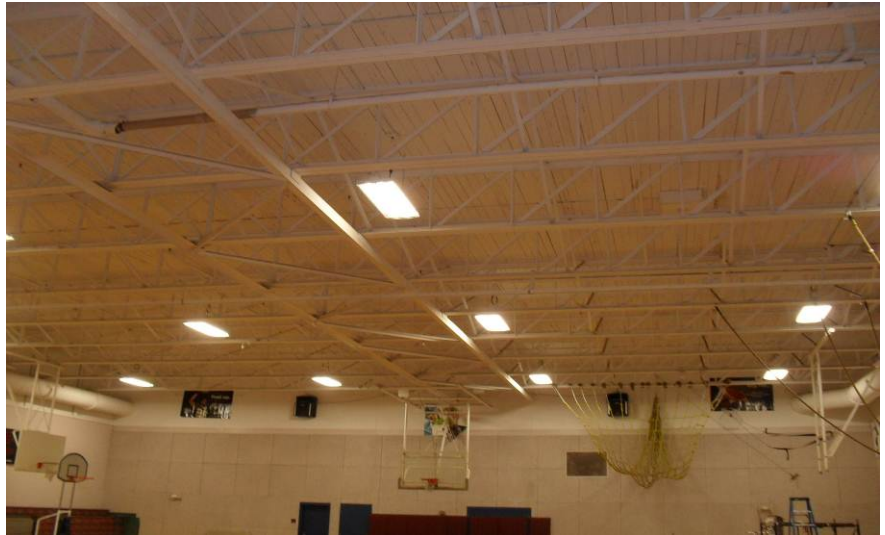
As part of a roof replacement project the new insulation was directly screwed to the wood deck over the old insulation, tar, and gravel. As part of any new roof replacement, and if a long warranty for the new roof is desired, the wood deck will have to be removed. It is highly probable that the existing wood deck and the bearing steel frame will not meet the new IBC roof load and drift load capacities required.

*Gymnasium Wood  
Decking*

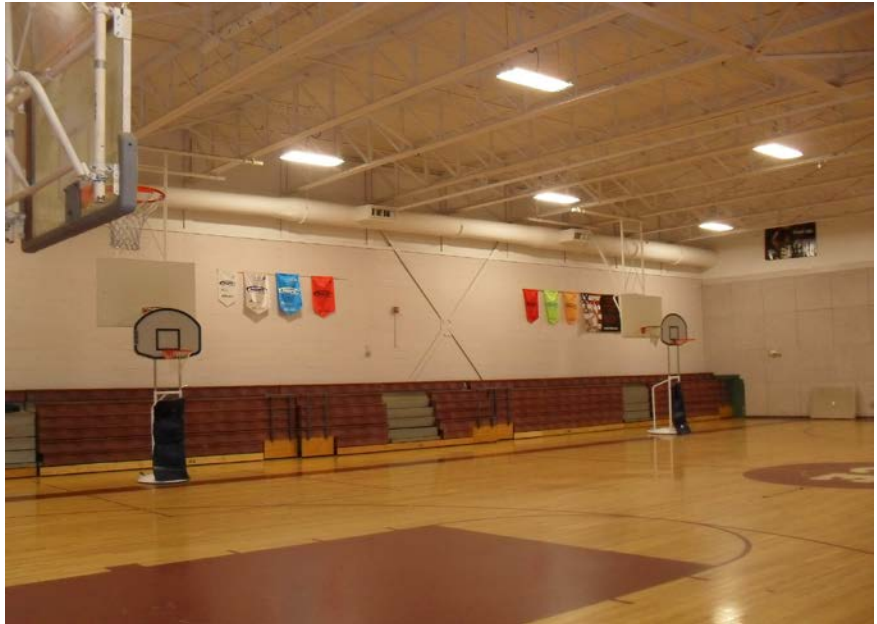
*Middle School Gym*

The gymnasium floor has been sanded as part of refinishing floor operations. There has been a substantial amount of wood surface removed during these sanding operations. The wood floor has been measured as low as 5/8" on the ends down from a 7/8" to 1" board when installed. Close inspection of the floor and one can see the tongue of the adjacent board thru the joint between. The wood floor is a direct nailed system and cannot be sanded again for a surface refinish system.

We would recommend a floor replacement be considered – the floor has been in place for almost 50 years.

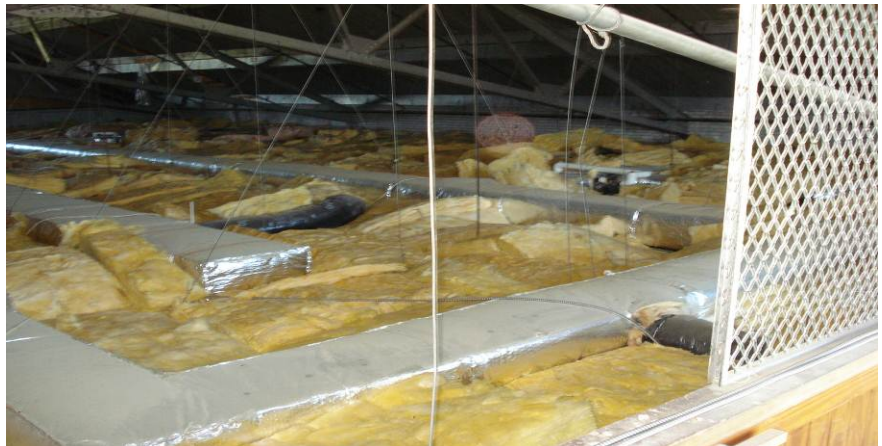
The 1934 original building was constructed with a second gymnasium space. To achieve the height for this space on a second level the roof was constructed with a series of steel angle truss girders spanning from wall to wall and steel beam cross purlins attached to the truss. On top of the cross purlins a large wooden beam was attached at each cross beam and a tongue and groove deck spanning from roof edge up the slope to the ridge is the surface for the roof shingle attachment.

*Steel Truss Girders*

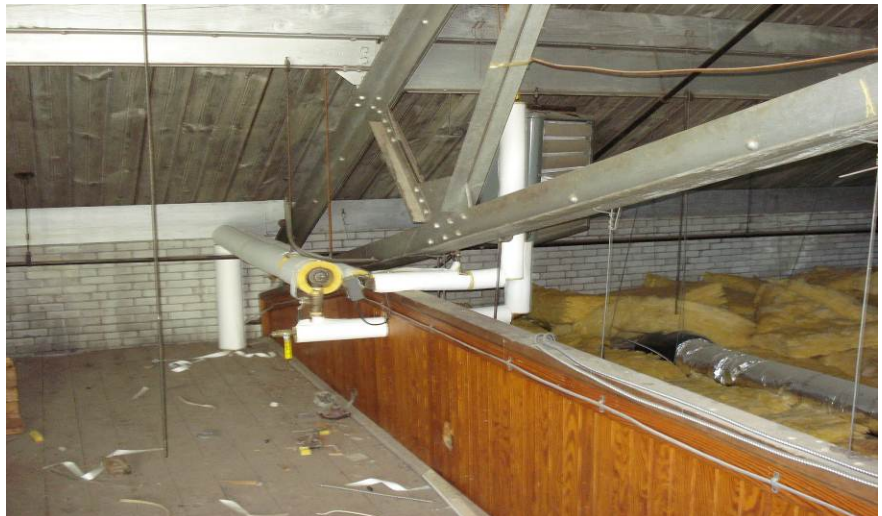
*Steel Truss Girder  
Old Wood Platform and  
Partial Wall*

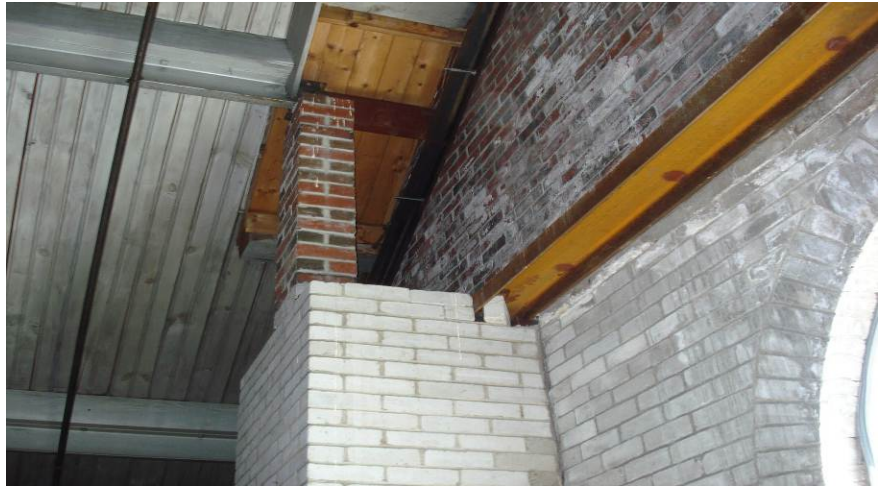
From the exterior the gable ends appears to have been repaired at some point, possibly when the roof was replaced. On the interior side of the gable ends a structural reinforcement of the walls has been installed. The picture indicates a series of structural shapes through bolted to the masonry from these new structural components and the components were welded back to the existing structure.

It would be safe to assume that added structural members were installed to brace the end wall. No design information was found to show what level of bracing was installed.

*Gable End Wall Brace  
Brick Pier off Existing  
Chimney*

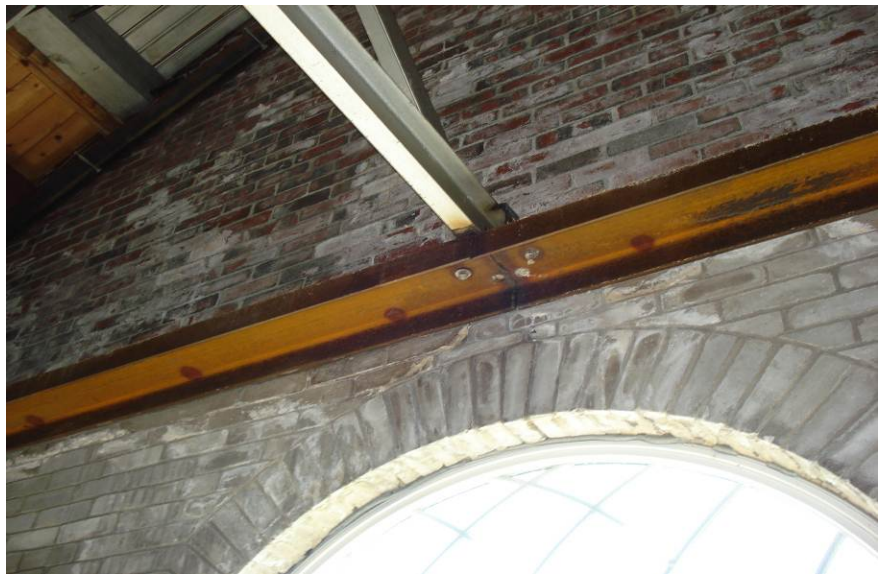
*Bolts Through Exterior  
Wall*

*Beam Shapes Welded  
and Bolted to Bottom  
Chord Cross Beam  
Extension*

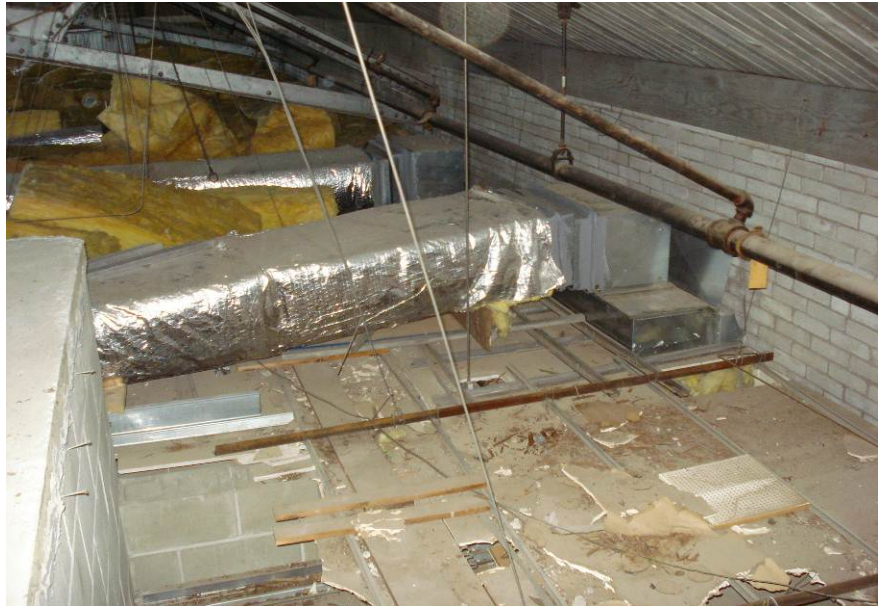
*Insulation Pulled Back  
From Ceiling*

*Drywall Ceiling  
Framing Sprinkler  
Piping Hangers to Cold  
Roll Channel Grid*

Recommend removal of the entire ceiling system and construction of a new insulated drywall ceiling and air barrier at an extended height. New system should have capabilities to hang all the relocated ductwork to a cavity between the insulation barrier and a new suspended ceiling. The attic space would then be turned into a cold space and properly vented. This repair should offer an energy savings by reducing the amount of volume the school is currently heating.

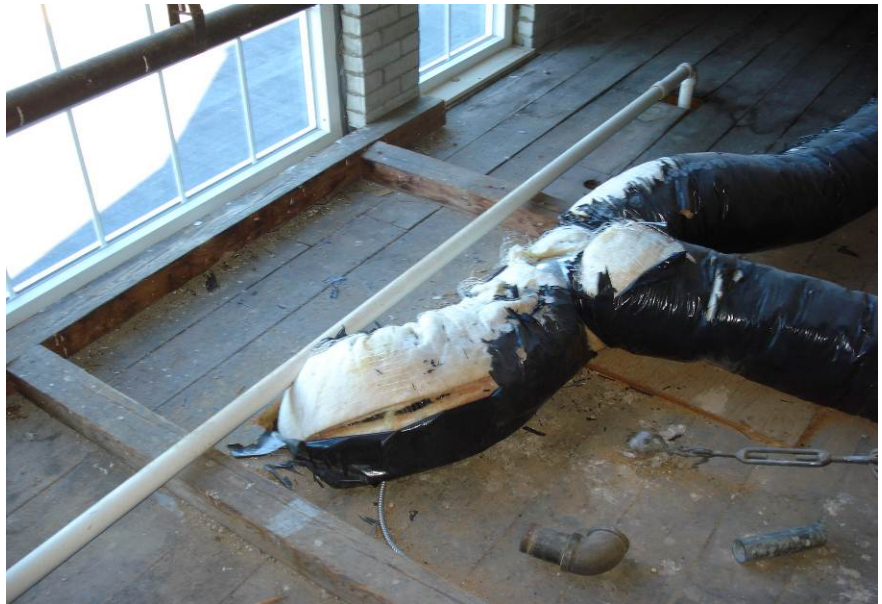
*Ductwork Through  
Existing Wood Platform*

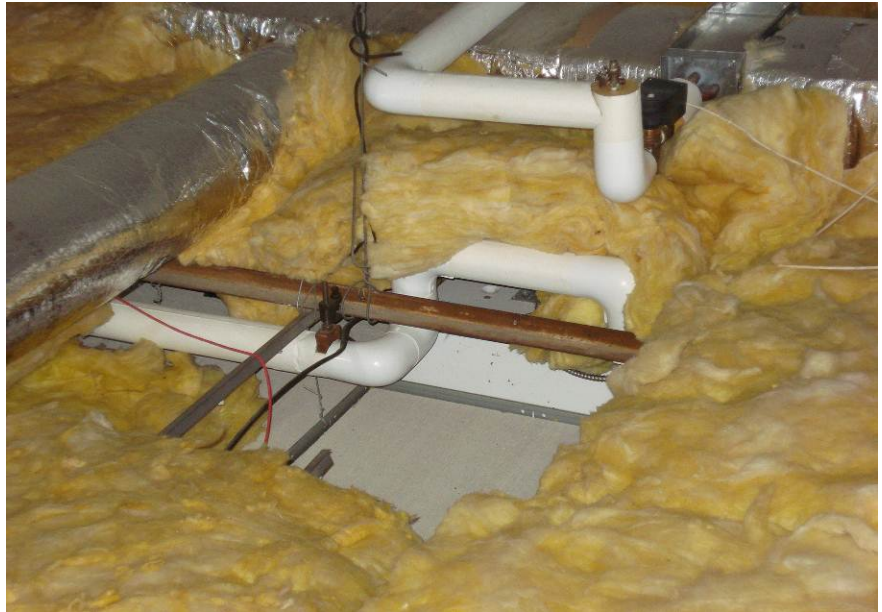
*Light Not Suspended  
Independently From  
Suspended Ceiling Grid*

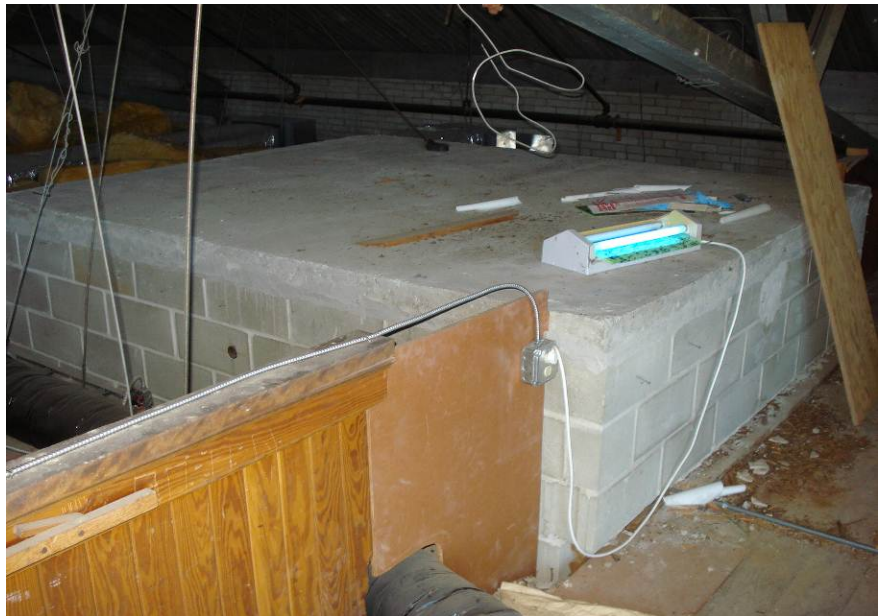
*Elevator Shaft Cap  
Existing Wood Deck  
and Wall*

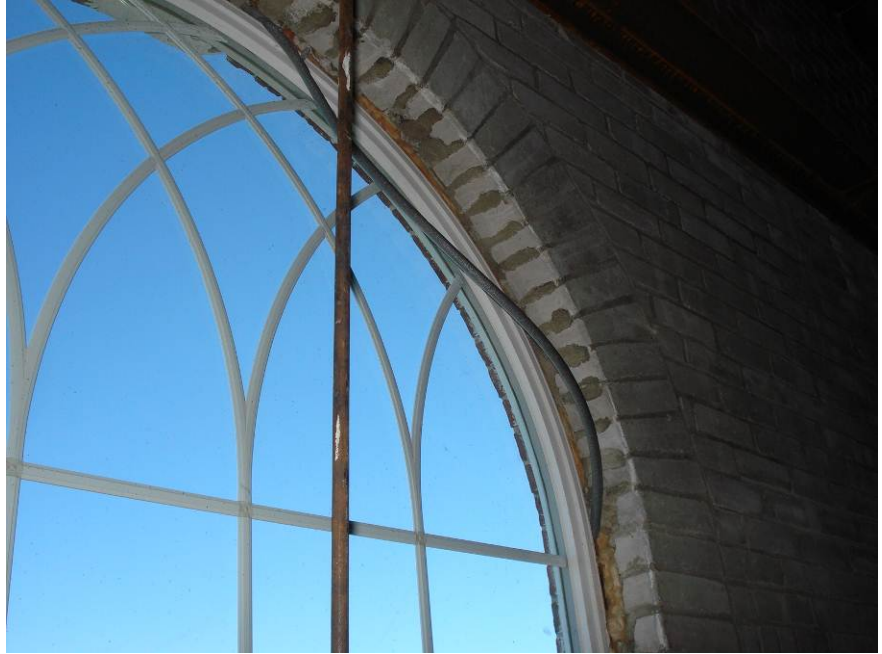
*Recent Window  
Replacement*

*Window Extends Into  
Attic Space*

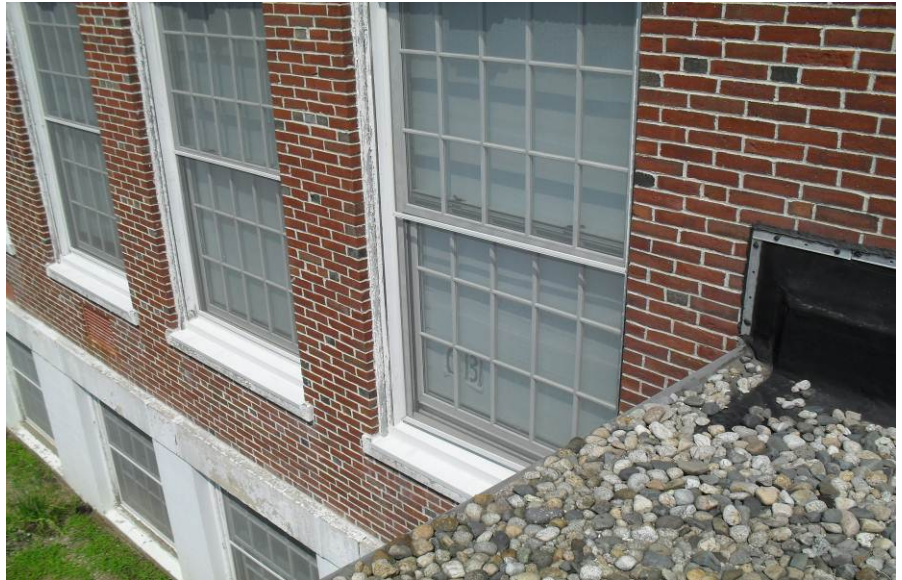
*Prefinished Metal Sill  
Over Cast Stone Sill*

We would recommend the installation of a prefinished metal panning system on all sides of the opening to extend the life of the wood frame. Currently a sanding, patching and repainting effort is underway to refinish these old frames. The frames are deteriorated to the point where this effort will be counterproductive. As a second option to this issue we would recommend removal of the existing aluminum sash unit, old wood frames, and window boxes. Provide new wood blocking and interior moulding to replicate a window of this type and install a new metal system on the exterior side as noted in option above.

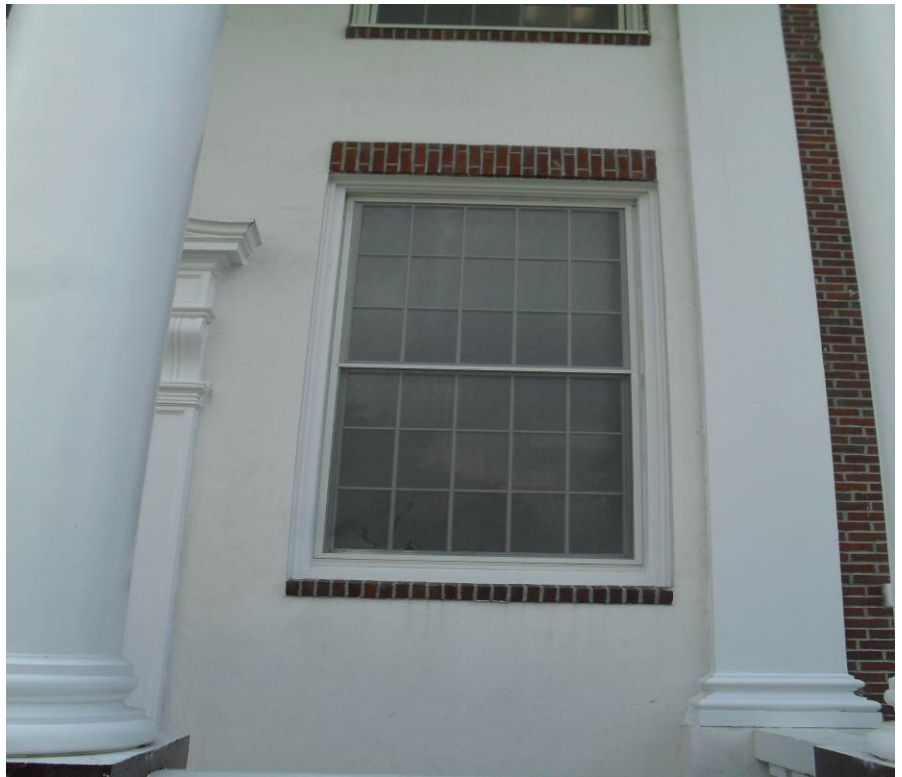
*Existing Window  
Completed With Metal  
Pan System*

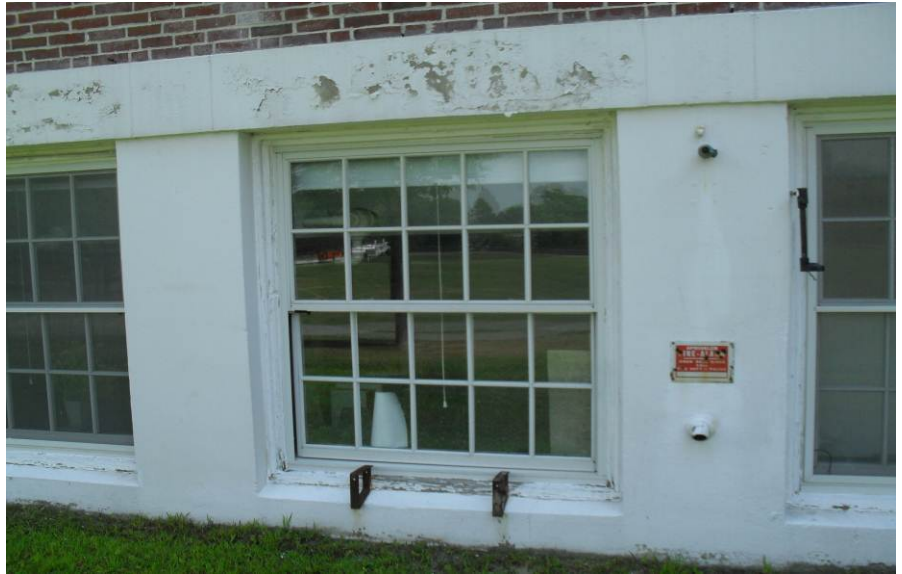
The white base of the building is the original exposed concrete foundation with a painted surface. Some exposures of the building have been repaired and refinished. Other exposures need work to the concrete surface with proper prepping and painting as well as window frames

*Concrete and Windows  
Requiring Repair and  
Refinish*

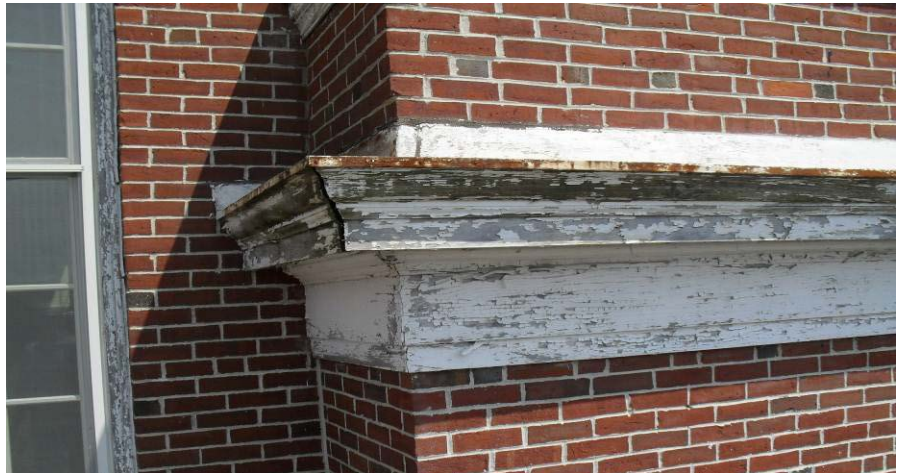
*Wood Cornice*

We would recommend the complete removal of all the wood trim and soffit boards and any rotted blocking system behind. Provide a new pressure treated wood frame system with a prefinished white metal bent cornice with a profile to match what was removed. By replacing this old wood cornice with a metal system it would preserve the appearance of the building as originally installed with low maintenance long term.

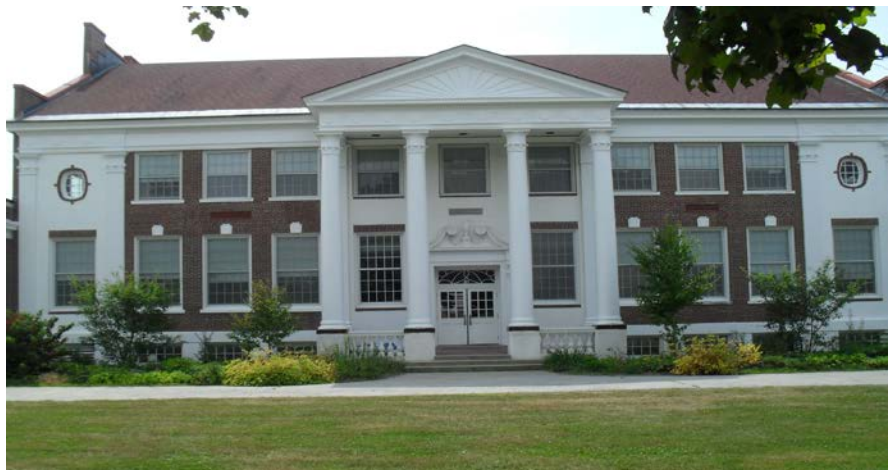
*The 1934 Building  
Exterior Columns at  
Front Entry*

The bases of the large exterior wood columns at the 1934 building have rotted out due to age. The columns are constructed of wood. Columns of this type and size will have to be custom made and we would recommend they be constructed of fiberglass. When the decision is made to repair the columns, at that time when the work commences it could be determined, depending on the condition, to do a partial replacement or if the condition is too deteriorated then complete replacement would be warranted.

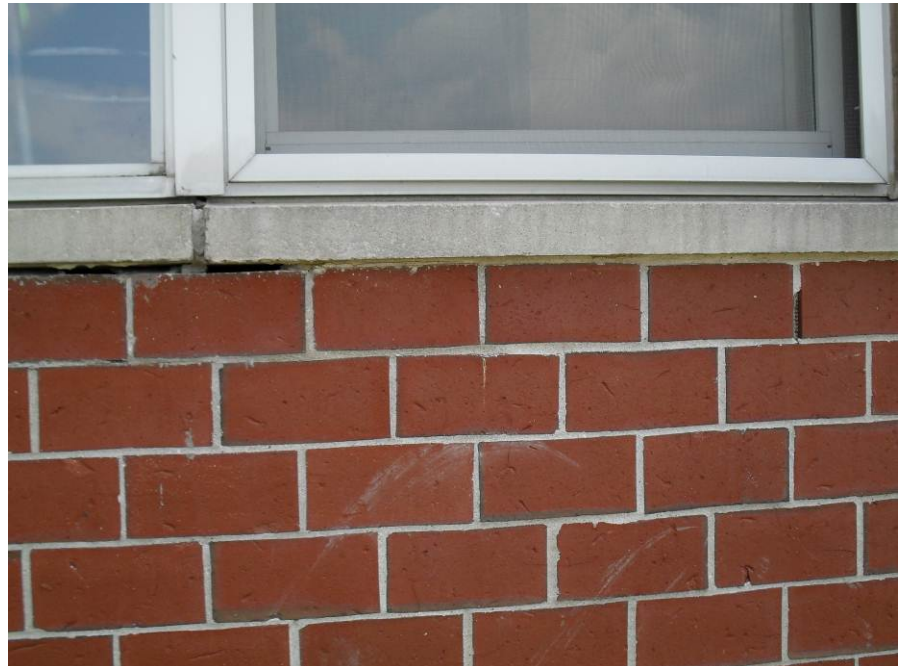
The new brick veneer installed on the elementary/middle school as part of the 1994 project has an issue with an improperly installed flashing system at the window sills. The brick module is an economy brick unit which is 4" x 8" extruded, with core holes in the brick center, it is not solid. In the contract documents a flashing system was indicated on the window details locating the flashing under the window sill and extending down to under the precast concrete sill. The constructed detail shows the flashing was extended down one course below the precast sill through the mortar joint. This flashing installation is trapping water and a freeze/thaw action has destroyed the mortar joints at the precast sill and the brick course below.

This type of damage should be corrected ASAP due to water entry causing more damage to the veneer and a more extensive repair cost.

*Damaged Butt and Sill  
Joints*

*Window Sill Damage*

Recommend a corrective repair to all existing windows that were built with this condition. It would involve removal of the precast concrete sill, brick and flashing down to the course where the flashing extends through the brick veneer. Though BIA recommends flashing under window sills we have, through our experience in this weather climate, not installed this flashing system. The issue with flashing not installed correctly thus forming a sag and trapping water at that level along with rapid changes in temperature during winter conditions leads to this type of damage. The brick should be re-installed with the same size unit and blend to match, and then reset the precast sill with a proper anchor and soft sealant joints at the butt and end joints. No anchorage of the sill was indicated on the contract documents but is required currently by IBC in conjunction with Siesmic Codes.

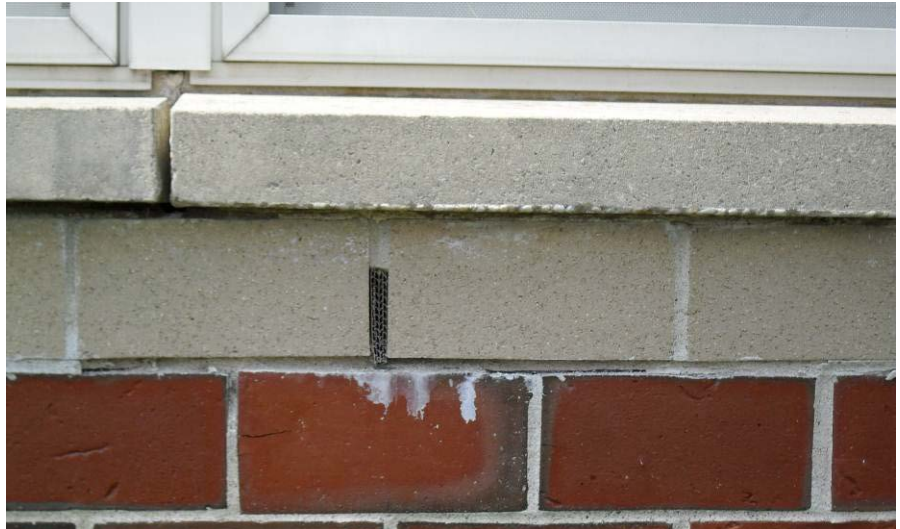
*Flashing at Location  
Different From Contract  
Documents*

*Fabric Flashing Extended  
Through Joint – Joint  
Spalled Off*

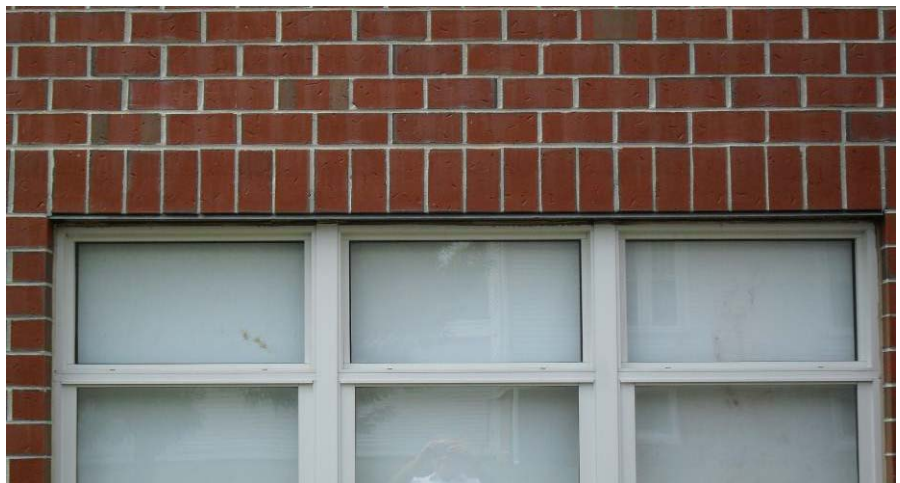
The new brick veneer installed on the elementary/middle school as part of the 1994 project has not been properly weeped at the window head. The contract documents indicate a location for the flashing on top of the lintel angle which has been verified. The weep hole was not installed as part of the construction process. The 2-story classroom wing appears to be the area with the most amounts of windows without weeps.

*Window With No Weep  
Holes*

We would recommend a corrective action of cutting in new holes at the proper location at a maximum spacing of 2'-0" o.c. at all window heads that have no weep holes. We also recommend at those window heads with a few weep holes that additional weep holes be cut in to provide the proper water drainage out from behind the veneer.

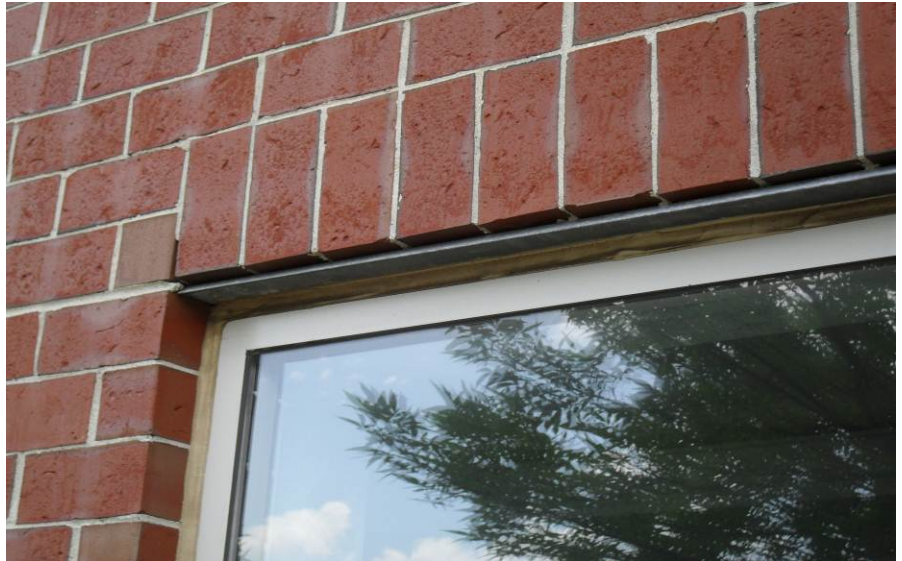
The flashing over the windows that was installed was not extended to the end of the steel lintel. A properly installed metal flashing at this location would extend a minimum 8" into the jam with an end dam turn up to keep water from migrating off the end and under the lintel.

*Flashing at Window Head*

*Flashing – Not Extended Properly – Weep Hole on End Only*

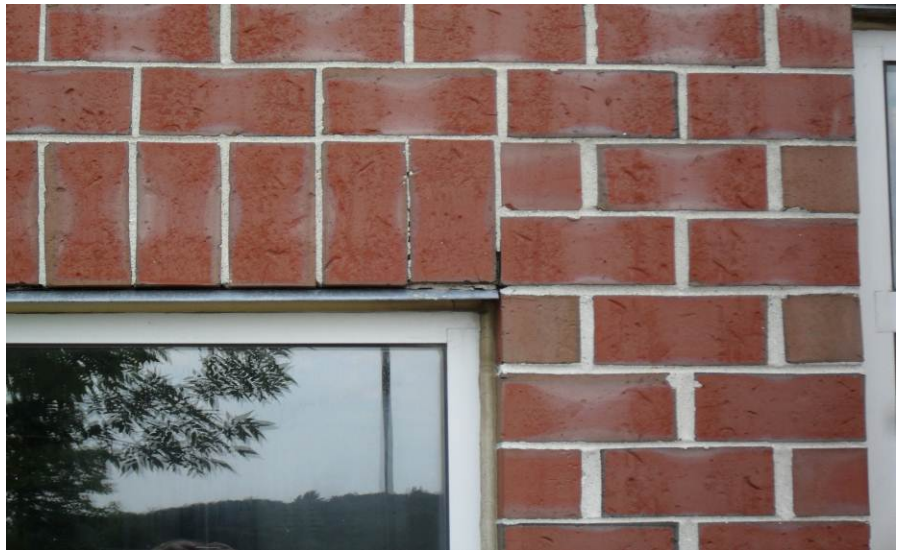
*No Butt Joint, Flashing Not Extended – Weep Drains Down Edge*

*Improper Window Head Installation*

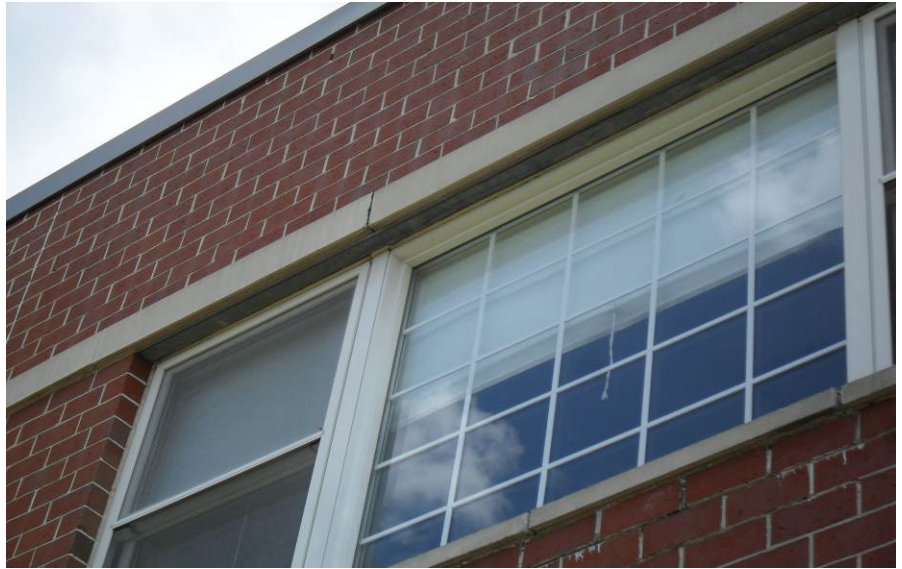
*Precast Concrete Lintel  
Head*

At locations where the precast concrete lintel is shown as an element over the top of windows, the flashing as indicated on the contract documents was installed. Most of the vertical butt grout joints between the pieces has broken and fallen out. The grout was broken either due to the expansion/contracting of the precast units or the fact that no weep hole was installed and freeze/thaw action has broken the mortar and allowed it to fall out.

*Broken Joint Between  
Units*
