**Town of Cape Elizabeth**  
Seven Building Facility Study  
*Cape Elizabeth, Maine*

HARRIMAN | Architects + Engineers

**Introduction****Town of Cape Elizabeth Facilities Study**

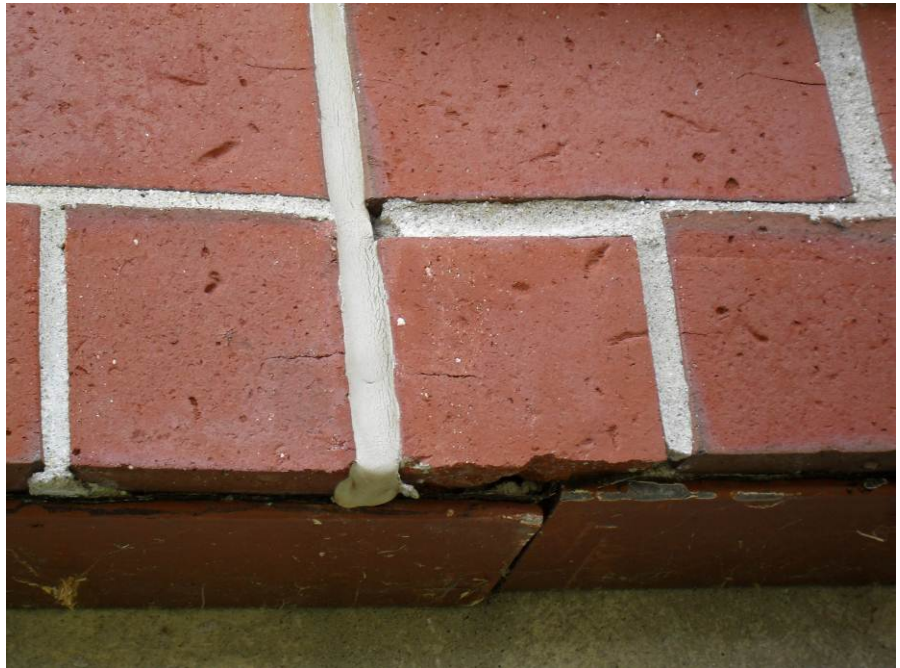
On two wings of the existing elementary school the 1994 construction documents called for installing a new brick veneer out beyond the face of the existing foundation. The detail shows a support angle bolted to the existing foundation with a new through wall flashing and weep holes. Field observation showed that no flashing was installed and no weep holes were observed at that point. Some locations showed weep holes at the same height as the bottom of the windows but no flashing was installed under the windows.

*Brick on Support Angle*

*No Flashing Pulled  
Through at Support  
Angle*

Since it was not constructed as detailed, we would recommend a forensic removal to find out how it was constructed. A corrective repair action could then be put in place. If left long term in its current state it would potentially have a long term impact on the life of this wall, especially on the support angle.

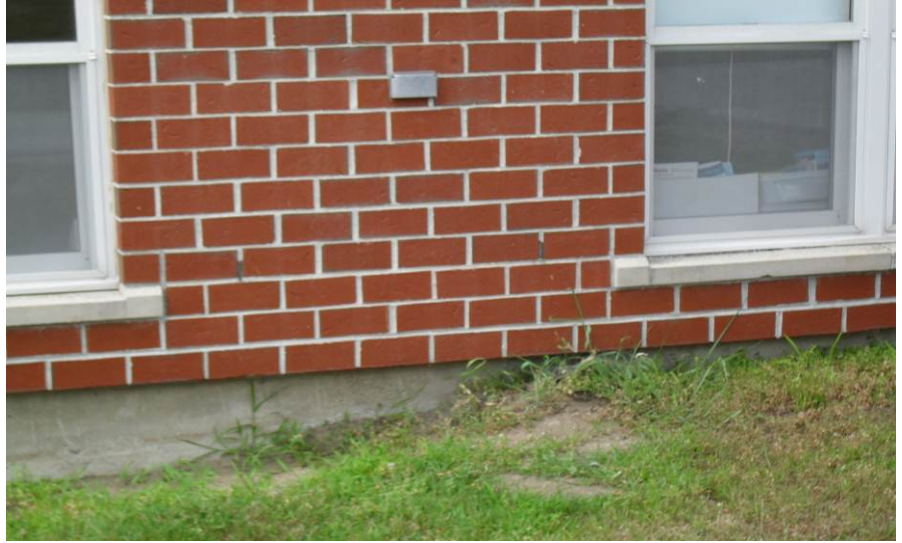
*Weep Holes Installed at Unexplained Location*

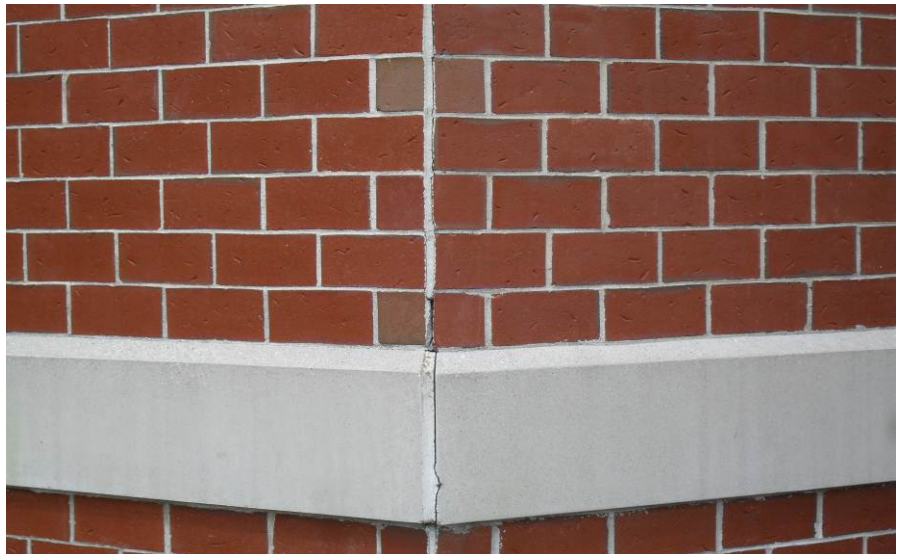
The precast concrete bands that horizontally course the new veneer were head jointed with mortar. Most of them have cracked from thermal expansion and some mortar has fallen out leaving an open joint. The open joint creates a water entry point that will only allow for more damage to the veneer in the future.

*Joint Failure*

Recommend that all head joints in this condition be routed out and then filled with a backer rod and sealant joint. Some joints have had an attempted repair but the improper installation has failed.

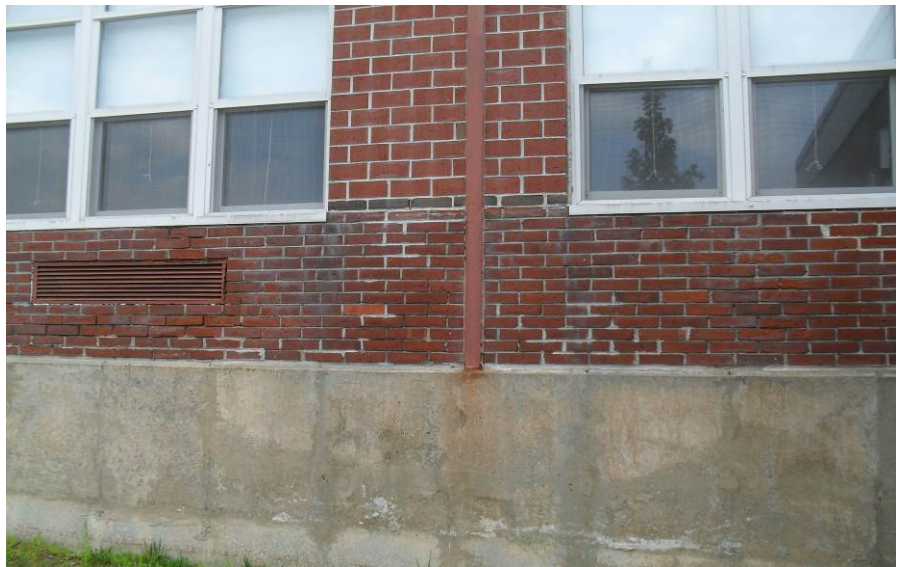
As part of the 1994 construction project the old window-wall system was removed and replaced with a new stud backup and brick veneer infill. The old window system was removed down to the bottom of the old window-wall sill and the old brick was left to the top of the knee foundation wall. The remaining face brick needs a major corrective repointing and brick patching. Some joints have been caulked up to stop water entry and patch mortar has been applied elsewhere. The original mortar is over 60 years old and needs work.

*Face Brick in Bad Condition*

*Elementary School - Wall*

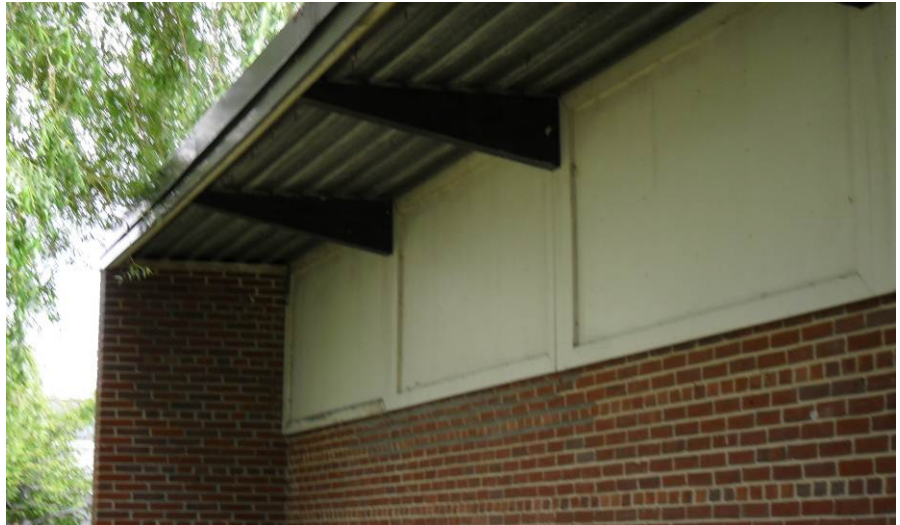
*Plywood Panels Needs Painting*

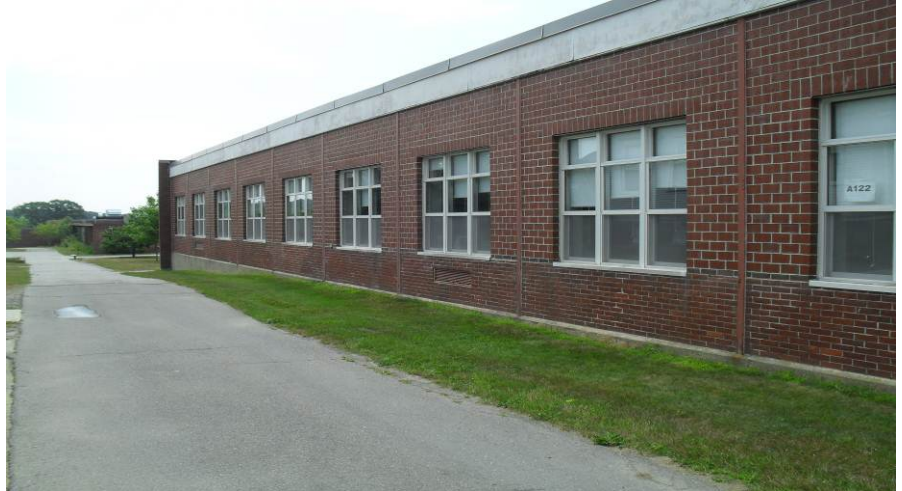
*Opposite Side Exposure –  
Brick Condition*

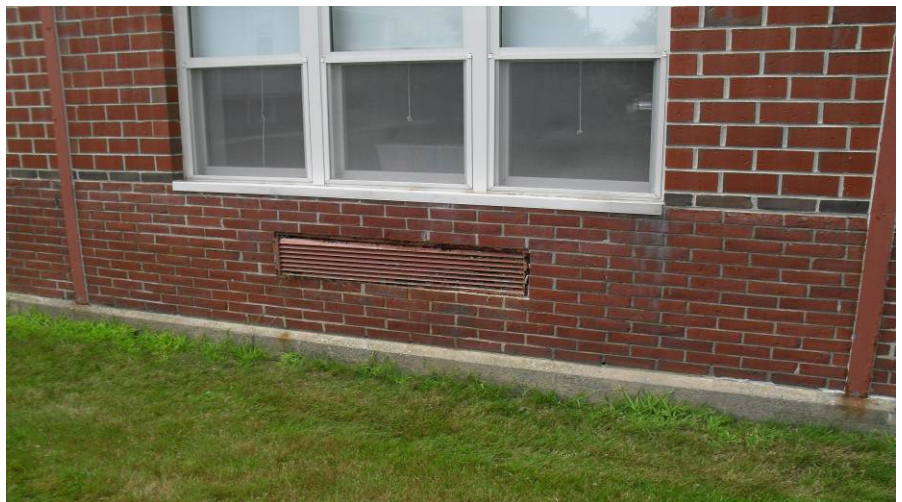
*Unit Ventilator lower in  
Bad Shape*

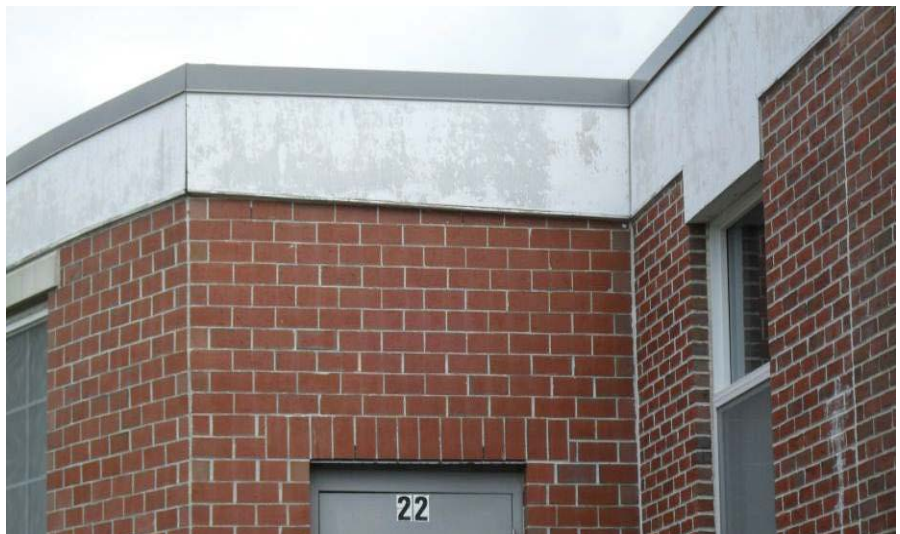
On the library addition and other locations there is a wood panel MDO panel attached to a wood backup framing system. The panel has become completely deteriorated due to weather exposure and should be completely replaced. Would recommend a maintenance free coated metal skin panel for long term durability.

*MDO Panel Has Failed*

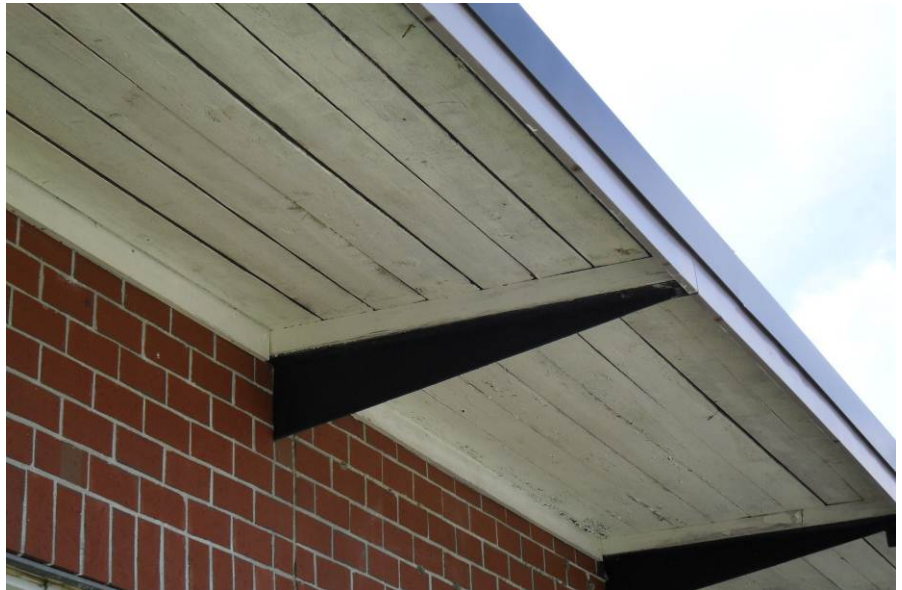
*Exposed Wood Decking*

As a potential roof replacement project for this area, the wood decking would have to be removed for a new metal deck to meet current loads.

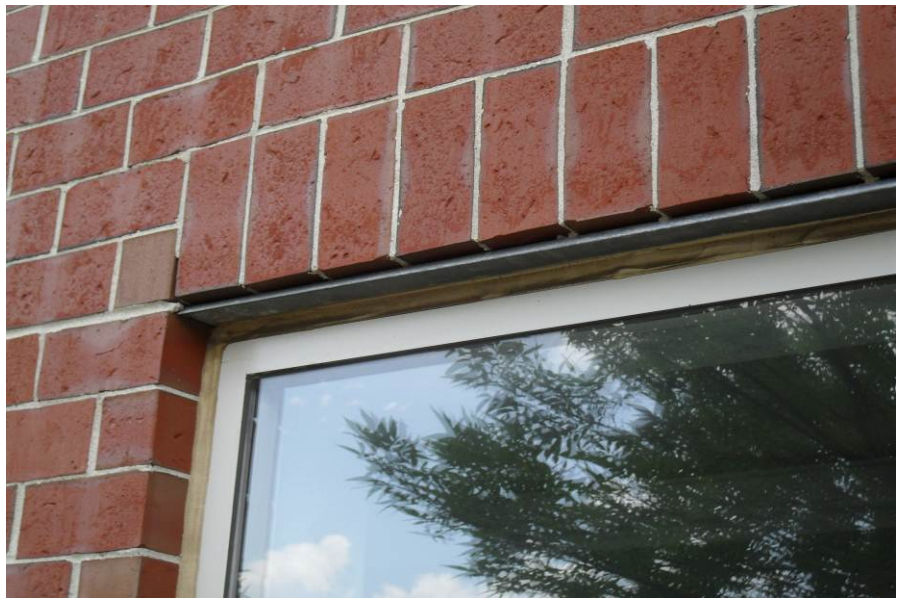
*Window Head Sealant Joint*

The caulking system that was applied around the windows as part of the 1994 additions is showing signs of imminent failure and discoloration. The head joint at the top was installed as an extremely large joint and on an average the installation was not very good. The joints at the jambs were done as an overlapping joint and traditionally this type of sealant joints are the first to fail in this type of application.

*Window Sealant System*

The sealant system around all your openings will have to be replaced in the near future.

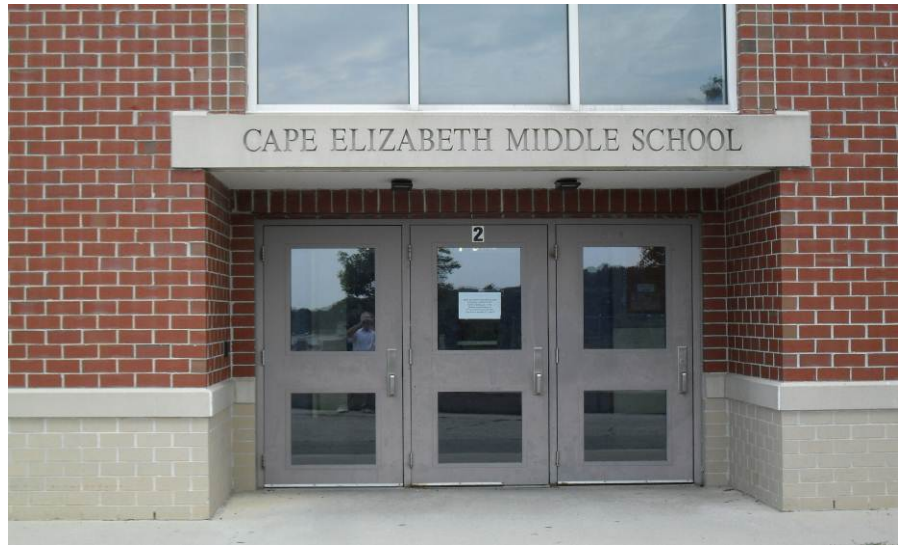
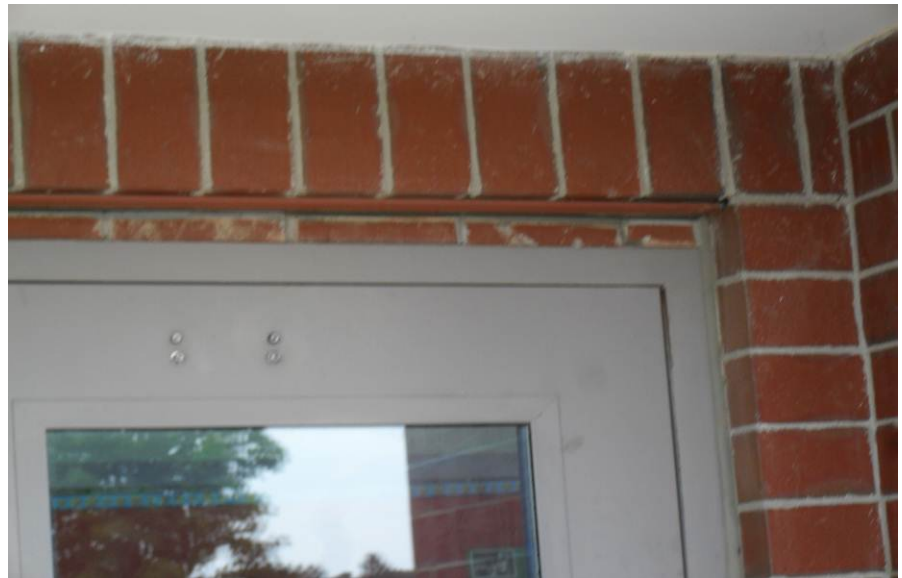
*Main Entrance*

The main entrance doors have a brick course directly over the doors. It would appear that the door frame was installed a few inches short and when the space discrepancy was discovered and was infilled with brick. The brick appears to be sitting directly on the door frame below the lintel.

*Close-Up of Brick on Door Frame*

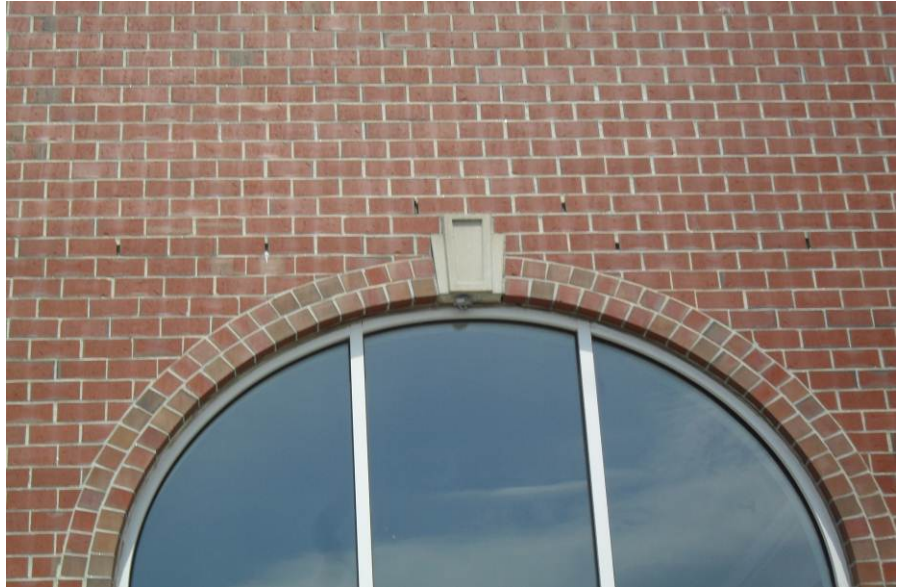
*Weep Holes Over Arch  
Masonry*

Over the main entrance there are weep holes in the brick that were inserted for an unknown reason. No through wall flashing indicated on details.

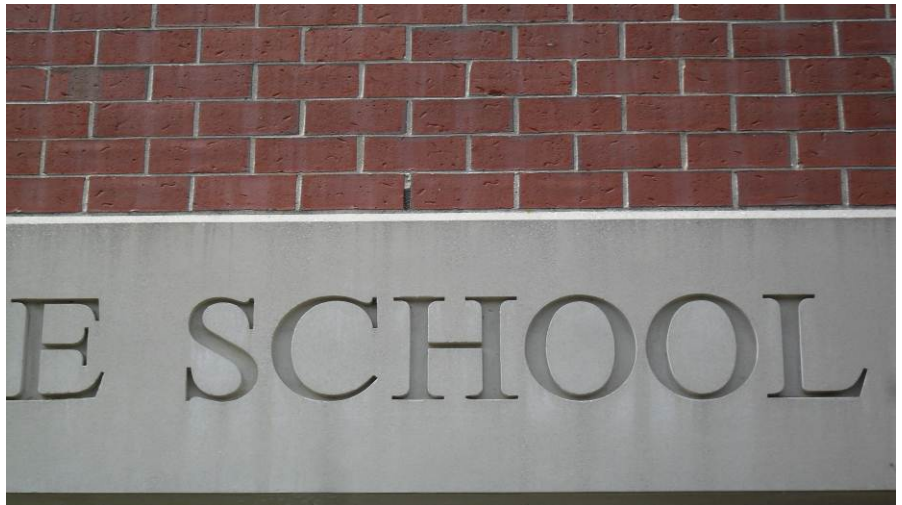
*Flashing Not Evident*

Weep holes have been installed in the brick course above the precast concrete sign, but there is no evidence that flashing was installed. Metal through wall flashing edge should be exposed.

*Weep Holes Without  
Flashing*

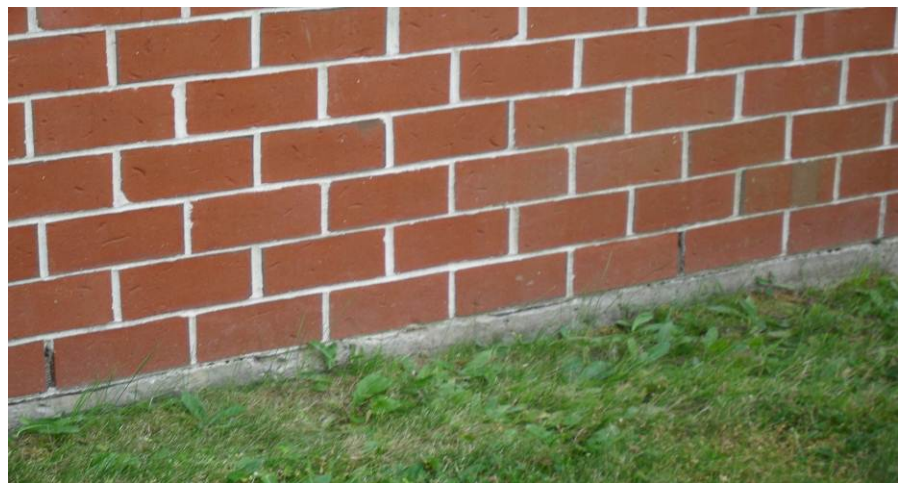
Around the perimeter base of the new brick the weep holes were installed at an odd spacing. The spacing is inconsistent from wall to wall with some locations exceeding 5'-4" o.c and others as short as 16" o.c. The weep holes are recommended by BIA to be inserted at a maximum spacing of 2'-8" o.c.. The spacing in the picture is at 3'-4".

*Weep Hole Spacing too  
Far Apart*

The through wall flashing shown is a fabric flashing and was installed in a poor quality manner. Would recommend cutting in new weep holes on all walls.

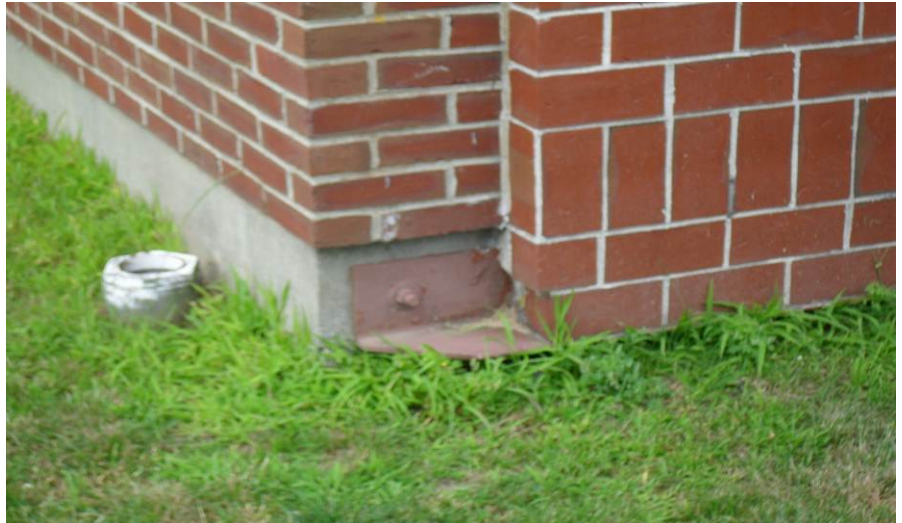
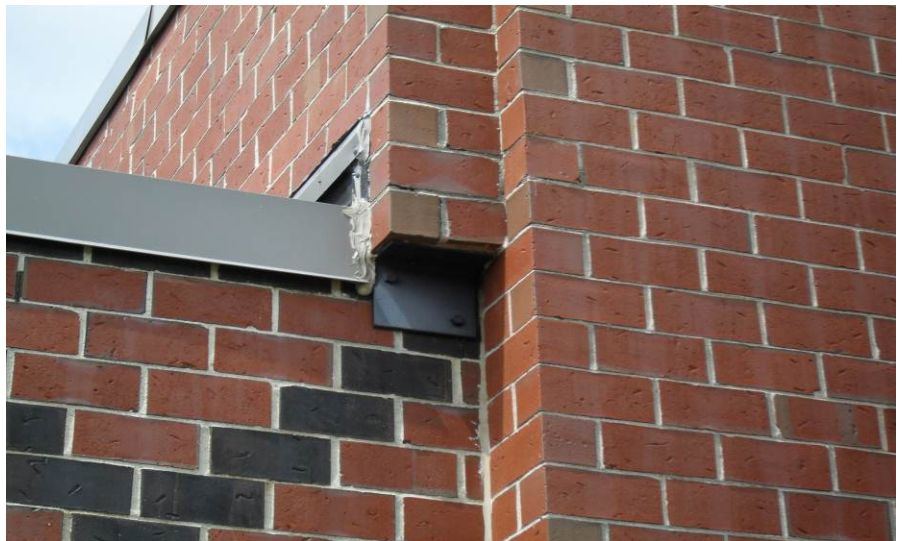
*Exposed Support Angle*

On existing buildings where the existing window-wall was removed a new support angle was bolted to the existing foundation to support the brick. There is no indication on the contract documents that these angles were galvanized.

Exposed angle for brick support.

They should be closely monitored and maintained to keep the angle from rusting.

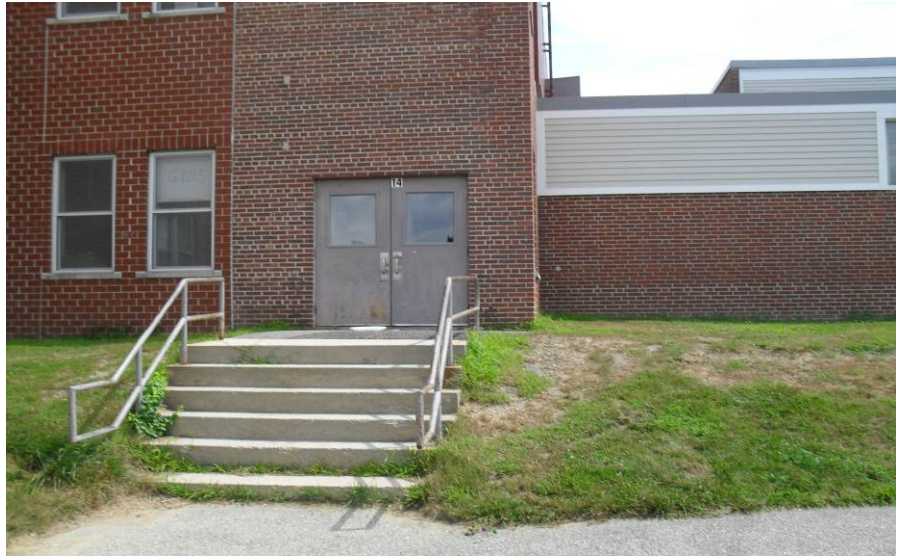
*Hollow Metal Entrance  
Doors and Frames*

The hollow metal doors and frames around the building will require replacement at some locations. Some are showing rust through the bottom of the frame or door edge. Most need to be repainted.

Recommend replacement as part of your annual maintenance budget. Install new galvanized doors and frames for long term durability.

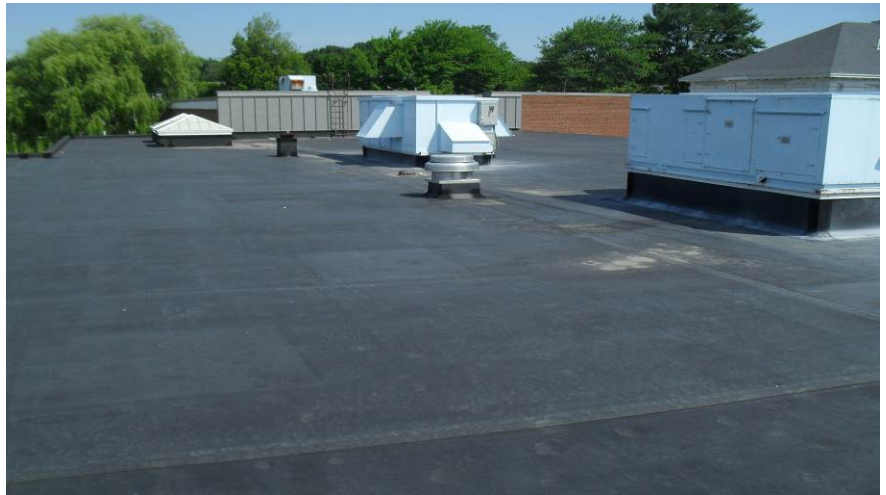
*Addition to Primary  
Constructed in 1955*

- Fully adhered .060 EPDM roofing membrane over roof insulation boards mechanically fastened to the existing wood deck.
- Denoted on the 1994 addition/renovation project as existing EPDM roofing to remain.
- Based on the note and no record of replacement we suspect this roof is already beyond its 20 year life span.
- This roof would be on a higher priority schedule for replacement due to its age since installation.

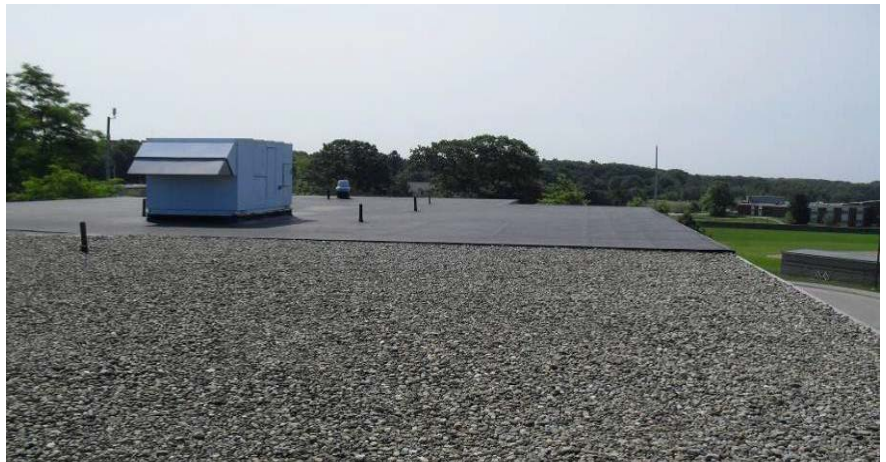
*Lunt Building –  
Addition to Primary  
Built in 1962*

- Fully adhered EPDM roofing membrane over two layers of 2 1/2" roof insulation mechanically fastened to the existing wood deck. Lunt roof is shown beyond the ballasted roof in the foreground.
- Denoted on the 1994 addition/renovation project as existing EPDM roofing to remain.
- Based on the note and no record of replacement we suspect this roof is already beyond its 20 year life span.
- This roof would be on a higher priority schedule for replacement due to its age since installation.

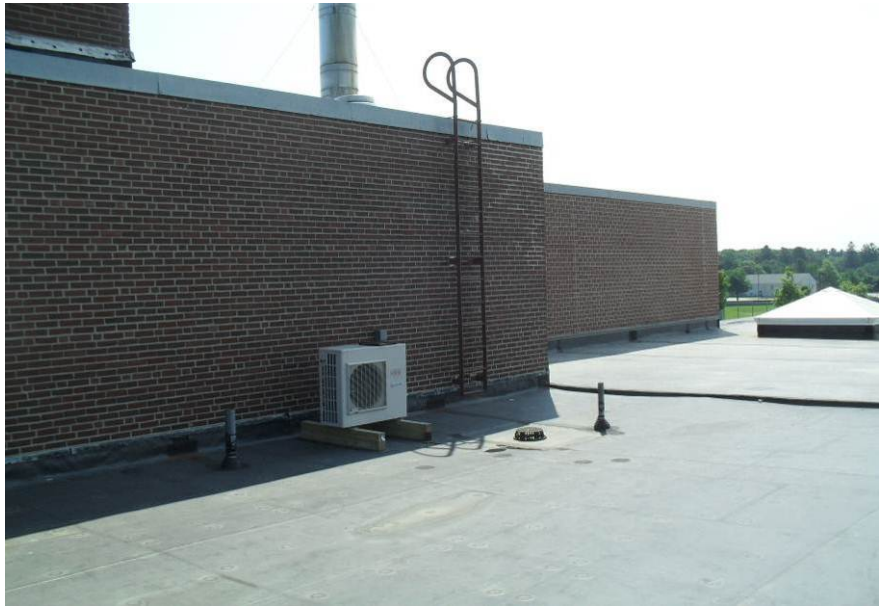
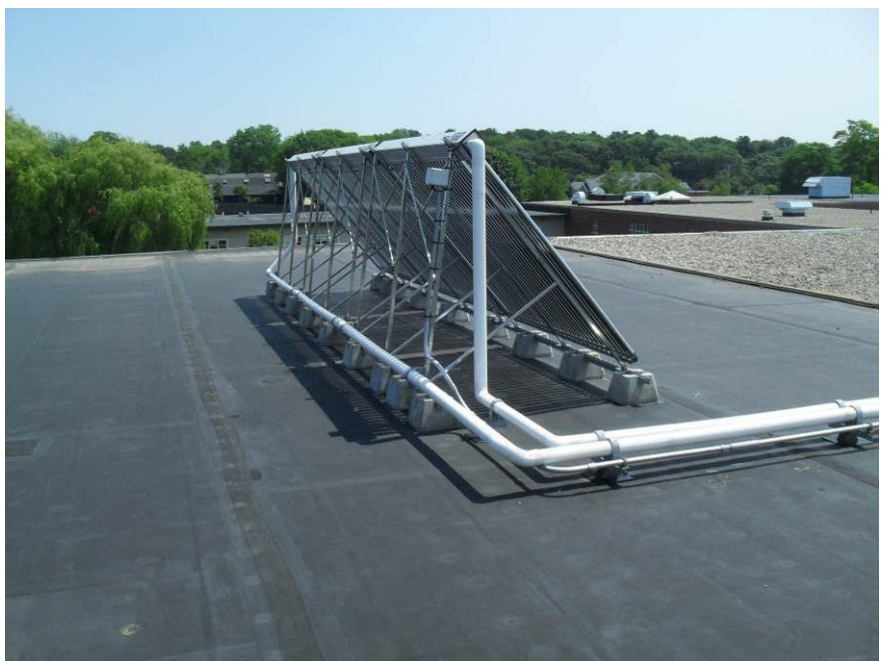
*Gymnasium /  
Classroom Addition to  
High School Built in  
1962*

- Fully adhered .060 EPDM roofing membrane over roof insulation boards mechanically fastened to the existing wood deck.
- Denoted on the 1994 addition/renovation project as existing EPDM roofing to remain.
- Based on the note and no record of replacement we suspect this roof is already beyond its 20 year life span.
- This roof would be on a higher priority schedule for replacement due to its age since installation.

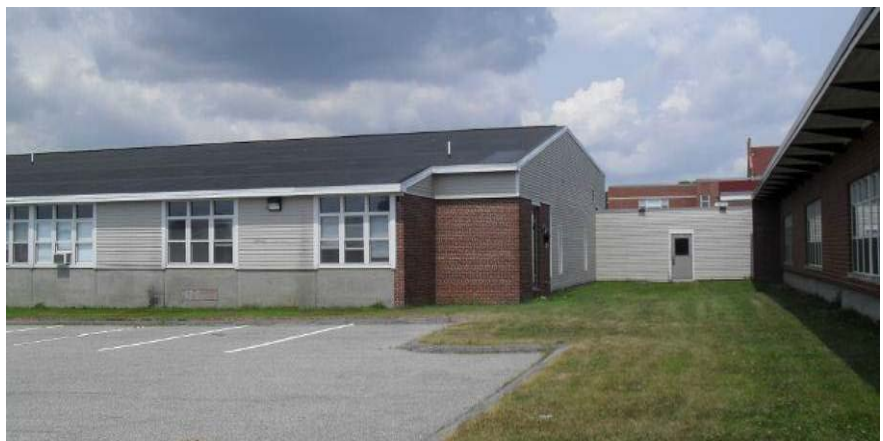
*Vocational Arts Wing*

- Fully adhered EPDM roofing membrane and roof insulation adhered to the existing wood deck.
- Existing wood beam and wood deck is visible from rooms below. Appears a wood truss pitched system was installed directly over the wood beam and deck system and an adhered membrane installed to the deck.
- Denoted on the 1994 addition/renovation project as existing EPDM roofing to remain.
- Based on the note and no record of replacement we suspect this roof is already beyond its 20 year life span.
- This roof would be on a higher priority schedule for replacement due to its age since installation.

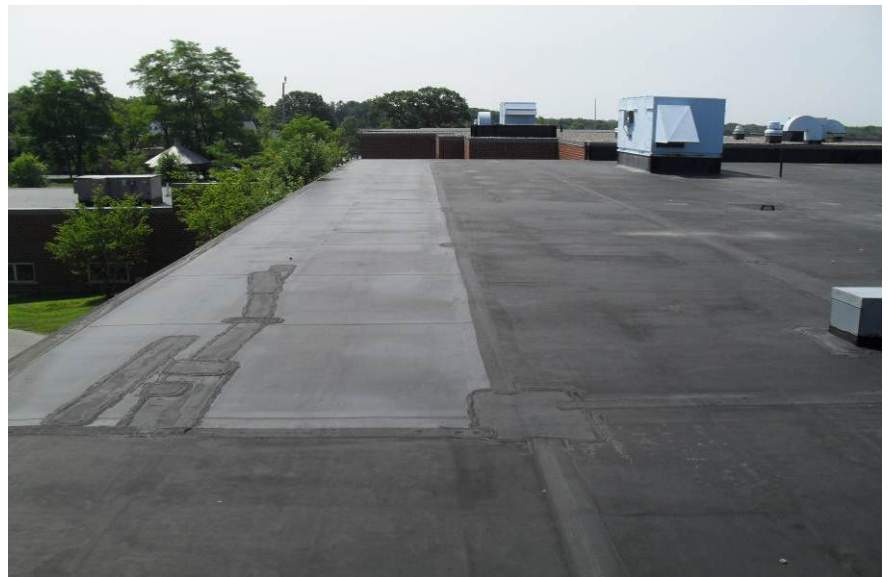
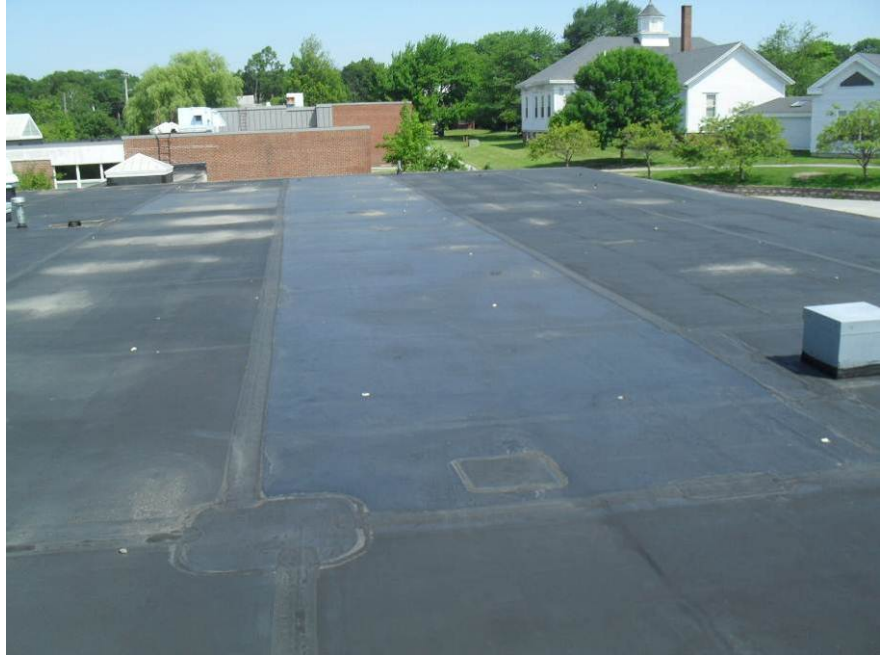
EPDM Roof with Seam  
and Membrane Repair

- The roof areas on the plan above plan designated No's 3, 5, 9, 18, 20, 22 should be considered high priority for replacement. These roofs have been down the longest and have been exposed to UV. The seams are showing signs of deterioration and may require closer attention from a maintenance perspective. The picture below shows repair work to membrane and seams.

*Elementary School Roof  
with Repair Membrane*

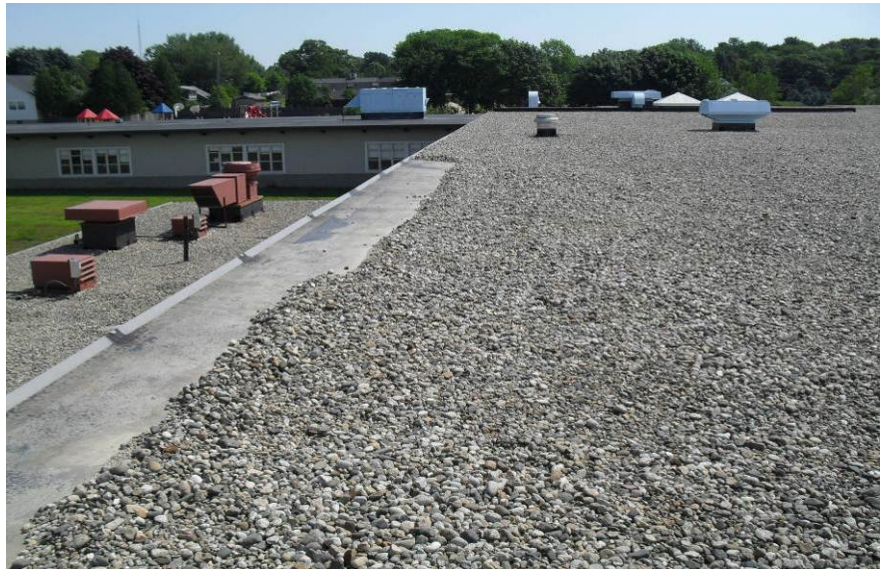
*Ballasted Roof System –  
Stone Directly Over the  
Membrane*

2. The ballasted roof areas denoted on the plan above as areas 6, 8, 11, 12, 14, 16, 17, 19 should be considered for replacement based on the age. Though these types of roof systems would be considered to offer a longer life to the membrane there are a number of issues connected with this installation that we will highlight further on in this report.

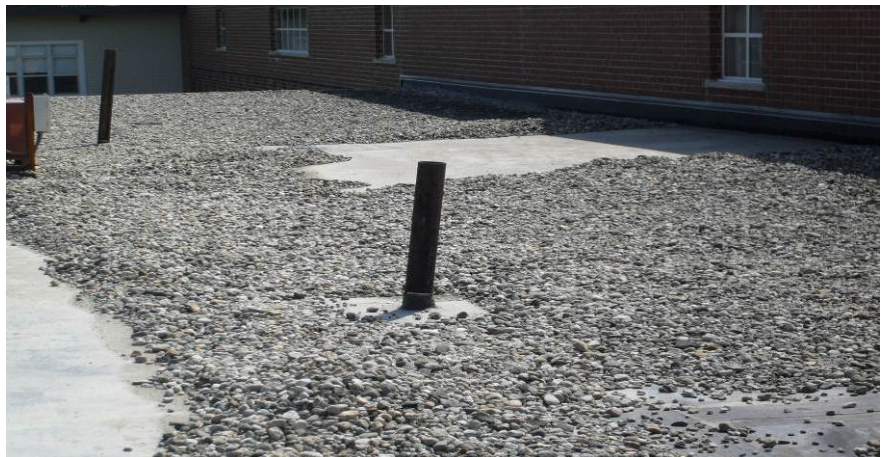
*Roof Membrane Badly  
Worn*

The picture below shows an area where the ballasted stone has been pulled back to reveal possible water leak locations. Patches were installed as a corrective action. The stone was never spread out back over the area. It is difficult to review the condition of the roof membranes with the stone ballast over. There were a number of locations on the roof where the membrane was exposed due to corrective action and this exposure is revealing that the membrane has prematurely started to wear out. Normally with a stone ballast roof there is a nylon protective mat that is laid down over the membrane to protect the membrane surface from the type of wear revealed at the locations where the stone was pulled back. At other locations where the stone was pulled back the membrane was showing similar wear. Based upon the visual observation at these locations I think you can assume the entire ballasted membrane is in similar condition.

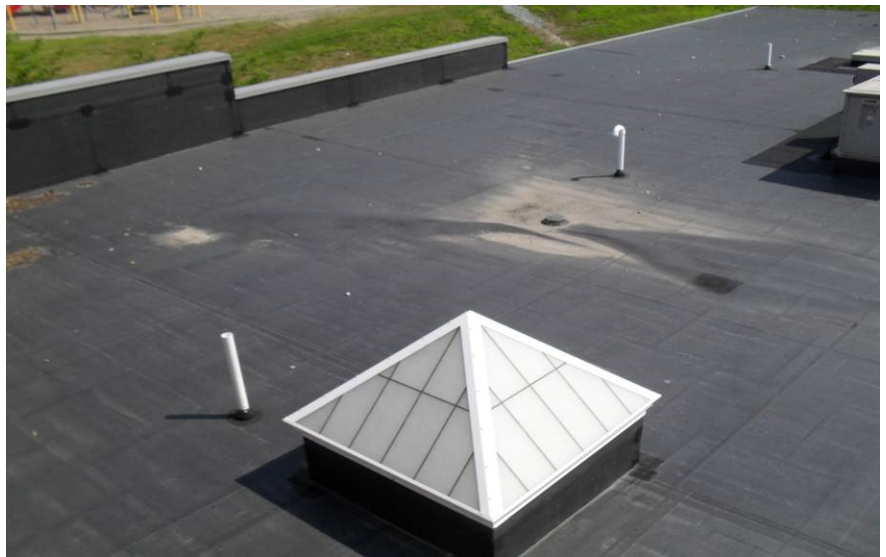
*Roof with Major Membrane Buckle*

3. On the kindergarten roof addition there are two large major buckles with the roof membrane. Per the contract documents, the system was installed as an adhered membrane to adhered insulation direct to a concrete deck and our observation indicates that there has been a separation of the membrane from the insulation.

This condition requires immediate correction because of the potential of a high wind condition lifting and causing the entire roof to separate from the insulation and causing a total roof failure.

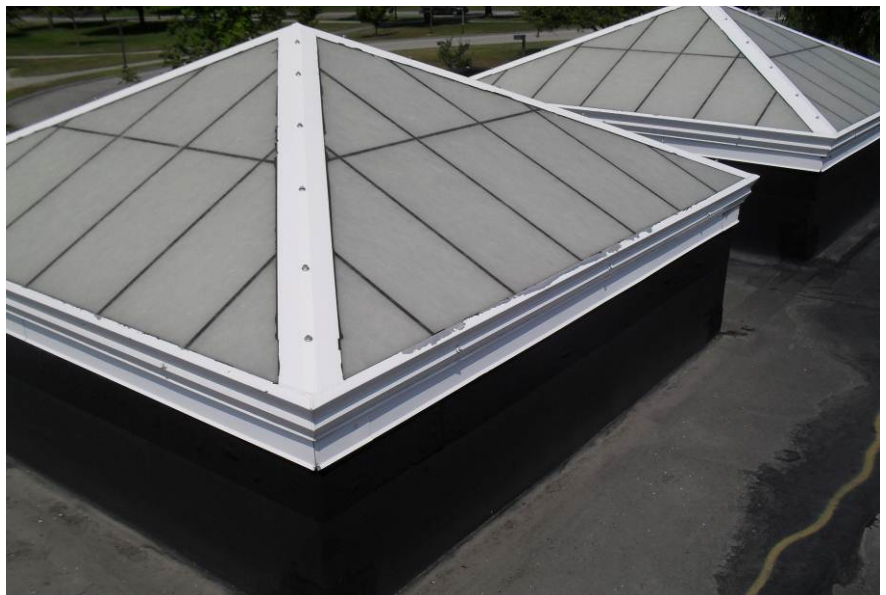
*Skylight Frame – Paint Finish Flaking Off*

1. Most of the skylights on the school are showing signs of paint peeling off the frames. This is a sign of low quality paint finish on the frames.

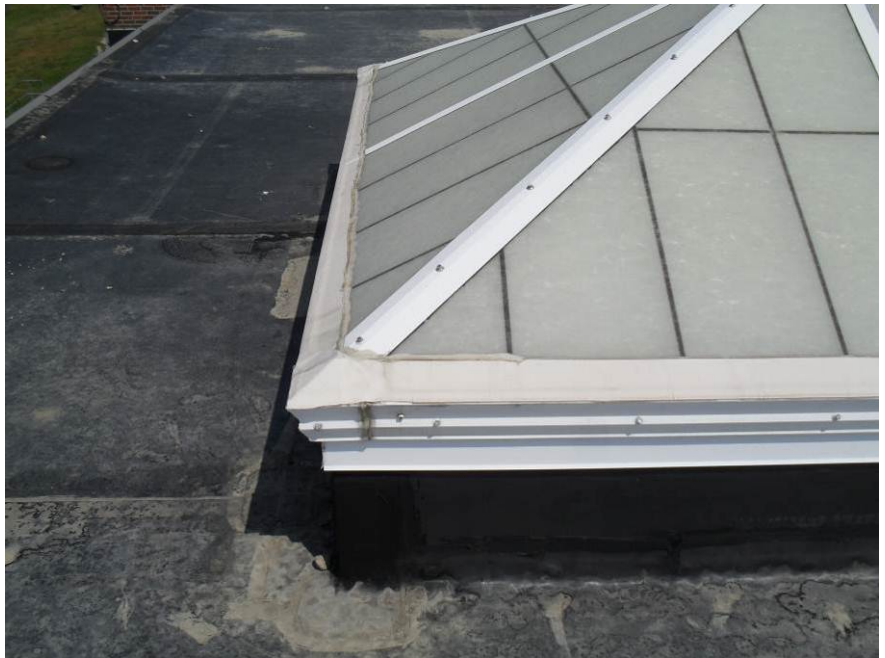
*Skylight Frame With  
Tape Flashing Over  
Frame*

2. A couple of skylights have an EPDM flashing tape applied over the frame and the skylight panel as a corrective measure to stop what we assume was leaking through the skylight frame. This is not a recommended manufacturer correction to these units and could be detrimental to the life of the panel with an adhesive applied to the panel.

We would recommend as part of a maintenance item, to procure a Glass and Glazing company which services this particular skylight and have them clean and patch all the paint finish flaking locations, dismantle the frame and panel and apply new seals between the frame and panels to bring the units back to the originally installed condition. If for some reason the clamping frame was removed from the panel, the original seal on both sides would have had to be replaced – this is a manufacturer’s requirement. The units may not have been installed correctly and thus the leak issues.

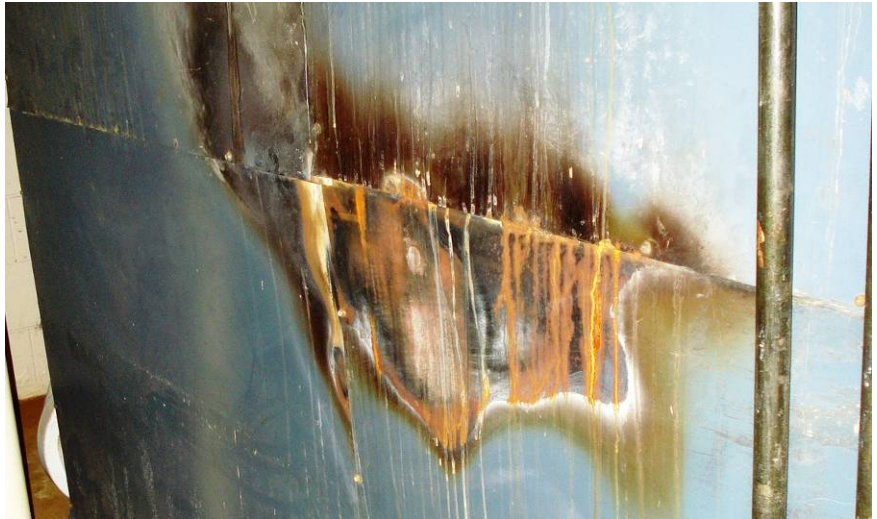
*Left Side of Boiler 1 (left-hand) Showing Signs Burned Surface*

The enclosures of the boilers are showing signs of their age. The side of Boiler 1 shows signs of combustion and gas leakage between the cast iron sections of the boiler. With proper maintenance and repair, this type of boiler can provide many years of service.

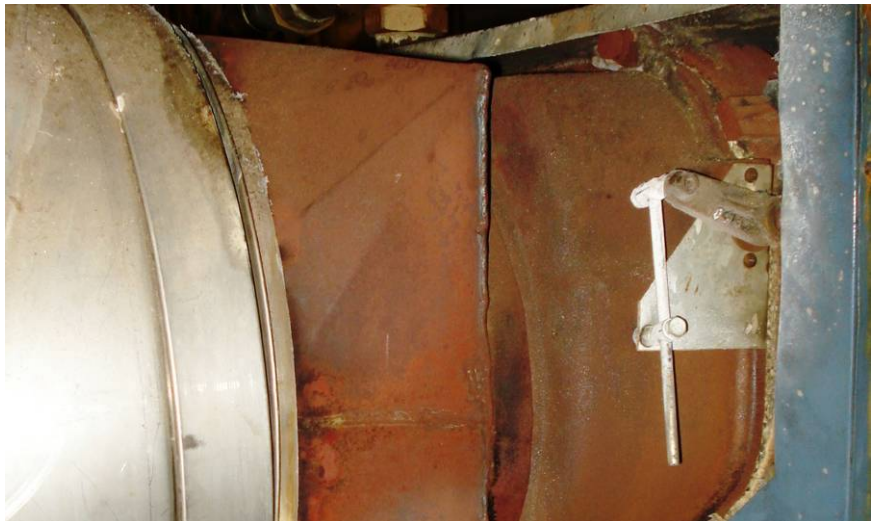
*Breeching Damper at Back of Boiler 1 Was Loose*

The linkage of the draft control damper at the rear of Boiler 1 is loose at the shaft of the damper. The position of the damper is unknown. Recommend the damper linkage be properly adjusted and tightened.

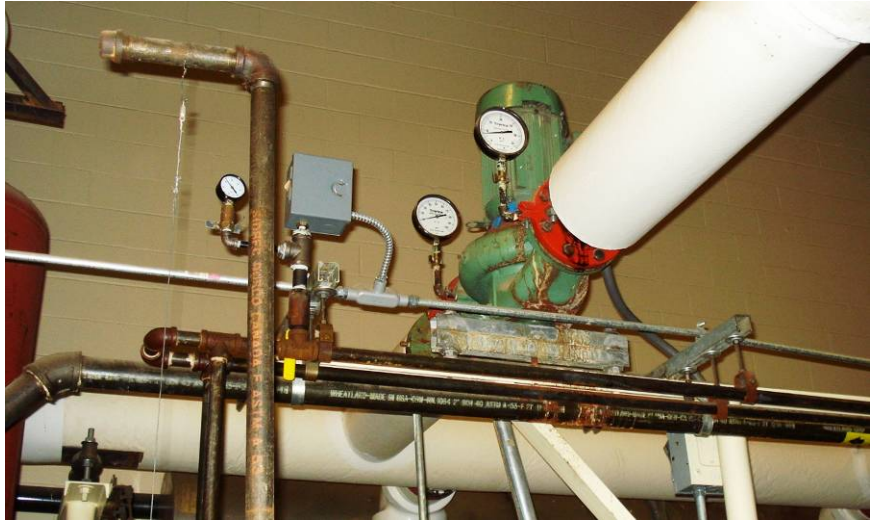
*Boiler 1 Injection Pump and Oil Pressure Gauge and Transmitter*

Each boiler is outfitted with an individual injection pump. The pump at Boiler 1 appears to be original and showing signs of leakage. The pump at Boiler 2 appears to be a recent replacement.

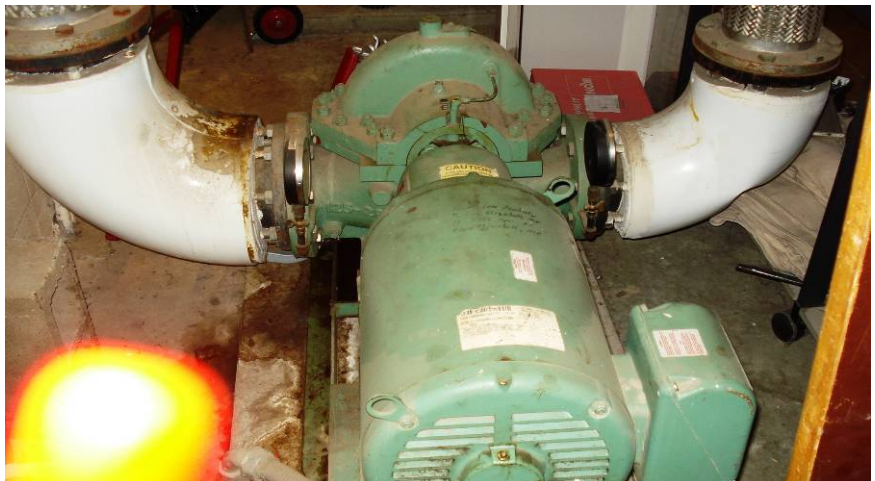
*Heating Hot Water Pump*

We would recommend upgrading the heating system hot water pump motors to high efficiency type and the installation of variable frequency drives for control and vary the speed of the pump to maintain a temperature differential across the heating hot water system.

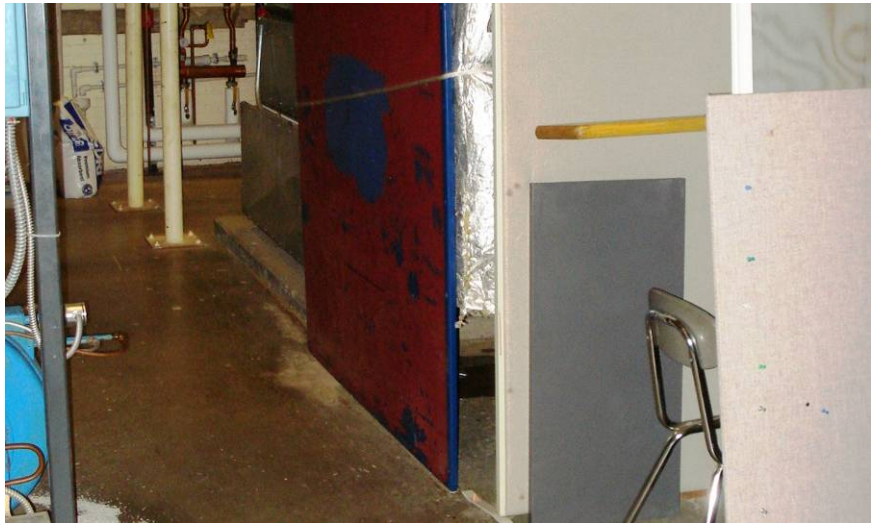
Combustion air to the boiler room is provided through the 54" x 60" insulated duct dropping down in the middle of the Boiler Room. The opening at the floor has been partially blocked off. It was reported the combustion air duct was partially blocked to help reduce the possibility of freezing the boiler(s).

*Combustion Air Duct  
Partially Blocked*

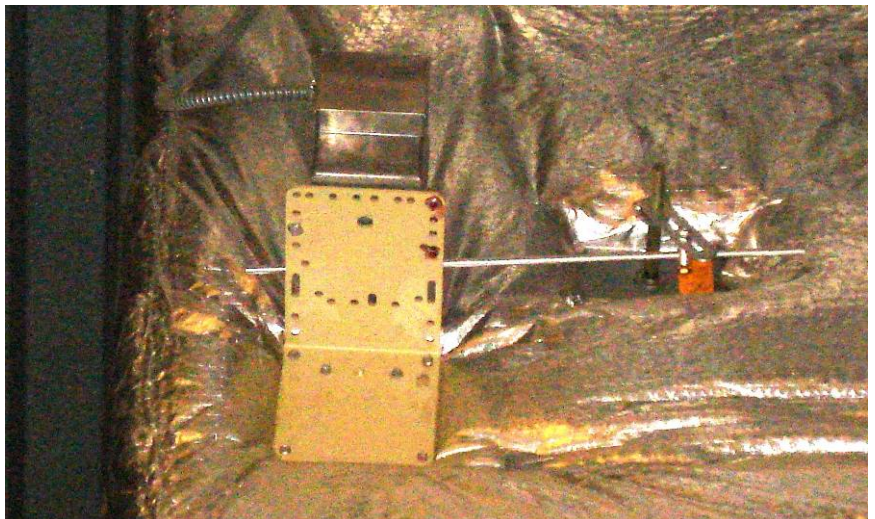
The damper actuator appears to be original and shows signs of oil leakage. At the time of review, the damper was open.

*Combustion Air Damper  
Actuator*

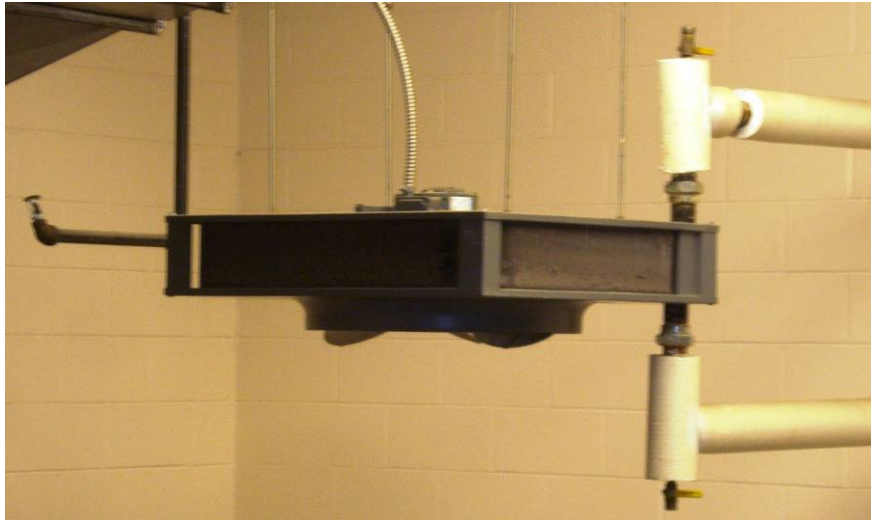
Heating in the Boiler Room is provided through two vertical hot water unit heaters. The coil of one of the heaters appears to be plugged.

*Vertical Unit Heater in  
Boiler Room*

*Coil is Plugged*

Recommend cleaning of the coils.

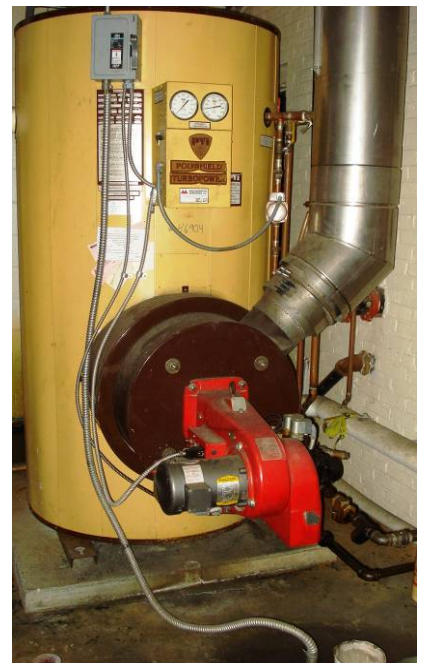
The domestic hot water system was upgraded during the Summer 2011. A part of the upgrade, the existing oil-fired hot water was abandoned in place. At the time of review, the oil-fired heater was turned off at the local disconnect.

*Domestic Hot Water  
Boiler*

We would recommend removal of the abandoned heater.

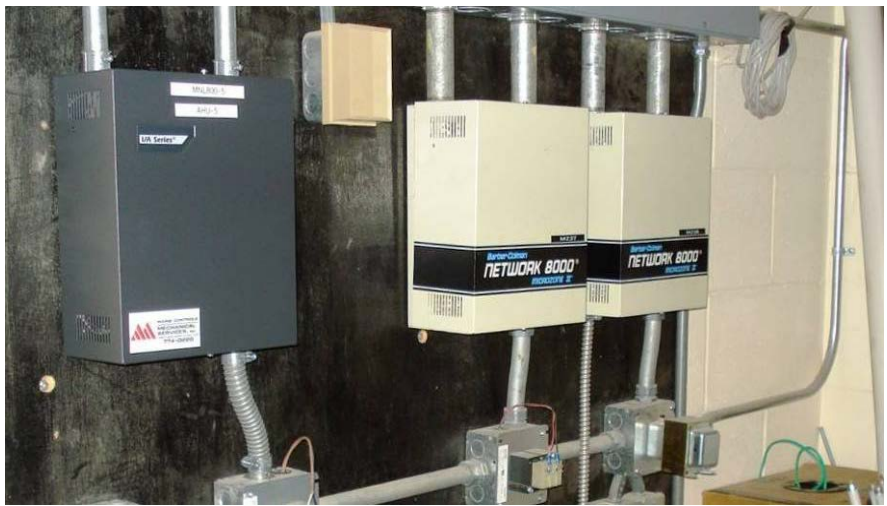
The Network 8000 Direct Digital Control (DDC) system components in the Boiler Room were provided and installed during the 1994 renovation project. The I/A Series Micronet components, pictured at the left of the panel, were provided and installed during the 2011 Boiler Room Upgrade project. The Network 8000 components are monitored through the original Signal graphics software package and the upgraded I/A Series components are accessed through the web-based Enterprise Server software package. We recommend upgrading the Network 8000 components to the I/A Series system components.

*Direct Digital Control System in Boiler Room*
