**Town of Cape Elizabeth**  
Seven Building Facility Study  
*Cape Elizabeth, Maine*

HARRIMAN | Architects + Engineers

**Introduction****Town of Cape Elizabeth Facilities Study**

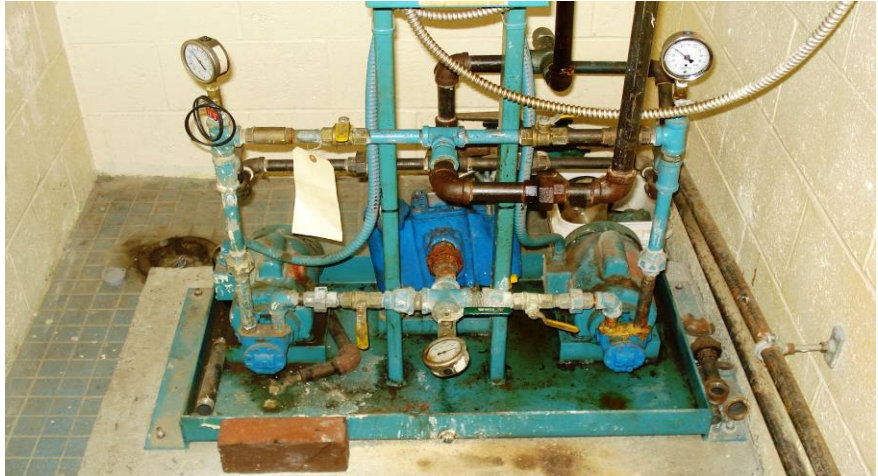
Fuel oil is provided to the boiler room through a duplex pump set located in the “E” wing janitor’s closet. The pump set is showing signs of leakage.

*Fuel Oil Pump Set*

We would recommend the pump set be replaced in accordance with NFPA 31 code requirements.

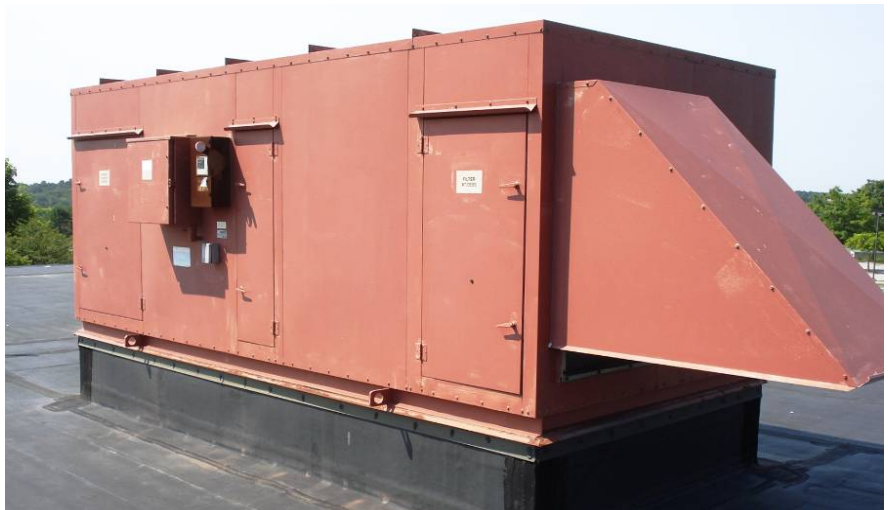
The rooftop air handling units and heat recovery units were provided and installed as part of the 1994 Additions and Renovations project making them approximately 18 years old and nearing the end of their expected service. Many of the units are showing signs of their age. At the time of review, the heat recovery units were not operating. Possibly down for the summer.

*Typical Des Champs  
Rooftop Heat Recovery  
Unit (HRU-5)*

We would recommend replacement of the rooftop units.

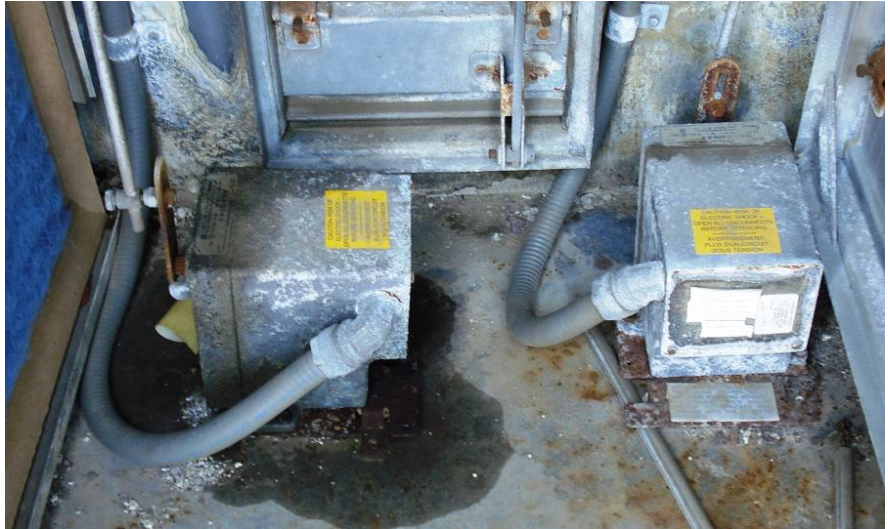
The outside air intake and bypass damper actuators, located within the outside air intake plenum, are original to the unit and are showing signs of oil leakage.

*HRU-5 Intake and Bypass Damper Actuators*

The condition of the interior surfaces of the rooftop units supports our recommend to replace the units. We would recommend replacement of the damper actuators as a short term correction.

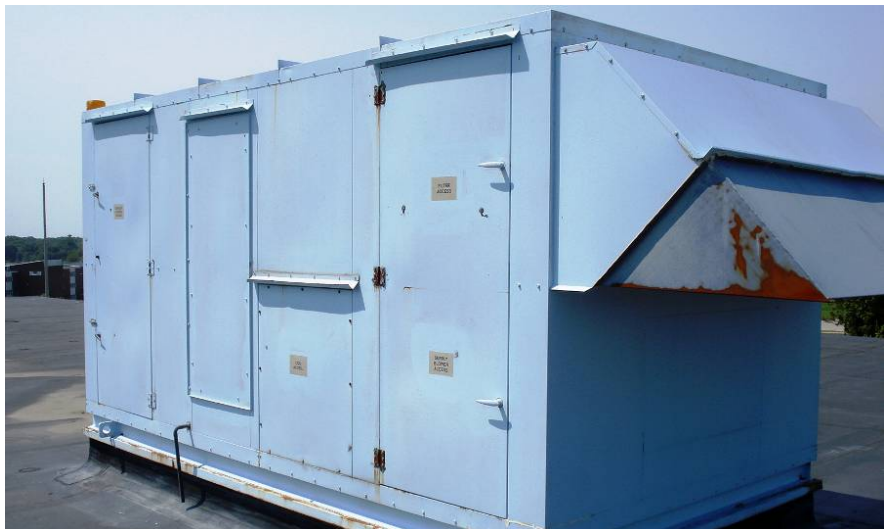
On a number of the units, additional sections of sheet metal were added to a number of the heat recovery units to help reduce the infiltration of snow into the unit. The filters in HRU-4 are noted as replaced in March 2012. On the filter it is also noted the plenum was very warm and the there was no snow.

*HRU-4 with Additional Intake Hood Section (right side of photo)*

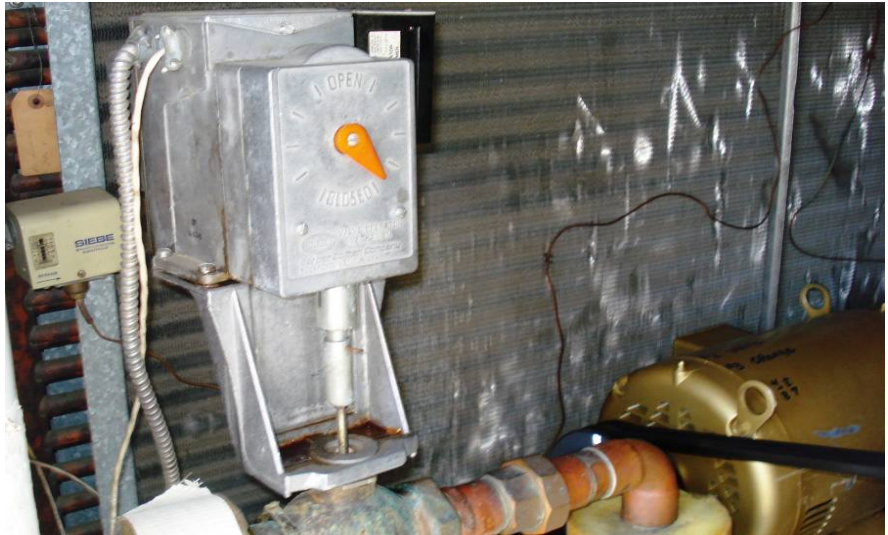
On HRU-4, the heating coil valve actuator appears to be original to the unit and is showing signs of oil leakage. The pointer on the front of the actuator indicates the valve is partially open possibly indicating the actuator has failed partially open.

*HRU-4 Heating Coil Valve Gear-Train Actuator*

We would recommend replacement of the valve actuator as a short term correction.

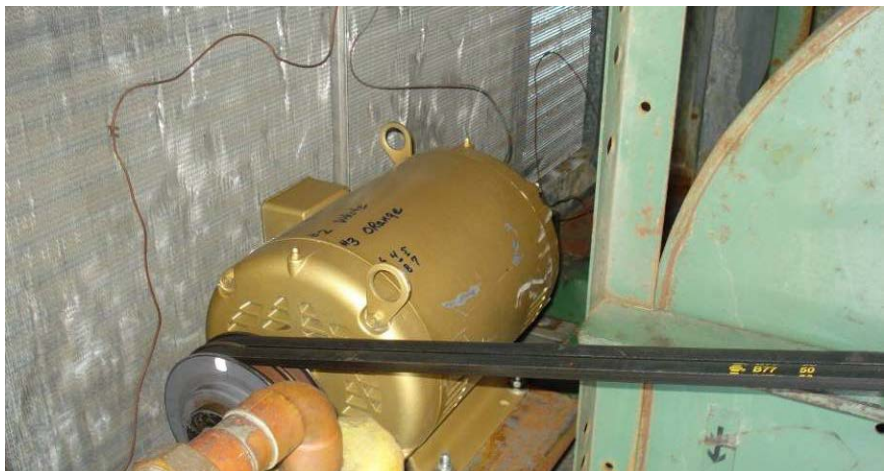
The HRU-4 supply fan motor appears to be a recent replacement. The heating coil low limit thermostat capillary has been partially removed from the heating coil fins and the fins have been bent over. The return air side of the heat recovery coil is very dirty.

*HRU-4 Supply Fan Motor, Heating Coil, and Low Limit Coil Capillary*

We would recommend reinstallation of the capillary, combing out of the heating coil fins and cleaning all rooftop heat recovery and heating coils.

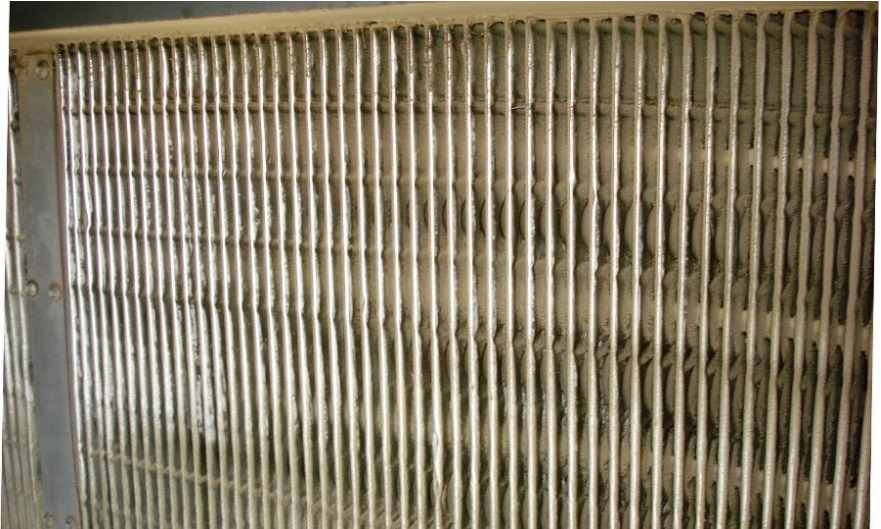
The return air side of the heat recovery coil is very dirty.

*HRU-4 Dirty Heat  
Recovery Coil  
(Return Air Side)*

We would recommend cleaning of all rooftop heat recovery and heating coils

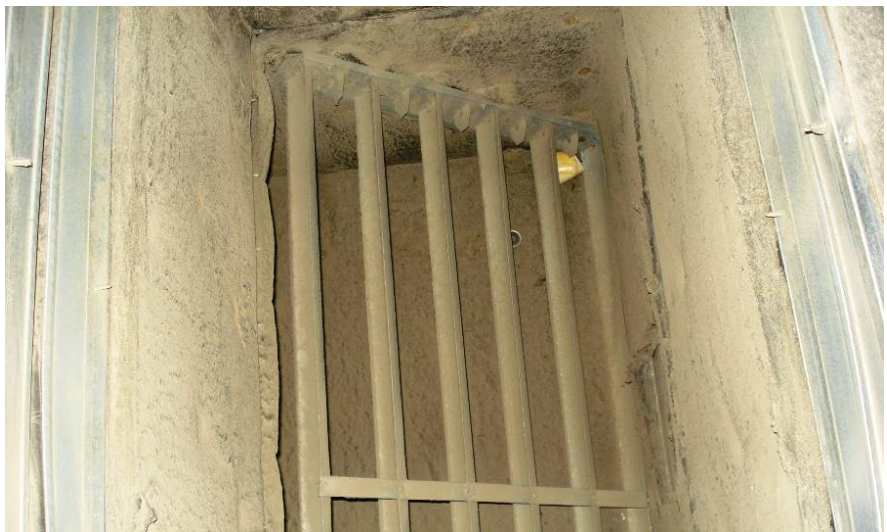
The acoustically lined return air plenum of HRU-4 is very dirty. This is typical of all units.

*HRU-4 Dirty Return Air  
Plenum Duct Connection*

We would recommend cleaning of all return and supply duct systems.

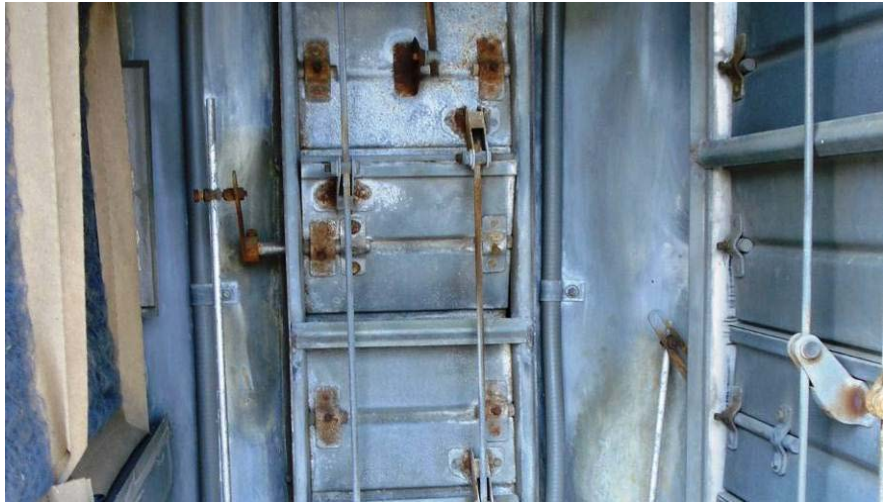
The bypass damper in HRU-3 is partially open indicating the linkage requires adjustment of the damper, original damper actuator has failed.

*HRU-3 Partially Open Bypass Damper*

We would recommend checking and repairing the damper as needed.

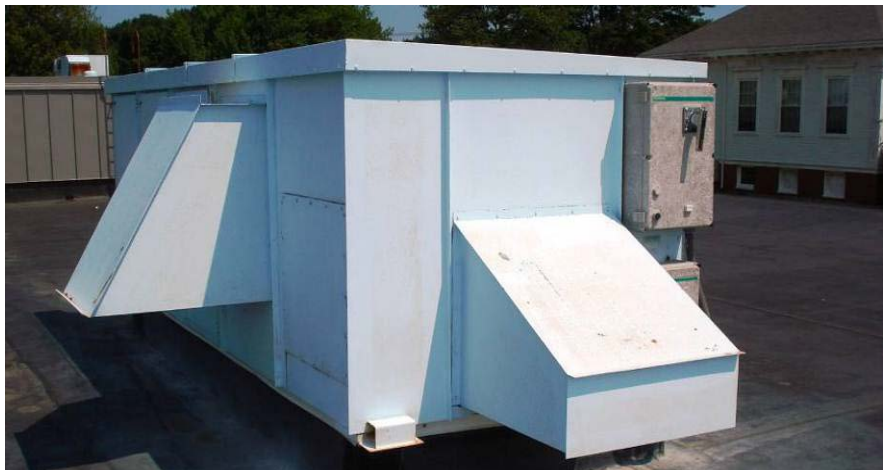
The Trane rooftop air handling unit AHU-1 serves the Variable Air Volume (VAV) system in Elementary School Media Center and adjacent Office Areas. The unit was installed as part of the 1994 Addition and Renovations project. The unit will vary the amount of air provided for the variable air volume system by opening and closing the inlet vanes at the constant speed fans. A more efficient method of varying the airflow would be to vary the speed of the fans through the use of variable speed drives (VFD).

*AHU-1 Trane Air Handling Unit*

We would recommend removing the inlet vanes, verify the motors are suitable for use with variable speed drives, and provide and install new VFDs.

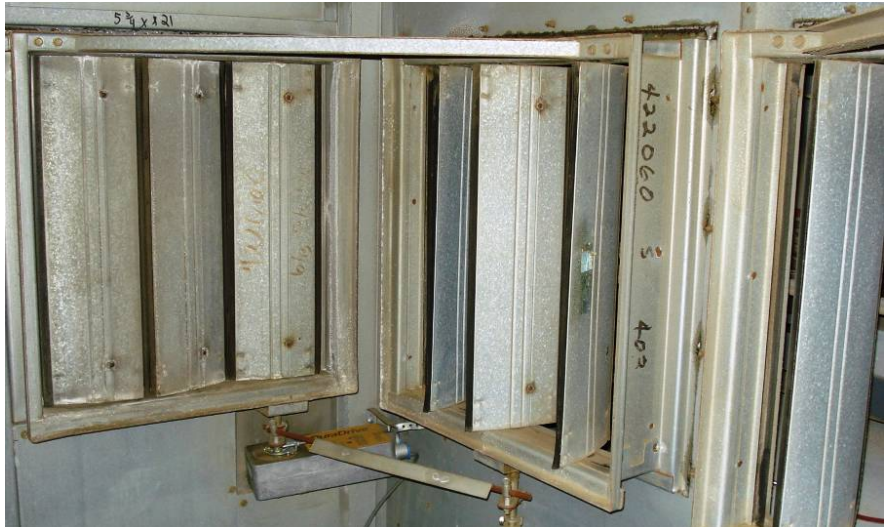
The outside air portion of the mixed air dampers (shown to the left of the photo above) were not completely closed allowing for a small amount of infiltration of outside air when the unit is off. Recommend adjustment of the damper linkage to allow the dampers to close fully.

*AHU-1 Mixed Air Dampers*

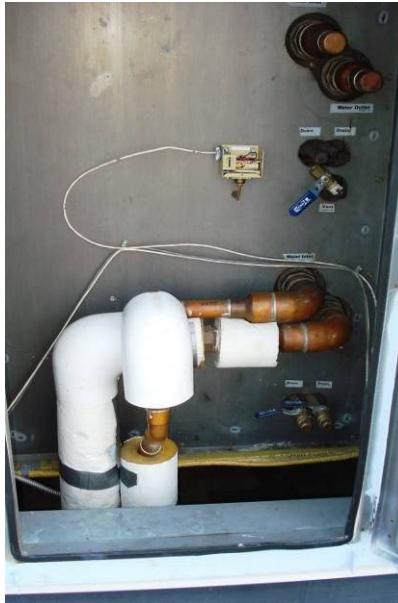
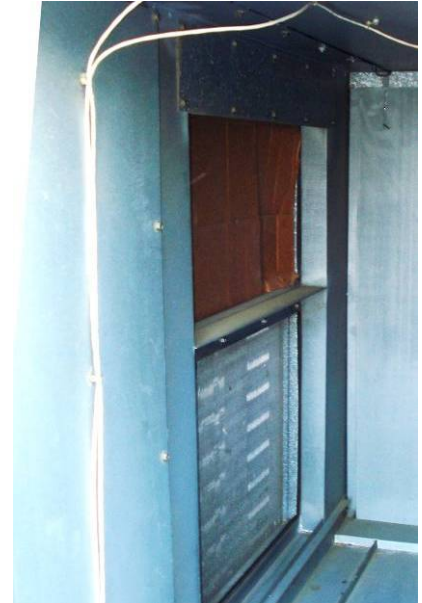
The upper portion of the coil section is not connected. The photo below on the right shows a piece of cardboard covering the cooling coil. According to the design documents, the upper coil was provided for future chilled water cooling. As a temporary measure, the upper coil was blocked off to prevent airflow from bypassing the heating coil.

*AHU-1 Coil Connections and Cardboard Covering Portion of Coil*

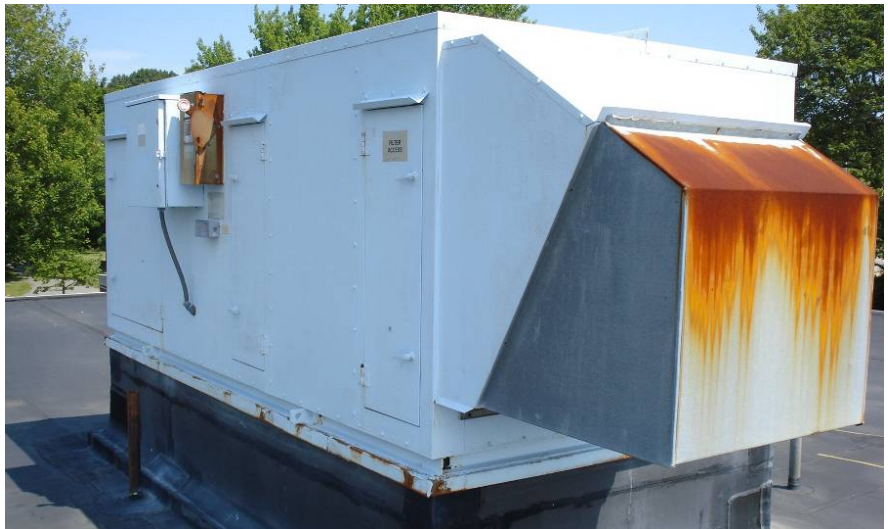
On HRU-1, additional sheet metal has been added to the outside air intake hood to help prevent snow from entering the intake. In many of the rooftop units, there are signs a corrosion between the sections of the HRU. Note the rusty areas shown in the photo below.

*HRU-1*

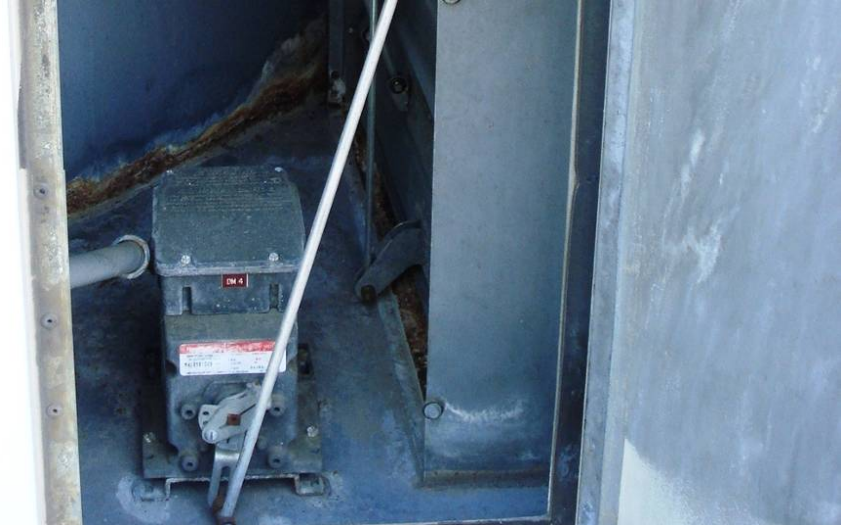
*HRU-1 Rusty Areas  
Within Unit*

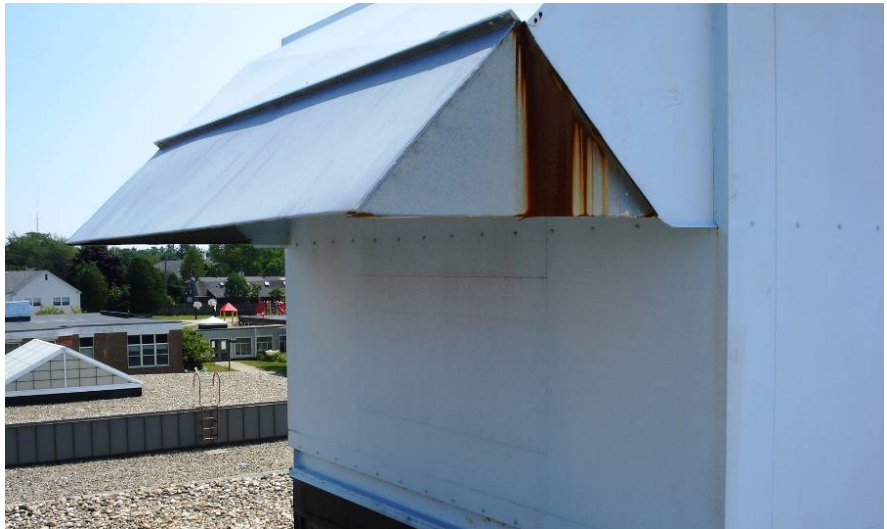
Additional sheet metal has been added to HRU-8 intake hood.

At the time of review, the unit was not operating but the intake closure damper was open possibly indicating the damper actuator has failed in the open position or the damper linkage is disconnected.

*HRU-8 Intake Hood*

As an immediate action, we would recommend servicing the intake damper. As a future action, we would recommend replacement of the unit.

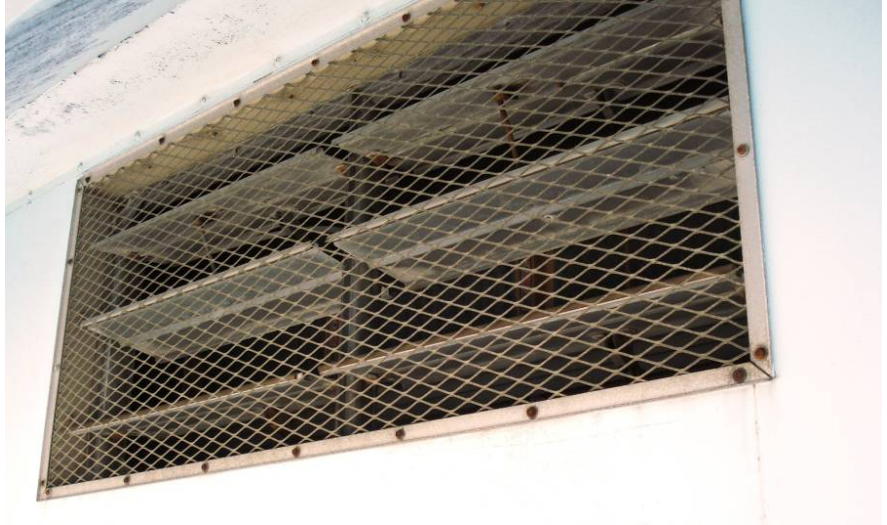
*HRU-8 Intake Closure Damper*

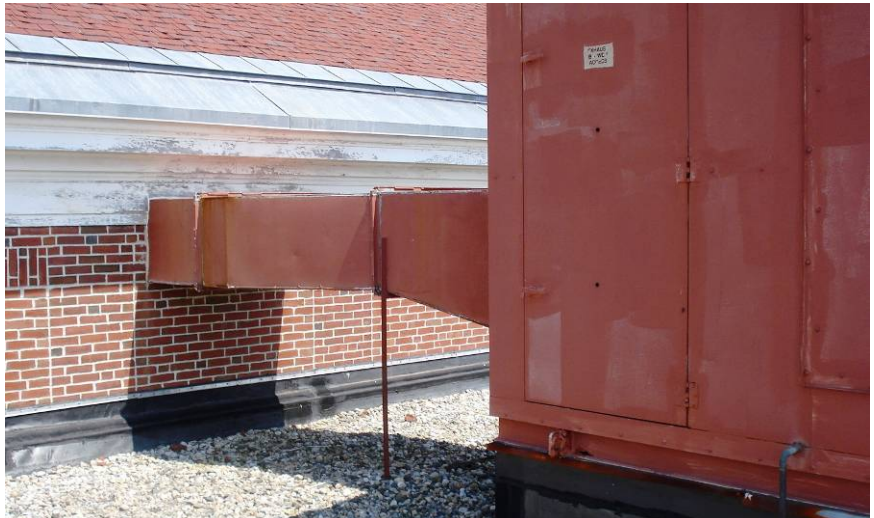
HRU-9 serves the 1930s “G” Building. The unit supply is provided out of the unit and through the exterior of the building. The wall penetration appears to be in good condition. The supply duct is not insulated on the outside but may internally lined. The return to the unit is installed up through the roof curb from the ceiling space below.

*HRU-9 Supply Duct*

We would recommend replacement of the unit and insulating the supply duct to reduce heat loss.

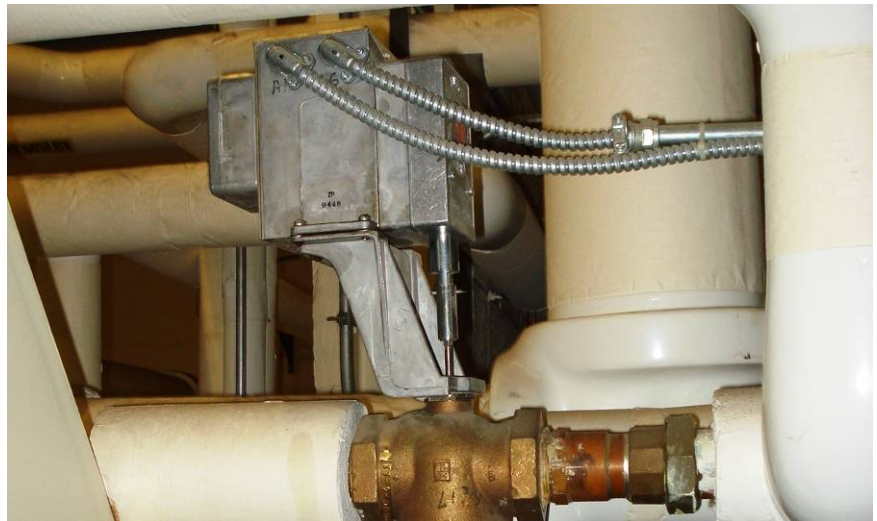
AHU-6 heating coil valve actuator is the original gear train actuator and is showing signs of oil leakage. At the time of review, the unit was off. The mixed air dampers partially open and showing signs of their age. One of the filters has been pulled of the frame.

*View of AHU-6 Heating  
Coil Valve*

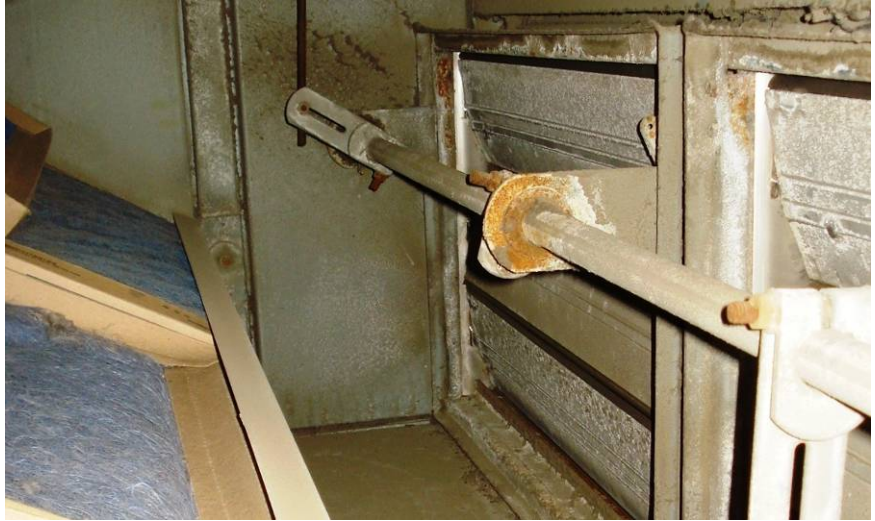
*AHU-6 Mixed Air  
Dampers and Filter*

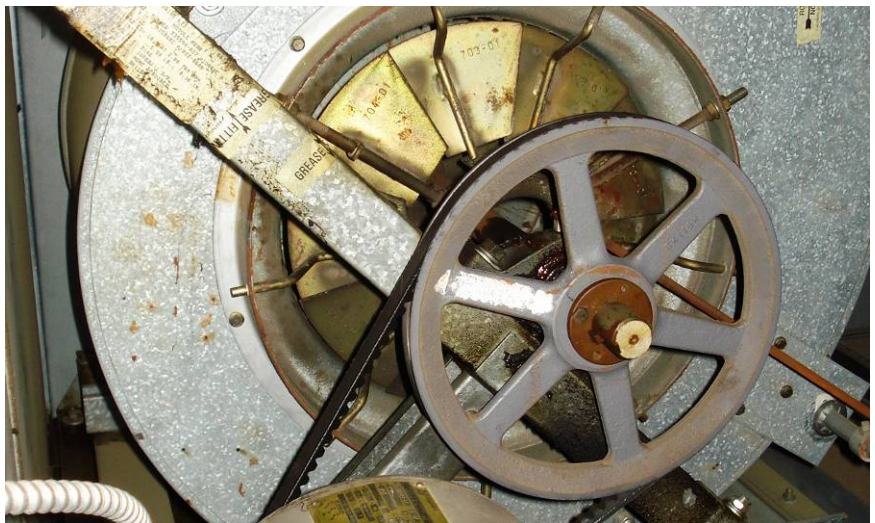
AHU-7 supply air is controlled by opening and closing the fan inlet vanes. This was a common practice before the introduction of variable frequency drives to control the speed of the fans.

*AHU-7 Adjustable Inlet  
Vanes in Supply Fan*

We would recommend the removal of the inlet vanes, verification of motor and VFD compatibility and the installation of a variable frequency drive.

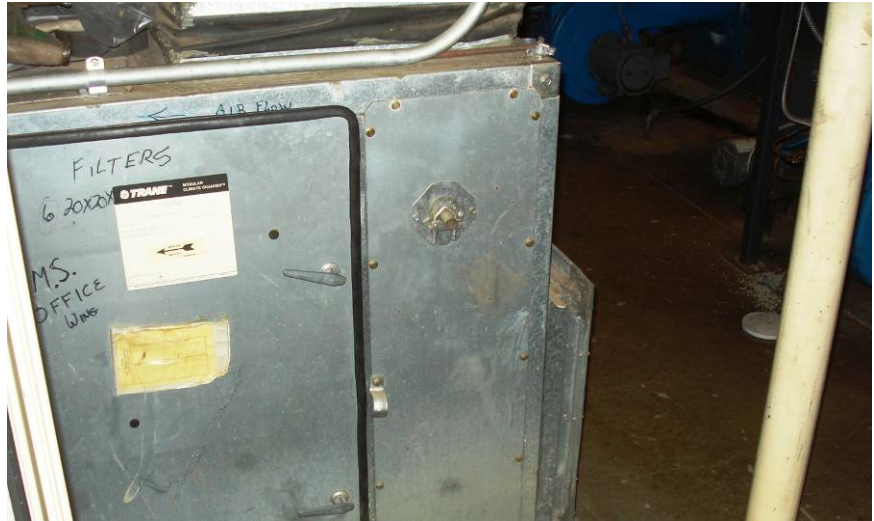
The damper at the end of the unit was blanked off during the construction. The unit was provided with mixed air dampers. Due to room constraints, changes were made to mix the return (return fan RF-4) and outside air in the ductwork above the unit and provide the mixed air to the unit through the top damper. The top damper was locked open and the damper at the end of the unit was blocked off.

*AHU-7 Blanked-off Damper at the End of Unit*

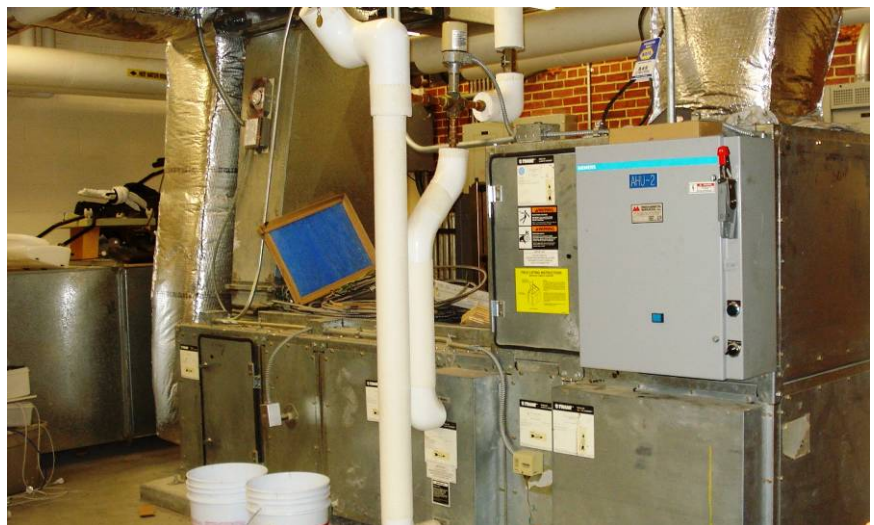
AHU-2 is a variable air volume unit and serves the Administration Offices on the ground floor (Area “C”) of the Elementary School. At the time of review, the return fan (RF-3) associated with AHU-2 was operating but the AHU-2 supply fan was off on reset. Depressing the reset button caused the fan to operate.

*AHU-2 Side View*

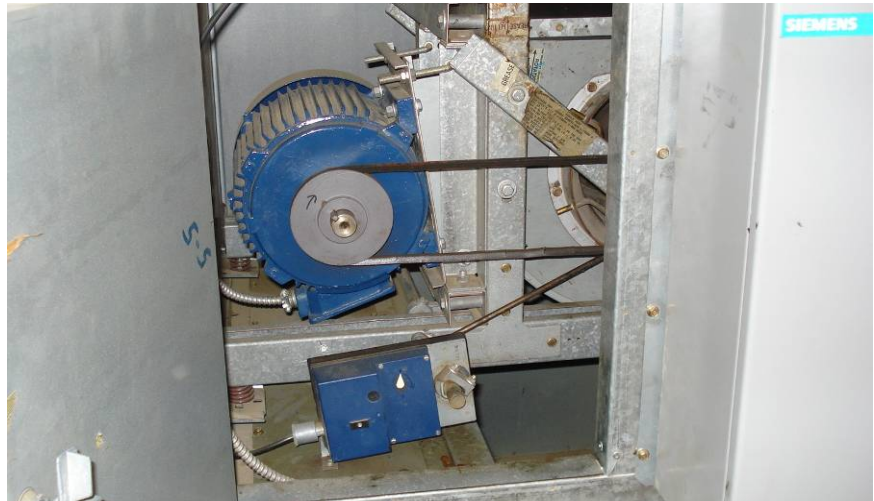
*AHU-2 Supply Fan and  
Inlet Vane Actuator*

The air volume of AHU-2 is controlled through the fan inlet vanes. We would recommend removing the vanes, verifying the motor is compatible with a variable frequency drive (VFD), and installing a VFD to control the fan speed.

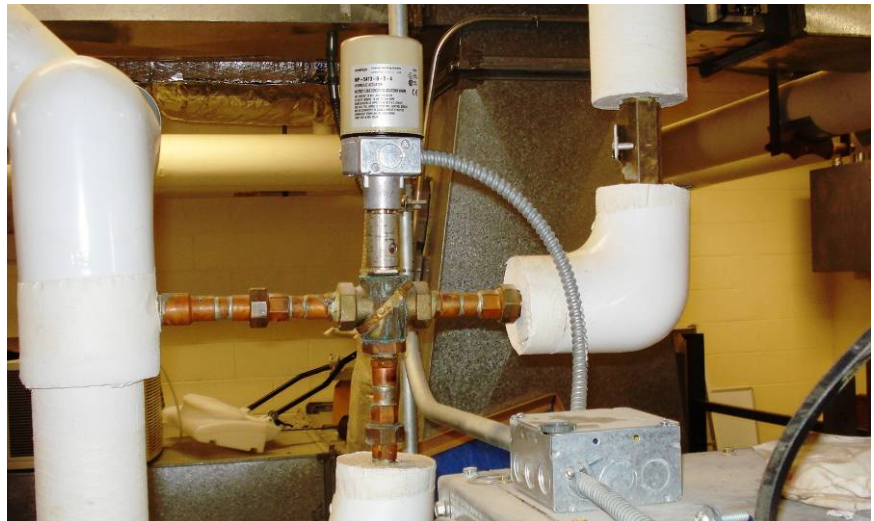
Sometime after December 2005 (date code 0551), the hydraulic actuator on the 3-way valve had been replaced. The valve appears to be original.

*AHU-2 3-way Control  
Valve Actuator*

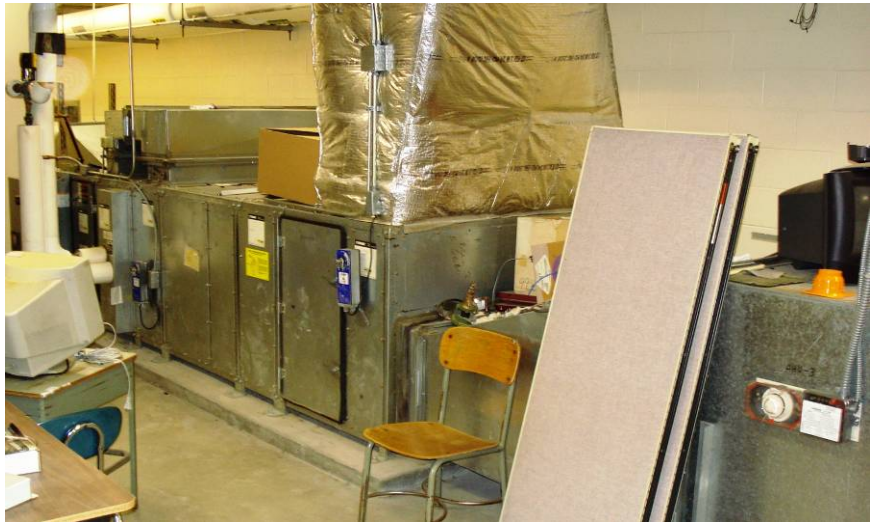
*View of AHU-3 and the Respective Duct Smoke Detector*

We would recommend the installation of access doors at all duct smoke detectors and cleaning of all smoke detector inlet tubes.

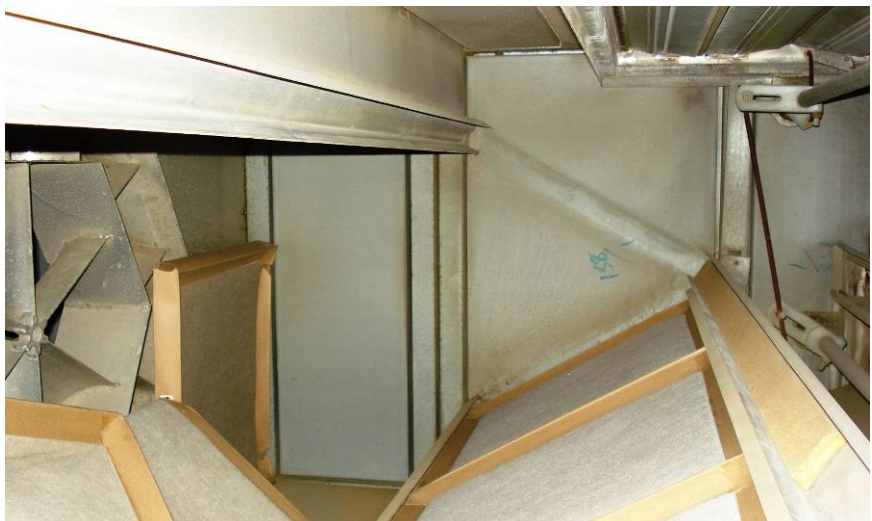
The inside of the mixed air/filter section is very dirty and the top filters have been pulled into the de-stratification device.

*AHU-3 Mixed Air and Filter Section.*

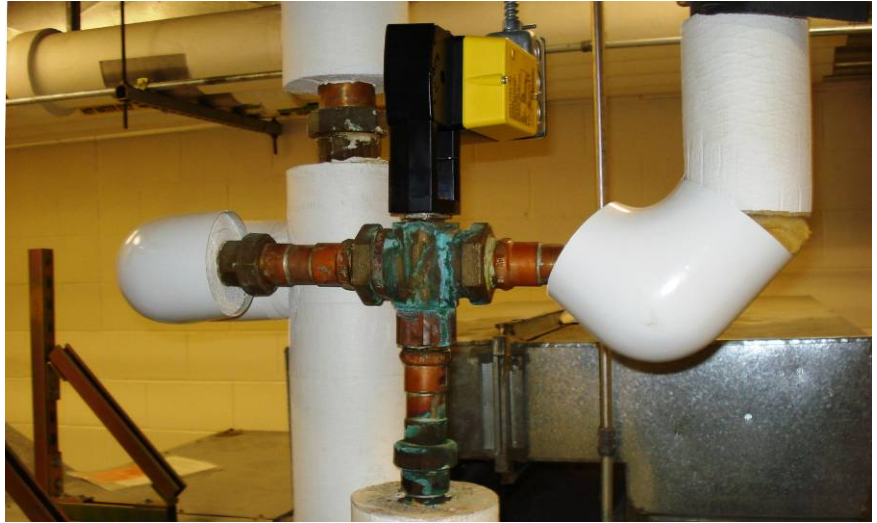
The actuator on the 3-way valve has been recently replaced. Based on the signs of leakage, it would appear the valve body may be original to the 1994 installation.

*AHU-3 3-way Control Valve*

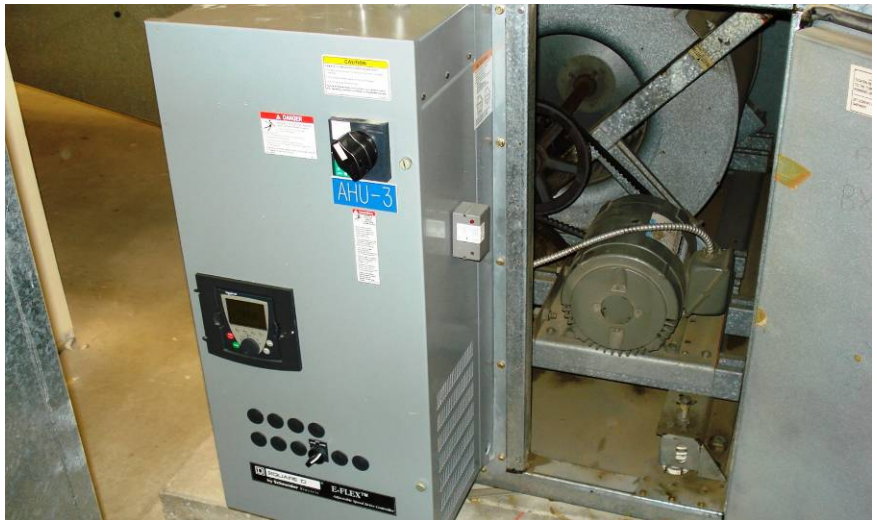
A variable frequency drive is mounted to the side of the unit. The sequence of operation for the fan is unknown.

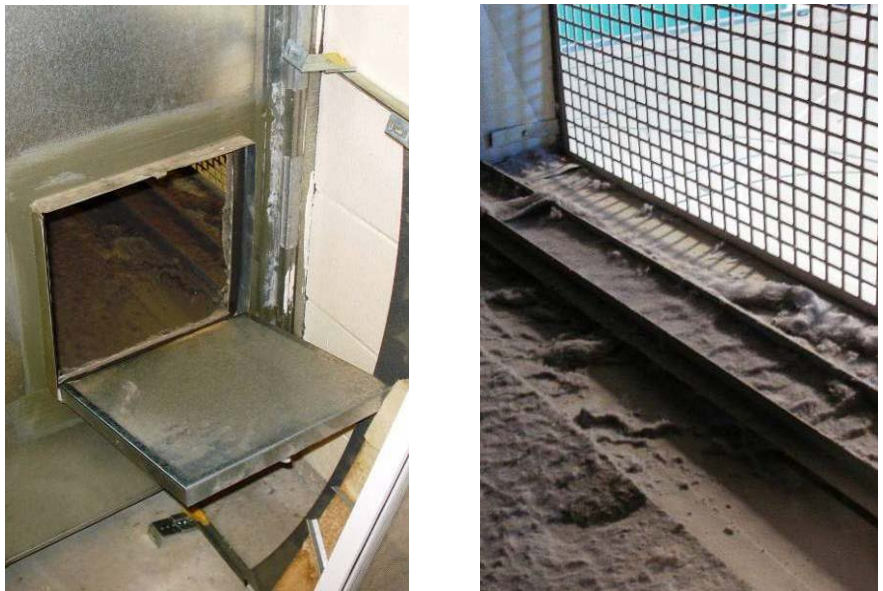
Fire dampers and access doors have been installed in the supply and return ducts at the wall between the gym and the Mechanical Room. The access doors may not be sufficient to exercise or reset the fire damper if necessary. Some of the wall penetrations have not been properly sealed. The inside of the supply and return ducts are very dirty.

*View of Access Door at Return Fire Damper and Dirty Duct*

We would recommend exercising of the fire dampers annually in accordance with NFPA providing additional access doors as necessary and sealing all wall penetrations and cleaning of all duct systems.

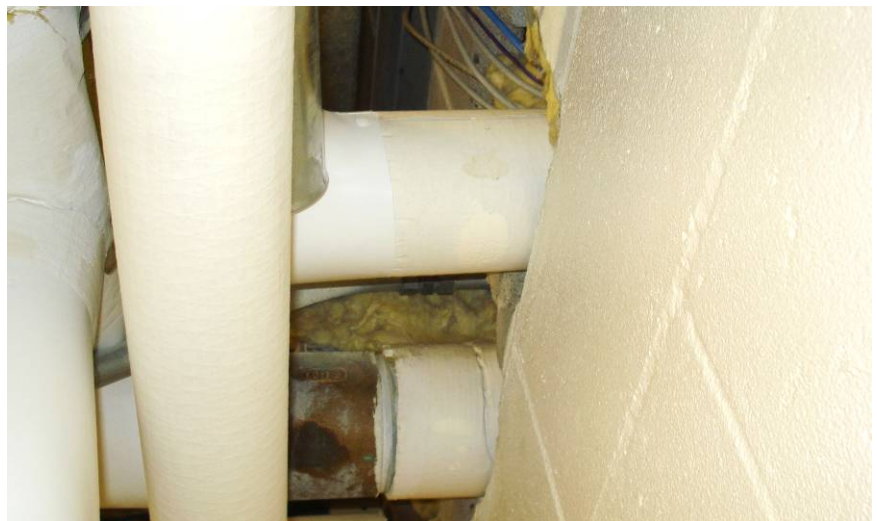
*Sample of Unsealed Wall Penetrations*

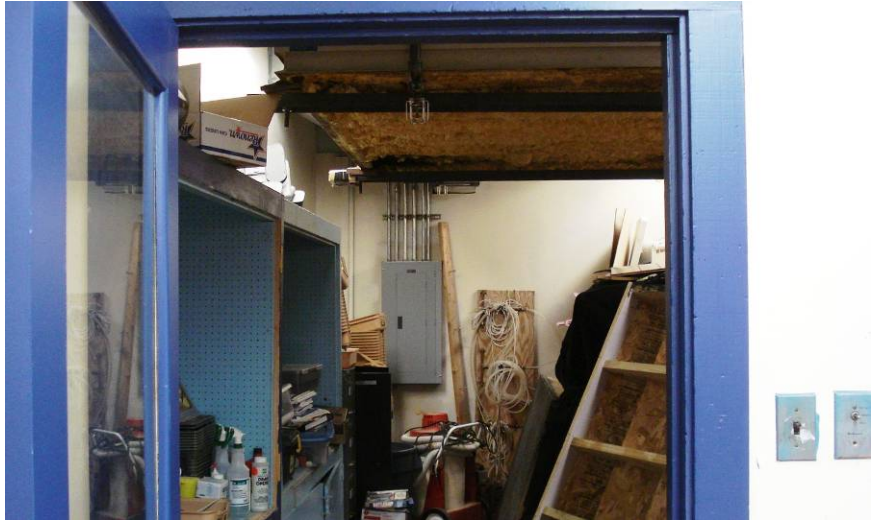
Heat Recovery Unit HRU-7 serves the “F” wing including the Band Room, Piano/Music Room, Technical and Applied Arts area and Teacher Workroom. At the time of review, the unit was turned off at the disconnect. The unit is rigidly supported directly from structure in the Storage Room F112. Spray foam has been applied to the bottom of the unit for an unknown reason. The 3-way valve hydraulic actuator is showing signs of leakage.

*View of Underside of  
HRU-7*

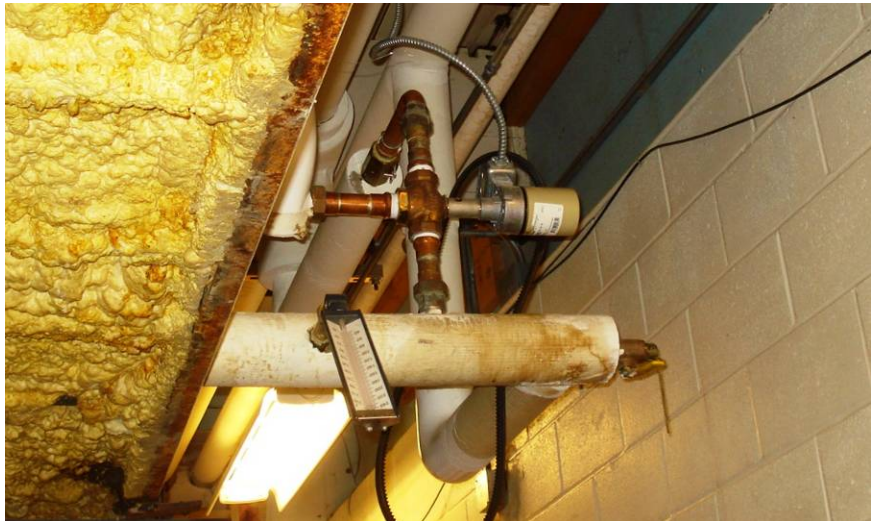
*HRU-7 3-Way Control  
Valve and Hydraulic  
Actuator*

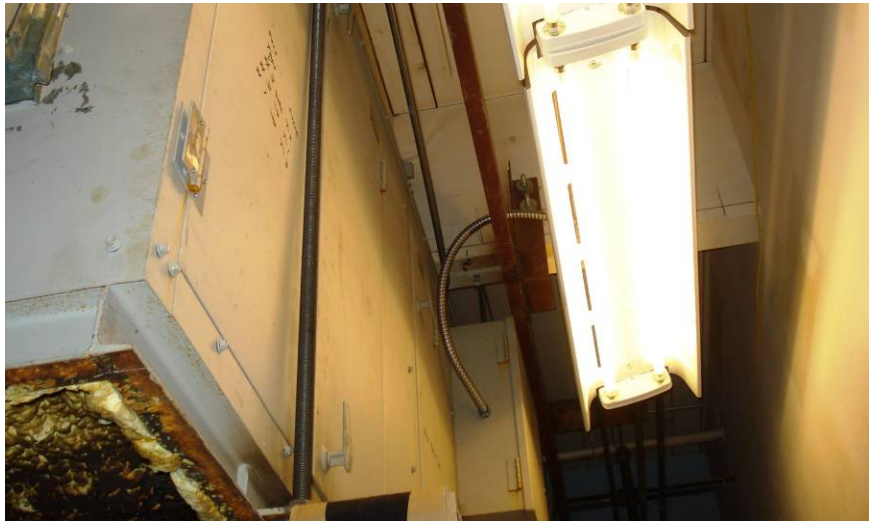
It would appear access to the HRU-7 is very limited. The hinges on the filter door appear to have been dismantled to gain access to the filters likely due to the location of the threaded rod supporting the unit.

*HRU-7 Filter Access Door*

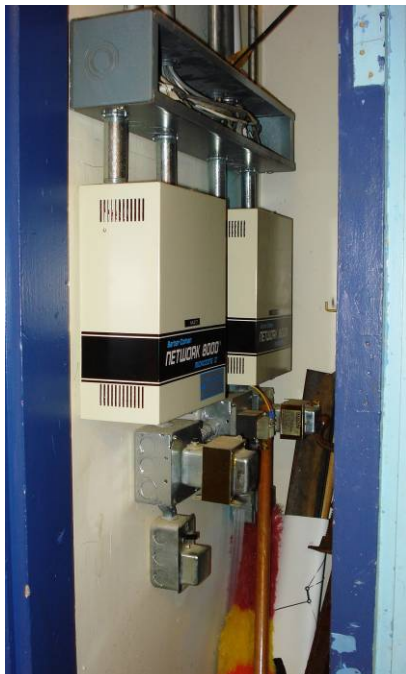
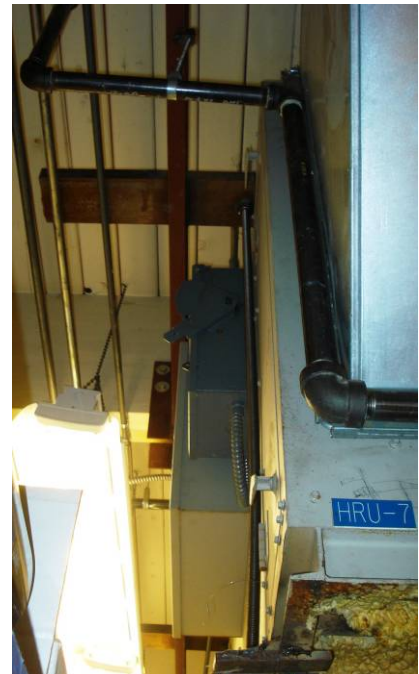
The unit-mounted electrical power disconnect and control panel are located in a very inaccessible location.

*HRU-7 DDC system Components and Unit-mounted Disconnect and Control Panel*

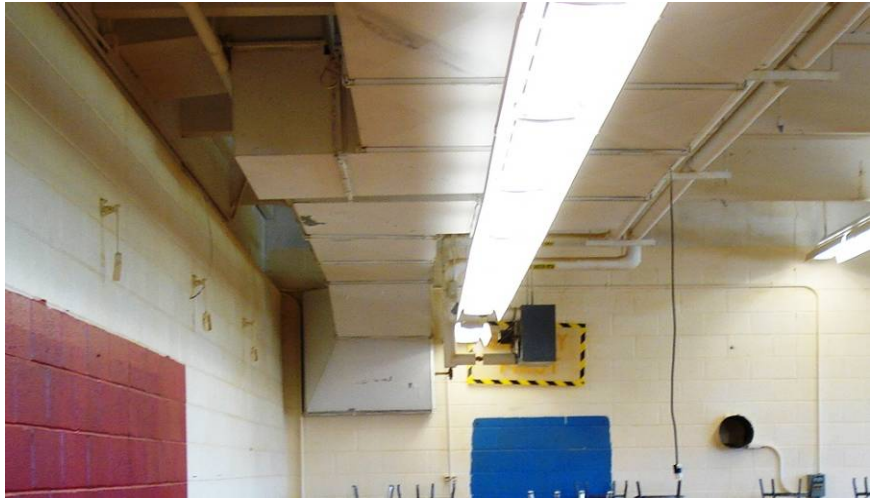
The ductwork running along the ceiling of the Shop Area is the HRU-7 outside air intake (through the further wall) and the unit exhaust (through the roof). The ductwork is un-insulated and there are no isolation dampers at the wall or ceiling. This is a tremendous heat loss.

*HRU-7 Outside Air Intake and Exhaust Ductwork*

We would recommend the installation of isolation motorized low-leak dampers at the wall and roof line and insulating the intake and exhaust duct.

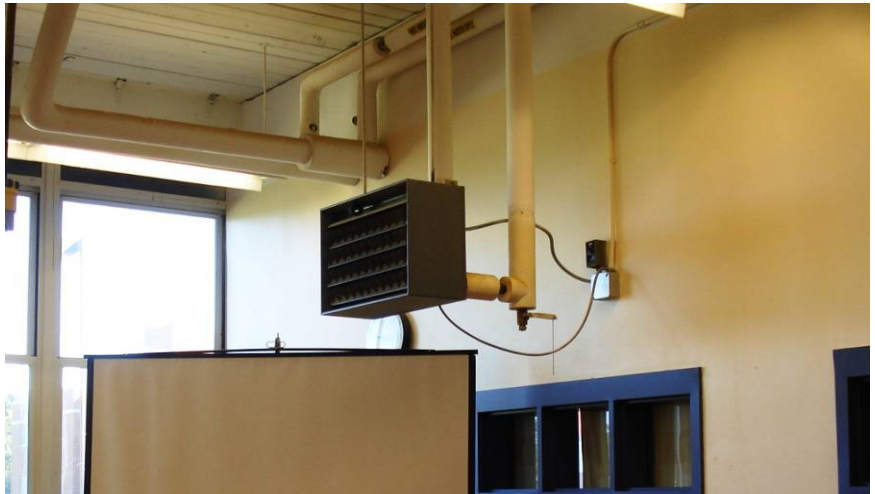
Additional heating in the technical and Applied Arts Shop area is provided through two horizontal unit heaters controlled by a local thermostat. Operation of the unit heaters is unknown. The thermostat cover is off and electrical tape is wrapped around the thermostat.

*Unit Heater in the Shop Area*

We would recommend replacing the thermostat with a DDC system space sensor and adding control of the unit heaters to the DDC system if points are available.

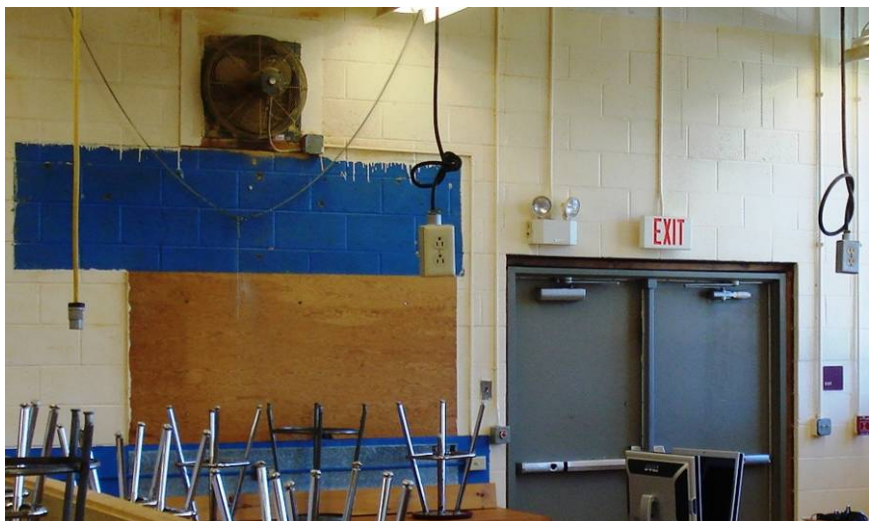
The wall-mounted exhaust fan at the back wall is controlled by the local wall switch near the door. The fan does not appear on the 1994 Addition and Renovations documents. Operation was confirmed. When the fan was turned off, the backdraft damper remained partially open after the fan stopped. After a few minutes it dropped closed.

*Wall-mounted Exhaust Fan*

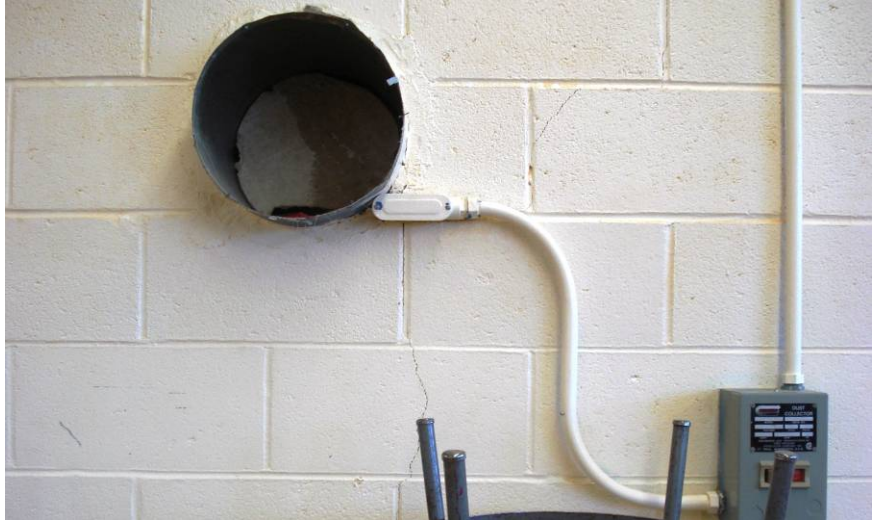
The old dust collection system has been abandoned, the ductwork removed, and the wall opening blocked.

*Abandoned Dust  
Collection System Wall  
Penetration and Switch*

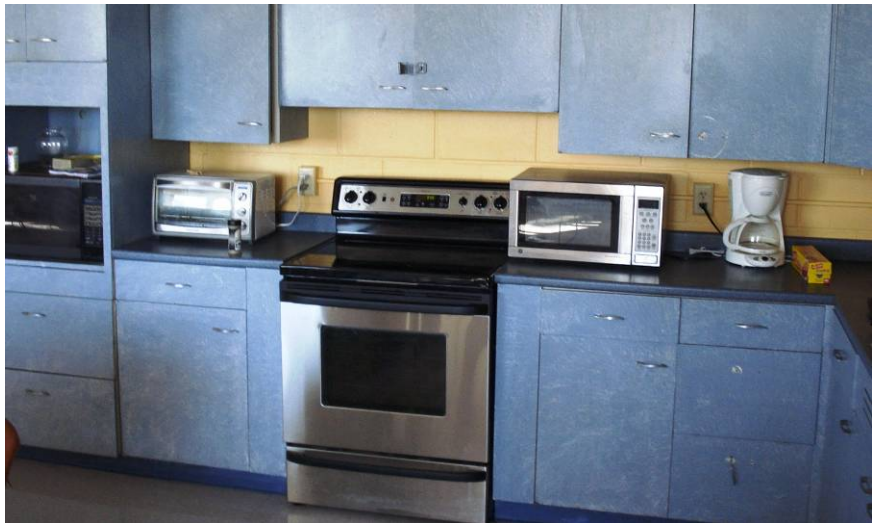
In the Teachers Workroom, a kitchen area was provided as part of the 1994 Addition and Renovations project without an exhaust hood or automatic fire suppression system above the stove.

We would recommend the installation of a hood and fire suppression system in accordance with current codes and the requirements of Fire Marshall and the Jurisdiction Having Authority.

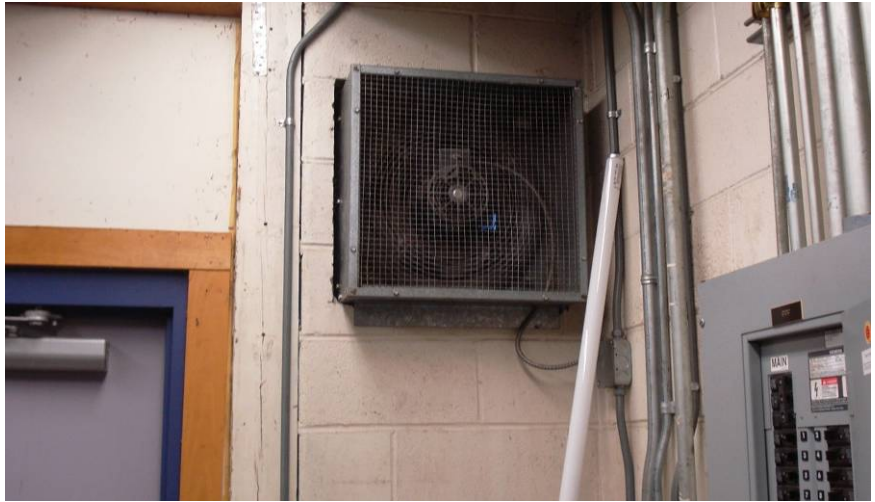
The exhaust fan (EF-14) serving the Main Switchgear Electrical Room F103 responded to the call for cooling at the local thermostat. Cycling the thermostat caused the fan to respond properly. Daylight is visible through the backdraft damper.

*Exhaust Fan in Main  
Switchgear Electrical  
Room F103*

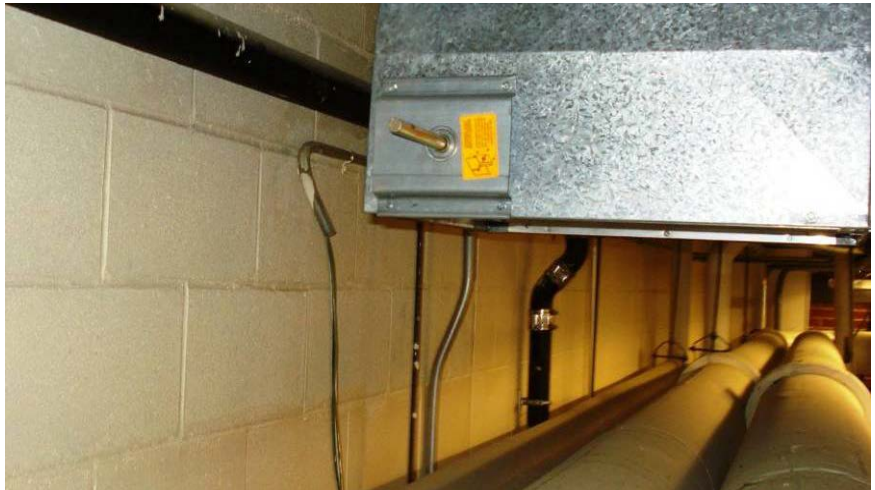
The exhaust fan (EF-17) serves the Mechanical Room C210 (near AHU-2), and, based on the contract documents, was to be interlocked with the motorized damper at the intake hood. The low-leak airfoil type damper is installed but, based on the wires hanging by the damper and the lack of screw holes in the duct, it appears the damper actuator was not installed. It is unknown whether the actuator was left off intentionally or not.

*Intake Damper Associated with Exhaust Fan EF-17*

If proper ventilation of the space has been an issue, we would recommend installation of the damper actuator and proper interlock with the exhaust fan.

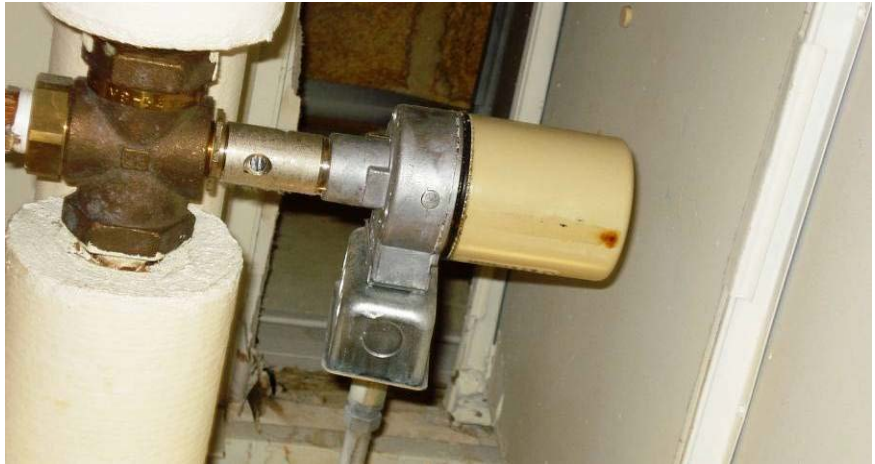
HRU-6 3-way heating control valve is located under the unit in the Laundry or Sports Storage Room E126. The MPR-5413 hydraulic valve actuator is showing signs of hydraulic fluid leakage.

*HRU-6 3-way Heating Control Valve*

We would recommend replacement of the control valve actuator.
