**Town of Cape Elizabeth**  
Seven Building Facility Study  
*Cape Elizabeth, Maine*

HARRIMAN | Architects + Engineers

**Introduction****Town of Cape Elizabeth Facilities Study**

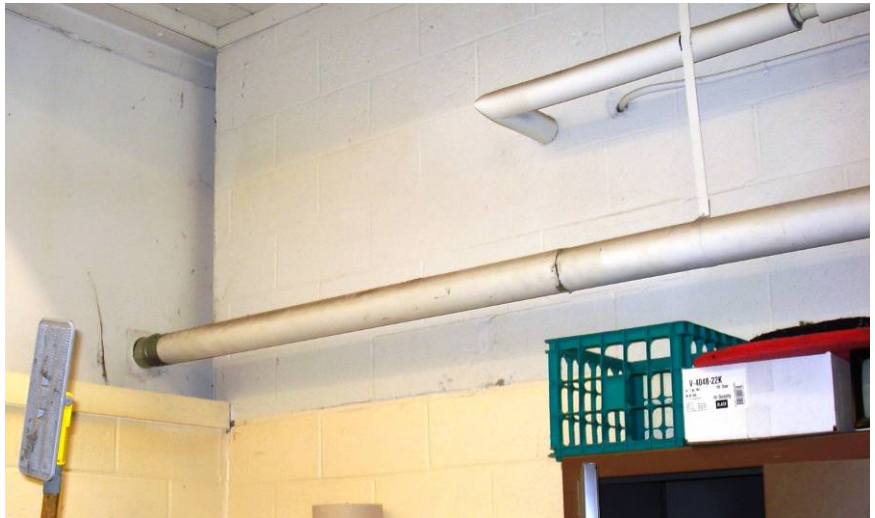
The horizontal portion of the drier vent duct, located in the janitor's closet E127 was installed as part of the 1994 addition and renovation project. The drier was installed by the school at a later date. The horizontal section is installed with screws at the joints. The duct near the drier appears to be assembled with duct tape; screws are unknown. Lint traps are not installed.

*Drier Vent Duct in the Janitor's Closet.*

We would recommend reinstalling the duct with lint traps as required in accordance with current codes.

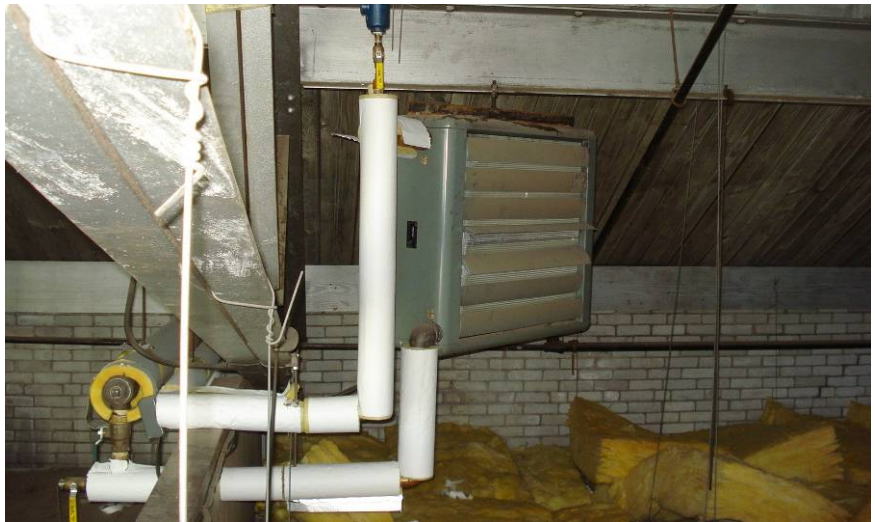
The ventilation of the 1930s Building is provided from the roof-mounted heat recovery unit HRU-9 (rooftop unit shown above). The attic space is heated by two horizontal unit heaters located at each end of the attic. Operation of the unit heaters is unknown and the fins are mostly closed.

*Unit Heater Located In Attic Space of 1930s Building*

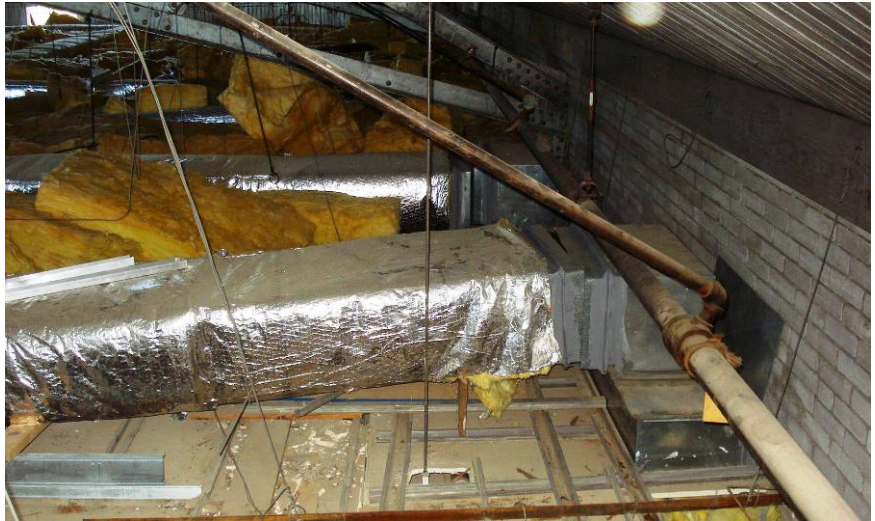
The supply and return from HRU-9 is ducted through out the building. The ventilation system appears to be well insulated but the piping and duct components do not appear to properly suspended.

*Supply (far duct) and  
Return Ducts located in  
the Attic Space of the  
1930s Building*

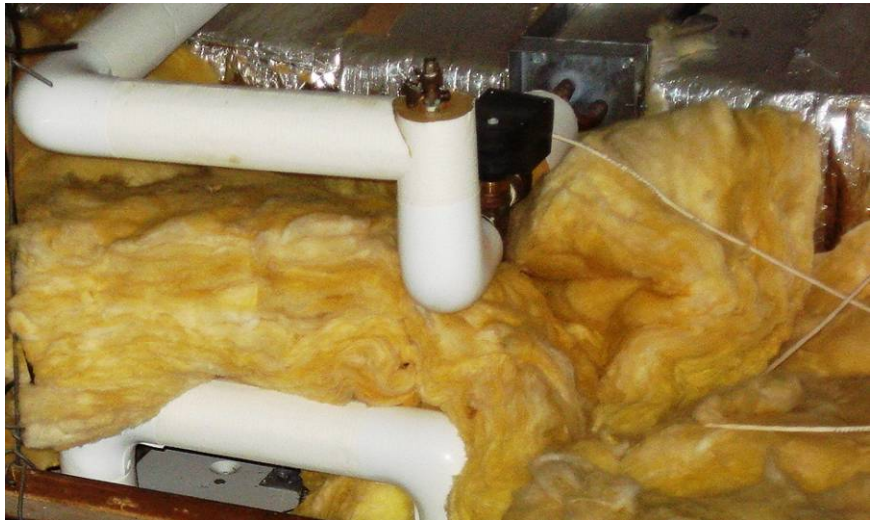
The heating control valves appear to be as installed during the 1994 Addition and Renovation project, nearing the end of their life expectancy, and may require replacement.

*Reheat Control Valve*

We would recommend a complete review and verification of proper operation of all reheat control valves.

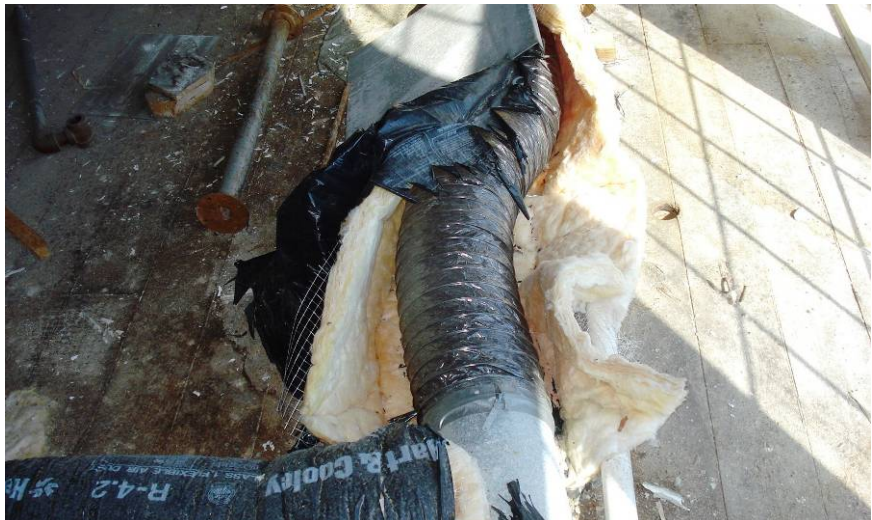
Where the branch flex duct is located in the line of traffic, some of the insulation has been damaged and the thin inner liner is exposed. Many of the metal branch tees are not insulated.

*Failed Insulation on Branch Flex Duct*

*Branch Tee is Not Insulated*

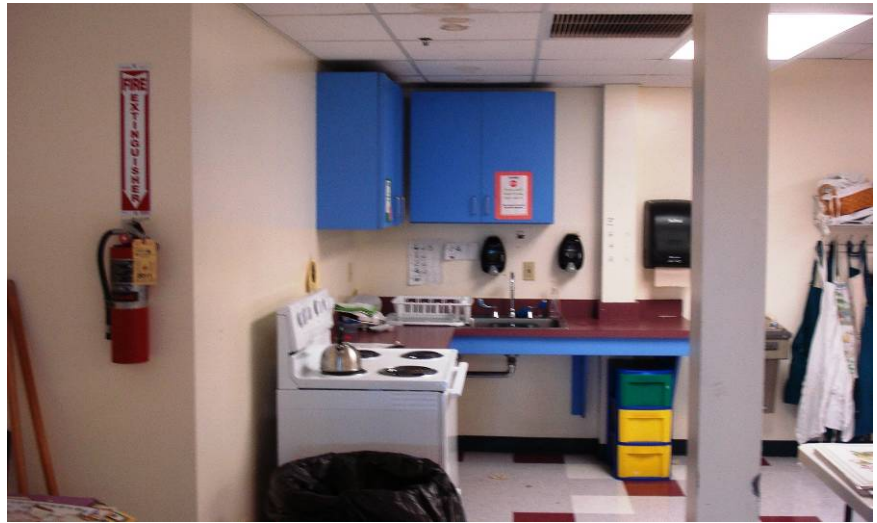
In the ground level of the 1930s building, a kitchen area has been installed without an exhaust hood or fire suppression system above the stove.

We would recommend the installation of a hood and fire suppression system in accordance with current codes and the requirements of Fire Marshall and the Jurisdiction Having Authority. Another option may be to remove the stove.

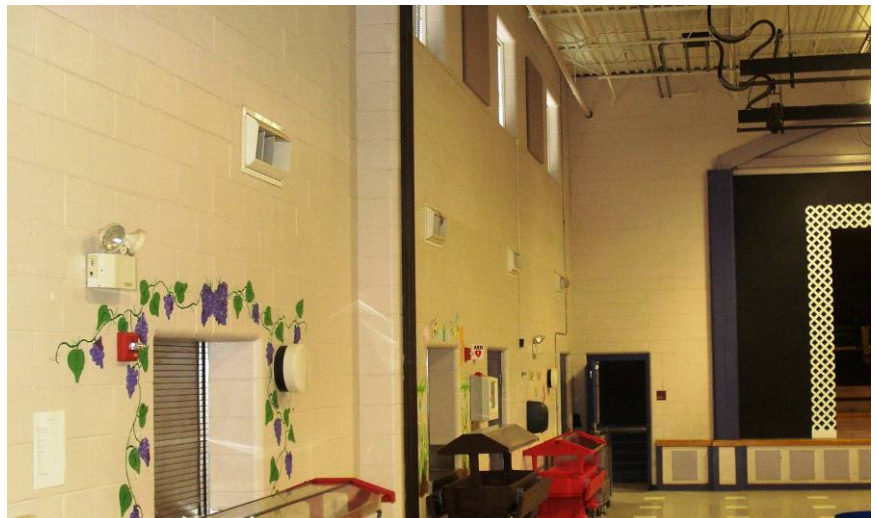
Ventilation for the Cafetorium is provided from AHU-5 located in the Boiler Room. The supply is installed along the north wall (kitchen side) and supplies air to the full length of the Cafetorium, including the stage, and both sides of the moveable wall. The return is installed along the south wall (corridor side) but does not provide for return from the west end of the café when the moveable wall is closed.

*View of North Side of Cafetorium Wall showing Supply Outlets*

We would recommend the return air system be revised to allow for return air from the west end of the café.

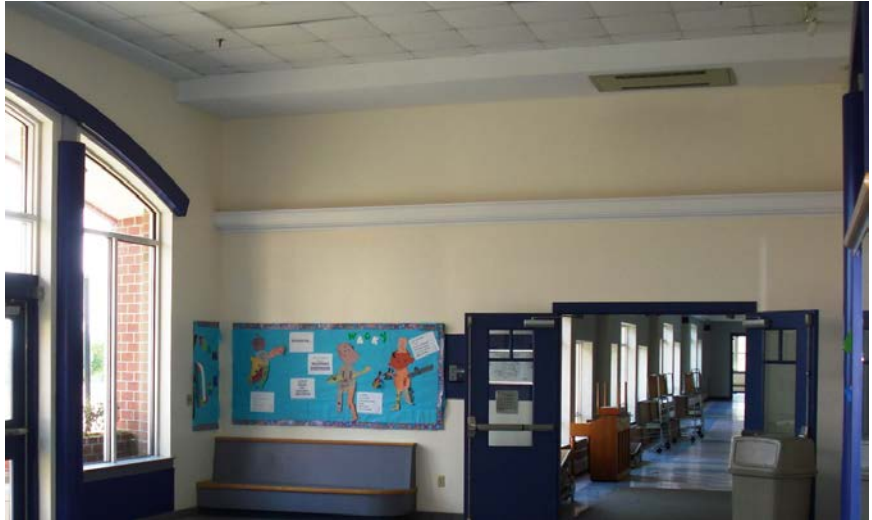
Ventilation is not provided for the Lobby or adjacent Corridors.

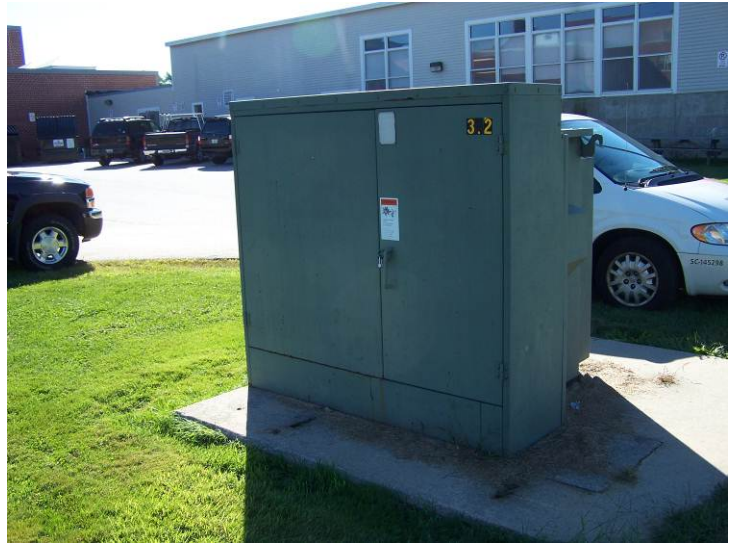
*Primary Service  
Transformer*

The Middle School pad mounted transformer is a 500kVA three phase transformer. Secondary service voltage is supplied at 277/480 volts. There is no peak demand data for this service as there is one primary meter for the High School and Middle / Pond Cove Elementary Schools; however, the 500kVA transformer appears undersized for the square footage of the building.  $500,000\text{VA} \div 163,110 \text{ sq ft} = 3.1\text{VA/sq ft}$  (typical design  $\text{VA/sq ft} \approx 8\text{VA/sq ft}$ ). As technology requirements increase it is likely that energy usage will increase also.

It is recommended that as building loads increase special attention be given to the primary service transformer and ultimately be replaced for a more appropriately sized unit.

| Building #2<br>Cape Elizabeth Pond Cove Elementary / Middle Schools - Electrical and Technology Systems | | | | | | <b>*Priority Scale:</b> #1 = 1 year<br>#2 = 2 years<br>#3 = 5 years<br>#4 = Future |
|---|---|--|---|---|---|--|
| E2.1 | Primary Service | Primary underground from Scott Dyer Rd. (see High School Assessment). Pad mount transformer is 500kVA. | 500kVA transformer is undersized for a building of this size. | Replace existing 500kVA pad mount transformer with new 1000kVA. | \$35,000.00 | 1 |

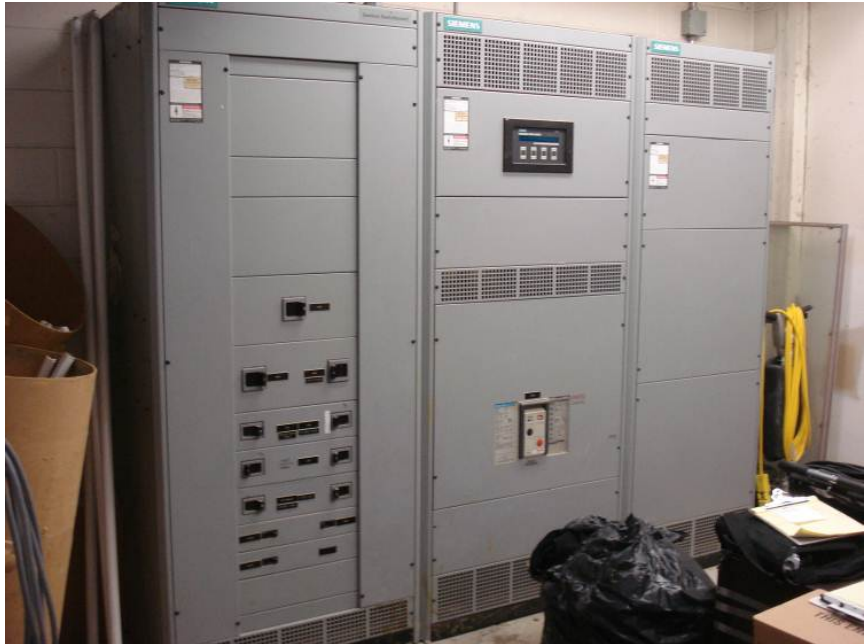
*Main Switchboard*

Main service consists of secondary conductors from the exterior pad mount transformer feeding a 1600A 277/480V 3phase 4wire Siemens main switchboard located in the Area F Main Electrical Room. The main switchboard serves two distribution panels, a motor control center, and multiple lighting/power panelboards throughout the facility. There is one spare breaker and one space provided in the main switchboard for future expansion. There are multiple transformers located throughout the building to provide 120/208V power. Distribution equipment appears to be in good condition. Most equipment was upgraded in the 1994 renovation project. Based on per square foot loads (see above) the main switchboard appears to be appropriately sized for this building. The switchboard has capacity for just over 6.5 watts per square foot.

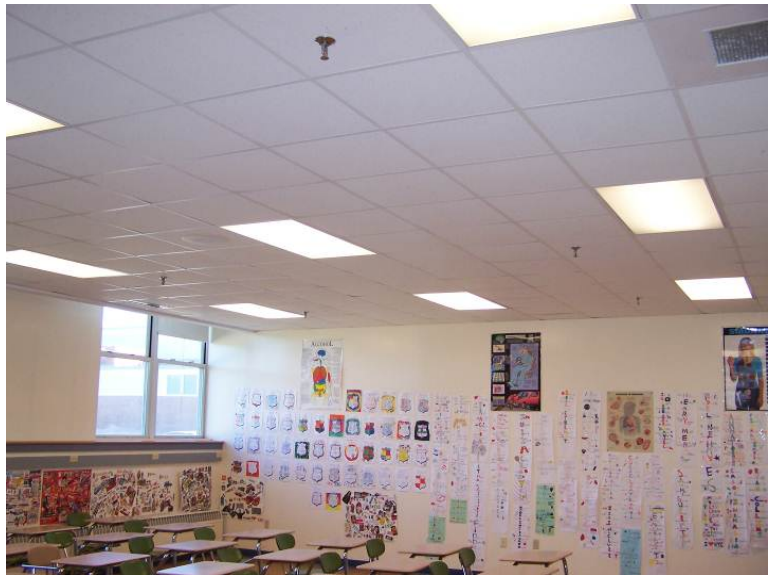
*Typical Classroom Lighting*

Most classroom lighting is achieved with 2'x4' three and four lamp T8 recessed troffers. There are a variety of switching arrangements including one level, two level, and three level switching. Generally switched rows are parallel with the windows allowing the outer rows of lights to be switched off on a brighter day. Lighting levels appear to be acceptable.

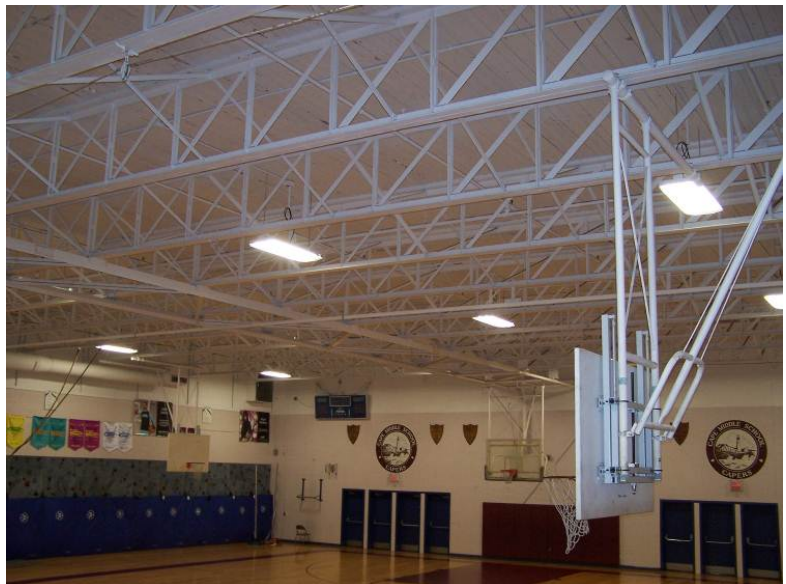
*Middle School Gym Lighting*

Middle School Gym lights consist of four rows of four, 6-lamp T5 high bay fixtures. Fixtures are in good condition. Lighting levels are average.

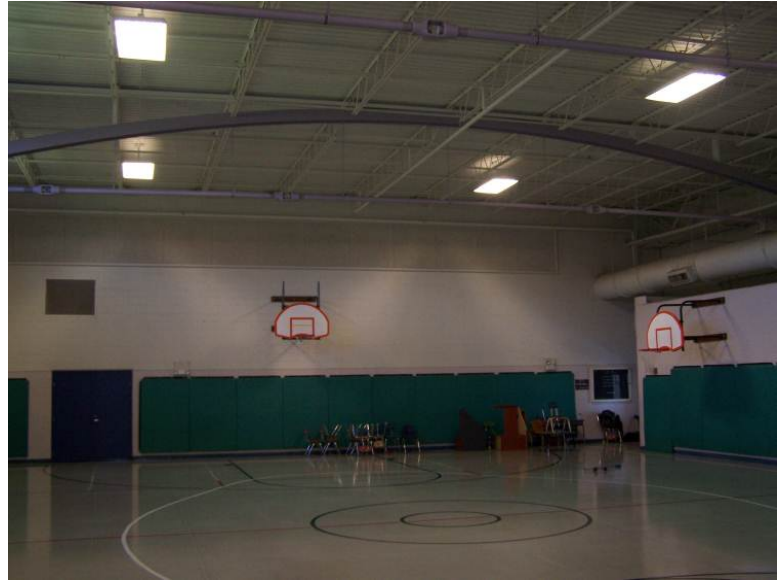
*Pond Cove School Gym  
Lighting*

Pond Cove School Gym lights consist of two rows of three, 6-lamp T5 high bay fixtures. Fixtures are in good condition. Lighting levels are fair. Further investigation into the use of this space and its required lighting levels is recommended

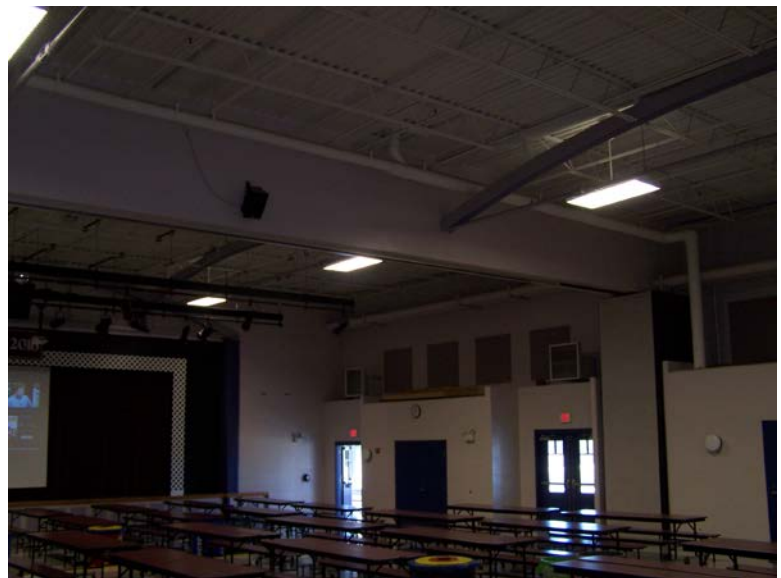
*Cafetorium Lighting*

Combination of two rows of four, 6-lamp T5 high bay fixtures, and incandescent wall mounted fixtures. Lighting is in good condition. Lighting levels are low for a multi-use space. Further investigation into the use of this space and its required lighting levels is recommended

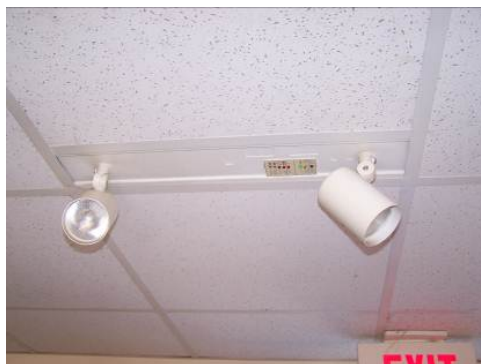
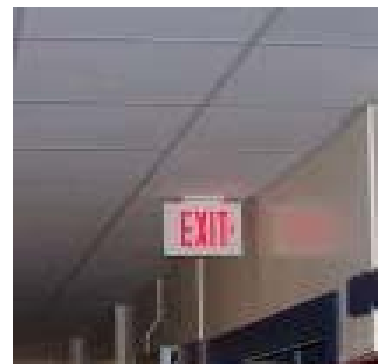
*Typical Emergency Lighting and Exit Signs*

Most emergency lights are surface wall mounted or ceiling recessed self-contained battery units with remote heads (EBUs). EBUs were generally in serviceable condition. Middle School Gym units were damaged and should be replaced. Generally emergency lighting coverage is good.

Exit signs observed are internally illuminated units with integral battery. Most signs are in good condition; however several areas including the Health/Tech Lab need supplemental exit signage to meet NFPA 101 requirements.

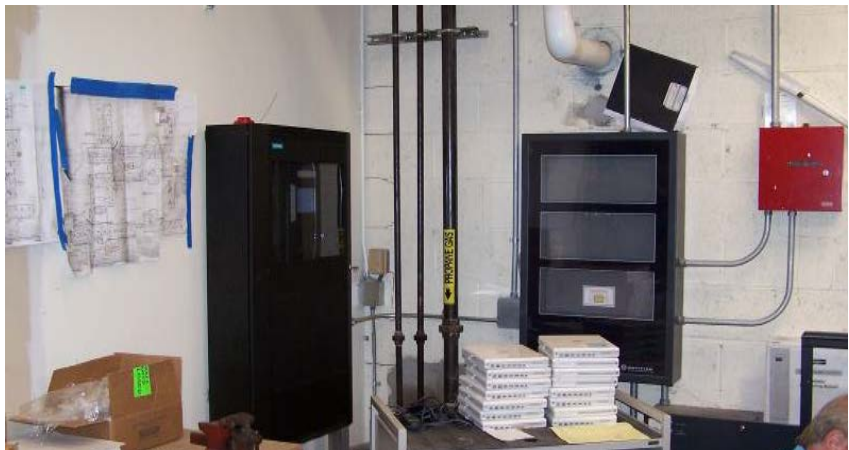
*Fire Alarm System*

Fire alarm system is a Siemens FireFinder XLS. The system was recently upgraded from an older Notifier installed during the 1994 renovation. The system is in good condition and no trouble was reported. In the event of an alarm, the system reports directly to Portland monitoring / dispatch facility. Several areas need additional notification appliances including the classrooms on the second floor of Area G.

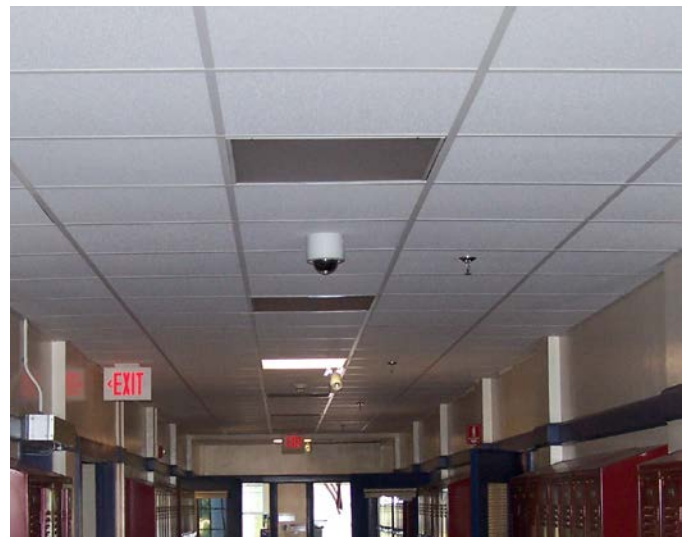
*Typical Camera*

The School is served by a video surveillance system with cameras at various locations throughout the building, mainly at building entrances. The system is an Integral Technologies system with a mixture of legacy and upgraded video platforms. The main server is based in the High School but also serves the Middle School, Pond Cove Elementary School, Police Department and Fire Department. Advance Technology is responsible for maintaining the system, and reports multiple failures of the system, with frequent database corruption and loss of camera function.

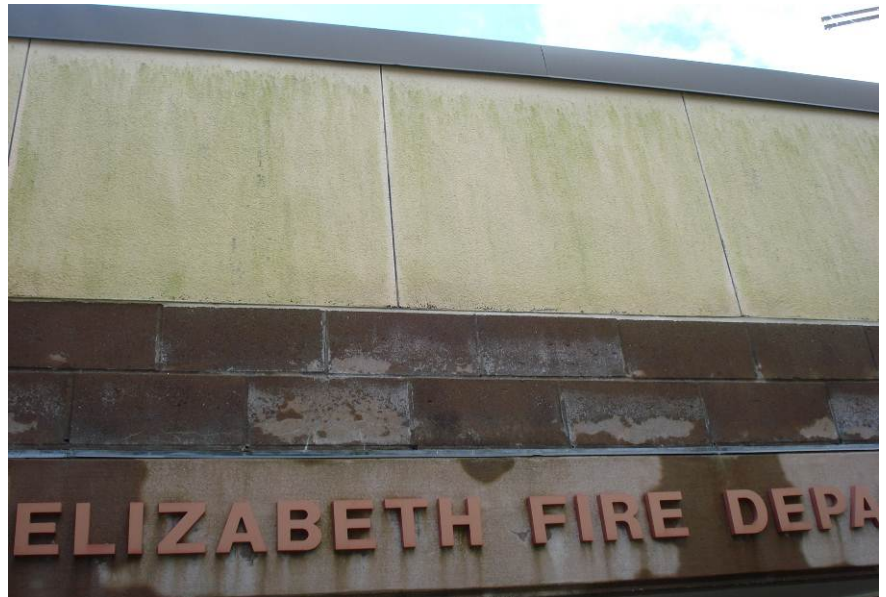
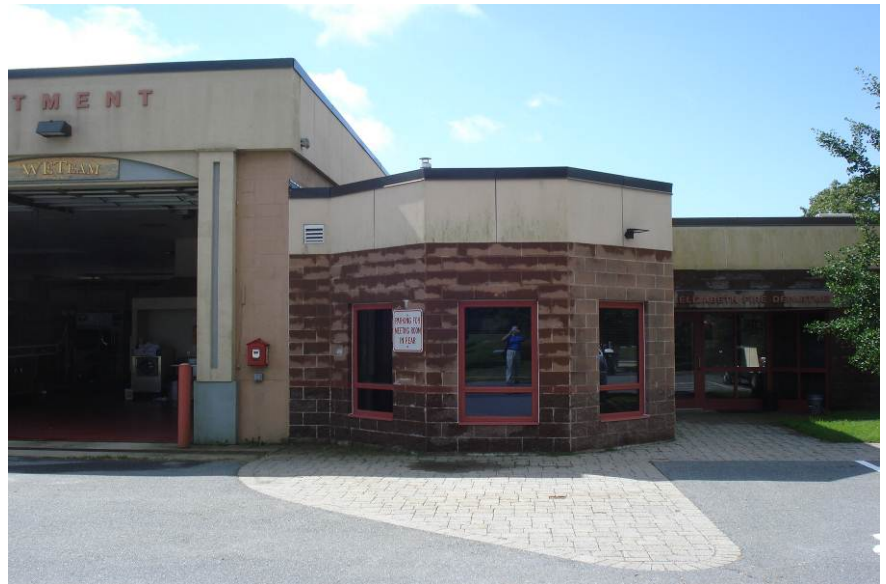
*Wet Masonry Surface*

The exterior wall system is a combination of pre-colored concrete masonry units, EIFS on steel studs and a durable paint system on regular block. The building was surveyed the day after a rain event. The pre-colored cmu veneer system had a surface wetness common with this type of masonry unit. Even though the system is cavity back with the proper flashing and drainage the presence of the moisture remaining in the block will be problematic over a very short term and will lead to a premature failure of the block system.

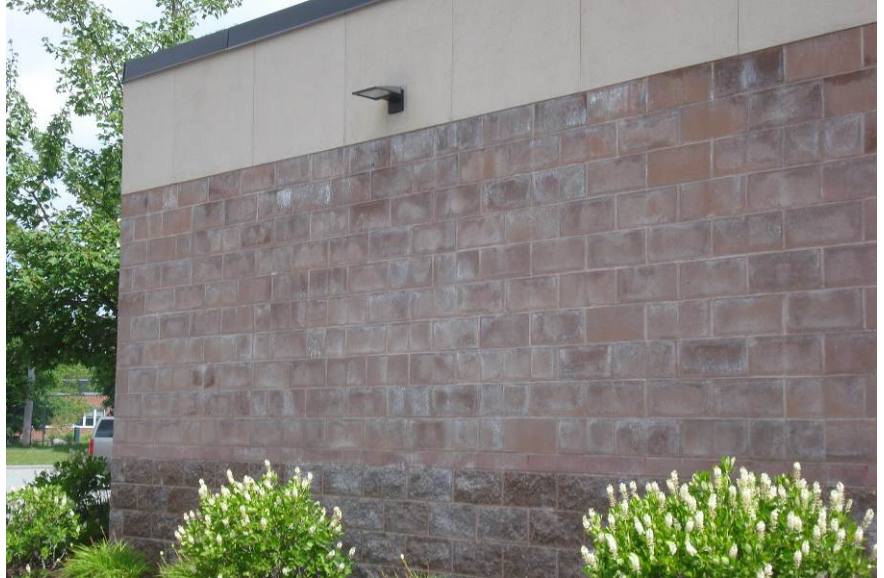
*Rear Wall – Moisture  
in Wall Has Discolored  
Pre-Colored Masonry  
Units*

*Rear Wall -  
Efflorescence*

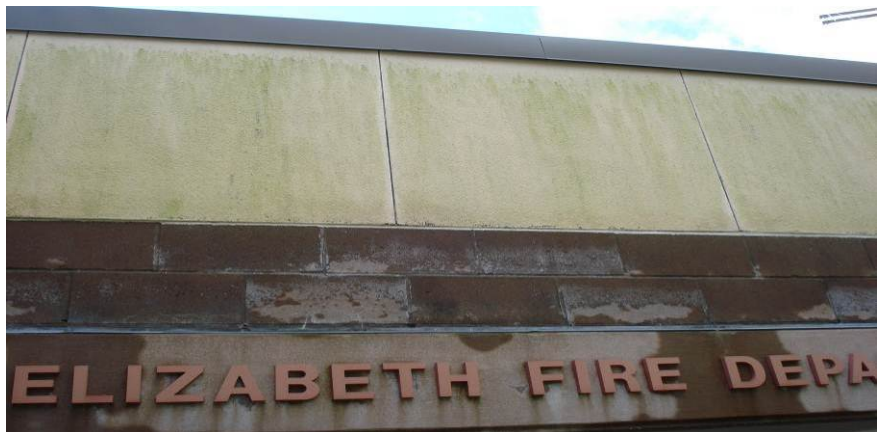
The EIFS panels on the office and meeting room areas are showing mold and mildew on the surface and the bottom edge is showing that parts of the finish has chipped off due to moisture.

*Mold and Mildew on  
Panel Surface*

Recommend cleaning of these panels with a strong bleach component building wash product to remove the mold and maintain the surface finish.

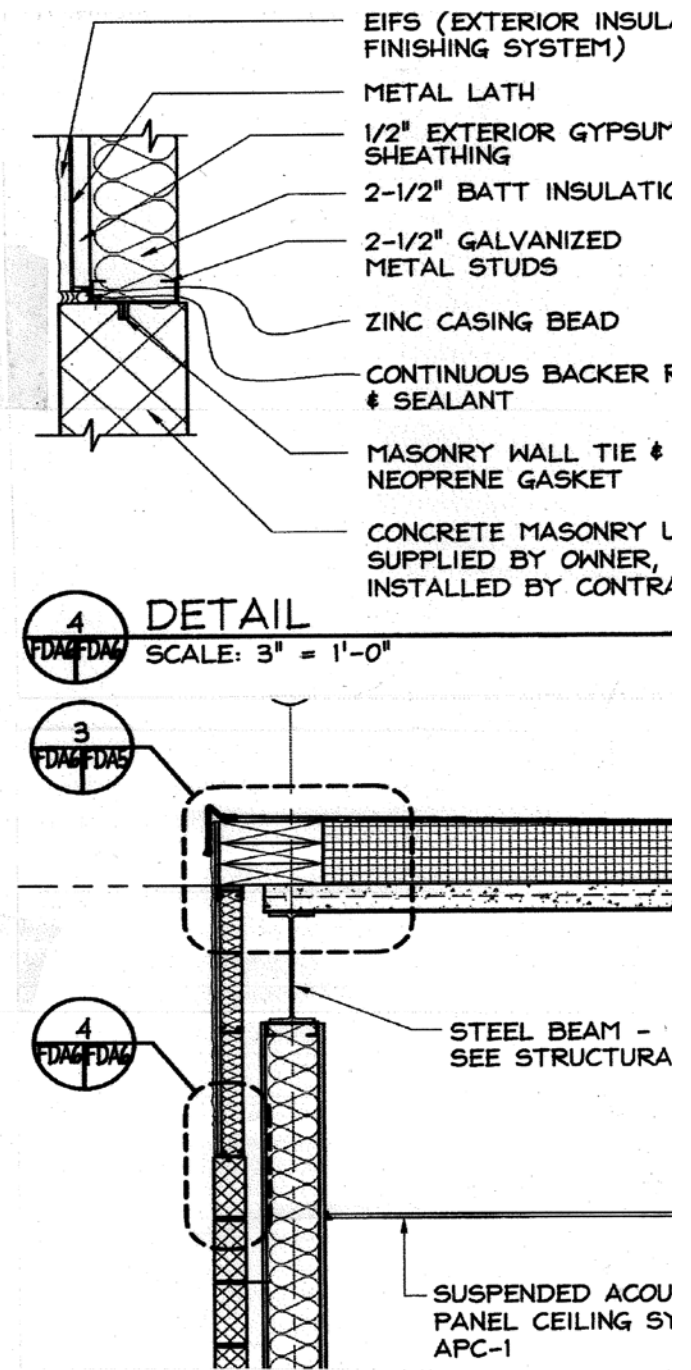
Fire Station – Top of Wall

The detail for the exterior panel, per the construction documents, is a very poor installation method. The detail shows a steel stud sitting directly on top of the block veneer and attached directly to the wood blocking at the roof line. The detail is showing a caulk joint between the panel and the top of the block. At a number of locations no caulking was installed which provides a location for water entry.

The detail of this installation should be checked to verify if indeed it was constructed in this manner. The lack of sheathing and moisture protection to the roof line from inside the cavity will cause long term issues with steel and stud connection as well as a non-insulated barrier to the inside.

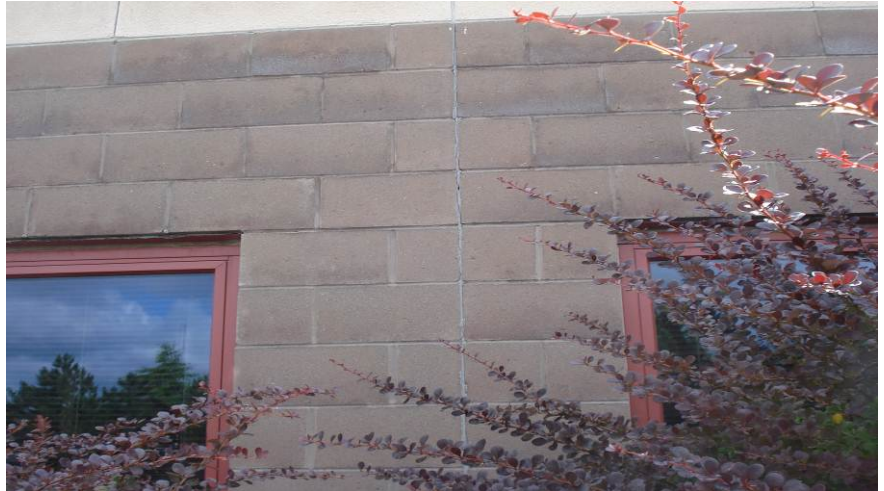
The new pre-colored block veneer has a number of cracks in the mortar joints due to contracting and expansion of the veneer. Because of the earlier issue described relative to the amount of moisture that the block is retaining this is more than likely the cause of the numerous joint cracks found around the building. These types of systems will expand and contract more due to moisture and temperature changes and the proper location of control joints is key to maintaining the wall appearance and not lead to water entry issues.

*Control Joint Failed*

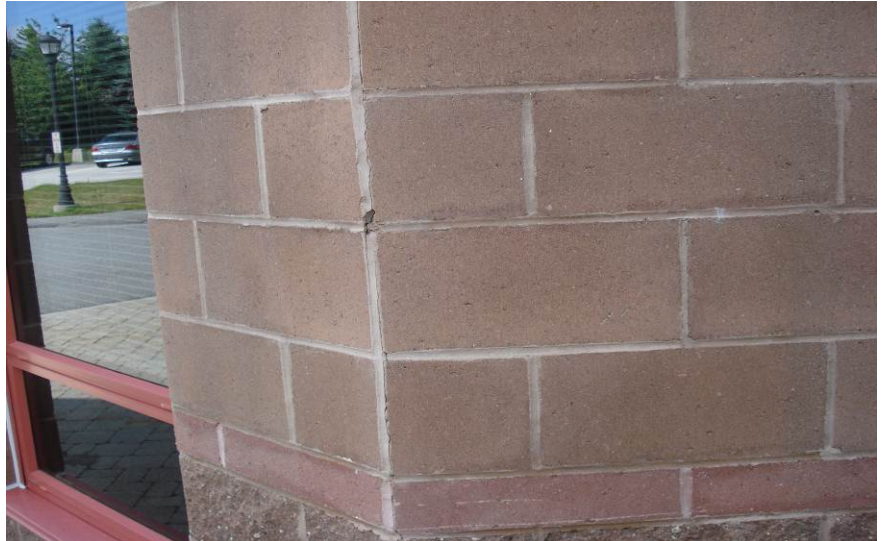
*Corner Joint Failed*

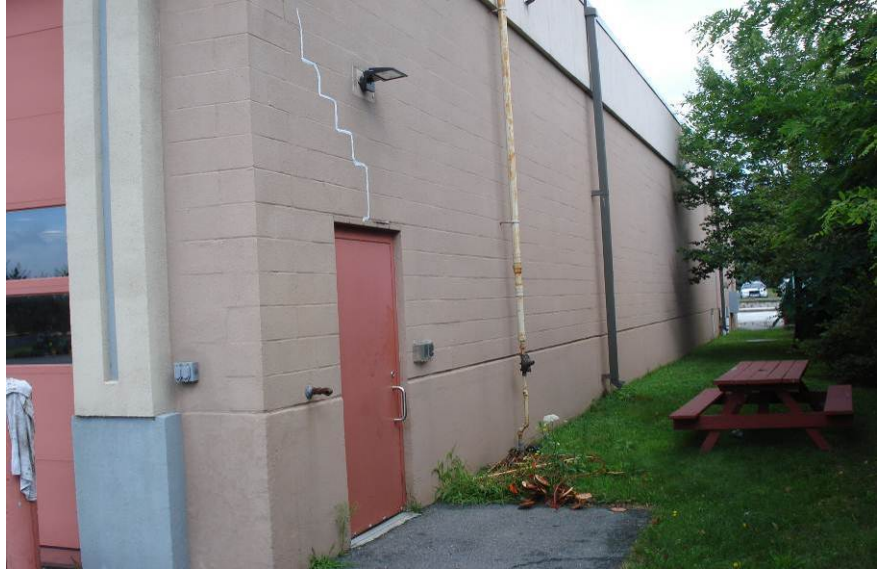
*Exterior Wall Crack  
Currently Being  
Repaired*

*Cracked Wall Being  
Repaired and Sealed*

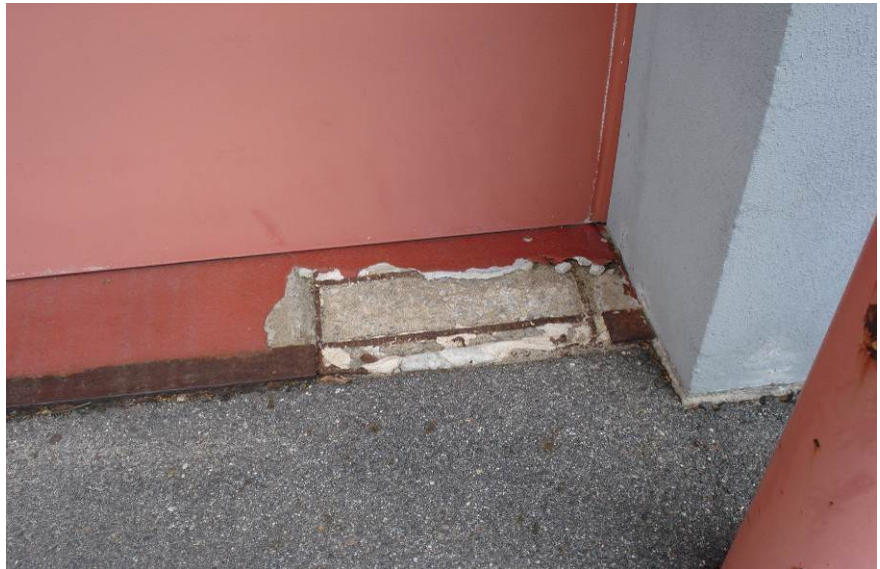
The concrete sill at one of the overhead doors to the garage bay is showing an area that has completely cracked and chipped off exposing the reinforcing bars to the weather. One very noticeable issue with this broken area is that the rebar within the concrete sill has been placed too close to the exterior surface. The metal angle edge is partially broken for an unknown reason. The detail, per the construction drawings, shows a thickened reinforced slab edge sitting on the foundation wall. The reinforcing from the foundation wall is dowel into the slab and it is not recommended to leave this rebar exposed to weather where, long term, this could lead to a failure of the foundation.

*Cracked and Chipped  
Sill at Overhead Door*

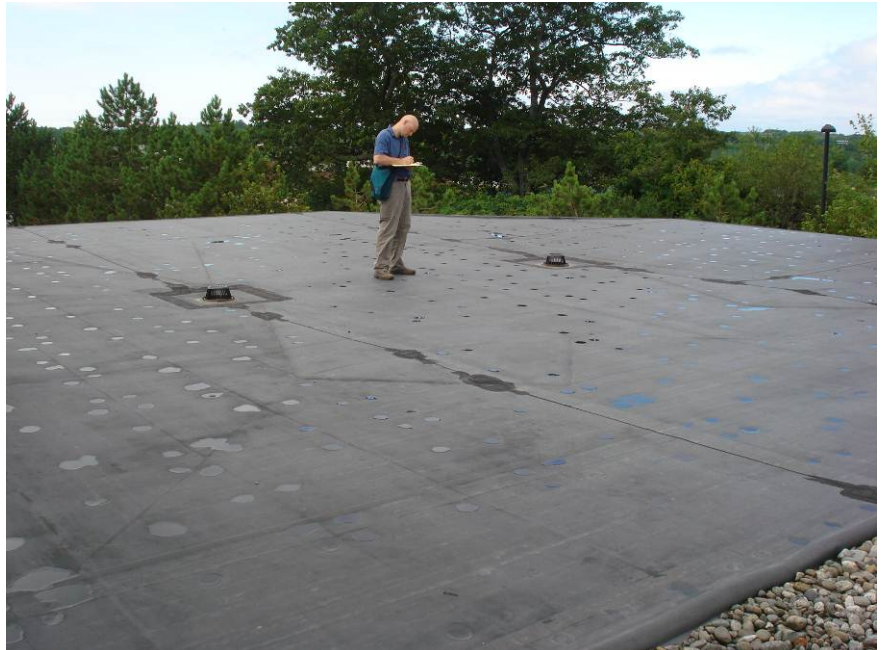
*Low Roof – Over Front  
Office – Ballasted Roof  
in Foreground*

At the time of replacement we would recommend additional roof drains and a code compliant tapered board system be installed. Unknown if this roof is part of the town's yearly inspection and repair program.

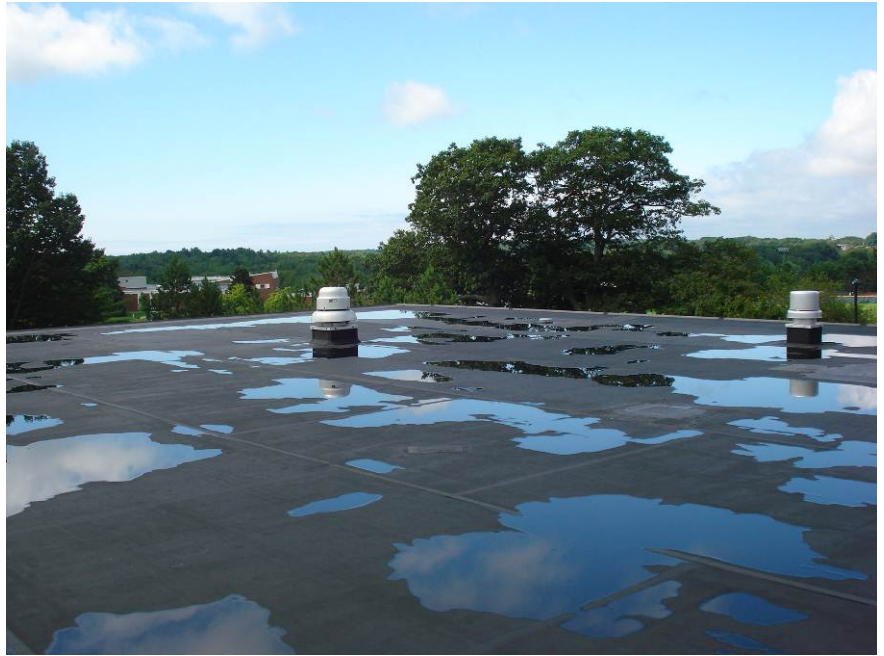
*High Garage Roof*

*Ponding on Roof –  
Drain in Background*

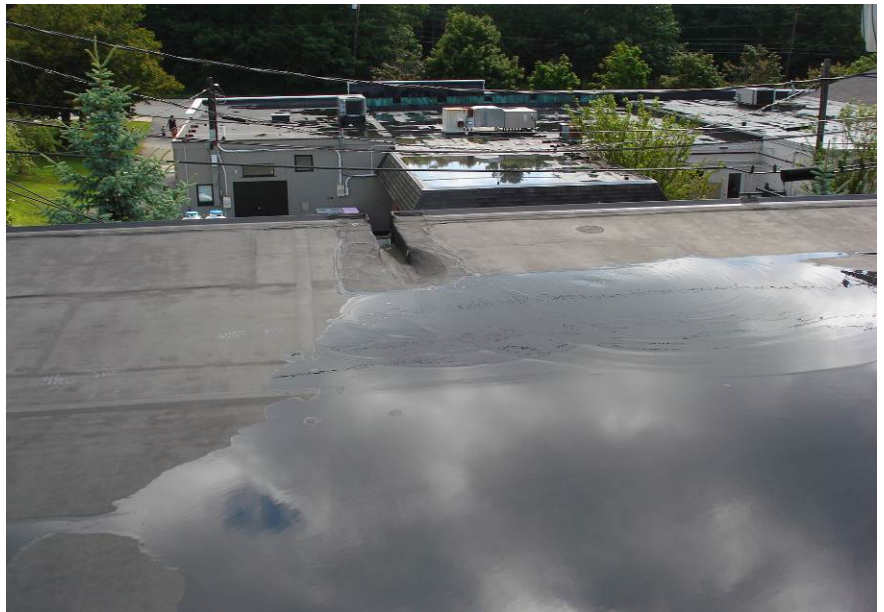
*High Garage Roof*

*Roof Drainage Cut Into  
Insulation with Ponding  
Nearby*

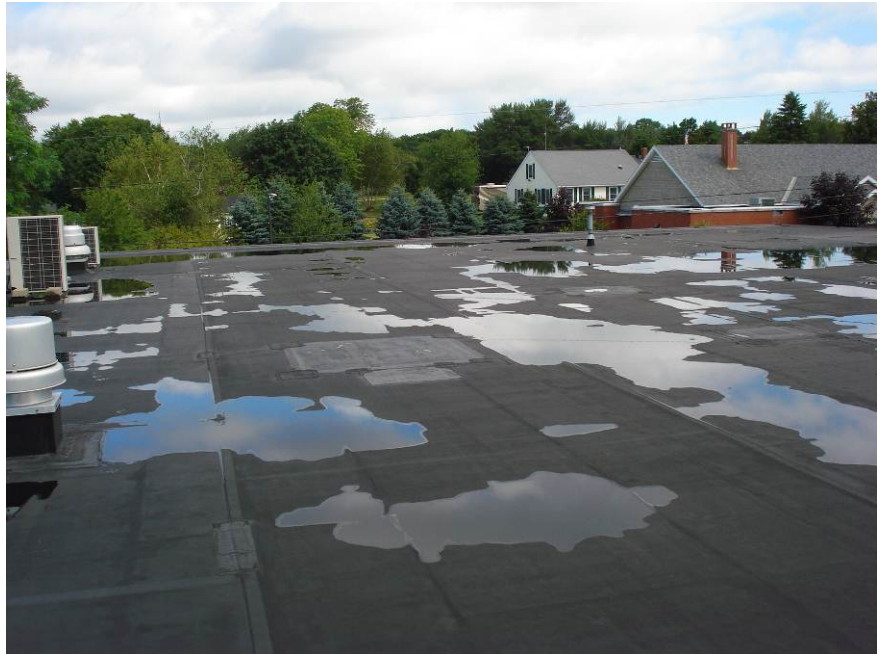
*High Garage Roof*

*Ponding Over Large  
Expanse of Roof*

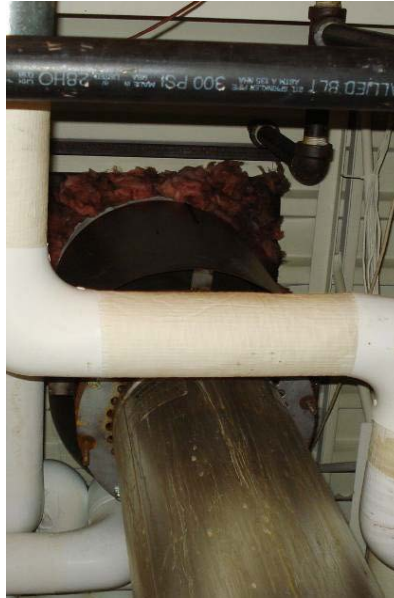
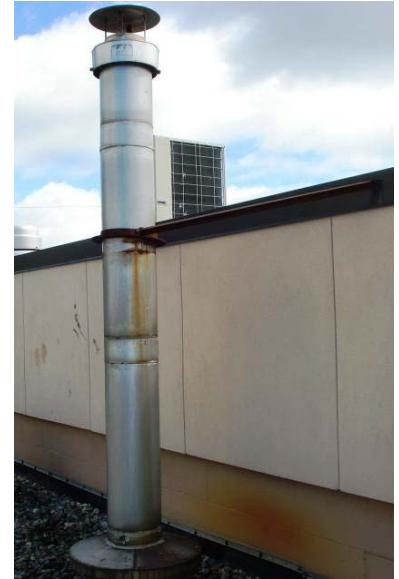
*Chimney*

The Ampco prefabricated double-wall chimney appears to be in good condition. The section of the chimney above the roof was supported off the upper roof flashing and is loose.

We would recommend the chimney be properly secured as needed.

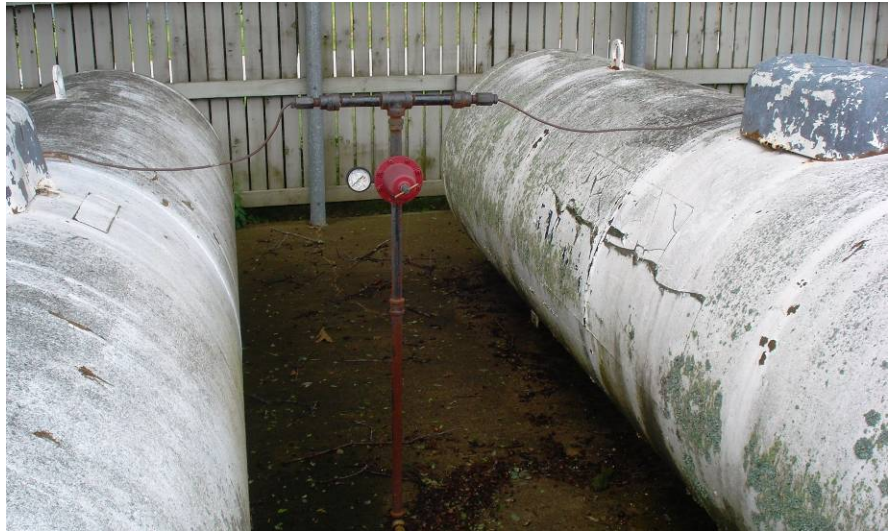
*Liquid Propane Storage Tanks*

Liquid Propane is stored in four tanks located across the back rear parking lot. The enclosure is not secured. The gas regulator and associated pipe is free standing in the middle of the tanks.

We would recommend the installation of additional support for the gas piping as needed.

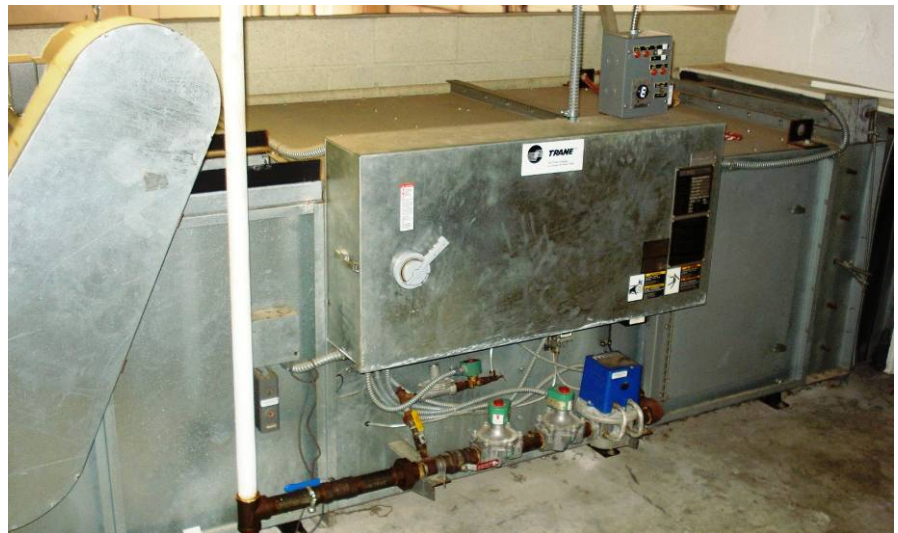
*Apparatus Bay  
Ventilation MAU-1*

Heating and ventilation for the Apparatus Bay is provided through the 2-speed gas-fired make-up air unit (MAU-1) located in the Mezzanine and the roof-mounted exhaust fans (EF-2, 3 & 4). The make-up air unit and exhaust fans were installed as part of the 2000 addition and renovation project and appear as installed. According to the dates on the air filters, they were replaced February 10, 2011 and appear to be in good condition.

We would recommend recalibration of the four NO<sub>2</sub>/CO gas detectors.

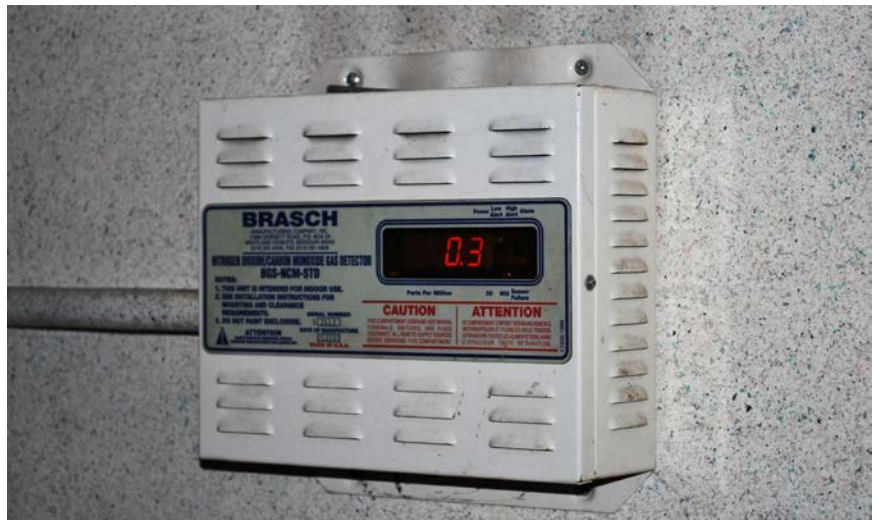
The make-up air system is controlled through the unit-mounted panel and is designed to either operate in the manual mode or automatically ventilate the Truck Bay in the event the levels of Nitrogen Dioxide (byproduct of a diesel engine running), or Carbon Monoxide (byproduct of a gasoline engine running), or gas exceed preset levels of concentrations as determined by one more of the four Brasch NO<sub>2</sub>/CO gas detectors located in the Truck Bay. Based on information provided by the gas detector manufacturer, regular recalibration of the NO<sub>2</sub>/CO detectors is recommended as part of normal maintenance. Recalibration would require the replacement of the main circuit board with a new board containing calibrated sensor.

*Brasch Combination Nitrogen Dioxide and Carbon Monoxide Detector*

| Building #3 - Cape Elizabeth Fire Station - Mechanical - Operations & Maintenance Budget Items | | | | | |
|--|---|---|--|---|---|
| M30.3 | Apparatus Bay Ventilation | The ventilation system is controlled through the (4) Nitrogen Dioxide/Carbon Monoxide Detectors located in the Bay. | The detectors were installed during the 2001 project. The calibration of the detectors may not have been done. | Calibrate the detectors in accordance with manufacturer's recommendations (replace the detector printed circuit board). | \$4,000.00 |

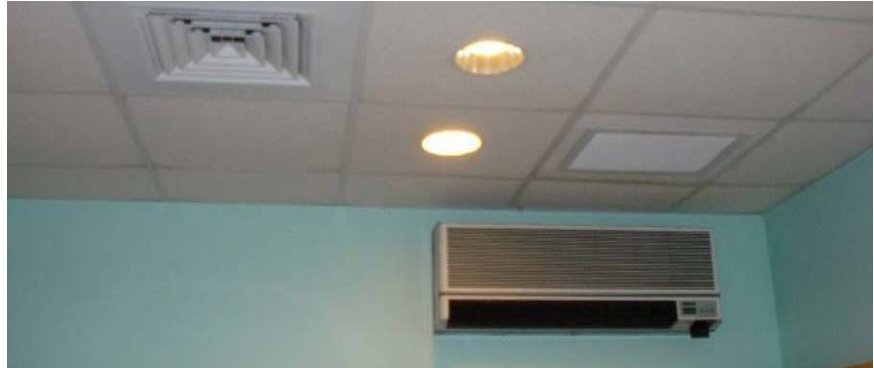
The ceiling supply diffuser in the Conference Room is installed in a location that may be detrimental to proper ventilation and cooling of the space.

We would recommend relocating the diffuser to a location closer to the center or other end of the room.

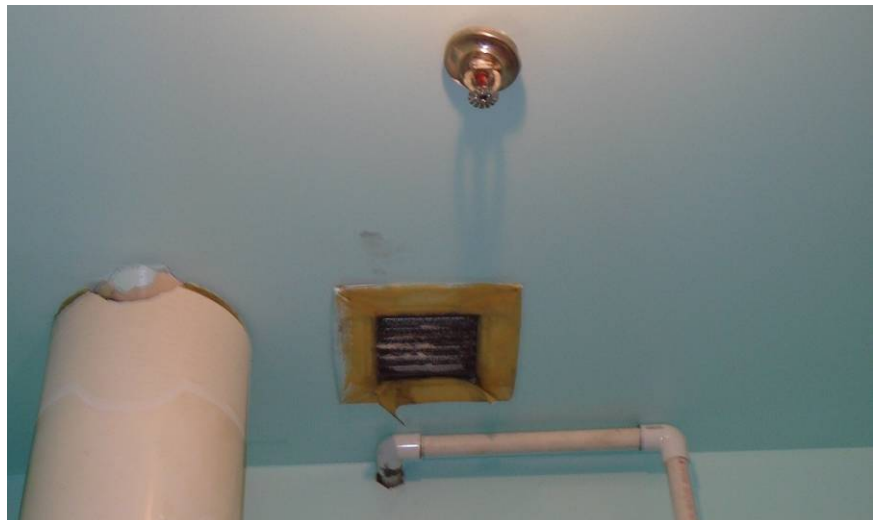
*Janitor Closet Exhaust Grille*

The exhaust grille in the janitor closet is showing signs of corrosion.

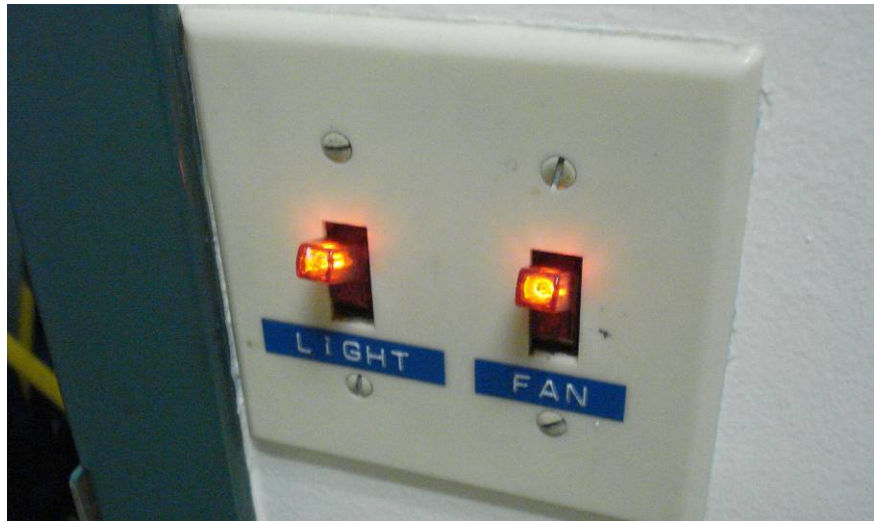
*Janitor Closet Light/Fan Switch*

The toilet and janitor closet exhaust fan is controlled by a local lighted wall switch located outside of the janitor's closet and does not meet the current code requirements. Operation of the fan was confirmed.

We would recommend interlocking the fan with the lights in each room served to operate when the lights are on and remain on for a time delay after the lights are turned off.

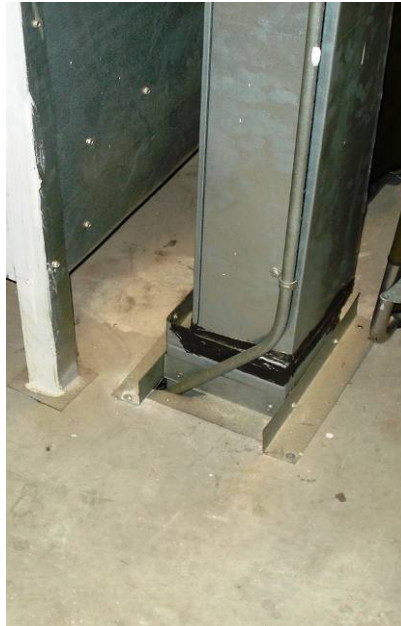
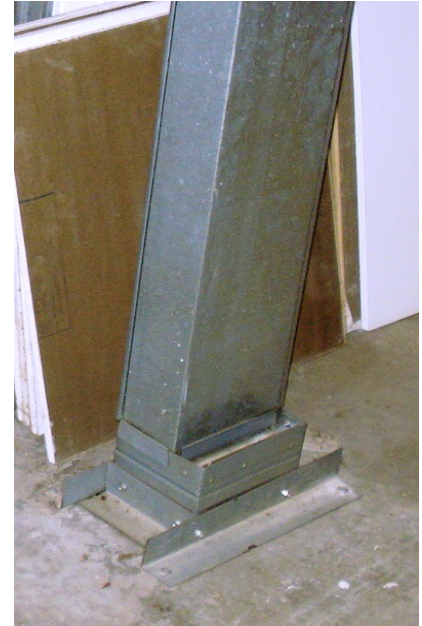
*EF-7 Duct Penetrations  
Through Mezzanine Floor*

Fire dampers have been installed at the floor level. Adjacent to one of the fire dampers (left photo below), a section of electrical pipe has penetrated the sheet metal near the fire damper. Access doors have not been installed above each fire damper. Access doors are required for annual inspection and testing of fire dampers. It would appear the mounting screws may have penetrated the damper channel.

We would recommend properly sealing the floor penetration, installing access doors, verifying proper operation of the dampers, and annually testing fire dampers in accordance with requirements outlined in NFPA 90A.

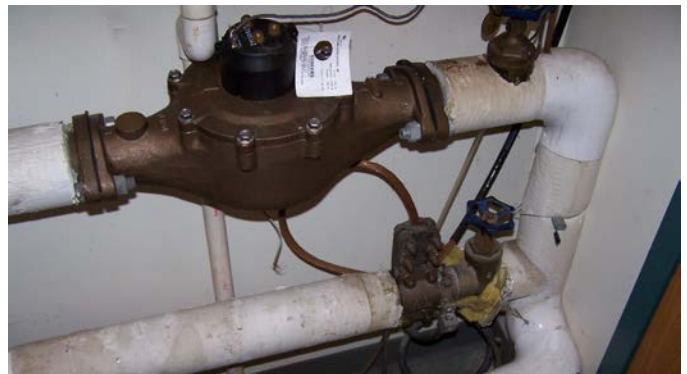
It was observed that there was no bonding jumper across the water meter in the boiler room.

*Water Meter missing bonding jumper*
