**Town of Cape Elizabeth**  
Seven Building Facility Study  
*Cape Elizabeth, Maine*

HARRIMAN | Architects + Engineers

**Introduction****Town of Cape Elizabeth Facilities Study**

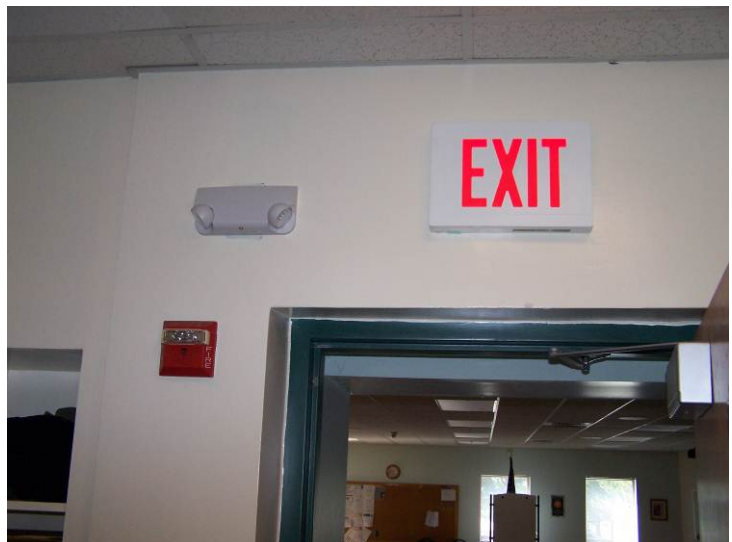
*Life Safety Lighting and  
Exit Signs*

Only a few emergency lights were observed in the corridors and restrooms. These units are surface wall mounted self-contained battery units with remote heads (EBUs). The units have been recently upgraded to an LED type. Generally EBU's are in excellent condition but coverage is limited to the restrooms and central corridor. If the occupancy of this building exceeds 50 the building is required to have full life safety lighting for all paths of egress per NFPA 101 standards.

| ITEM | System | System Status | Assessment of System | Recommended Maintenance System Replacement | Probable Cost |
|---|---|--|---|---|---|
| E30.4 | Emergency Lighting | Emergency lighting is achieved with Self-Contained Emergency Battery Units with remote heads. Exit signs are internally illuminated. Emergency battery units and exit signs appear to be in serviceable condition. | If the occupancy of this building exceeds 50 the building is required to have full life safety lighting for all paths of egress per NFPA 101 standards. | Evaluate occupancy of building and provide additional life safety lighting per NFPA standards | \$15,000.00 |

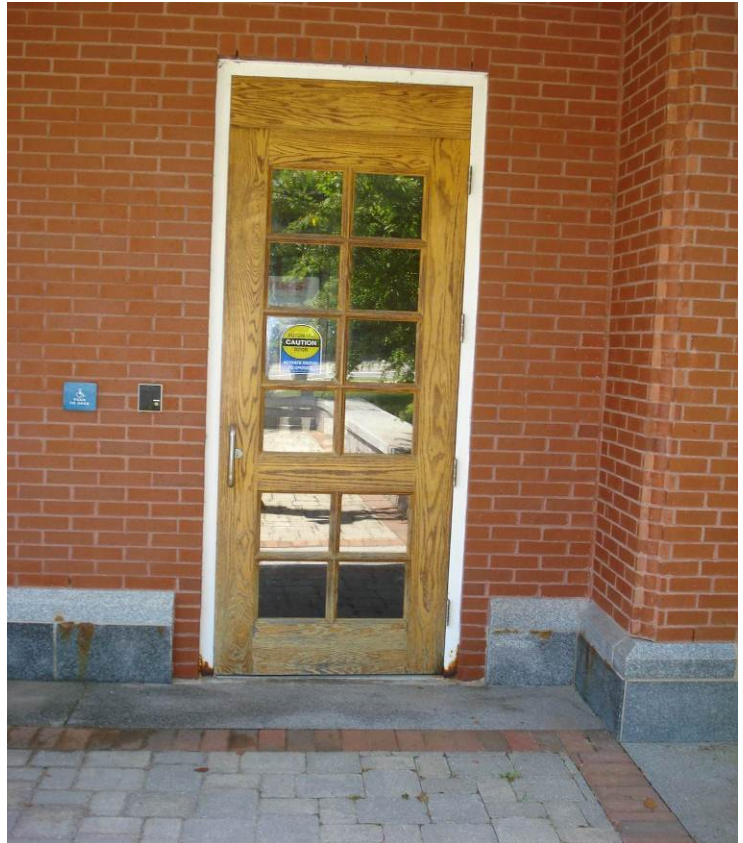
*Front Entrance – Wood Door*

The items requiring maintenance or replacement would be the exterior doors and frames. The front entry wood door needs replacement – the door is sticking to the jamb and the frame is showing rust through the bottom of the hollow metal frame.

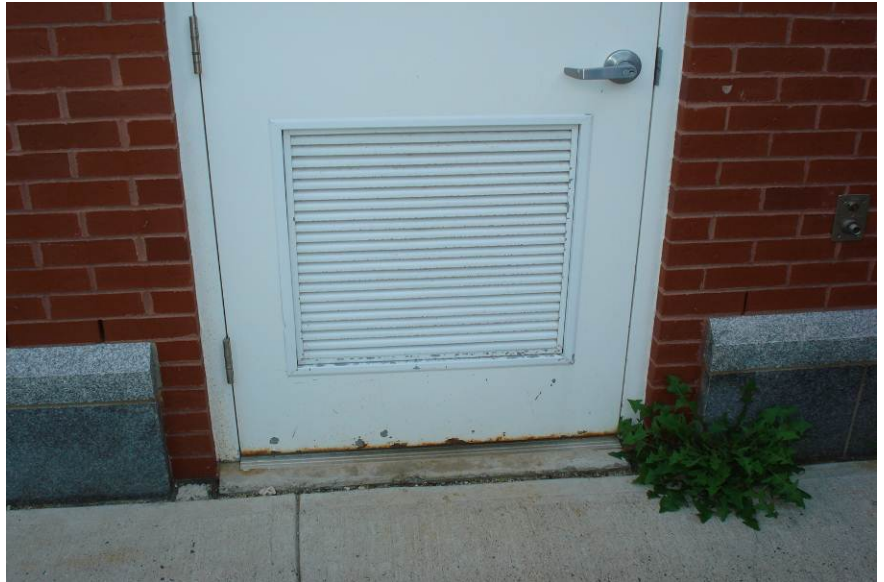
The exterior painted white doors and frames will need replacement soon as the bottom edge of the doors and frames are rusted out to the point where sanding and painting will be ineffective.

*Painted Doors Bottom  
Edge Rusted*

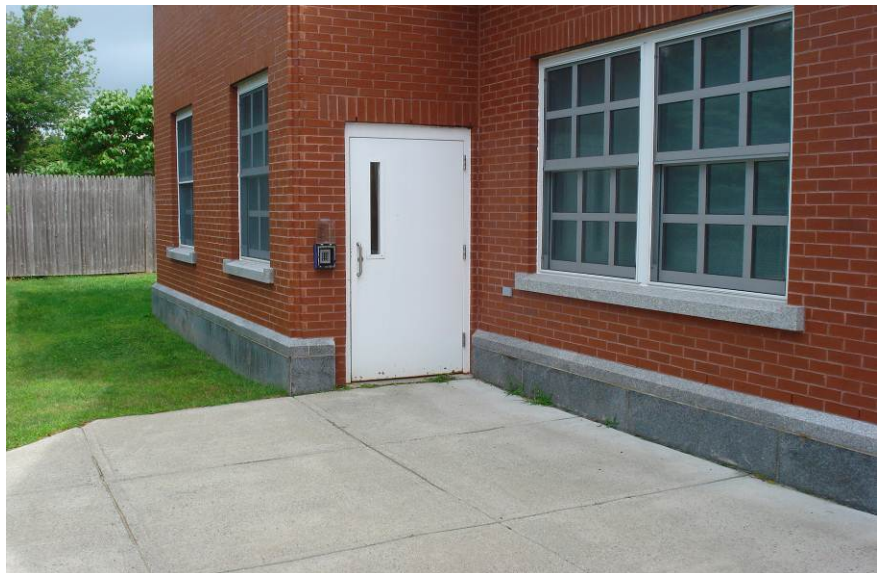
*Rusted Bottom Edge  
Door*

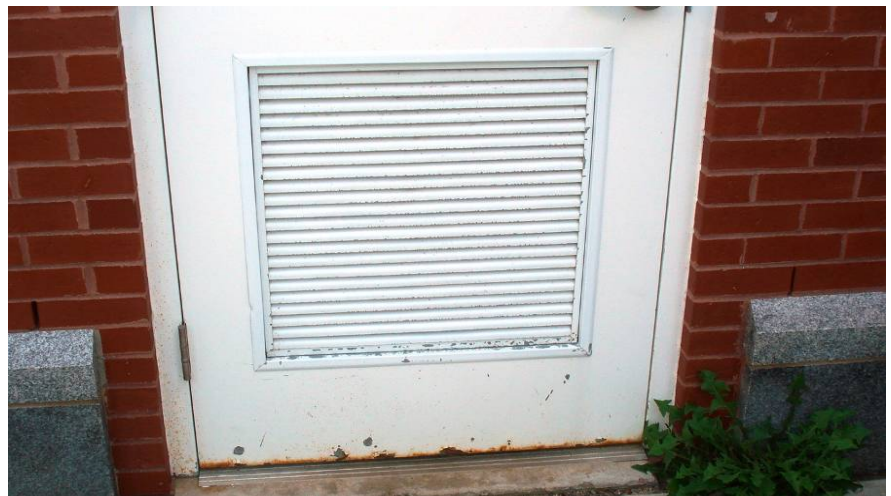
The second combustion air opening is a louver cut into the boiler room door. Based on the duct tape around the inside of the opening, it would appear efforts have been made to reduce the infiltration through the door-mounted louver.

*Door-Mounted  
Combustion Air Louver*

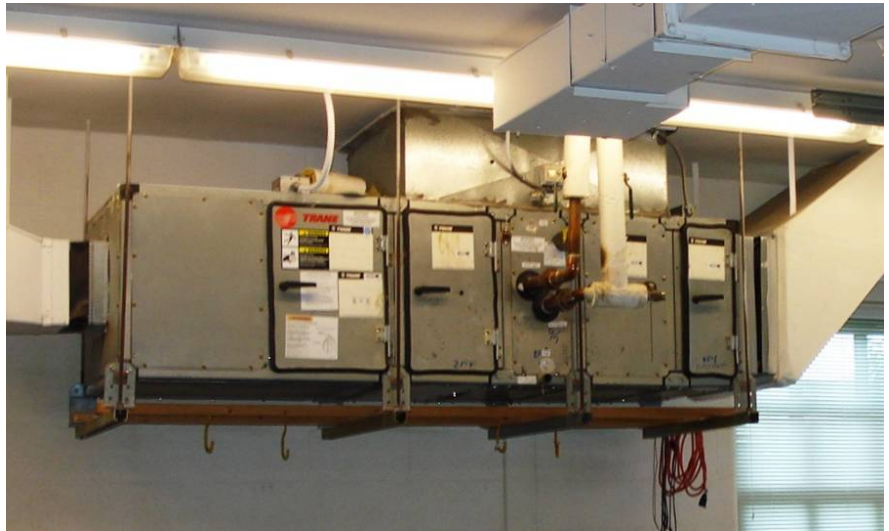
Heating and ventilation for the sally port is provided through the 1100 cfm Trane HV-1 unit suspended from the structure in the sally port. The unit appears to be in good condition. When manually commanded on, the duct-mounted intake and return dampers opened. However, the duct-mounted relief damper failed to open. As a result, the space may be improperly ventilated.

*Trane Heating and  
Ventilation Unit HV-1*

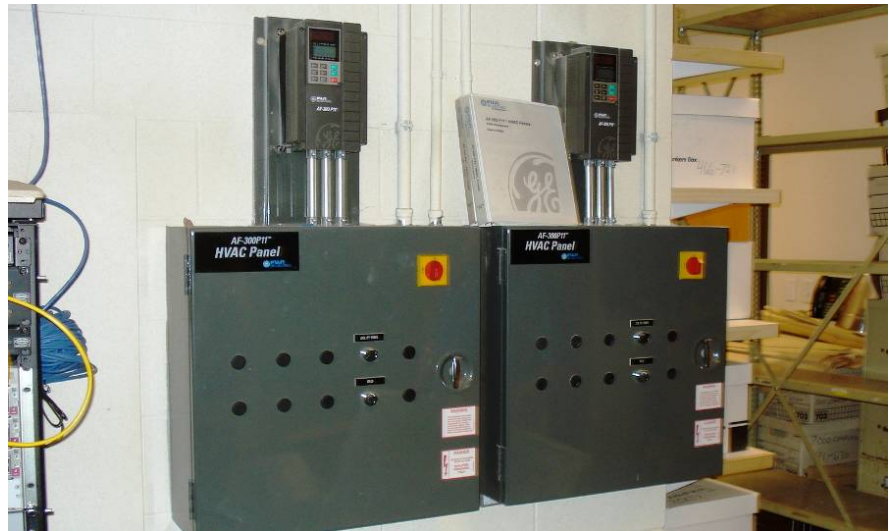
*Variable Frequency  
Drives (VFD) for the  
AHU-1 and RAF-1  
Fans*

We would recommend review of the installation of the return fan verifying the fan is properly suspended from structure with vibration isolation devices.

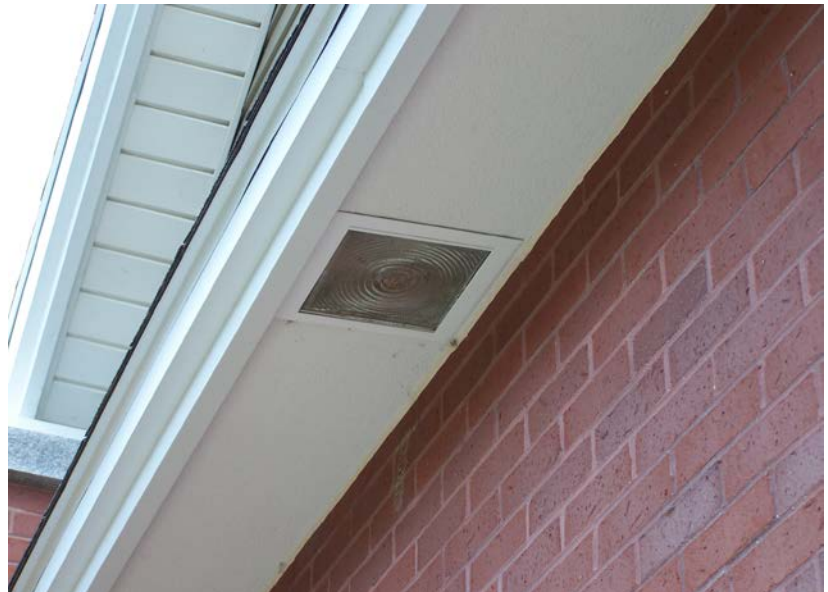
The Cape Elizabeth Police Department is served by a variety of lighting fixtures (lens troffers, parabolic troffers, compact fluorescent downlights, incandescent downlights, surface wraps, vapor-tight). Most fixtures are T8 or bent tube T8 lamps. Many spaces are switched for two levels of lighting. Occupancy sensing lighting controls were observed in some spaces. Rear exterior soffit lighting showed signs of dirt and insect infiltration.

*Rear Soffit Lights*

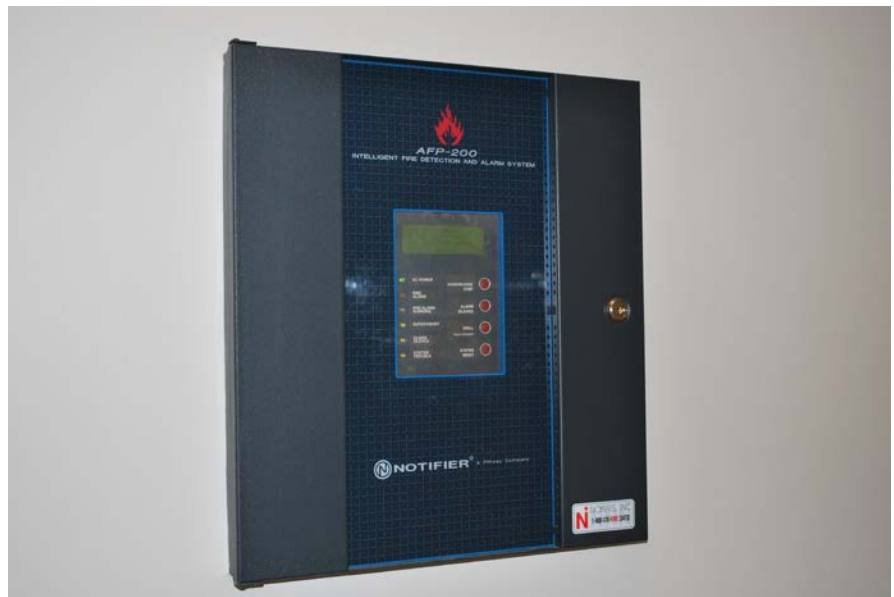
The police station is served by a fire alarm system. The system is a Notifier AFP-200. It appears that this system is original to the 2000 construction. Notification appliance, smoke detectors and pull stations are located throughout the building. In the event of an alarm, the system reports directly to Portland monitoring / dispatch facility. The police department reports no trouble with the control panel but has experienced some trouble with the dialer.

#### *Fire Alarm System*

| ITEM | System | System Status | Assessment of System | Recommended Maintenance System Replacement | Probable Cost |
|---|---|---|---|--|---|
| E40.6 | Fire Alarm System | Notifier AFP-200 system installed during 2000 construction. | System is in serviceable condition. Trouble with dialer reported. | Maintain existing system, contract with vendor to repair dialer. | \$7,500.00 |

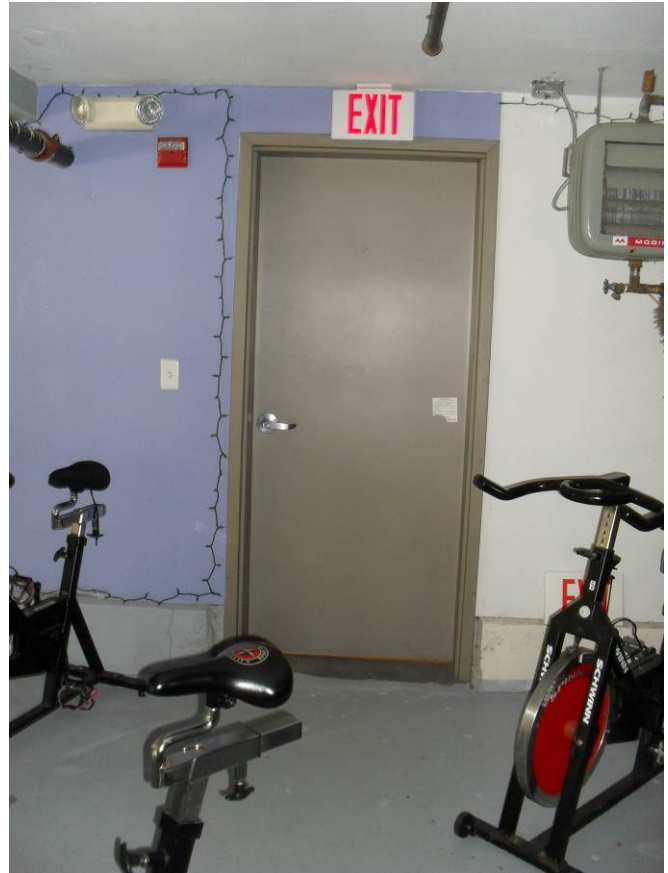
*Exit Door Enters Into a Storage Room – Code Does Not Allow Exiting Into a Higher Hazard Space*

*Means of Egress Door to Storage Room*

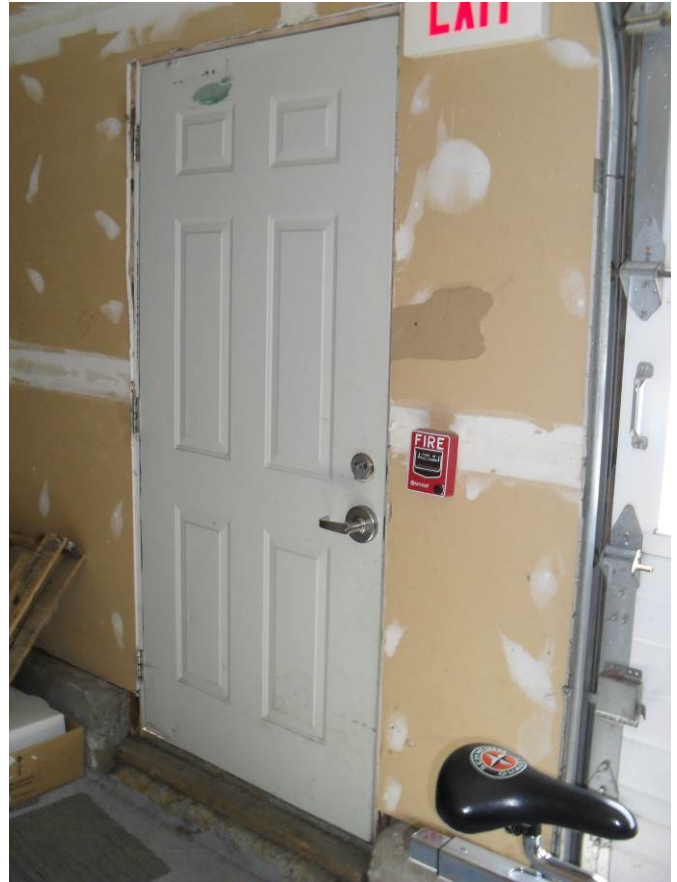
*Life Safety Code  
Requires Floor to be at  
Same Level at Each  
Side of an Exit Door*

*The levels on each side of  
the door are not the same  
height as threshold.*

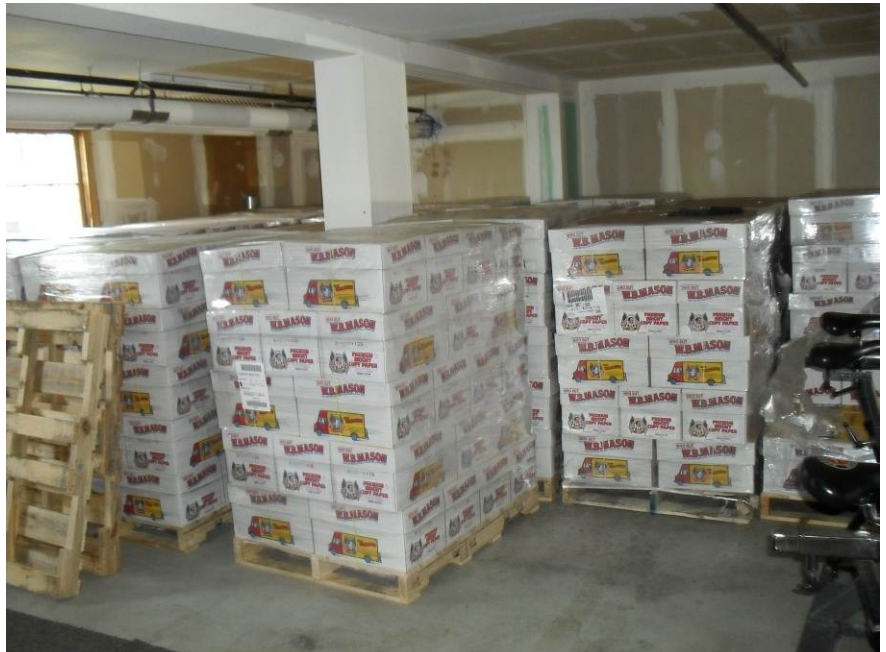
*Occupied Space with  
Combustible Materials*

*Combustible Material  
Storage*

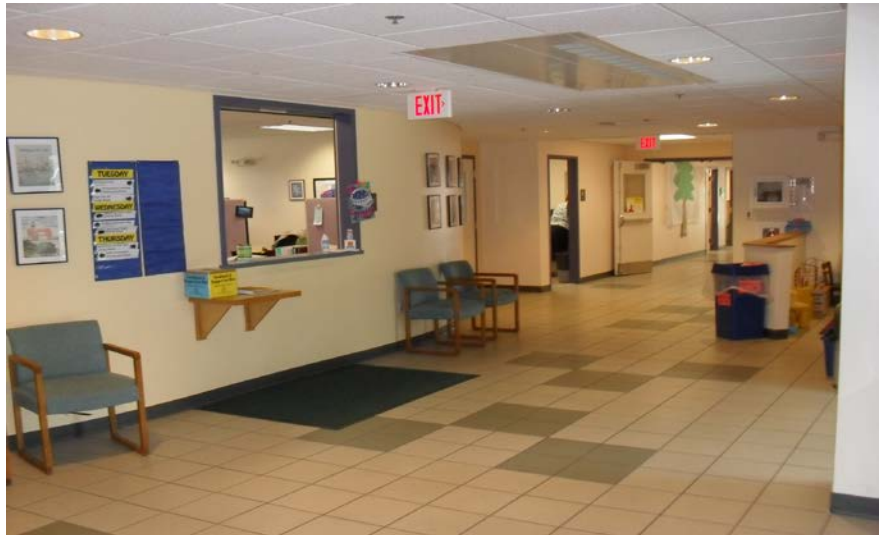
The porcelain tile lobby floor is having continuing issues with the grout joints cracking, loosening, and breaking the tile bond with the substrate below. It has been reported that a number of repairs have already been conducted to the floor system. There are a number of items connected with this floor that can produce this condition. The framing may be flexing under live load conditions or the bond or type of grout used is not bonding properly to the substrate.

*Lobby Tile Floor*

The method of correction for this floor is to remove the tile and plywood substrate and replace the underlayment with a product designed for this application.

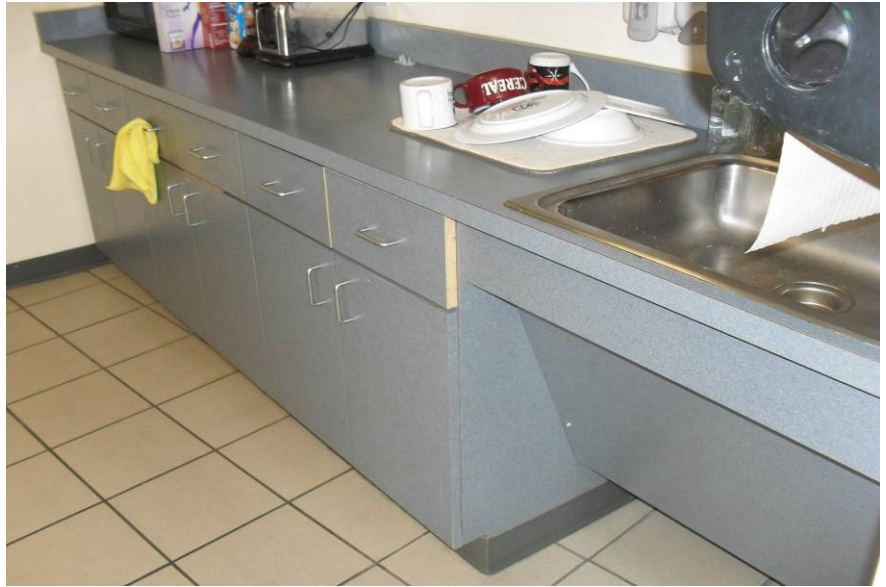
*Laminate Edge - Repair*

Recommend minor repair.

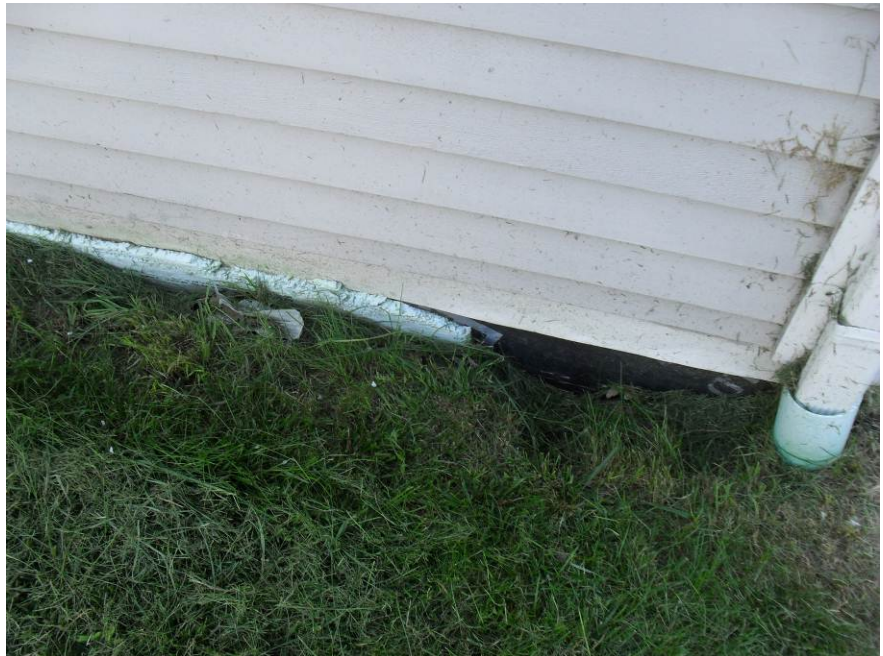
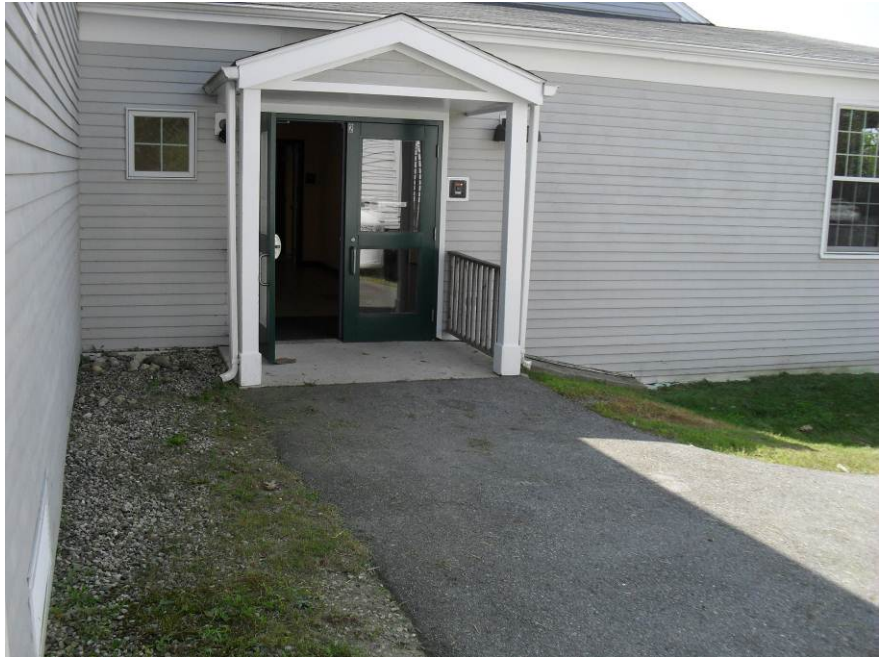
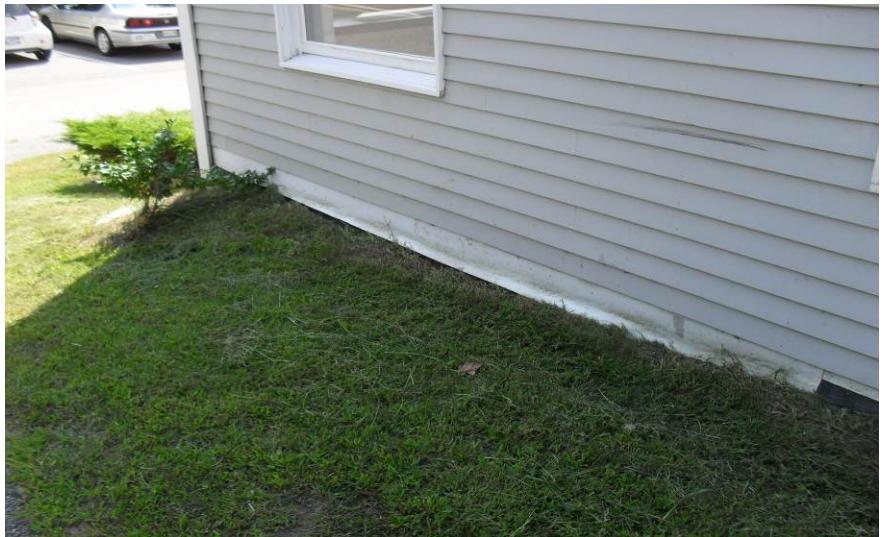
The base of the barn has a construction detail that will require attention. As part of the renovation project a series of materials was added over the existing framing system to protect it from grade. The sills were replaced with new pressure treated framing and insulated to help keep the crawl space warm. The materials used in series as sketched are not designed for this application in this particular location. Ground water and moisture in the grade will break the system down and allow moisture to get at the wood frame components and rot out even though they are noted as pressure treated products.

*Base Detail – Ice and Water Shield Exposed*

*Base Detail on These Walls*

*Base Detail – Front of Barn*

We would recommend a correction of this detail with a waterproofing product designed for this application and a new underdrain system on all sides where this detail occurs.

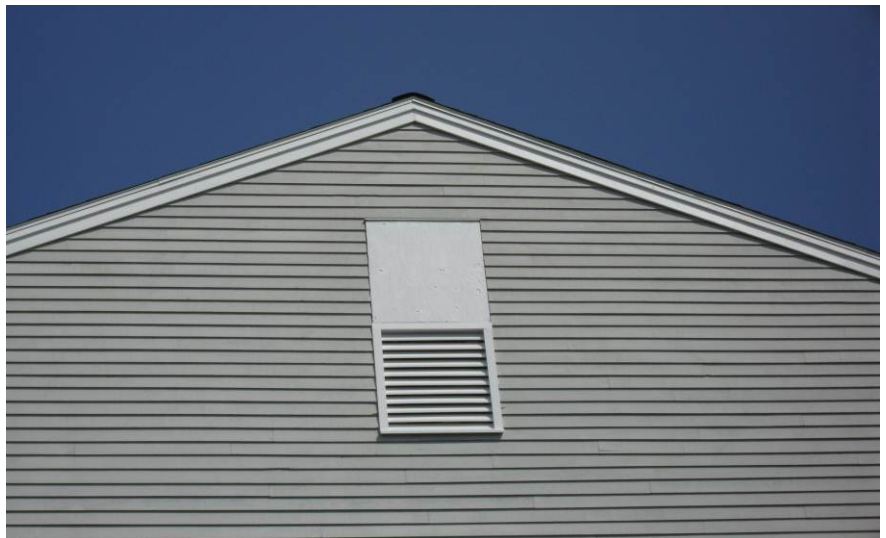
The documents did show two louvers on this gable end stacked and per the picture one has been removed and blocked up with a plywood panel. This type of gable end louvers of this size can be problematic by allowing wind-blown snow to enter the attic and pile up on top of your ceiling insulation. When the temperature rises enough to allow melting of the snow then water damage will appear on the ceilings below and may give the appearance of a roof leak.

*Blocked up Gable End  
Vent Louver*

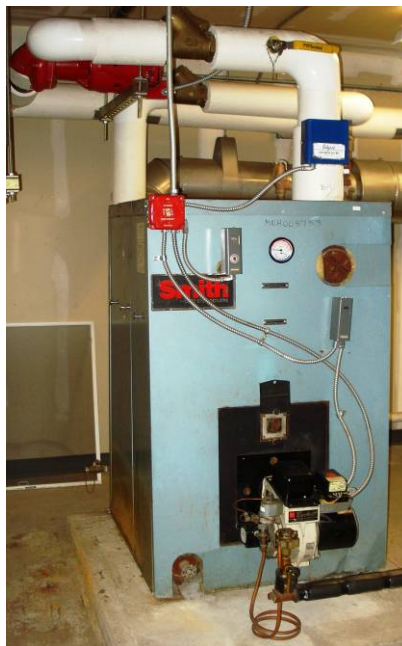
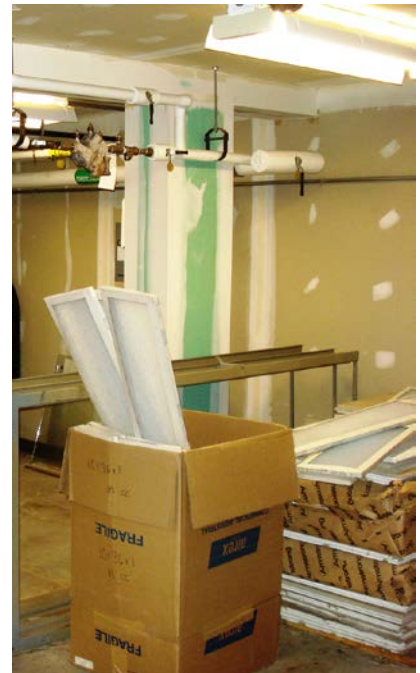
The boiler room is being used as a storage room. This is in violation of code. Combustible materials are not to be stored within the boiler room.

*View of Boiler 1*

*View of Combustible  
Materials Stored in the  
Boiler Room*

We would recommend check out of the boilers, injection pumps, and review of the boiler operating system and DDC interlocks.

We would recommend removal of all flammable and combustible materials stored in the boiler room.

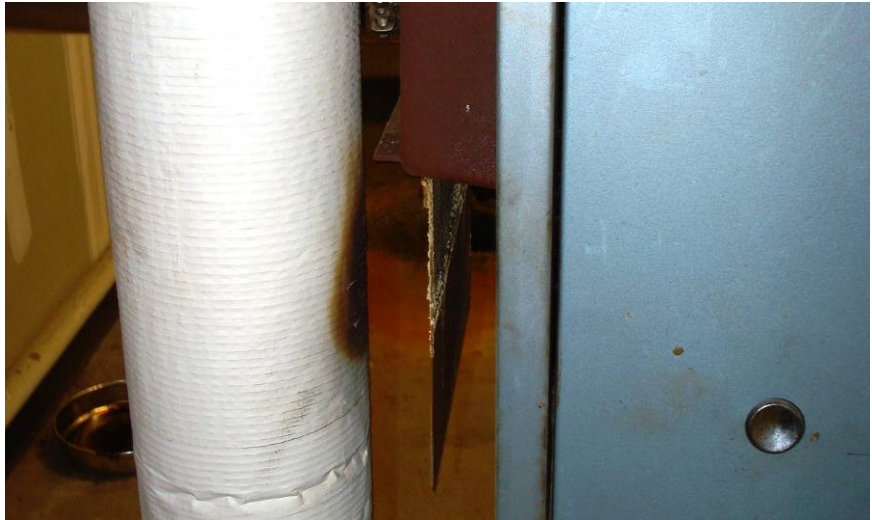
At Boiler 1, the return pipe insulation is burnt indicating a possible leak from the combustion chamber.

*Burnt Pipe Insulation at the Rear of Boiler 1*

| Building #5 - Cape Elizabeth Community Services - Mechanical - Operations & Maintenance Budget Items | | | | | |
|--|---|--|--|---|---|
| M50.1 | Boiler | The boilers are operational and showing signs of leakage from the combustion chamber | There are locations at the boilers where insulation has been charred. | Review overall condition of boiler sections and make repairs as needed. | \$0.00 |

We recommend repair of the combustion leak.

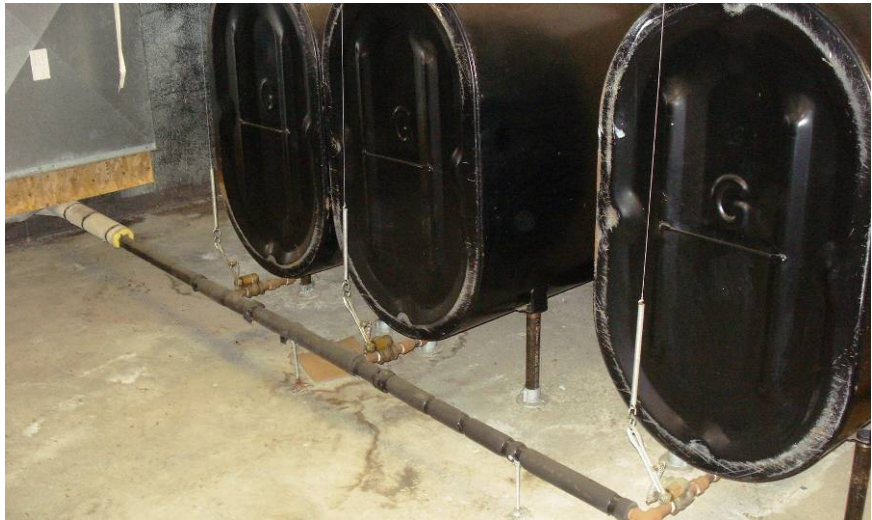
Fuel oil is stored in three tanks located in the boiler room. The fuel line is covered with insulation indicating there may have been a problem due to the location of the fuel line in relation to the combustion air opening. The fuel line installation does not meet code. The fuel line could be damaged and creates a tripping hazard.

*Oil Tanks*

| Building #5 - Cape Elizabeth Community Services - Mechanical - Operations & Maintenance Budget Items | | | | | |
|--|---|--|--|---|---|
| M50.2 | Fuel Oil Transfer | Fuel oil lines are installed at the same level as the tank discharge port. Lines are installed under the lower combustion air opening. | The installation of the fuel line is non-code compliant. The raised fuel line pose a tripping hazard and at risk of damage possibly causing oil leakage. | Reinstall the fuel line in accordance with code. | \$0.00 |

We recommend reinstallation of the fuel line in accordance with code.

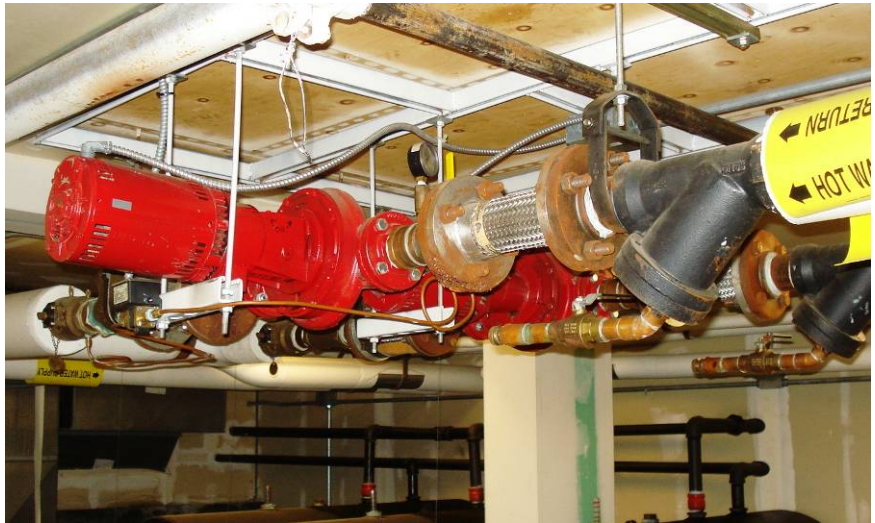
Heating hot water is circulated through the building by one of two Bell & Gossett in-line constant volume pumps and is controlled through the DDC system. The pumps are installed with threaded rods directly attached to the structure with rubber in-shear vibration isolators as specified. This may cause structural borne vibration noises to be transmitted through the building.

*Heating Hot Water Pumps*

| Building #5 - Cape Elizabeth Community Services - Mechanical - Operations & Maintenance Budget Items | | | | | |
|--|---|--|--|---|---|
| M50.3 | Heating Hot Water Pumps | The pumps are supported directly from structure without vibration isolation. Pump supports are installed on the system side of the expansion couplings. Many of the pump accessories are showing signs of water leakage. | During normal operation, pump vibration will be transferred through the pump supports to the structure and may become objectionable to occupants in the space above. | Install vibration isolation support devices. Support pumps in accordance with manufacturer's recommendations. Repair water leaks at pump accessories. | \$0.00 |

We would recommend the installation of vibration isolation at the pump and associated supports.

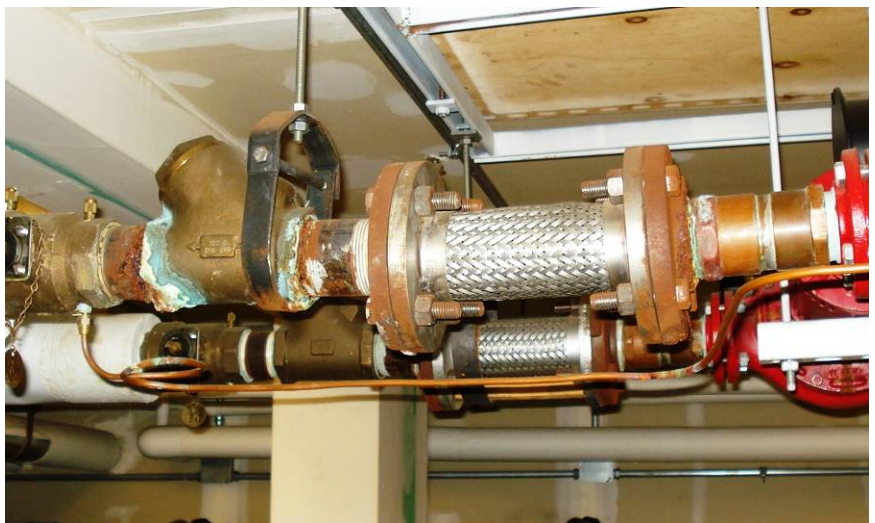
Some of the piping connections around the pumps are showing signs of excessive leakage and corrosion.

*Pipe Fittings Around Pump P-3 Showing Leakage, Corrosion*

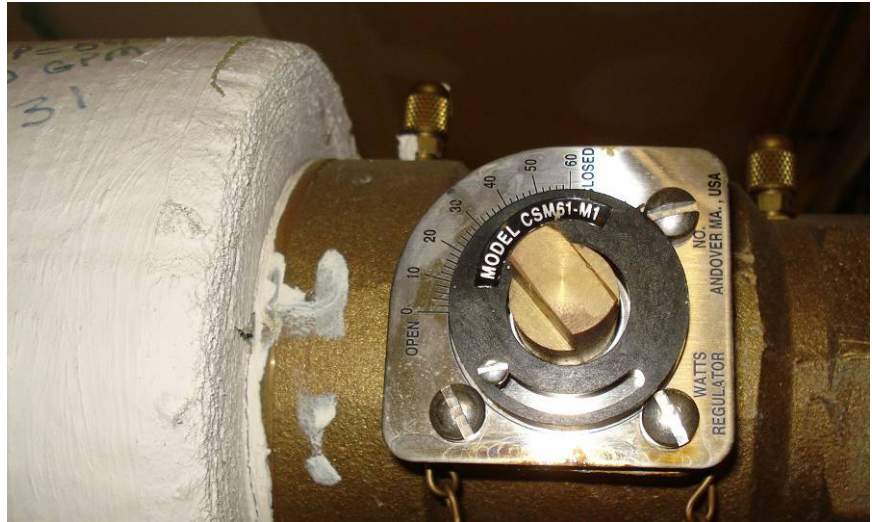
The circuit setters at each pump discharge have been set to approximately 50% open indicating the circuit setters required adjustment to restrict the flow to provide 80 gpm flow through the system (connected load is 75 gpm). According to design documents, the pumps were scheduled to provide 75 gpm. The circuit setters were not installed as noted on the design documents (length of straight pipe before and after the CS).

*Hot Water Pump Circuit  
Setter*

We would recommend opening the circuit setters to 100% open and the installation of variable frequency drives to reduce the speed of the pumps to accomplish the design water flow while reducing the energy consumption of the pumps.

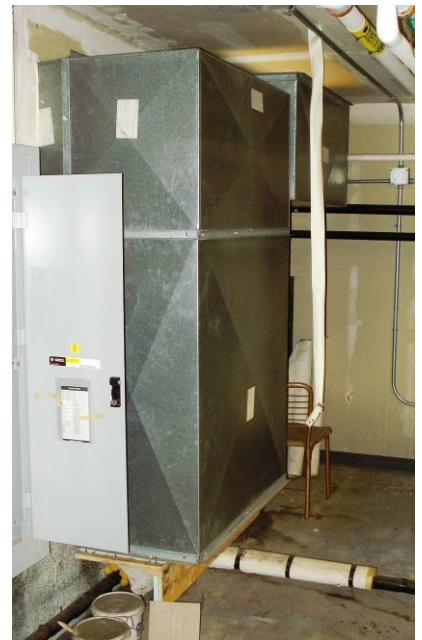
Combustion air is provided through two ducted openings; one is approximately 12” above the floor and the other is approximately 6” below the ceiling. The lower duct opening is partly blocked with insulation and plywood. It would appear the lower opening was blocked due to the location of the fuel oil piping directly under the opening. As installed, the combustion air duct system does not meet current code requirements.

*Combustion Air Ducts*

We would recommend revision of the combustion air system to meet current code requirements.

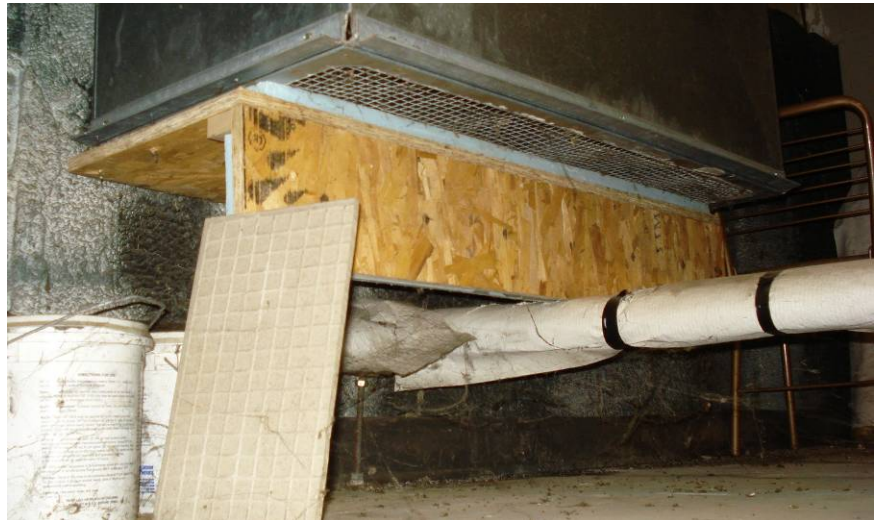
*Combustion Air Duct  
Blocked Off at Floor*

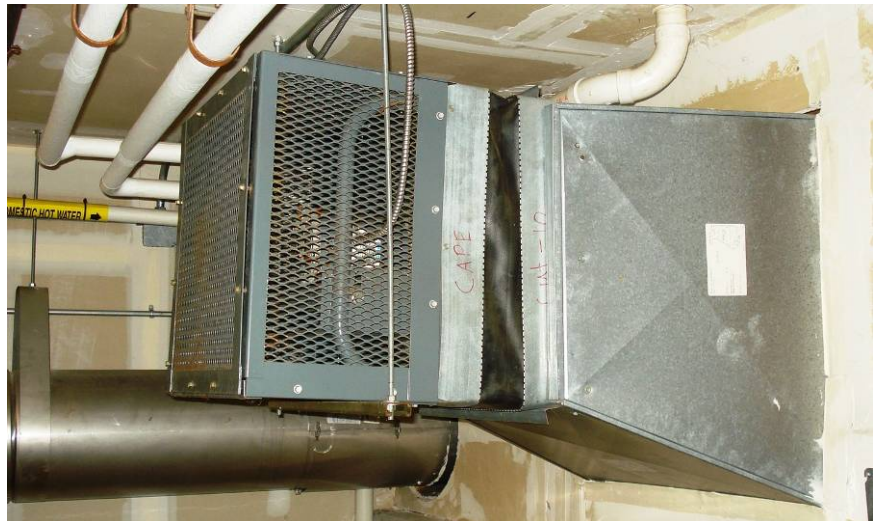
Boiler room ventilation is provided by the wall-mounted paddle exhaust fan and motor operated damper based on the local electric thermostat. At the time of review, the damper was closed and the fan off. On a call for cooling, the damper opened but the fan remained off.

*Boiler Room Ventilation Fan*

We would recommend the installation of vibration isolation devices and full review of the supply fan operation.

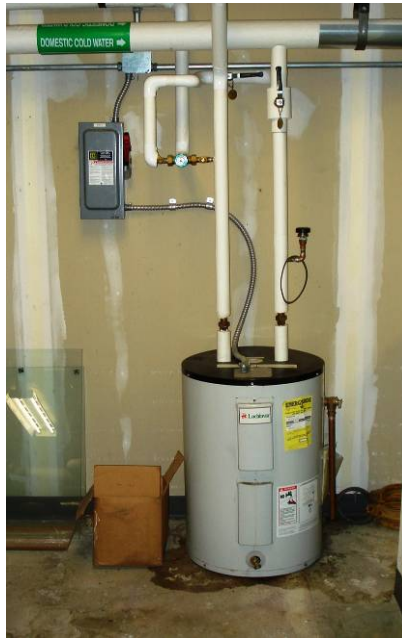
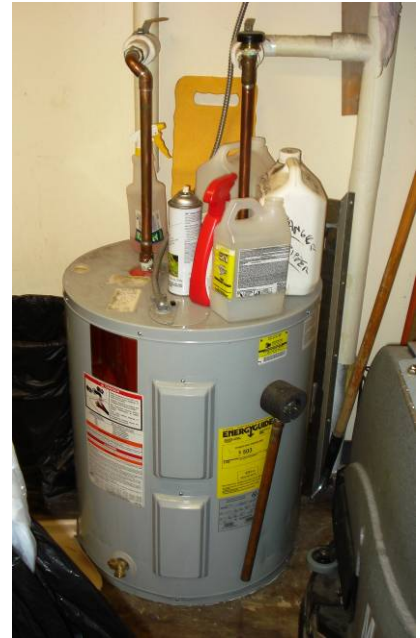
The heater in the boiler room appears to showing signs of leakage based on the floor stains around the heater. Both heaters appear to be resting directly on the floor without any means of leak retention.

*Electric Domestic Hot Water Heater*

| M50.6 | Domestic Hot Water Heater | The domestic hot water heater in the boiler room is showing signs of leakage and is resting directly on the floor. The heating in the Janitor Closet is resting directly on the floor. | The heater in the boiler room has been leaking. The heater is not installed on a housekeeping pad. | Replace the boiler room heater and install the new heater on a housekeeping pad. Install a leak retention pan and housekeeping pad under the heater in the Janitor Closet | \$0.00 |

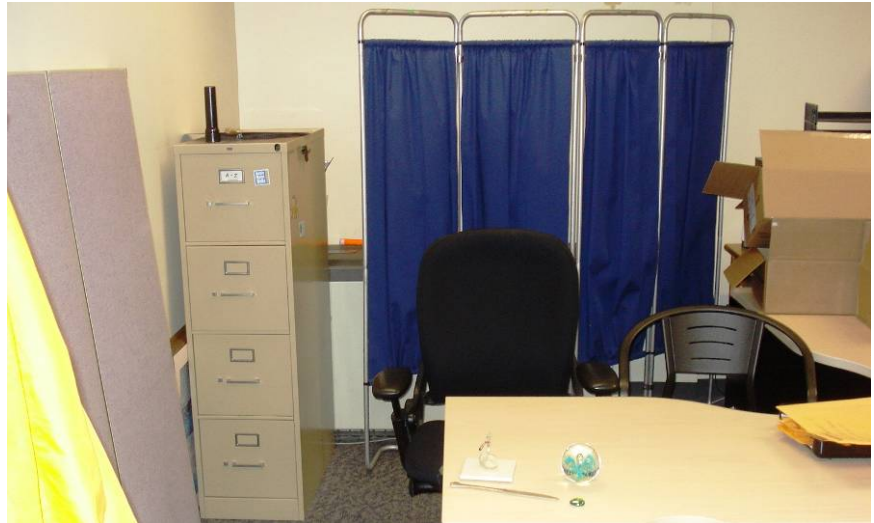
Heating, ventilation and air conditioning is provided to the Community Services open office area through two unit ventilators (UV), provided with mechanical (DX) cooling coils, located at the outside wall. At the time of review, the left-hand unit was operating and the right-hand unit was not. According to the occupants, air flow of the left-hand unit was being deflected by the portable blind to help reduce cold drafts. It was noted that during the cooling season it is typically too cold and during the heating season it is typically cold also.

*Unit Ventilator in the  
Open Office Area*

*Portable Blind Deflector*

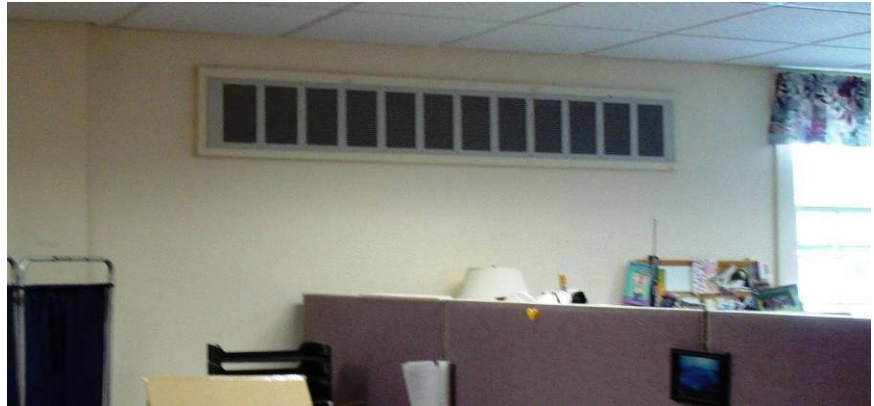
Relief for the office area is provided through two wall-mounted vented louvers located directly above each unit ventilator. According to the contract documents, the designed was based on the Ventimatic through-wall shutter assemblies manufactured by AFF. Actual vent model is unknown. According to the occupants, during the cold weather, cold air typically drops down from these relief vents.

*Unit Ventilator Relief Vent*

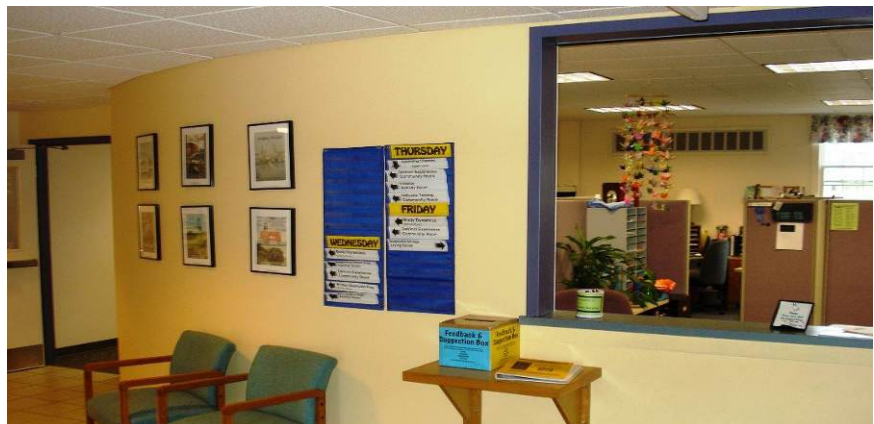
At the time of review the spaces felt moist and cool. The outside air was warm and humid. The single UV in the office was operating at full mechanical cooling and the condensing unit was short cycling. The lobby UV was operating at perhaps full ventilation or economizer. As a result, unconditioned air from the lobby may have been adversely affecting the air conditioned air in the office.

*Lobby Window*

| M50.7 | Ventilation of Open Office, Main Lobby and adjacent Corridors | Cooling is provided in the Office Area. Ventilation is provided in the Lobby or Corridors. | The Open Office area is open to the Lobby through a large wall opening. The two spaces are not conditioned in a similar manor. | Conduct an in depth study of the spaces to determine the best system to provide better comfort for the occupants. | \$0.00 |

We would recommend further in-depth review of the office and lobby ventilation systems.

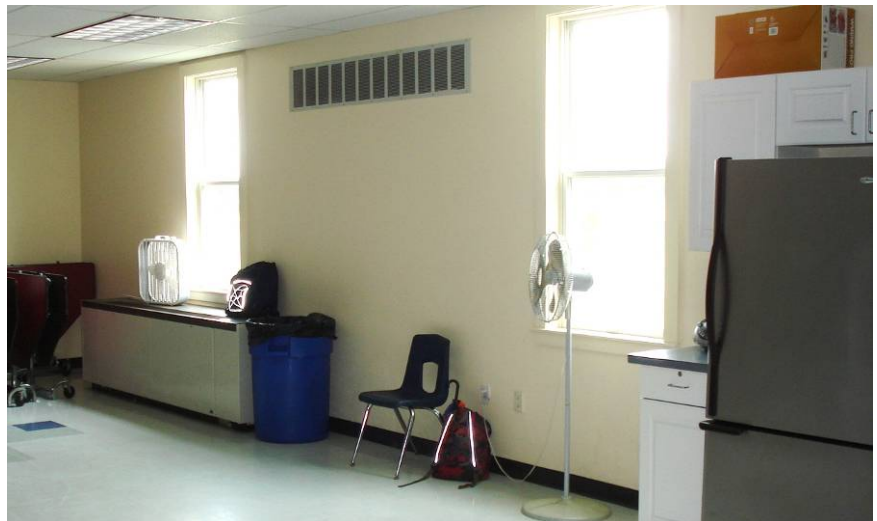
Heating and ventilation for the community room is provided through a single unit ventilator and respective relief vent louver. Mechanical cooling is not provided. At the time of review, the UV was not operating. The window was open and a large fan was circulating air in the room.

*Community Room Unit  
Ventilator and Vent*

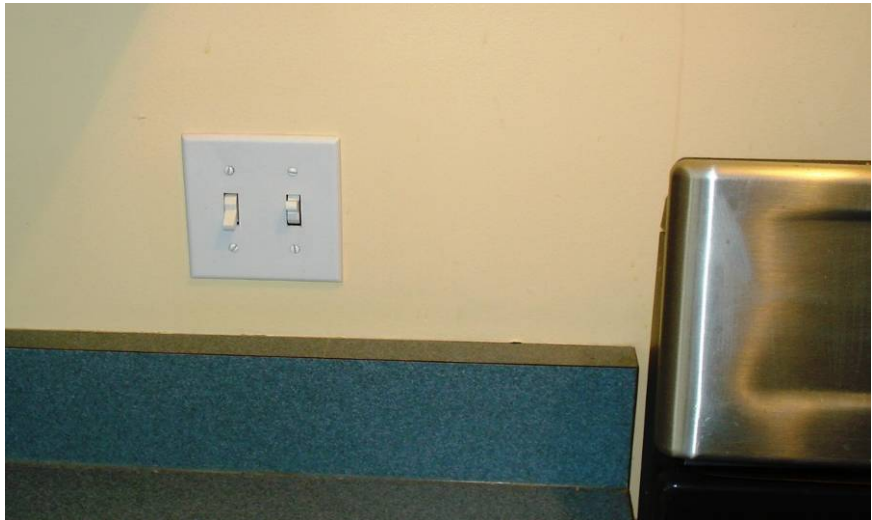
A Kees range hood is provided above the gas stove. The lights and fan of the hood are controlled through the wall-mounted switch located to the left of the range. The unit mounted switches are left in the on position. The wall-mounted switch is not labeled. An Ansul automatic fire suppression system is installed. It appears the fire suppression system is interlocked with the gas shut-off valves located behind the range.

*Hood Light and Fan Switches*

*Fan switch is in the on position.*

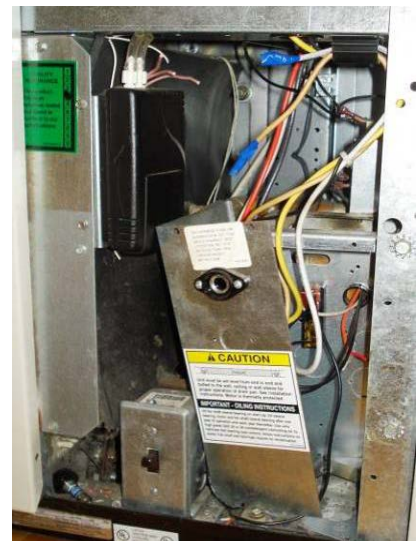
The unit ventilators are controlled through the DDC system. Based on review of the right-hand UV, it would appear it is in need of repair.

The black box at the upper left corner of the photo below appears to be a gas detector; perhaps carbon dioxide. With the tubes installed as shown in the photo, it is likely the sensor does not properly monitor the level of gases in the room or the return air from the room.

*View of Right-Hand Unit Ventilator End Panel*

We would recommend further in-depth review of both unit ventilators and the respective DDC controls.

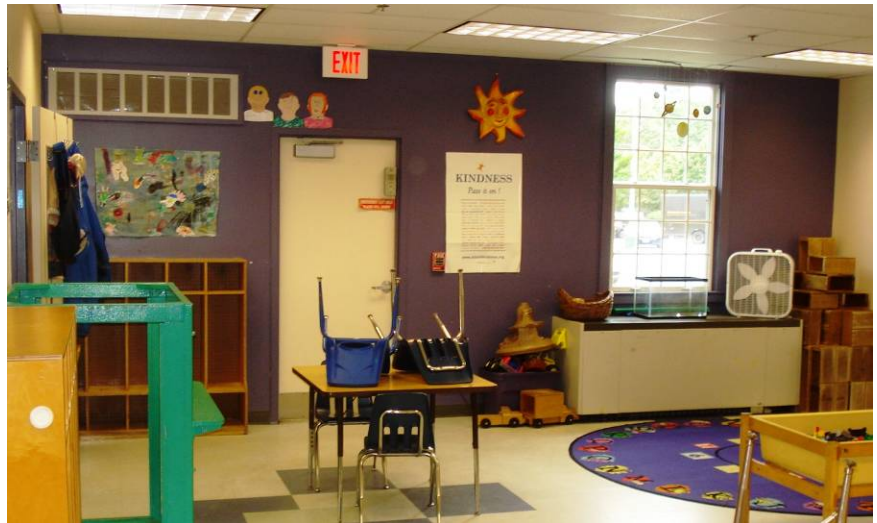
Heating and ventilation of the extended school care (ESC), meeting, living and game rooms is provided by typical unit ventilators and respective relief vents. At the time of review, the majority of the units were not operating. The displays at many of the DDC system wall sensors were blank possibly indicating the unit ventilators have been turned off. By turning the unit off, power for the unit DDC system controller may have been disconnected as well.

*ESC Room "B"*

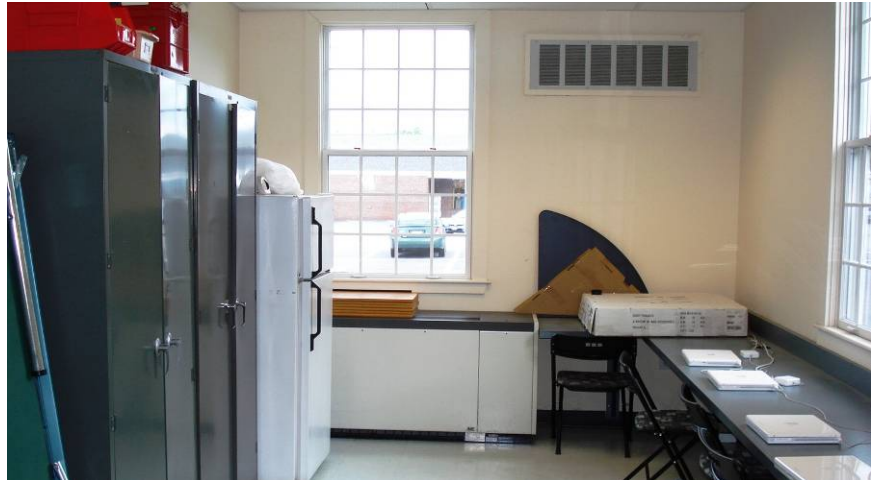
Heating, ventilation and cooling of the computer lab is provided by a unit ventilator, provided with a mechanical (DX) cooling coil, and the respective relief vents. At the time of review, the unit was not operating and the sensor display was blank.

*Computer Lab*

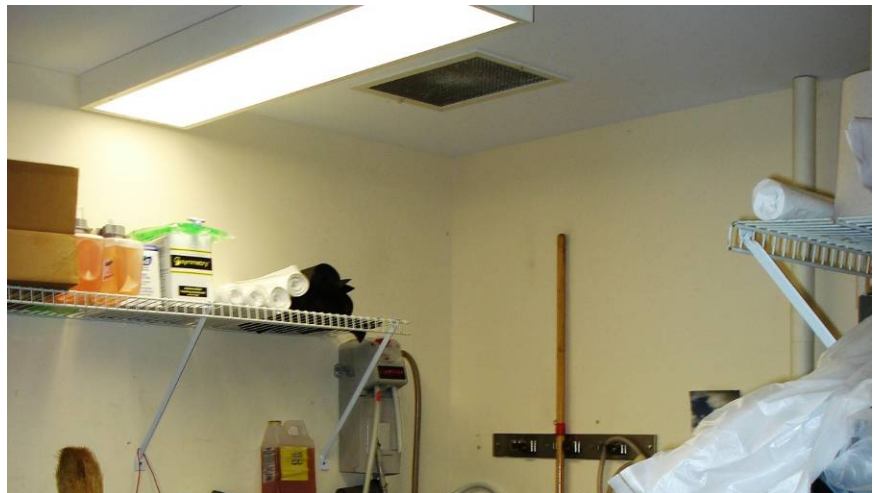
Heating is provided in the toilets and janitor closet by ceiling-mounted radiant panels controlled by individual wall-mounted thermostats. Exhaust is provided in the toilets through individual ceiling-mounted exhaust fans interlocked to operate when the lights are on.

*Janitor Closet Ceiling Exhaust Fan*

We would recommend the installation of time delay relays at each exhaust fan to allow the fan to remain operating for a delay period after the lights are turned off.

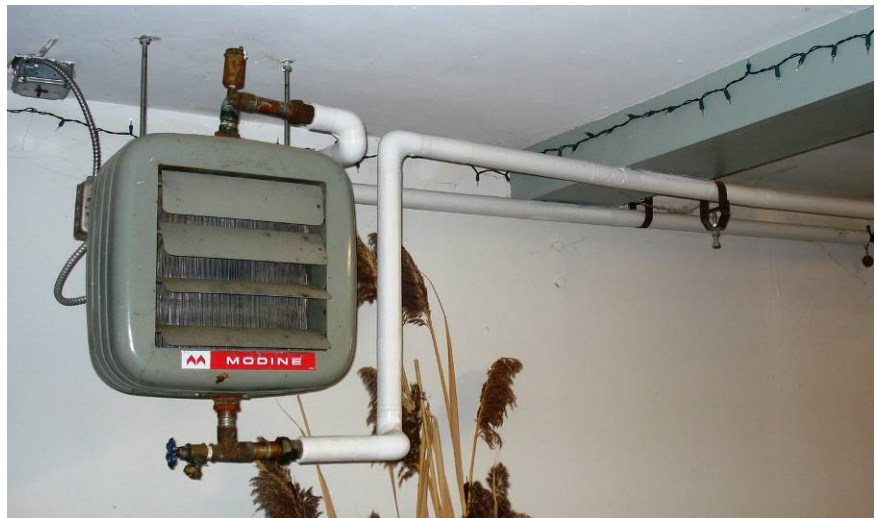
Heating is provided in the lower level spaces by a number of horizontal hot water unit heaters controlled by the respective local wall-mounted thermostats. In many locations, the piping in the lower level is not properly supported.

*Typical Horizontal Hot  
Water Unit Heater*

*Note clevis hanger upside  
down on pipe.*
