**Town of Cape Elizabeth**  
Seven Building Facility Study  
*Cape Elizabeth, Maine*

HARRIMAN | Architects + Engineers

**Introduction****Town of Cape Elizabeth Facilities Study**

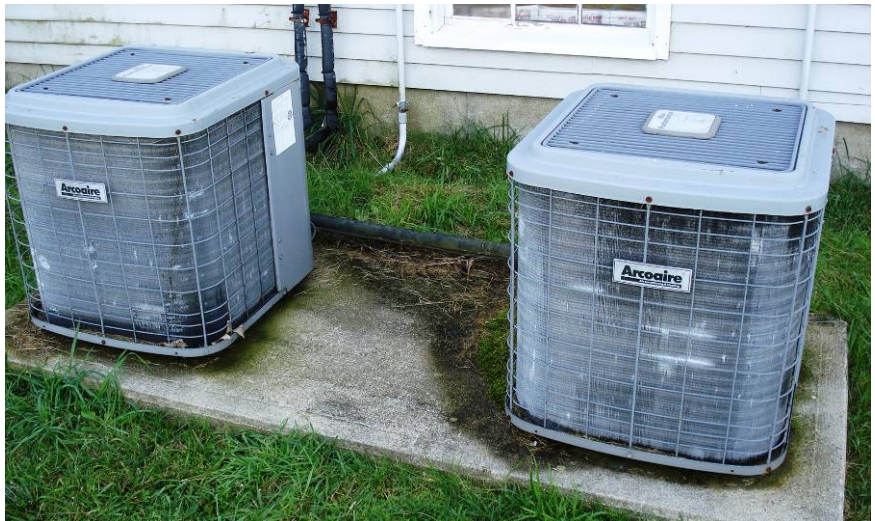
The condensing units for the Community Service office and computer lab unit ventilators and the conference room and office split-system heat pumps are located on the north side of the building. At each of the condensing units, the refrigerant and power piping is installed on grade and is showing signs of possible damage due to lawn care.

*Condensing Units for the Conference Room and Office Heat Pumps*

| M50.8 | Outdoor Condensing Unit | The condensing units and associated refrigeration and electrical piping are showing signs of age and damage. | The condensing unit are installed at or near ground level. The refrigeration lines are on grade or below and may be damaged by the lawn care equipment. One unit has been moved from the original location. | Re-install the condensing units in such a manor as to prevent damage. | \$0.00 |

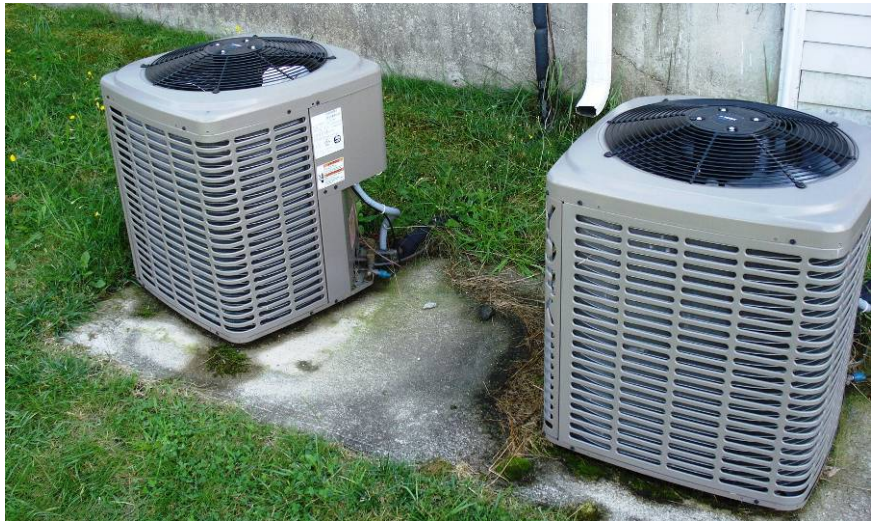
*Condensing Units for the Community Service Office Unit Ventilators*

*Note unit at left has been moved.*

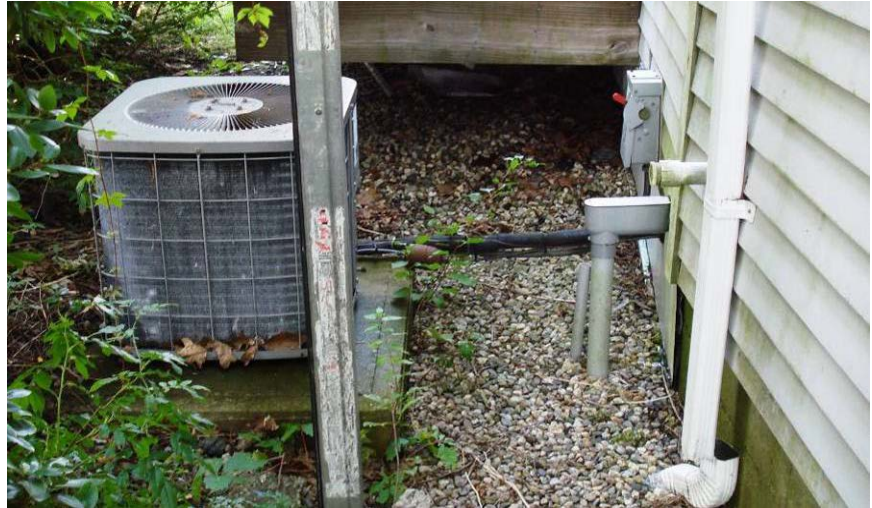
The condensing unit serving the computer lab UV is installed behind the trees near the corner of the building and is showing signs of deterioration and neglect. The fins of the coil are corroding and there is debris on the fan blade.

*Condensing Unit for the Computer Lab Unit Ventilator*

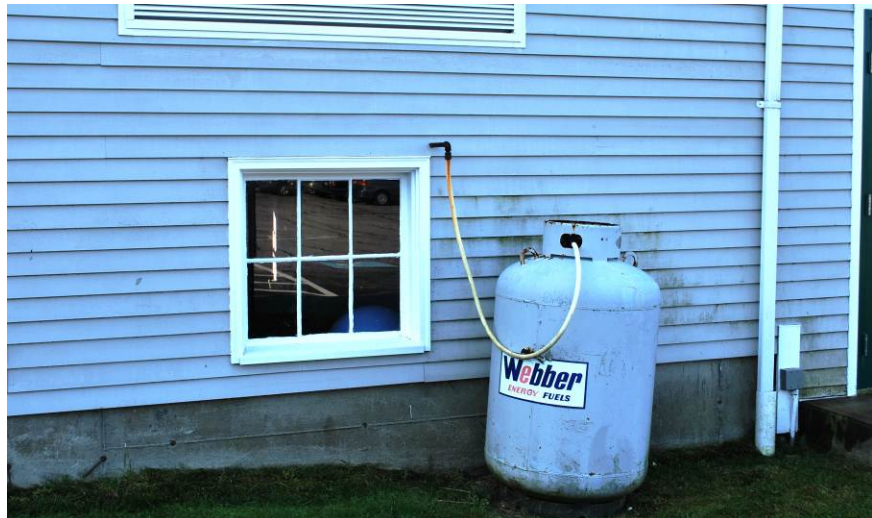
The propane storage tank for the gas range is located next to the building and within 10 feet of the adjacent window and fresh air intake louver. The tank is resting on concrete blocks below the level of the grass. The installation does not meet code.

*Propane Storage Tank*

We would recommend the relocation and installation of the propane tank in accordance with code.

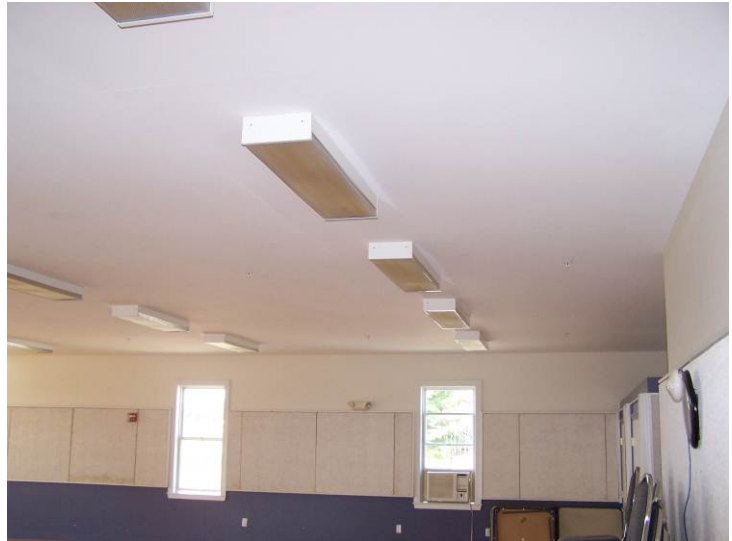
There was yellowing of the lenses observed in the Event space indicating deterioration in the acrylic lenses. There were lenses missing on several fixtures and several fixtures require lens re-adjustment.

*Surface Wraps*

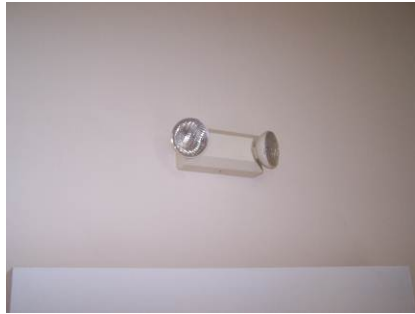
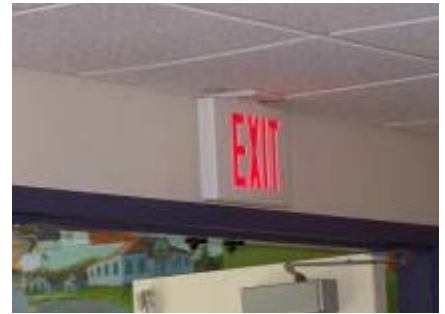
*Life Safety Lighting and Exit Signs*

Exit signs are internally illuminated. Signs are in good condition; coverage is good throughout the building. One exit sign was observed in the basement area directing emergency exit through a storage space. This is a code violation.

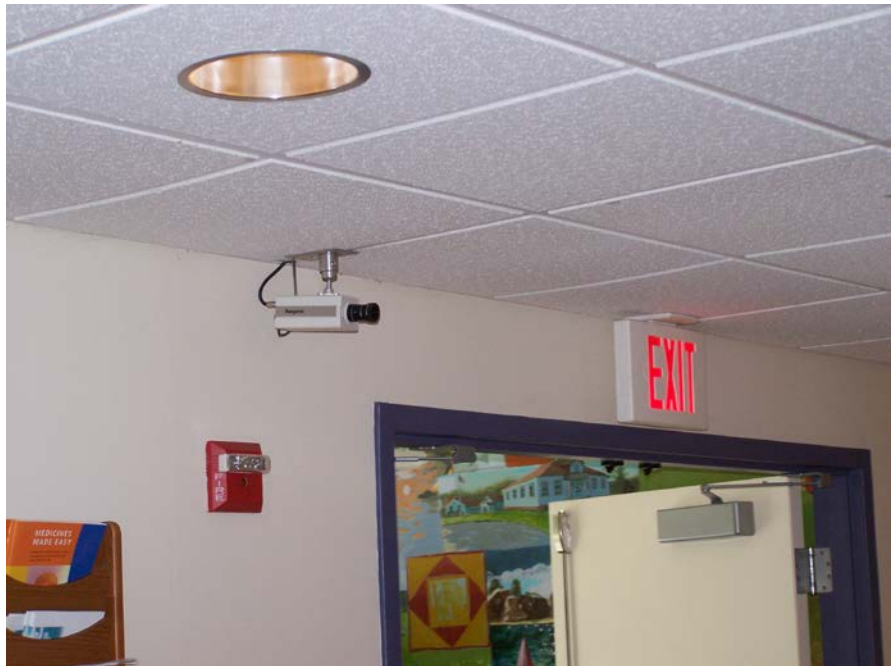
*Typical Camera*

The system is an Integral Technologies system with a mixture of legacy and upgraded video platforms. Server is based in the High School but also serves the Middle School, Pond Cove Elementary School, Police Department and Fire Department. Advance Technology is responsible for maintaining the system, and reports multiple failures of the system, with frequent database corruption and loss of camera function.

| Building #5 - Cape Elizabeth Community Services - Electrical and Technology Systems - Operations & Maintenance Budget Items | | | | | |
|---|---|--|--|--|---|
| E50.5 | Security Surveillance System | Older Integral Technologies system. Mixture of legacy and upgraded video platforms. | The camera system has encountered multiple camera failures and data corruption. | Install new surveillance system cameras and cabling, integrate with the new system in use in other town buildings. | \$10,000.00 |

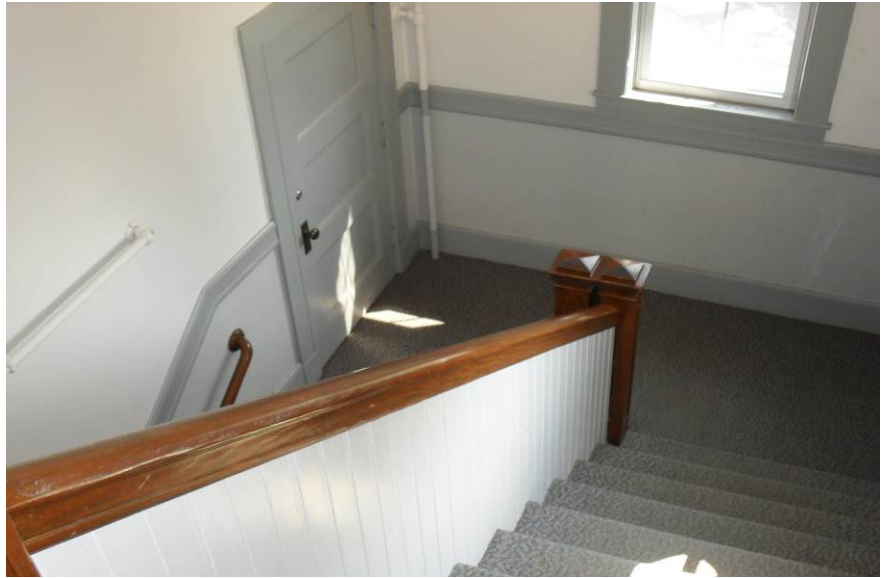
There are main stairwells on each side of the building that are original to the building with wood handrails, dividing wall and wood stair treads. The wood treads have been carpeted over and the carpet is worn. The stairwells have accessible rooms with doors off the stairwells.

*Original Stairwell  
Construction with Door  
to Storage Room*

Recommend a major upgrade to the stairwells to bring them into compliance with the life Safety Code.

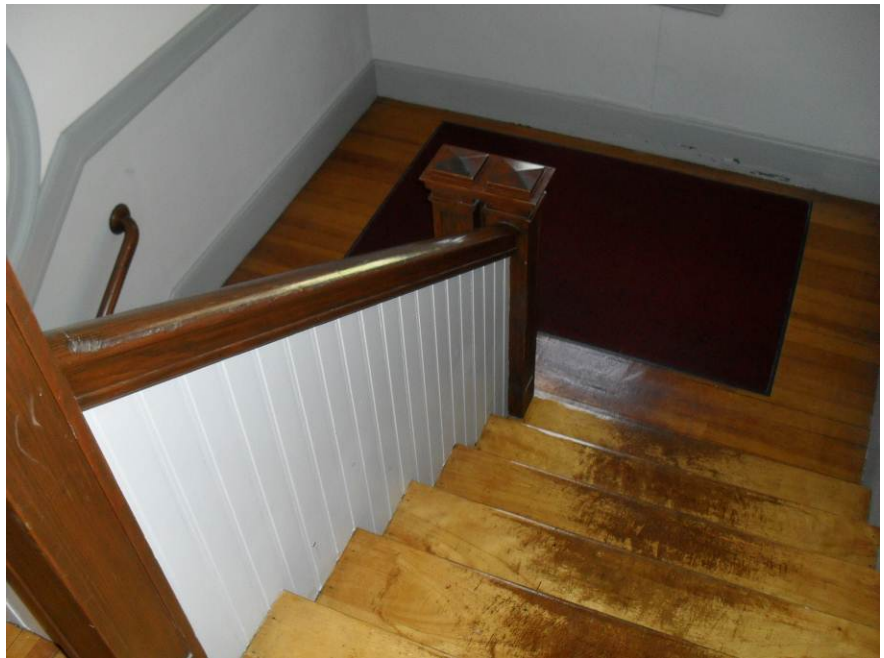
*Exit Stairwell  
Non-Compliant Stairs*

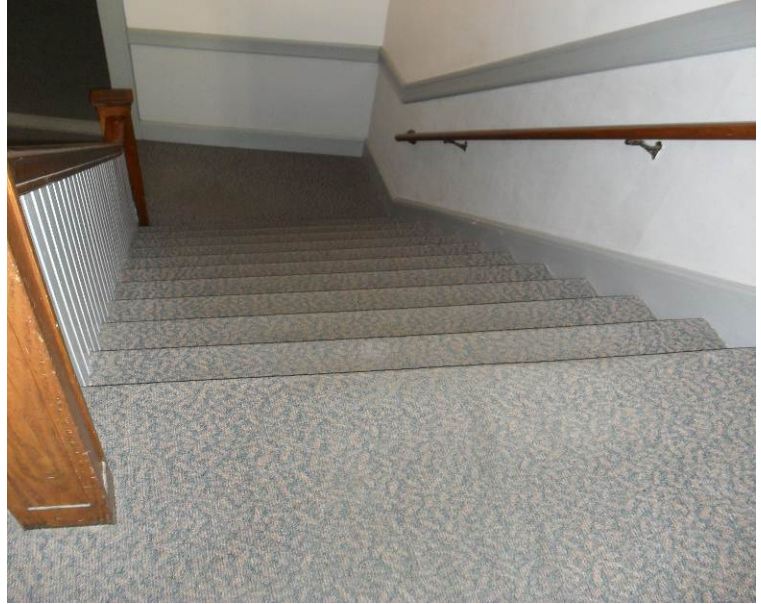
*Exit Stairwell*

*Non-Compliant Stairs*

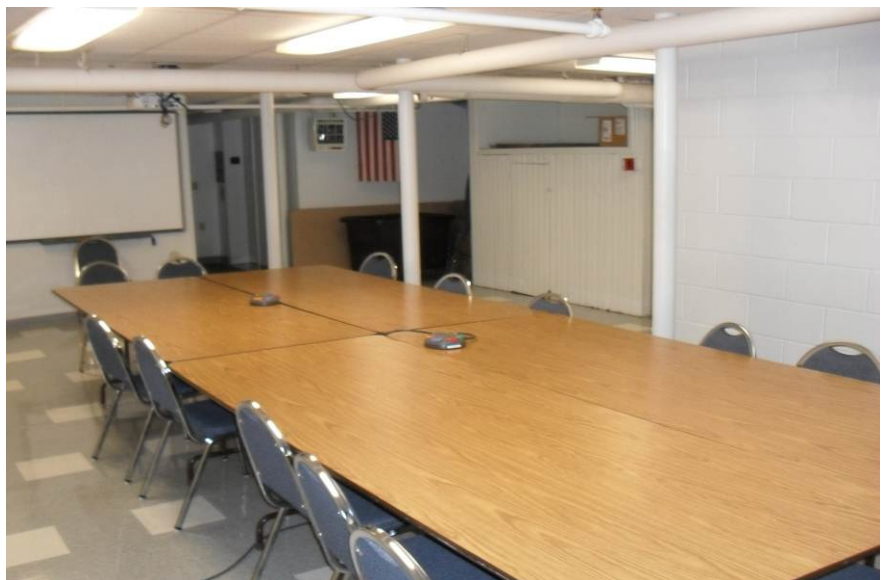
*Conference/Cafeteria*

There is a space being utilized as a conference/cafeteria area. Mounted on the wall is a sign noting a maximum capacity of 57. This space has only one means of egress to an open stairwell. This means of egress has no door separating the space from the stair. Per Life Safety Code, two means of egress are required from this sub grade level space.

*Sub Grade Space in  
Basement*

Recommend consultation with the local Fire Department about the functional use of this space and the egress issues.

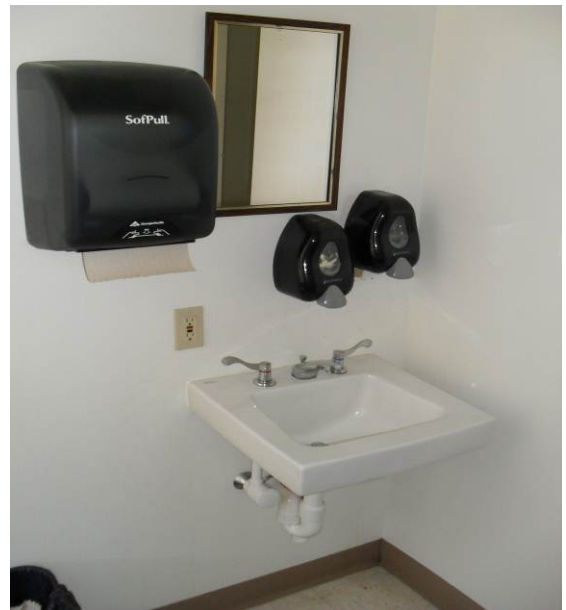
*Paper Towel Dispenser  
too Close to Sink*

Recommend relocation to be in compliance.

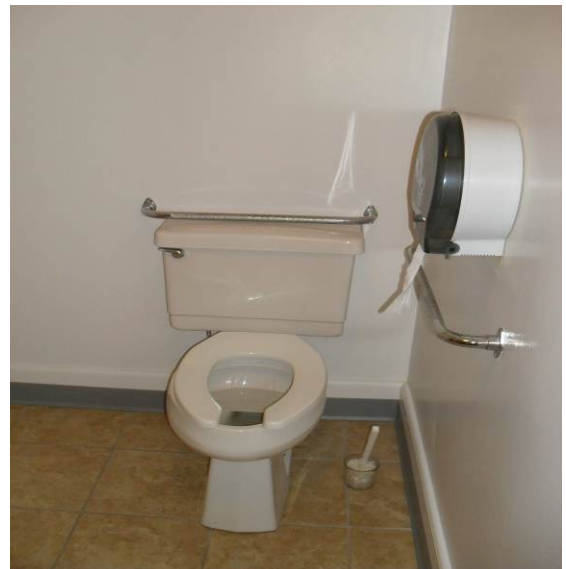
*Tissue Dispenser too  
High*

*Grab Bar Needs to be  
Higher*

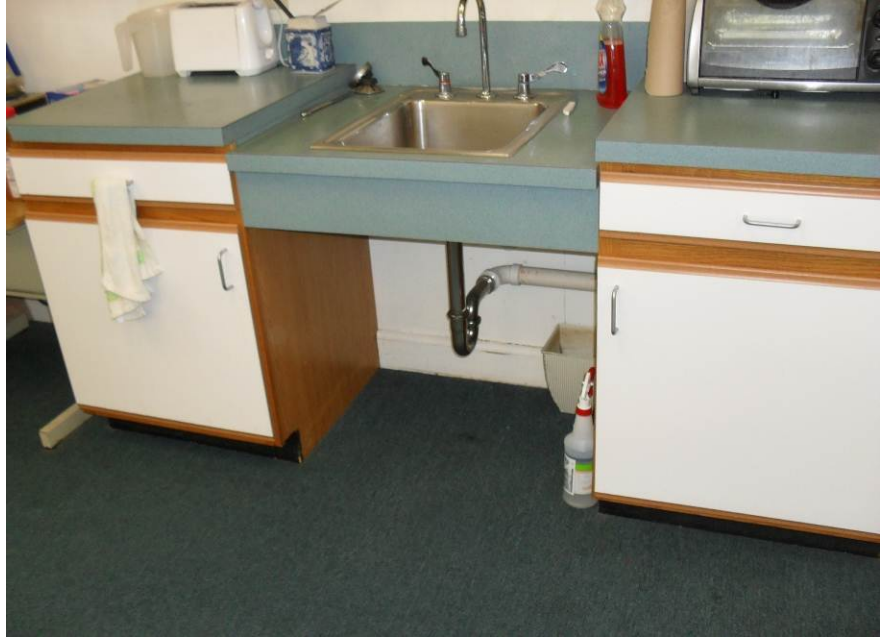
*Drain Line in Conflict with Knee Clearance*

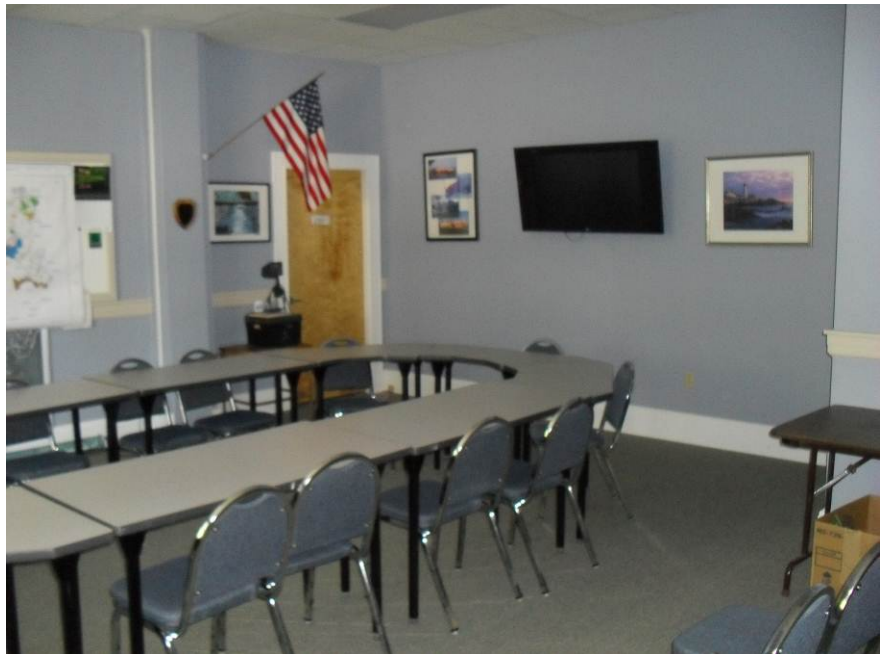
*Conference Room Next to Council Chambers*

Main conference room behind the council bench. The only means of access is through a stairwell.

Recommend when stairwells are renovated for code compliance that this door issue be addressed.

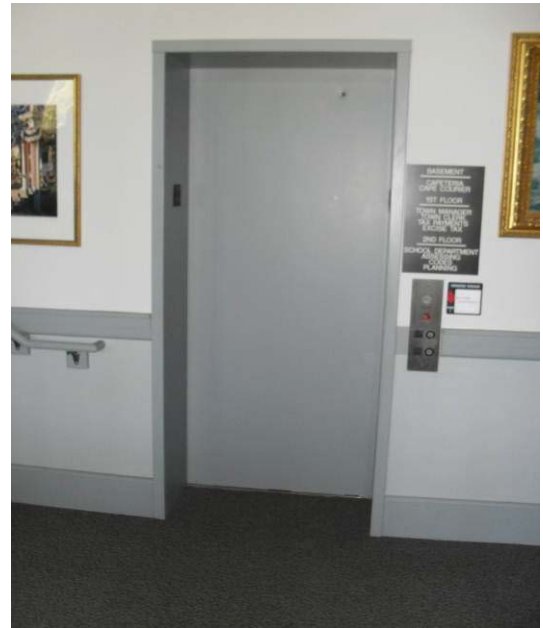
*Elevator Entrance From  
the Council Chambers*

Elevator does meet the intent of ADA. Access to this vertical accessibility system is accomplished by an accessible route though is very remote relative to the defined ADA entrance to the building.. Improved signage would be an assist to the public not familiar with the building. The size of the elevator is not current with the 2005 ADA requirements. The car as it stands is grandfathered until the time it would be relocated then it will be required by law to be sized up accordingly.

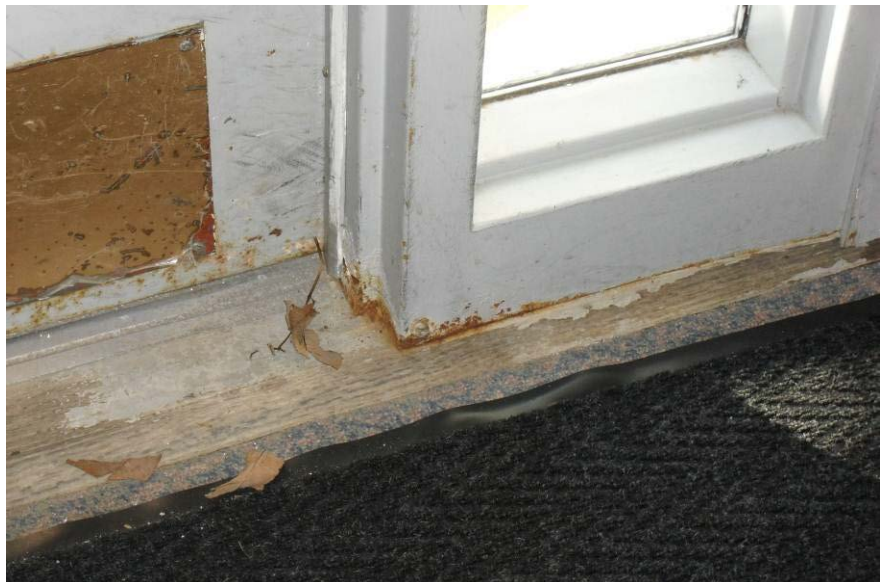
*Side Entrance Door*

The door and frame at this entrance needs to be replaced. Both door and frame are rusted and the exterior trim, although recently painted, should be replaced.

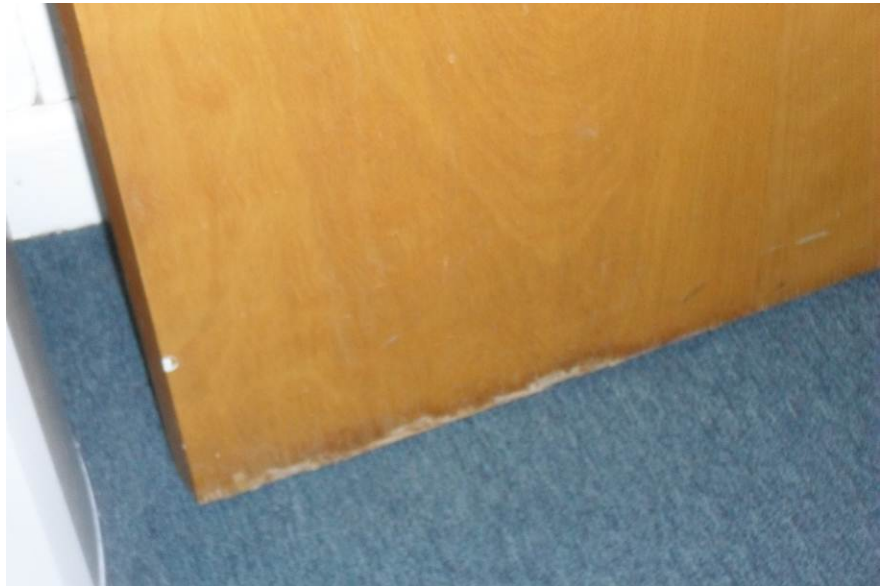
Those doors and frames that were not replaced as part of the renovation project are showing chips along the bottom edge.

These chips cannot be repaired and eventually the veneer will start to delaminate away from the core.

*Chipped Bottom Edge of  
Doors*

Recommend door replacement with kick plates as the maintenance budget would allow.

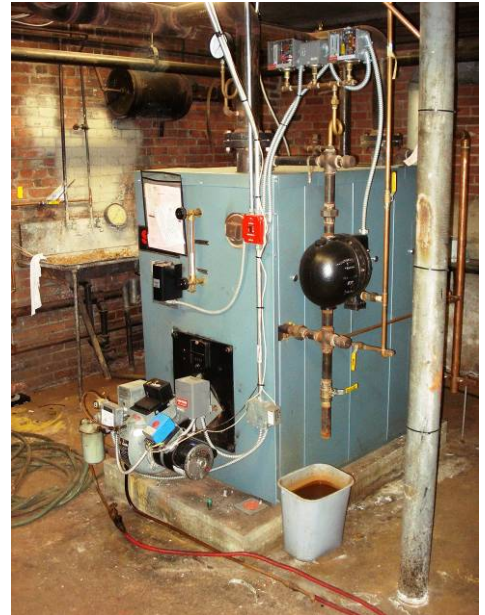
*Boiler 1*

The heating steam is generated from one H.B. Smith series 19A cast iron boiler with a Carlin oil-fired burner. According to the boiler nameplate, the net heat output of the boiler is 2,817 sq. ft. and, based on the State of Maine inspection certificate, was installed in 2003. The boiler appears to be in good condition. The water showing in the sight glass is clear and the burner is interlocked with the Direct Digital Control (DDC) system.

We would recommend re-trimming the steam boiler for conversion to hot water, removal of all steam heating system components and piping, and the installation of a hot water heating system.

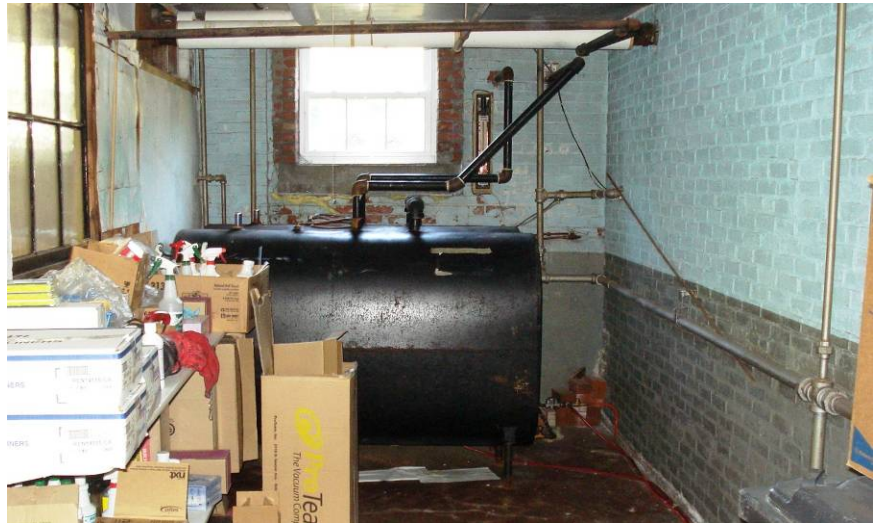
*Oil Tank*

The fuel oil storage does not meet code. Fuel oil is stored in two oil tanks located in a room adjacent to the boiler room. The oil fill pipe is installed closer than two feet to the adjacent window and does not meet code. Fuel lines are installed along the wall, in front of the door and routed into the boiler room through an open hole in the brick wall.

We would recommend the relocation of the fuel oil storage in accordance with code.

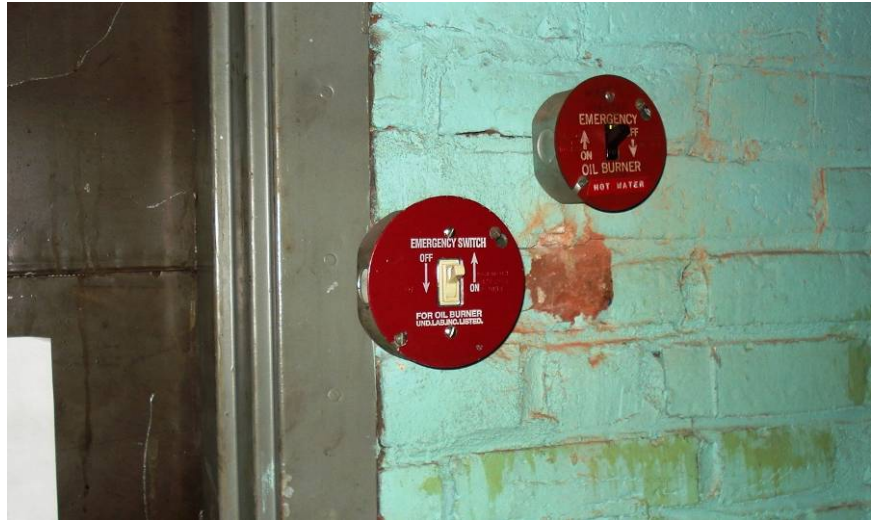
*Oil Burner Emergency Switches*

The emergency switches do not meet code. Two emergency oil burner switches are located outside of the boiler room indicating there may be two separate safety circuits. Code would require a single safety circuit to shut down all devices.

*Right switch is labeled for hot water.*

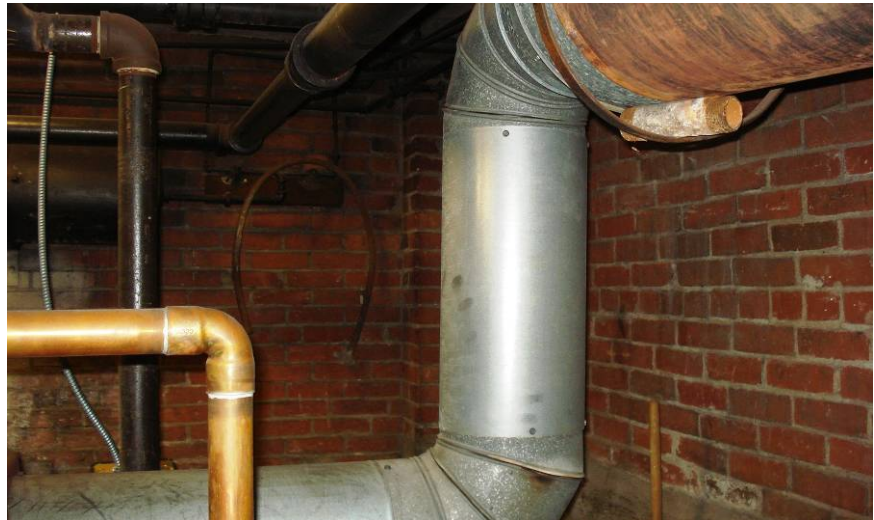
The breeching and chimney system does not meet code. The boiler and domestic hot water heater breechings appear to be a combination of single-wall un-insulated galvanized steel and older single-wall riveted un-insulated steel. The boiler and domestic hot water heater enter the breeching at the same level. The masonry chimney is unlined and does not meet code.

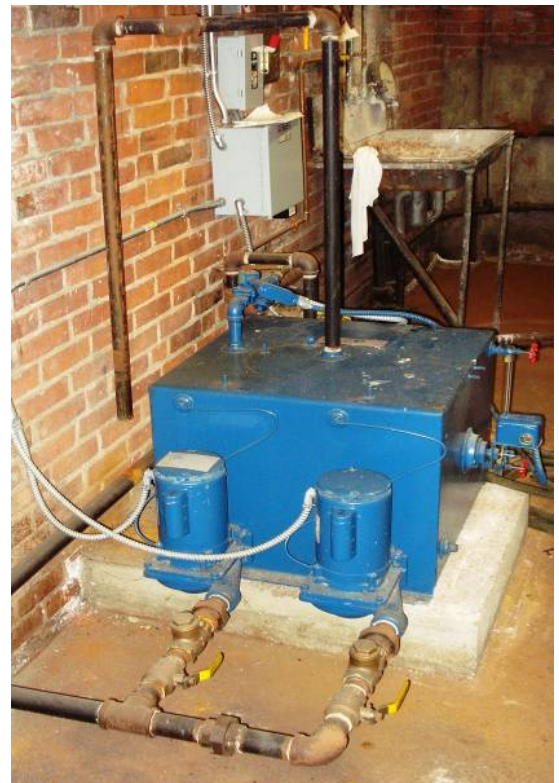
Condensate from the steam heating system is returned to the duplex pump condensate receiver tank located adjacent to the boiler. The condensate tank has been recently replaced. The tank is vented to the boiler room and does not meet code.

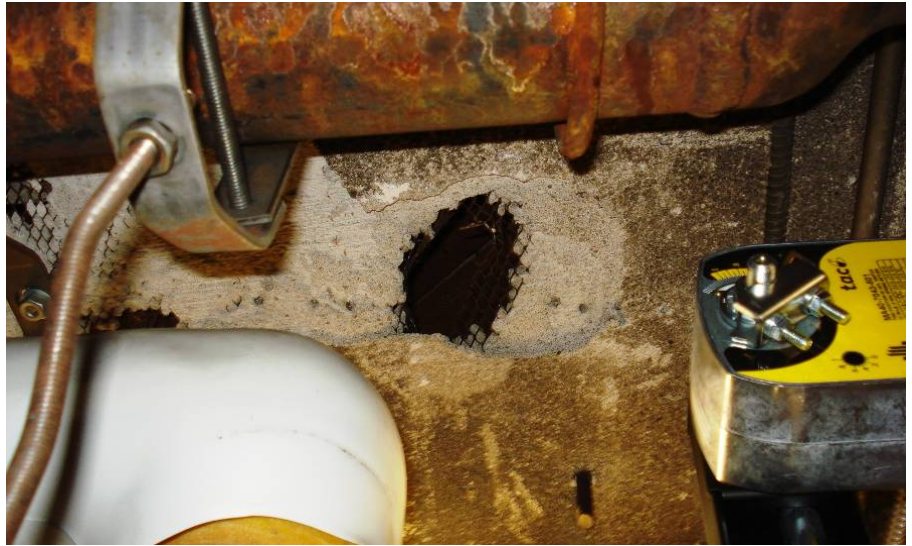
There are numerous penetrations and openings in the ceiling and walls. A non-fire rated wall has been installed to provide storage space for various combustible paper products. The door to the adjacent spaces is not fire rated.

*Typical Hole on Plaster Ceiling*

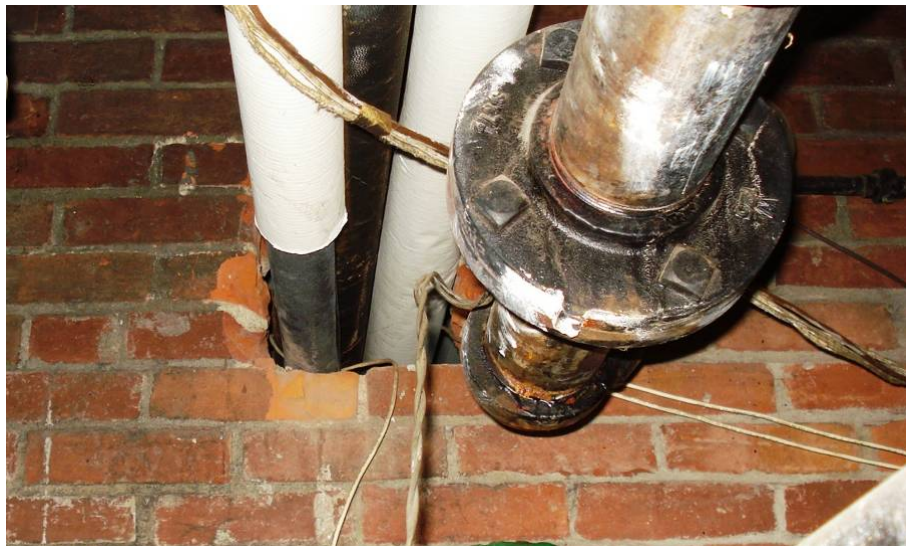
*Typical Boiler Room Wall Penetrations*

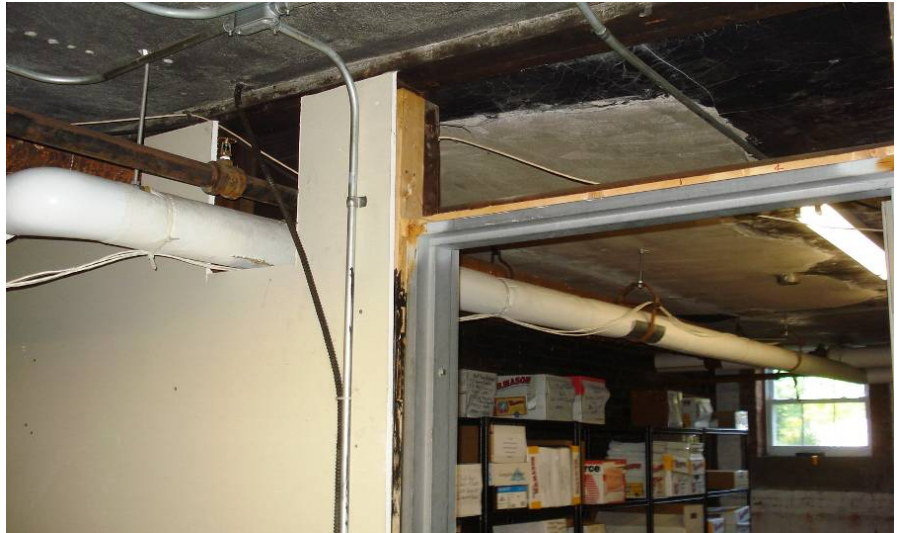
*Noncompliant Wall for Storage Room*

*Note: Combustible products on shelving.*

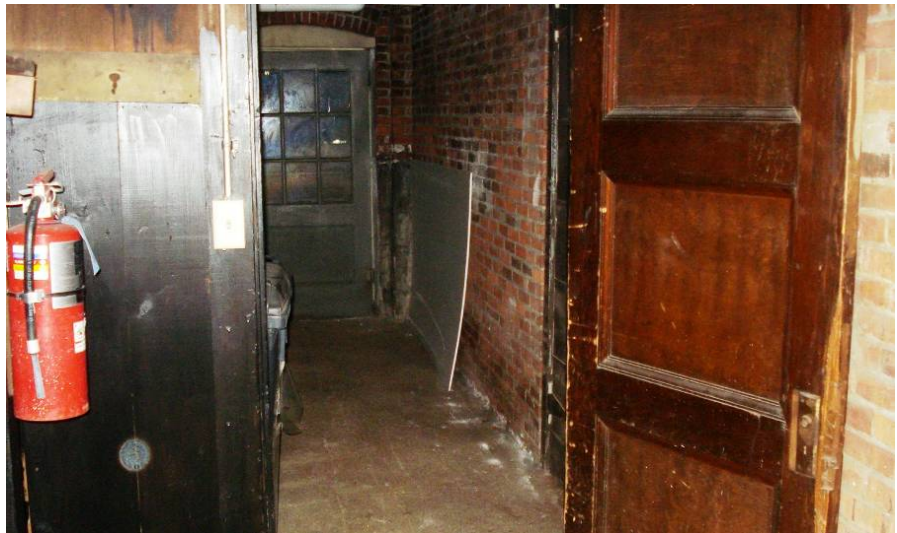
*Noncompliant Wall and Door to Adjacent Areas*

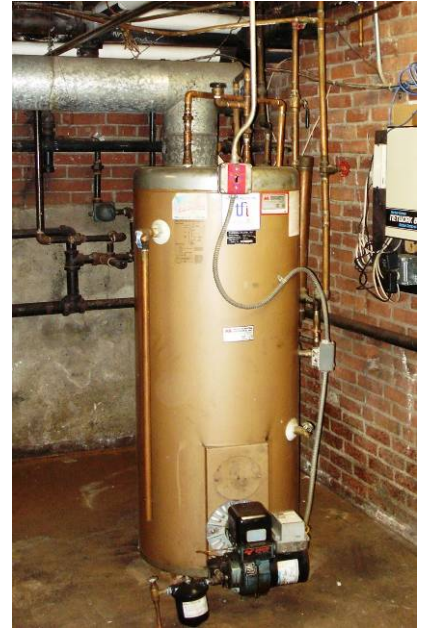
Domestic hot water is generated from an oil-fired hot water heater located in the boiler room. The age and overall condition of the heater is unknown.

*Oil-fired Domestic Hot Water Heater*

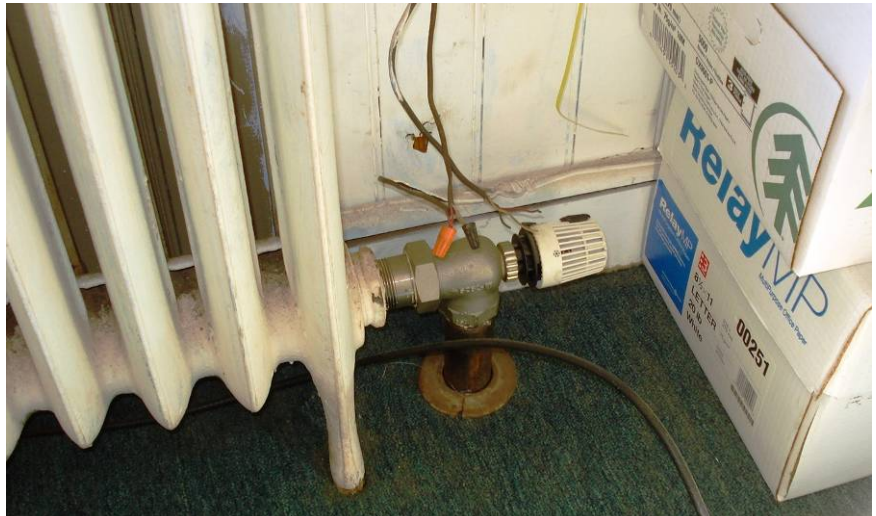
Heating is provided in the building through old-style cast iron steam radiators or cast iron baseboard radiation with a variety of self-contained automatic control valves, electric automatic steam control valves, or no control valves. When the system is heating, the steam radiators would be very hot. Some of the old wiring has been abandoned in place. Some of the wiring connections to the electric valves are exposed. As a whole, there is a substantial lack of controllability.

*Example of Self-Contained Control Valve on Cast Iron Radiator*

*Notice exposed abandoned control wiring at valve.*

As noted above, we would recommend the removal of all steam heating system components and the installation of a hot water heating system.

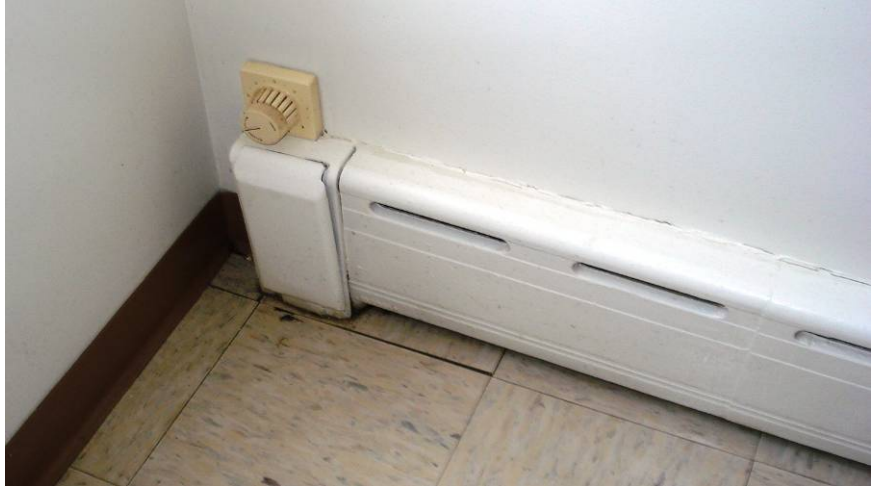
*Example of Self-Contained Valve on Cast Iron Baseboard Radiation*

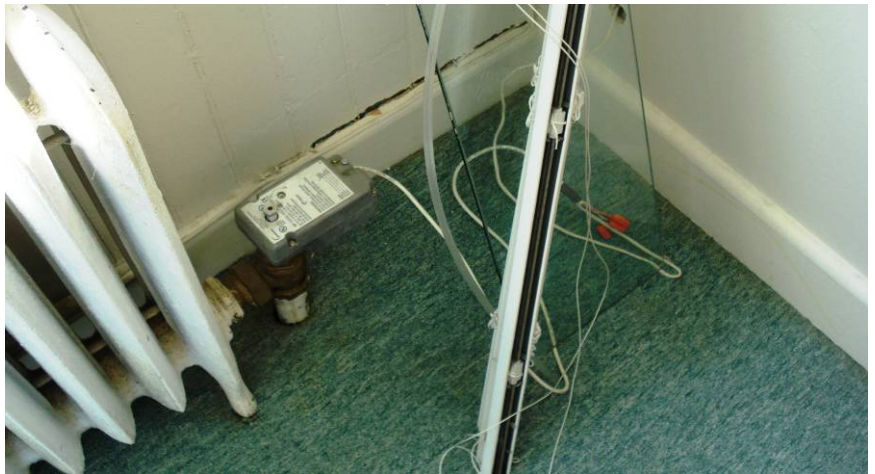
*Example of Electric Automatic Control Valve on Cast Iron Radiator*

*Notice the exposed wiring connection to the right of the valve.*

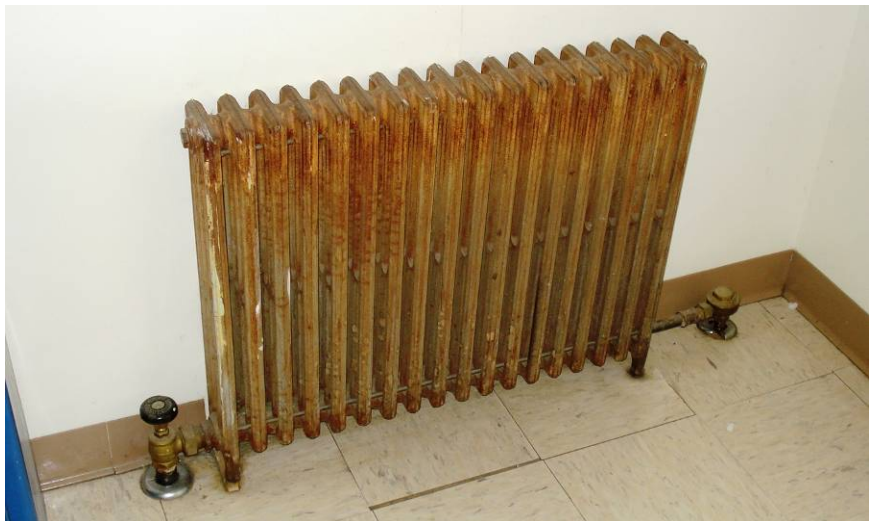
*Example of Steam Radiator Without an Automatic Control Valve*

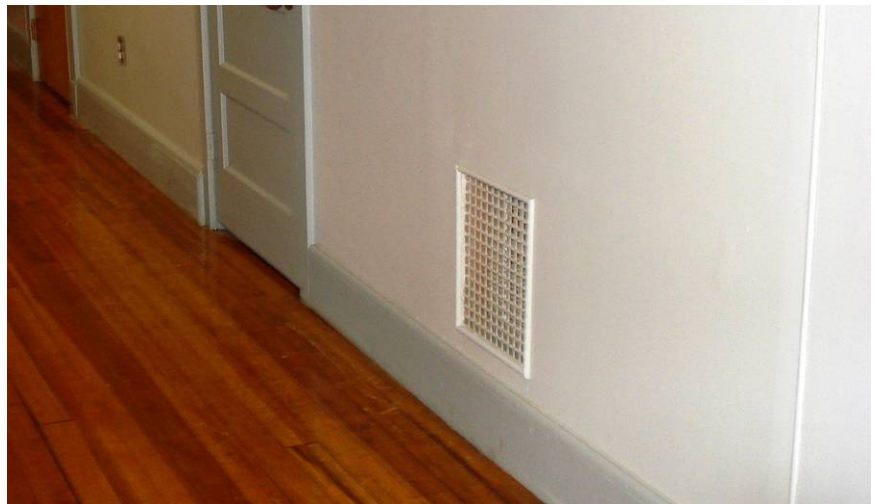
Currently, in general, there is no mechanical ventilation provided. Occupants open windows for ventilation and fresh air. Cooling is provided in certain areas through the use of window-mounted air conditioning units installed in the operable windows or more permanently installed through the exterior walls of the building.

*View of Old Wall Vent*

We would recommend the installation of an engineered ventilation and air conditioning system.

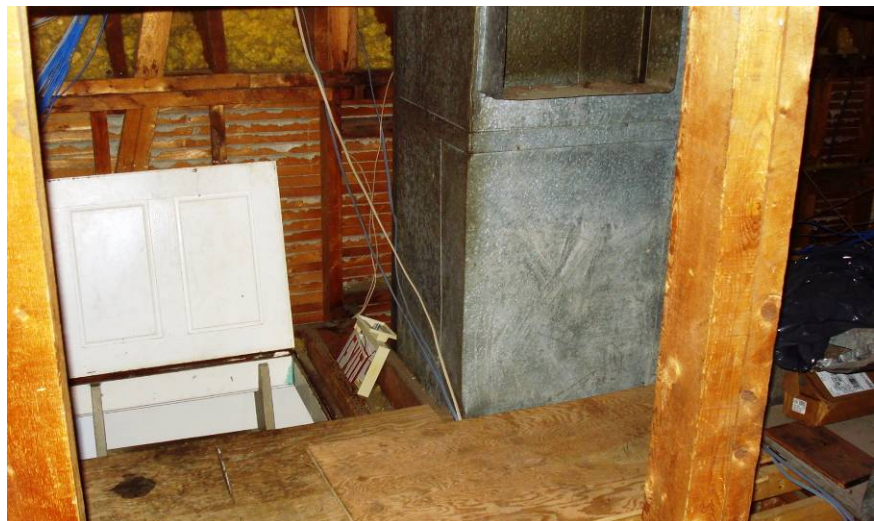
*View of Abandoned Ductwork in Attic*

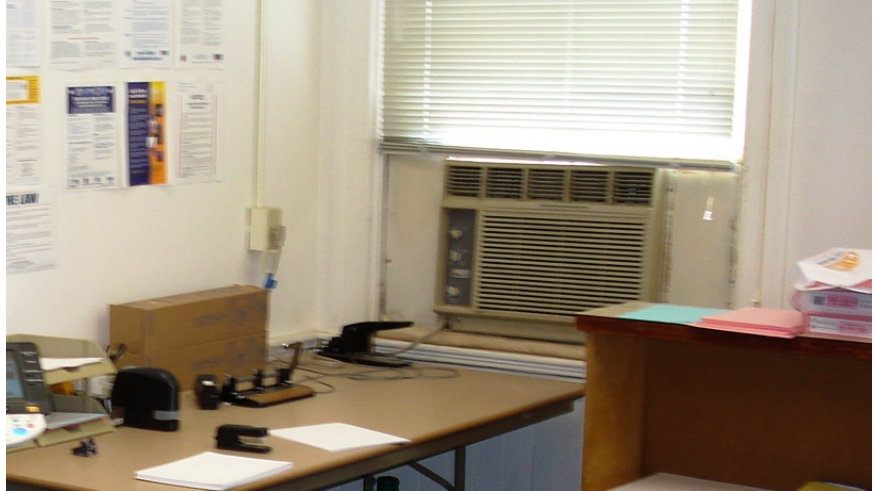
*Example of Window Air Conditioning Unit Installed in Window*

| Building #6<br>Cape Elizabeth Town Hall - Mechanical | | | | | | *Priority Scale: #1 = 1 year<br>#2 = 2 years<br>#3 = 5 years<br>#4 = Future |
|--|--|---|---|--|---|---|
| M6.3 | Ventilation and Air Conditioning | Mechanical ventilation is not provided in the building. Air conditioning is provided through window air conditioners installed in the windows or through the walls. | Window air conditioning units may be effective in cooling small areas but are inefficient for cooling larger office areas. | Install an engineered ventilation and air conditioning system. | \$350,000.00 | 3 |

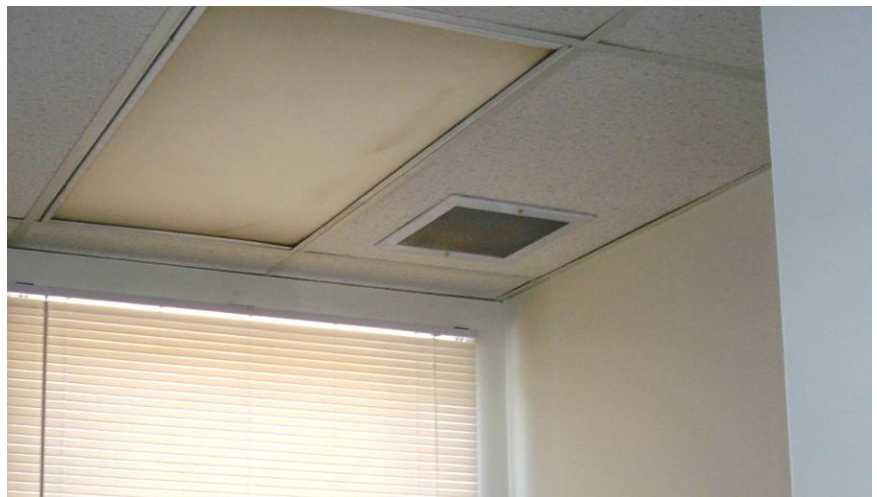
Exhaust is provided in the toilets and the print/copy room through individual ceiling-mounted exhaust fans interlocked to operate when the lights are on. The discharge of each fan is either ducted directly to outside of the building through the exterior wall caps or a common duct to the roof vent. It is unknown if each exhaust fan is provided with a backdraft damper.

*View of Toilet Ceiling Exhaust Fan*

We would recommend the installation of time delay relays at each exhaust fan to allow the fan to remain operating for a delay period after the lights are turned off.

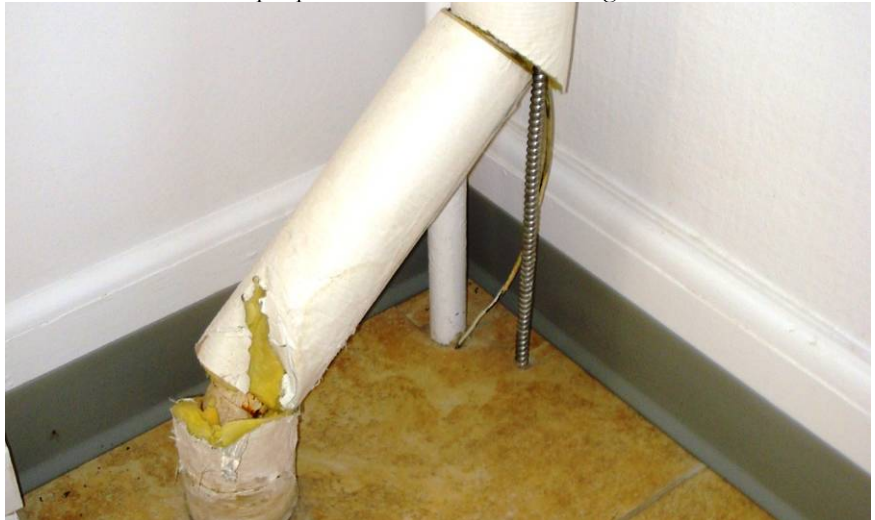
In one of the council chambers toilets there is a section of power and cable wiring installed under the pipe insulation.

*View of Power Wiring  
and Cable Installed  
Under Pipe Insulation*

We would recommend proper installation of the wiring.

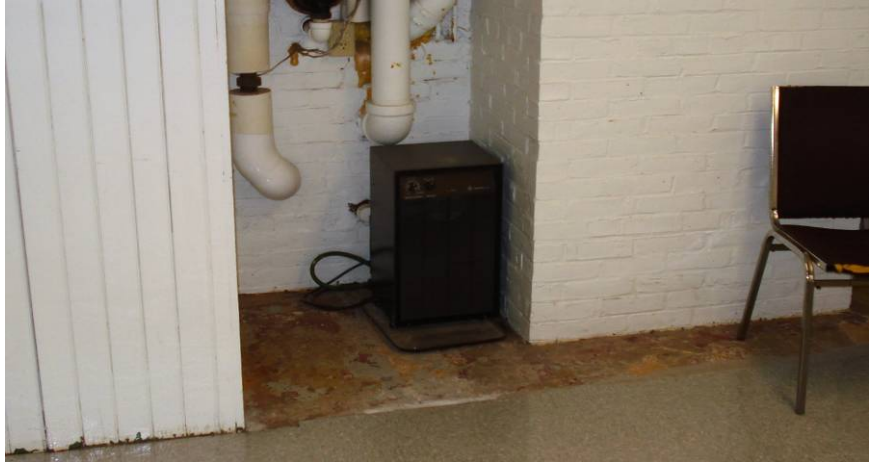
There is no ventilation provided to the tech conference room. Heating is provided through ceiling-mounted cast iron radiators similar to the one at the end of the small corridor. A small dehumidifier has been provided to reduce the humidity levels. The capacity of the dehumidifier is unknown. The discharge of the container is installed through the wall. Termination of the other end is unknown.

*View of Dehumidifier  
Located in Tech  
Conference Room*

We would recommend the installation of proper ventilation for the basement tech conference areas.

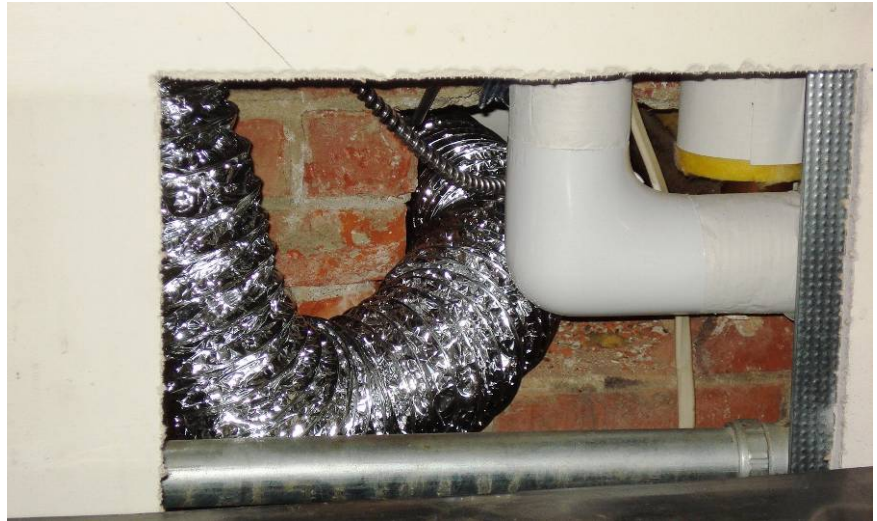
Through the wall of the room to the left of the ground floor elevator entry, we observed flexible duct and an inline fan typically used for dryer exhaust. If this is being used as drier exhaust, it does not meet code.

*View of Possible Dryer Duct Installed Through Wall*

We would recommend further review and possible corrective action.

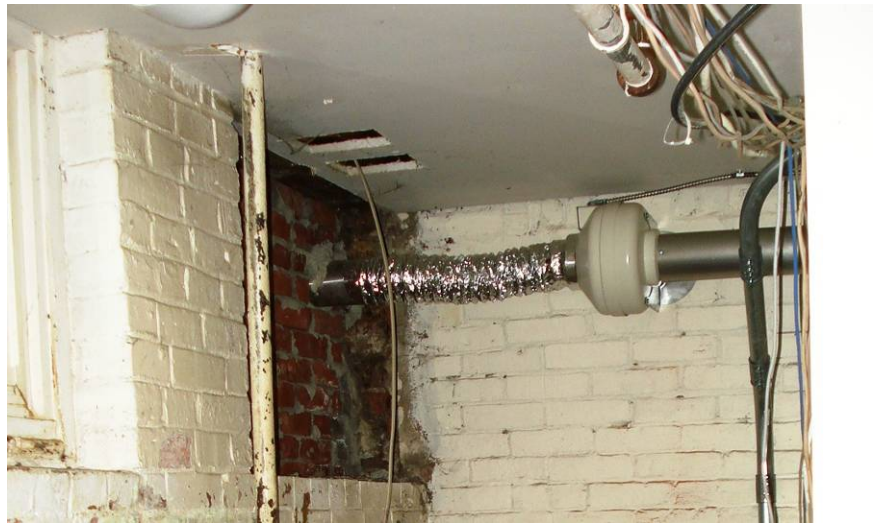
*View of Drier-Type In-Line Exhaust Fan*

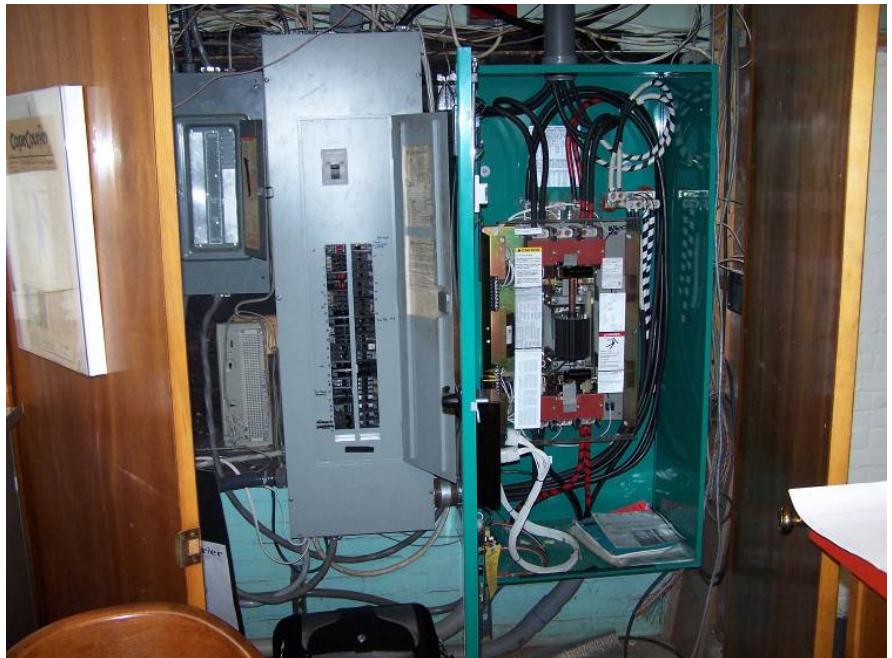
The main service consists of secondary conductors from the exterior meter directly feeding the normal side of a 400A automatic transfer switch; no service disconnecting means was observed. National Electrical Code requires service entrance conductors to be provided with a service disconnecting means. Currently there is no way to safely perform maintenance on the transfer switch without having Central Maine Power Company disconnect power to the building.

*Main Panel &  
Automatic Transfer  
Switch*

| ITEM | System | System Status | Assessment of System | Recommended Maintenance System Replacement | Probable Cost |
|---|---|--|--|--|---|
| E60.2 | Standby System | 100kW generator and 400A transfer switch provide standby power to entire building. | System is in good condition. Generator is too close to building and has been shifted from its concrete pad. No main disconnect before the transfer switch. | Relocate generator to a more remote location. Re-feed transfer switch via main disconnect. | \$10,000.00 |

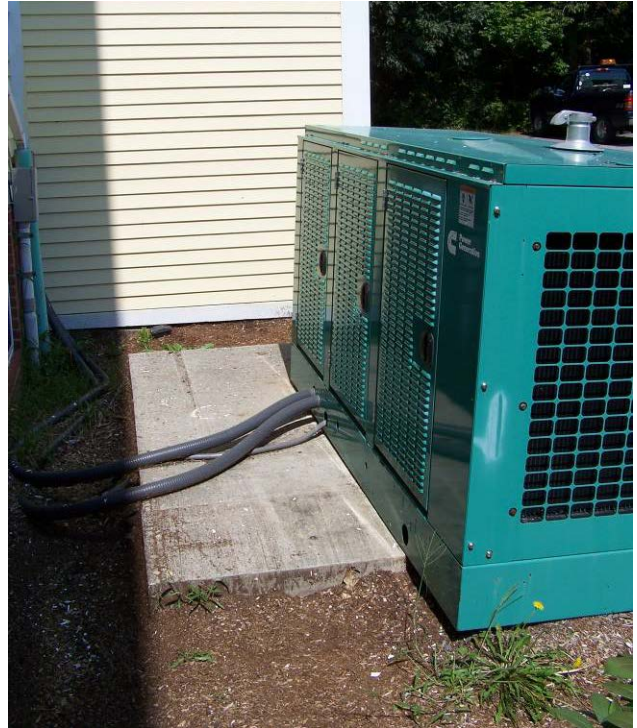
The standby portion of the automatic transfer switch is connected to an exterior 100kW 120/240V 1 phase 3 wire self-contained Cummins Onan propane gas generator. The generator was observed to have shifted from its concrete base.

*Standby Generator*
