**Town of Cape Elizabeth**  
Seven Building Facility Study  
*Cape Elizabeth, Maine*

HARRIMAN | Architects + Engineers

**Introduction****Town of Cape Elizabeth Facilities Study**

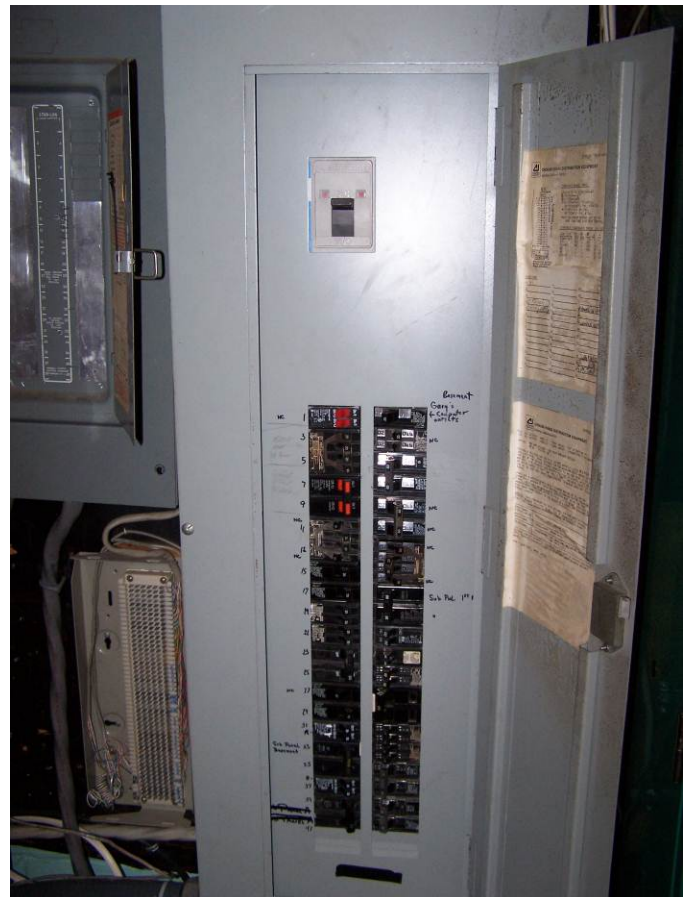
The main distribution panel is a 400A 120/240V 1 phase 3 wire Crouse-Hinds panelboard located in Cape Courier lease space in the basement. The main distribution panel is fed by the automatic transfer switch and in turn feeds multiple panels throughout the Town Hall. Distribution equipment varies in age and condition from very old Federal Pacific load centers to newer Siemens panels.

Some of the distribution equipment appears to be in poor condition and many different wiring types were observed including knob and tube, cloth covered, romex (some with undersized ground conductors), metal clad, and single conductors in conduit. Many code violations were observed including multiple open junction boxes, undersized grounding conductor, minimum clearances not met, and unsupported cables.

*Main Distribution Panel*

| ITEM | System | System Status | Assessment of System | Recommended Maintenance System Replacement | Probable Cost | * Priority |
|---|---|--|---|--|---|---|
| E6.1 | Service entrance and Distribution | 400A main panel feeds multiple panels throughout the building. Panels have been added at various times. Some distribution equipment is very old and unserviceable. | Distribution system needs to be replaced with new equipment. Main distribution equipment should not be in locked lease space. | Remove existing distribution and replace with new in central electrical room. | \$40,000.00 | 1 |

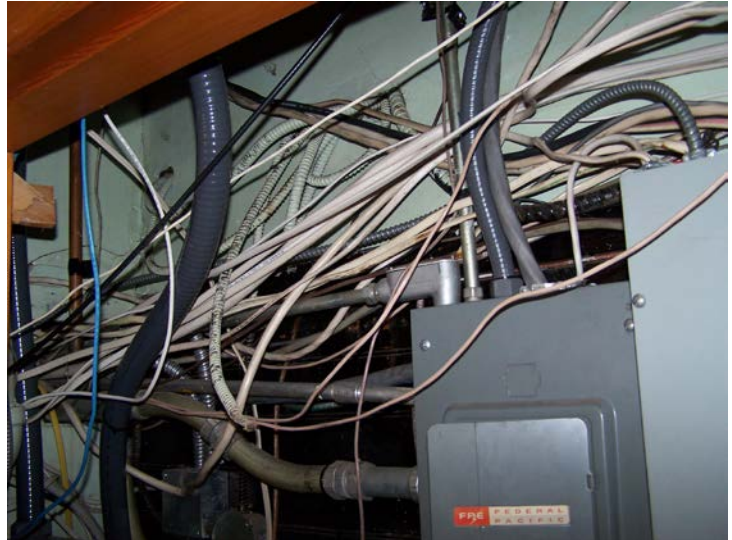
*Wiring above Main  
Distribution Panel*

| ITEM | System | System Status | Assessment of System | Recommended Maintenance System Replacement | Probable Cost | * Priority |
|---|---|--|---|--|---|---|
| E6.2 | Power Wiring | Many different wiring types including knob and tube, cloth covered romex, romex with undersized ground. | Many code violations. Many instances of unsupported wiring, open junction boxes. Some of the wiring poses a fire hazard. | Remove power wiring and replace with new. | \$70,000.00 | 1 |

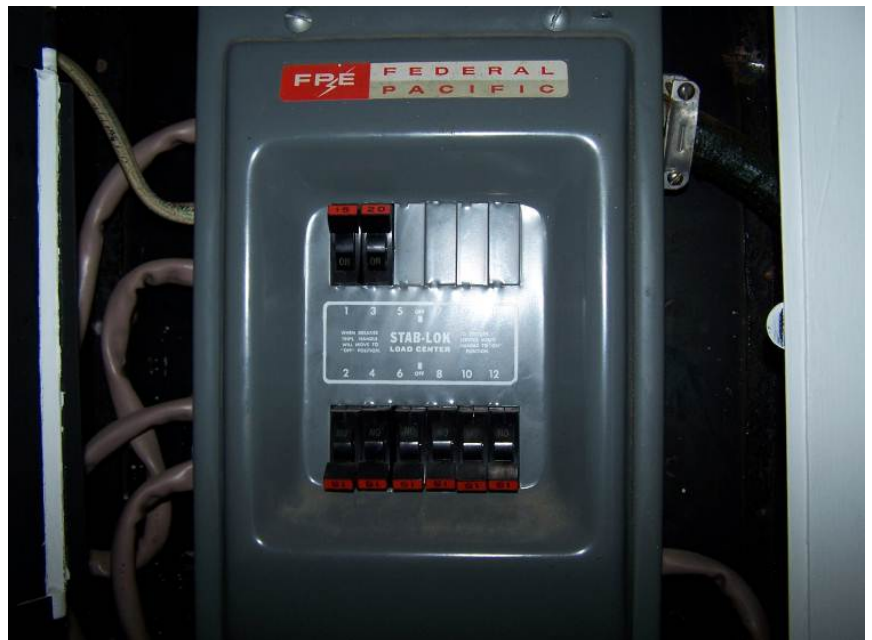
*Federal Pacific Stab-Lok  
Loadcenter*

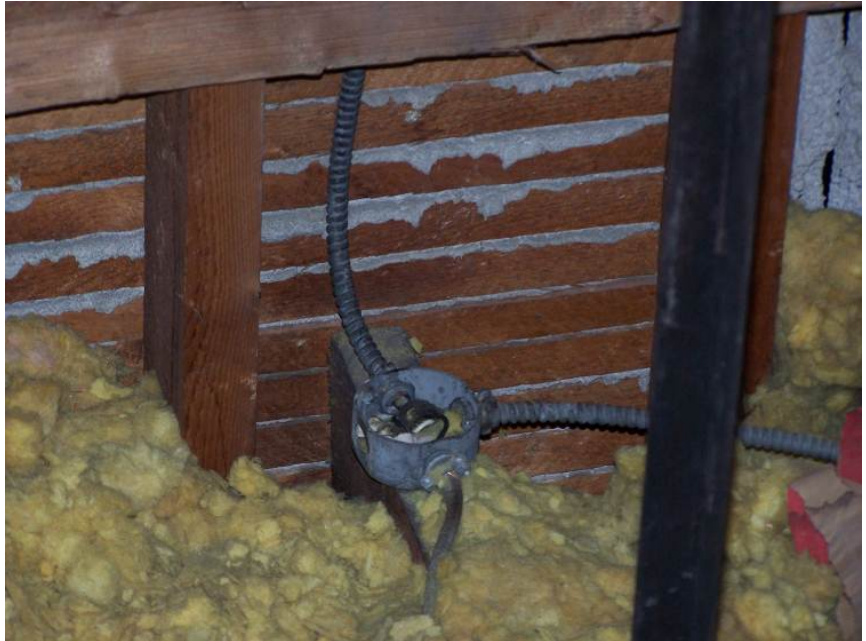
*Open Junction Box*

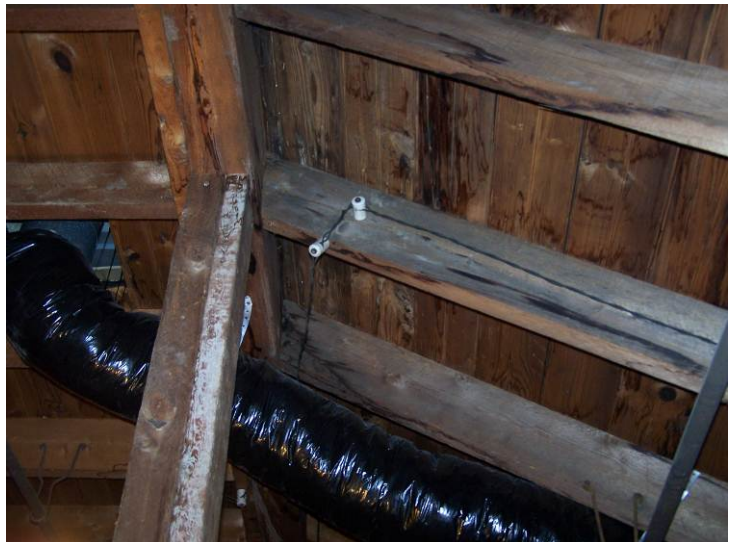
*Knob and Tube wiring*

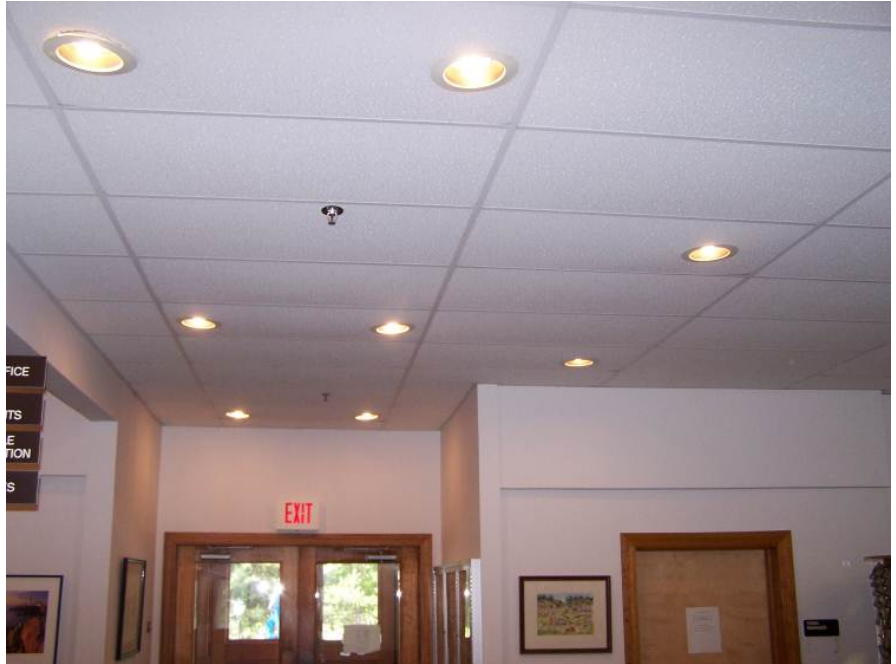
*Incandescent Downlights*

| ITEM | System | System Status | Assessment of System | Recommended Maintenance System Replacement | Probable Cost | * Priority |
|---|---|--|---|--|---|---|
| E6.3 | Lighting | Most lights are T8 fluorescent fixtures with electronic ballasts but there a variety of other fixtures including some incandescent. | Most fixtures are in good condition. | Replace incandescent fixtures with compact fluorescent. | \$10,000.00 | 1 |

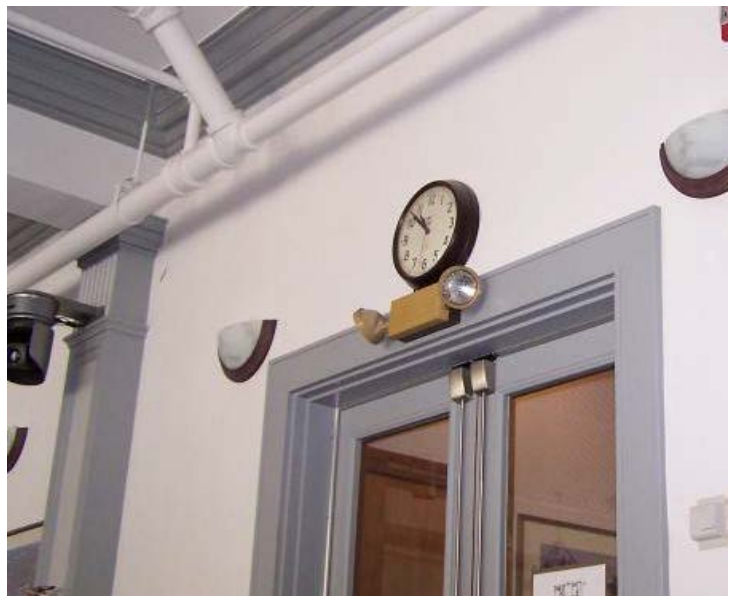
Emergency lighting was observed throughout the building. These units are surface wall mounted self-contained battery units with remote heads (EBUs). Generally EBU's are in serviceable condition with some updates. Several are showing signs of age. Coverage is good in most areas.

*Life Safety Lighting*

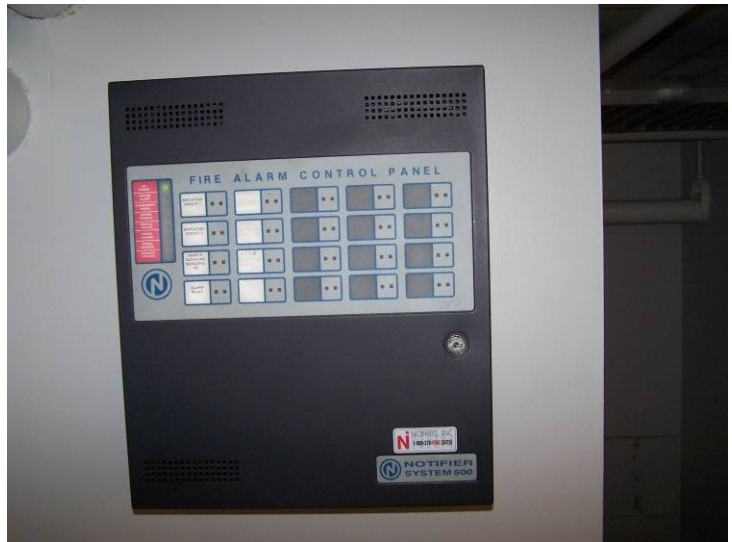
The Town Hall is served by a fire alarm system. The fire alarm system is a Notifier Sytem-500. Notification appliances, smoke detectors and pull stations are located throughout the building. In the event of an alarm, the system reports directly to Portland monitoring / dispatch facility. Coverage appears good in most areas although several areas were observed to have insufficient notification appliance coverage.

*Fire Alarm System*

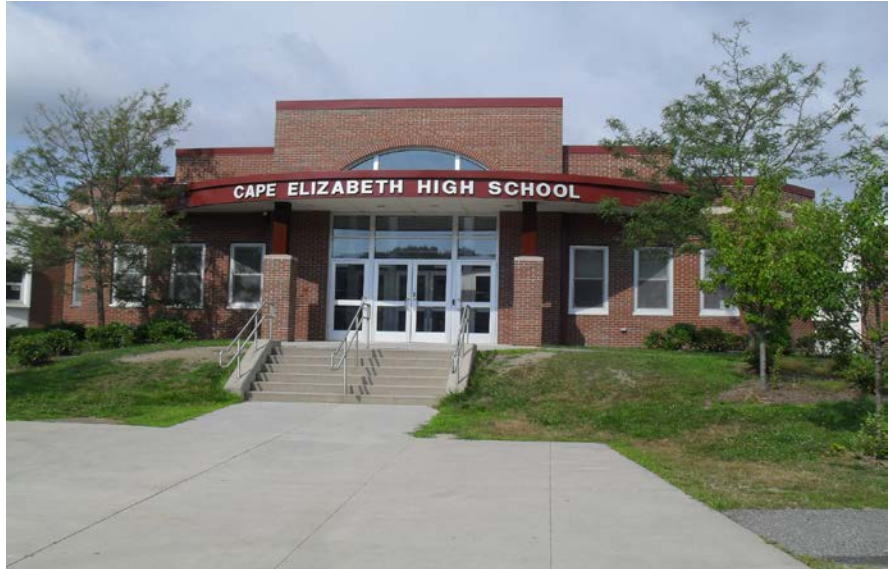
The issue of building security for the schools as part of our observations should be looked at to bring the schools up to current state standards for schools. Both school complexes lack a comprehensive security system for monitoring the building entrances, the corridors, visitors to the building and a building lockdown system in case of an event within the building.

We know that the software infrastructure for this type of system is currently being reviewed and priced for potential installment. To reach the level of security noted you should consider this upgrade as an add-on to you current web-based software system.
